Archaeological Survey,  
Glen (Old) Church & Graveyard,  
Rathkieran,  
Co. Kerry.

September 2007

Client: The Heritage Office,  
Kerry County Council,  
County Buildings,  
Ratass,  
Tralee,  
Co. Kerry.

RMP No.: KE096-009

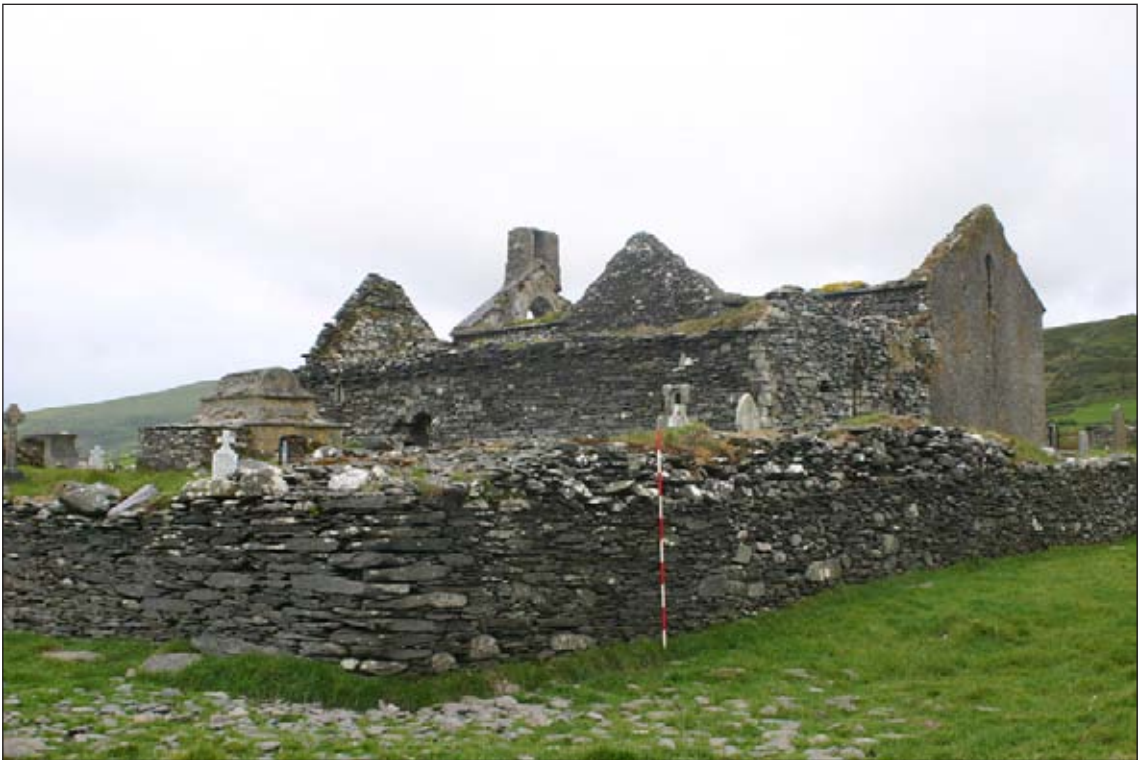
The graveyard is bounded by a well built drystone wall of split local red sandstone (Plate 2).

The boundary wall varies in height from 1.5 to 2.5m and ranges in thickness from 0.5m to 1m.

This current survey undertaken in 2007 recorded a number of deteriorations in the condition of the Medieval church (Plate 2).

Plate 2: View of Medieval Church and boundary wall taken from southeast

The upper 0.6m of the western extent of the southern boundary wall needs to be reduced and relaid.

A sheep wire fence should be constructed around the outer wall to prevent animals from rubbing off or climbing onto it.

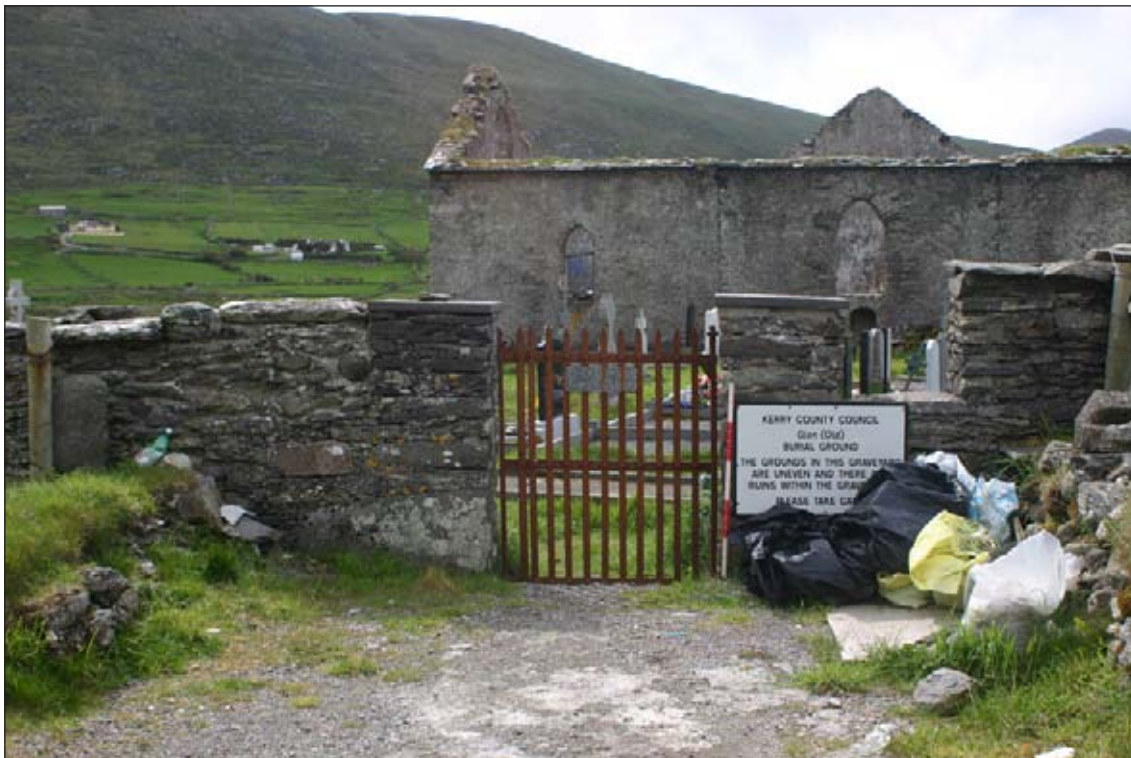
The original 19<sup>th</sup> century gate is in good condition (Plate 3).

It is set between two supporting stone piers with square slate coping in good condition.

Plate 3: View of entrance gate taken from north

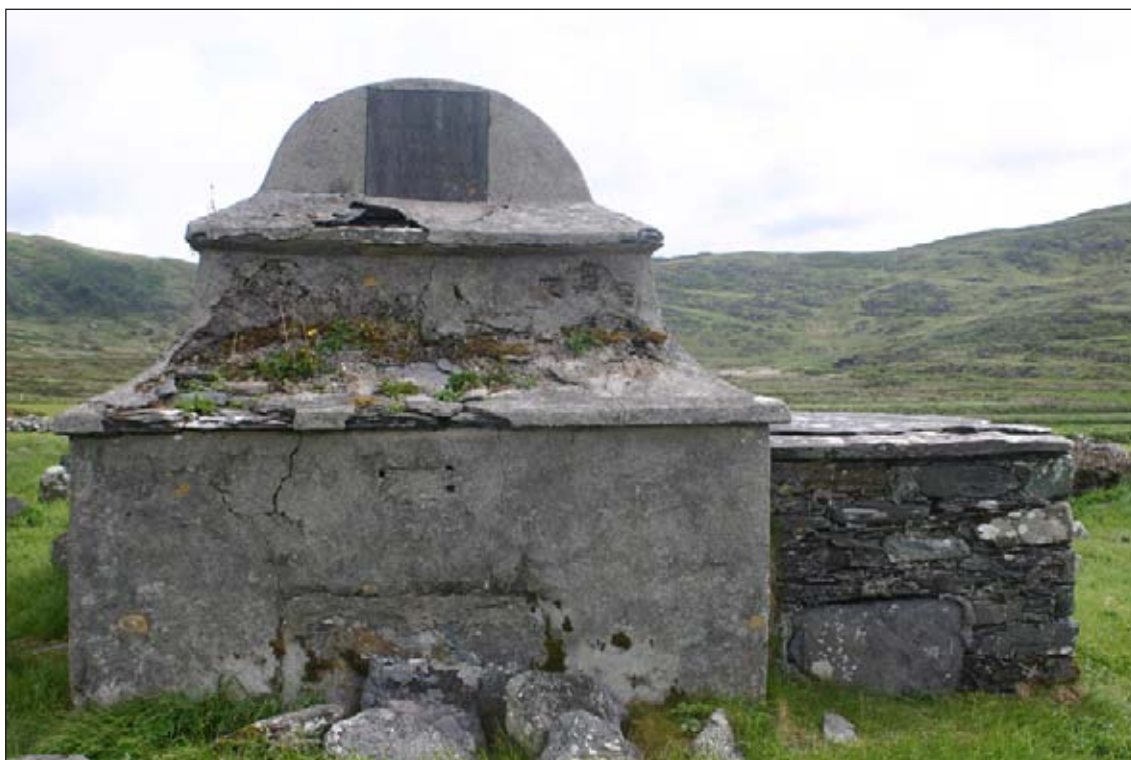
The render is cracking collapsing from the O' Connell tomb (Plate 4), exposing its drystone rubble courses beneath.

Plate 4: View of O'Connell family tomb (ref. no. 283) showing poor state of render, taken from west

The render on the O' Connell tomb should be repaired sensitive to its original construction.

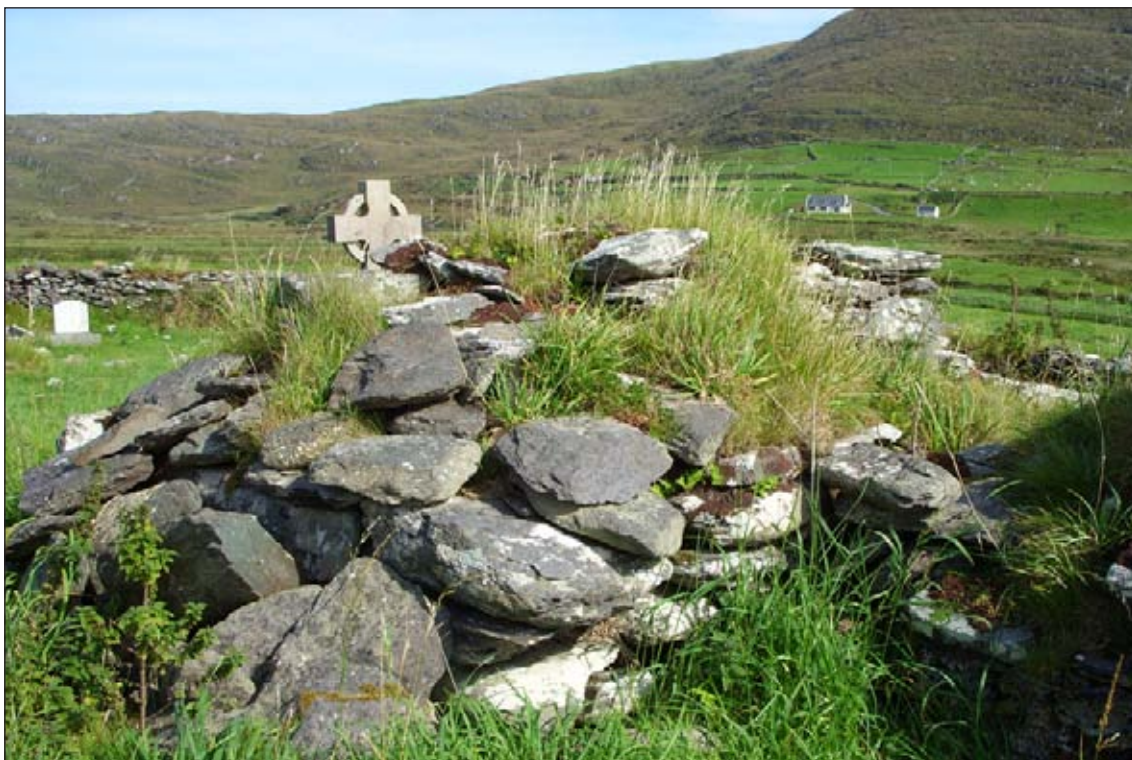
Plate 5: View of unnamed tomb (ref. no. 285) in early state of collapse taken from west

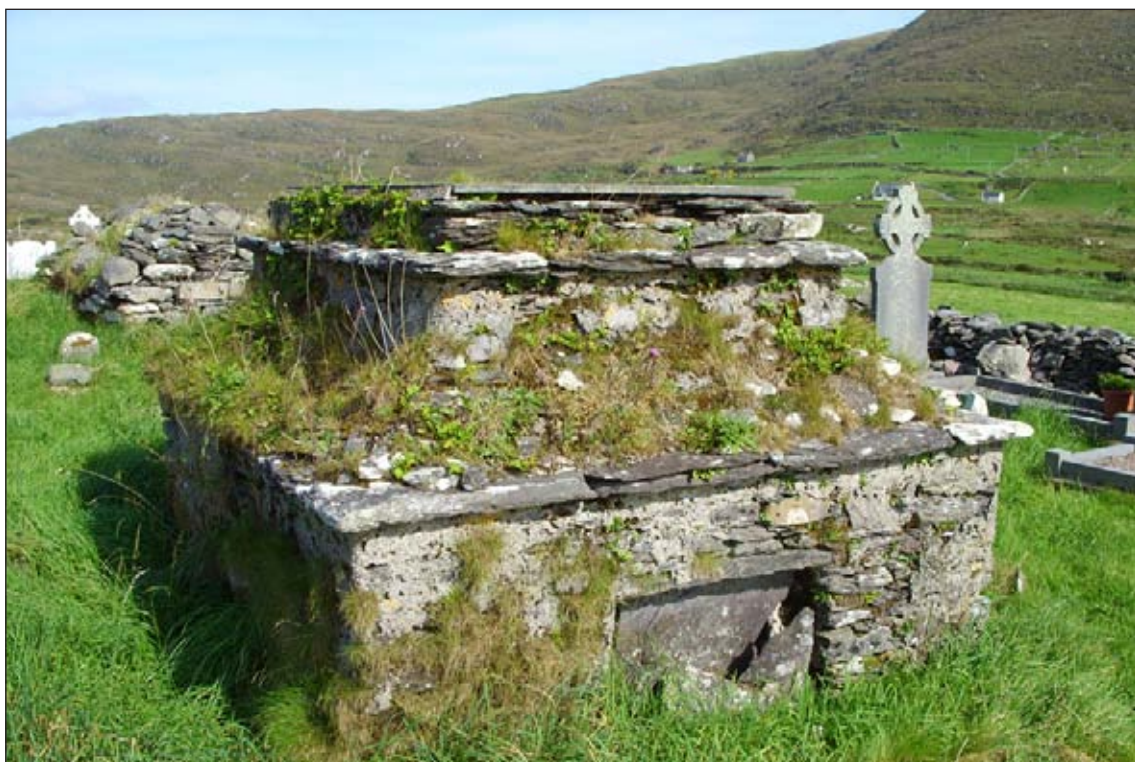
Plate 6: View of unnamed tomb (ref. no. 292) taken from northwest

Tomb ref. no. 292 is in a relatively good state of preservation. The render is partially surviving and the structure seems to be quite robust. The upper tier is partially overgrown with grass (Plate 6).

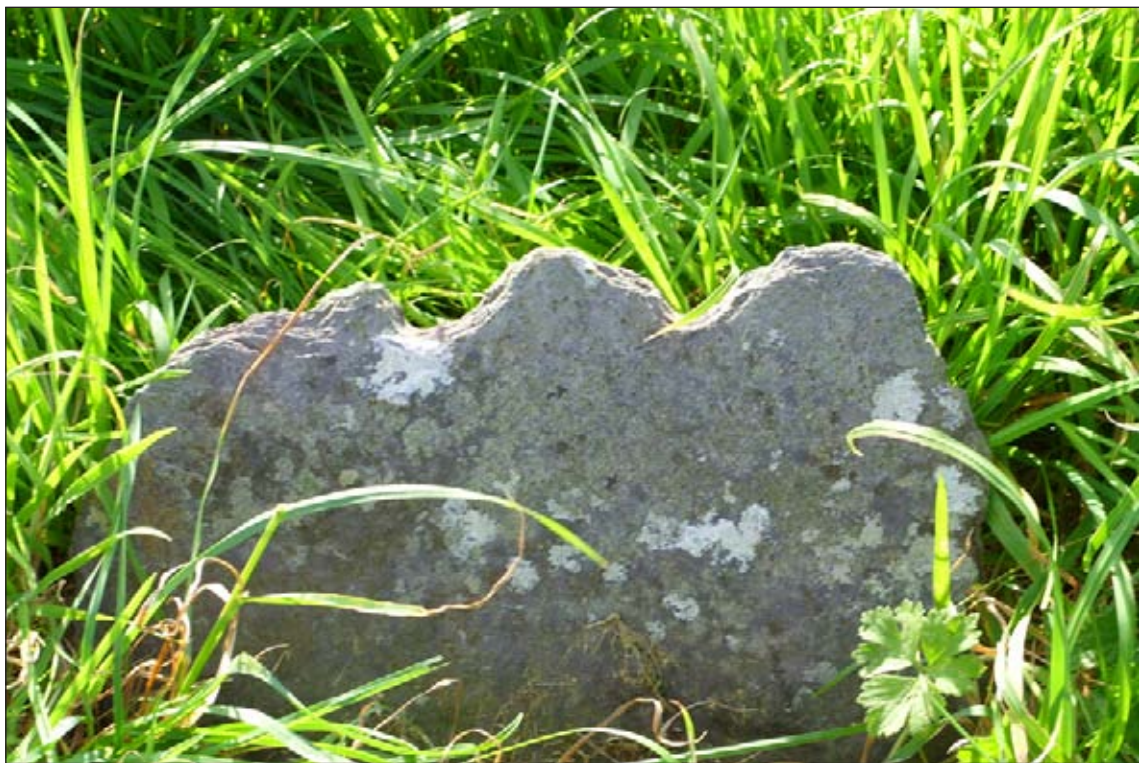
Plate 10: View of unnamed gravemarker

Many of the gravemarkers recorded at The Glen displayed this concave shape on the top of the stone (Plate 10).

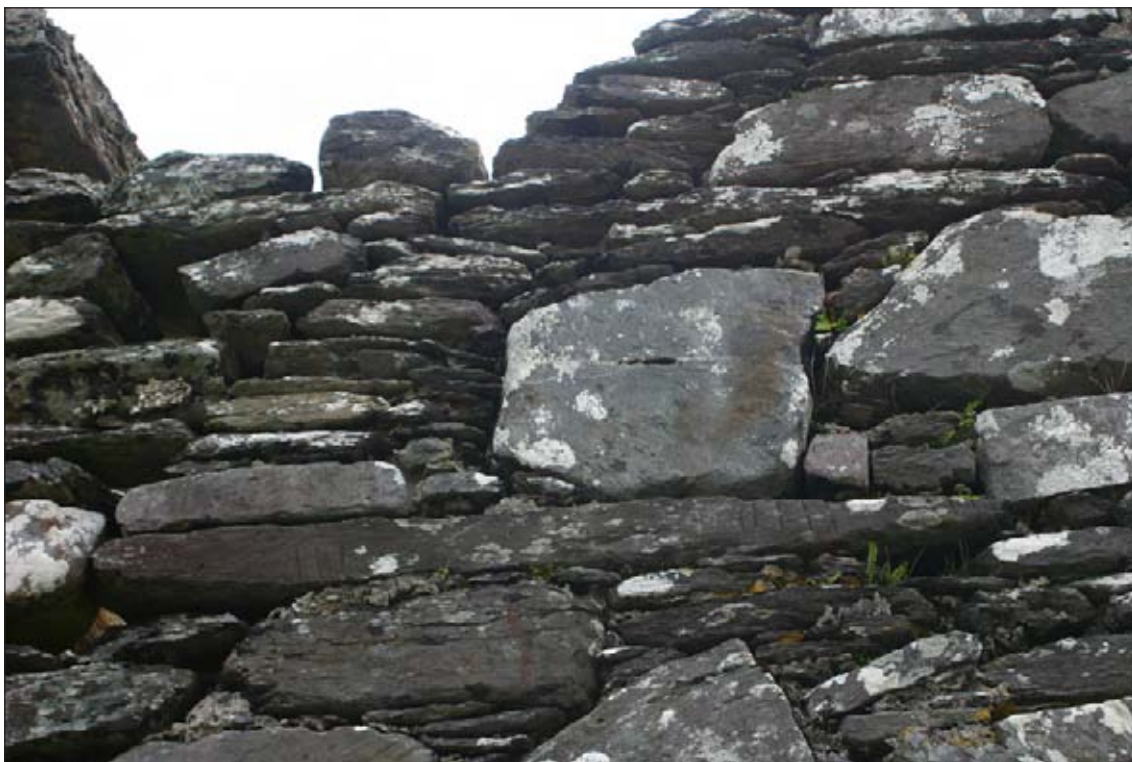
Plate 11: View of Ogham Stone within west gable of Medieval Church

## 13 Ogham Stone (Plate 11)

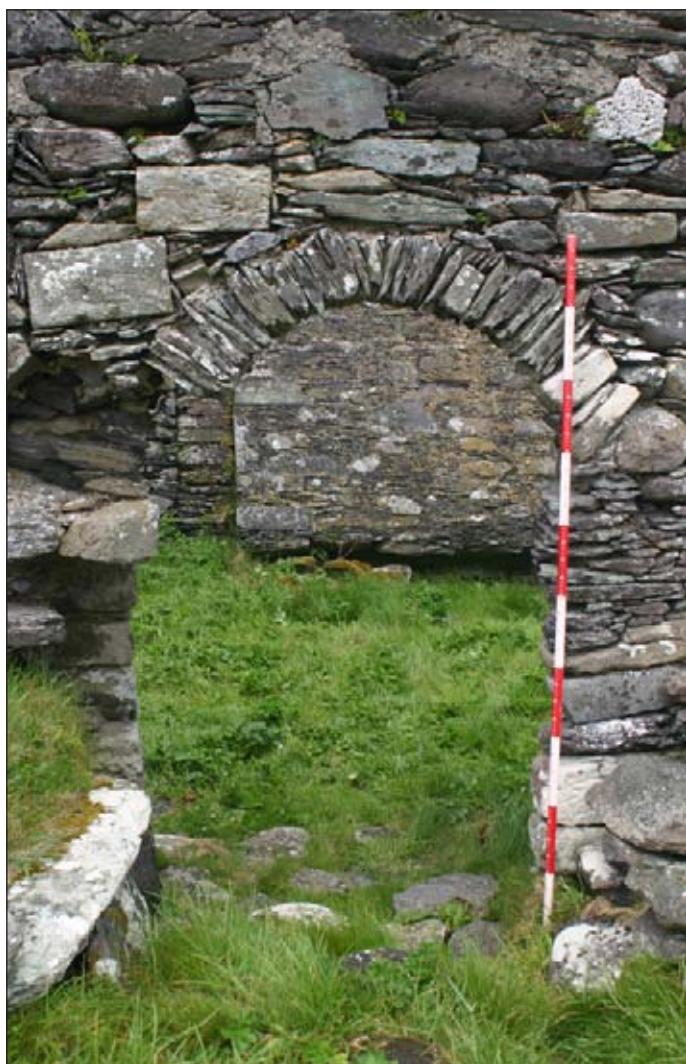
Plate 12: Exterior view of doorway of Medieval church taken from south

- The doorway arch of the medieval church, on its exterior and interior, is in need of urgent care and attention to prevent its collapse.
- The interior and exterior of the window in the Eastern gable are in need of urgent repair to prevent its total collapse.

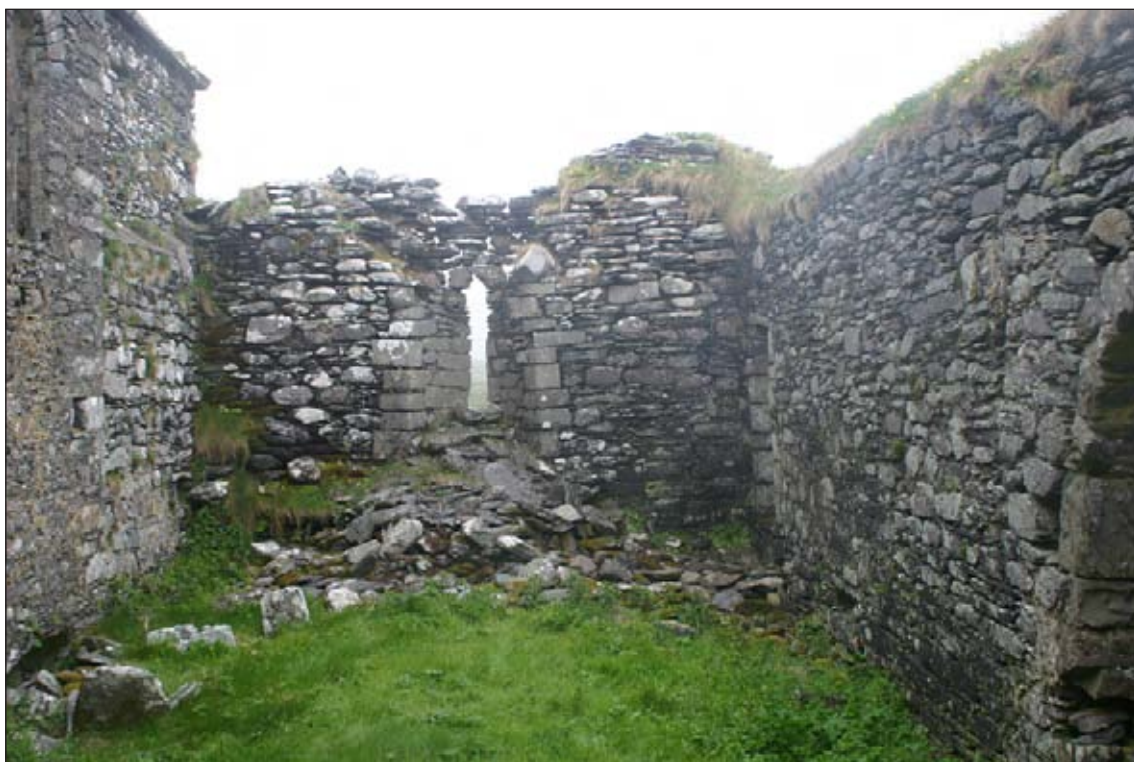
The central window appears to have collapsed even further and the window is in danger of imminent total disintegration (Plate 14).

Plate 14: Interior view of east gable Medieval church taken from west

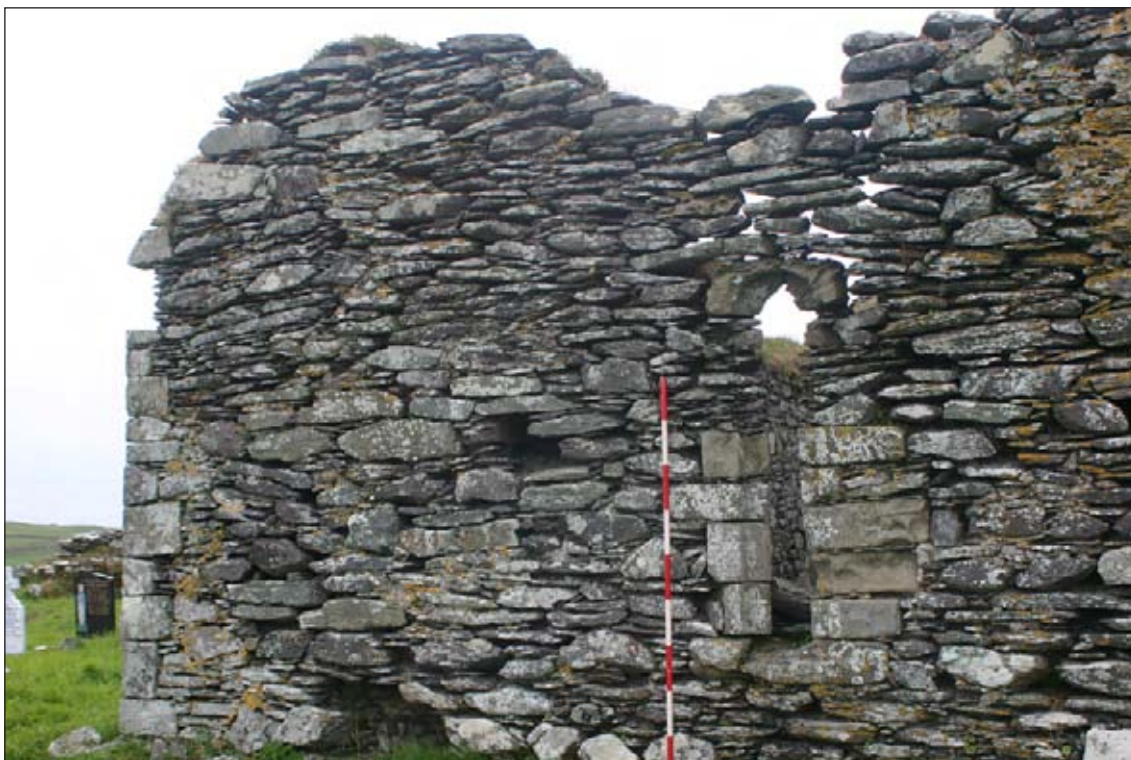
#### *Exterior East Gable* (Plate 15)

Plate 15: Exterior view of east gable of Medieval Church taken from northeast

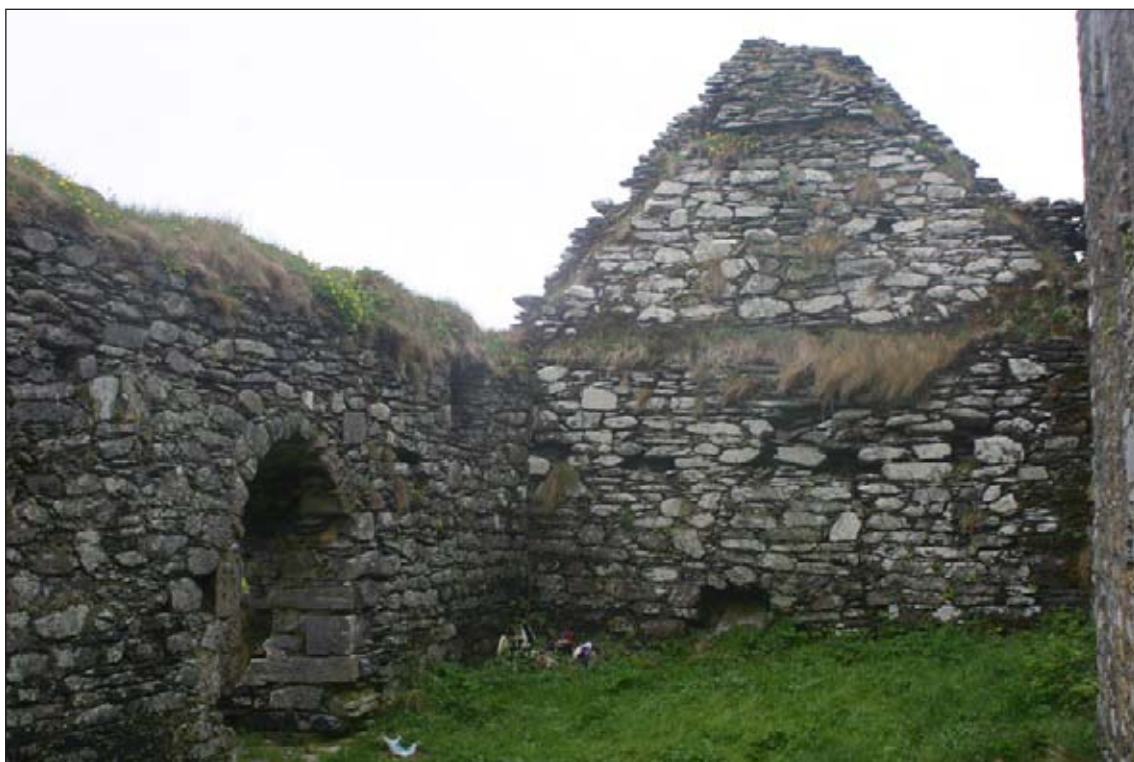
### *Interior West Gable* (Plate 16)

Plate 16: Interior view of west gable taken from east

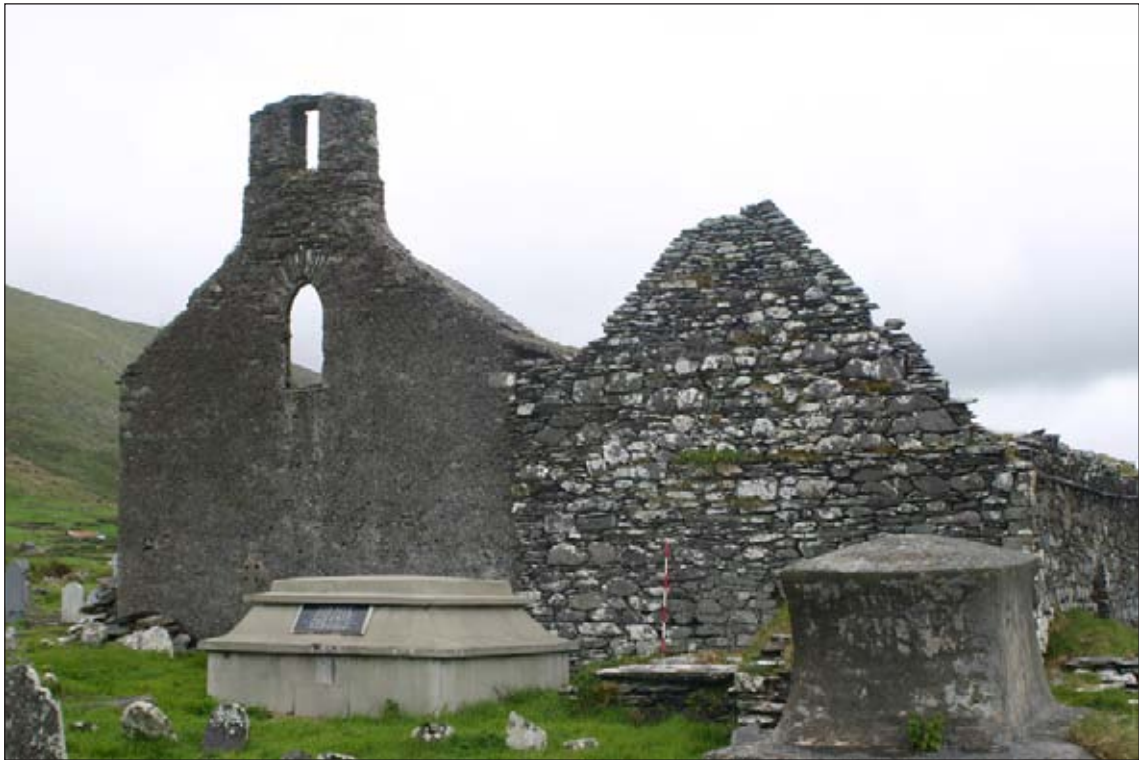
#### *Exterior West Gable* (Plate 17)

### *Exterior Western Gable (Plate 17)*

Plate 17: Exterior view of west gables of Medieval and 19th century churches taken from west

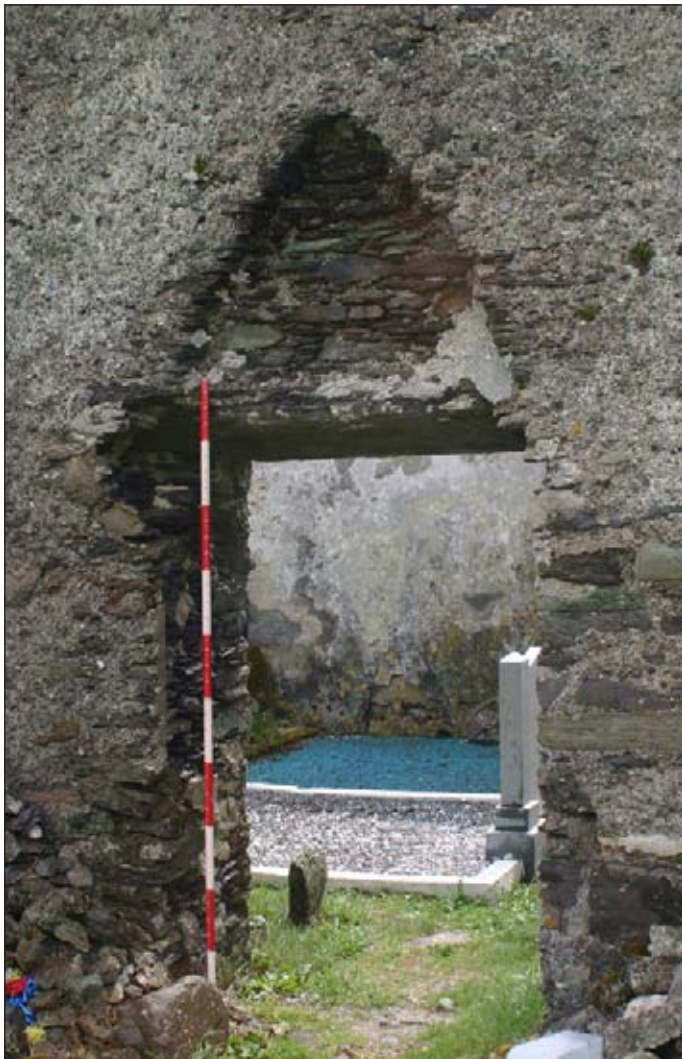
### *Doorway (Plate 18)*

Plate 18: Exterior view of doorway of 19th century church taken from northwest

- The uppermost angle of the lintel in the side wall of the 19<sup>th</sup> century doorway should be repaired.
- Refuse disposal facilities, which do not currently exist at the graveyard, should be provided as soon as possible.

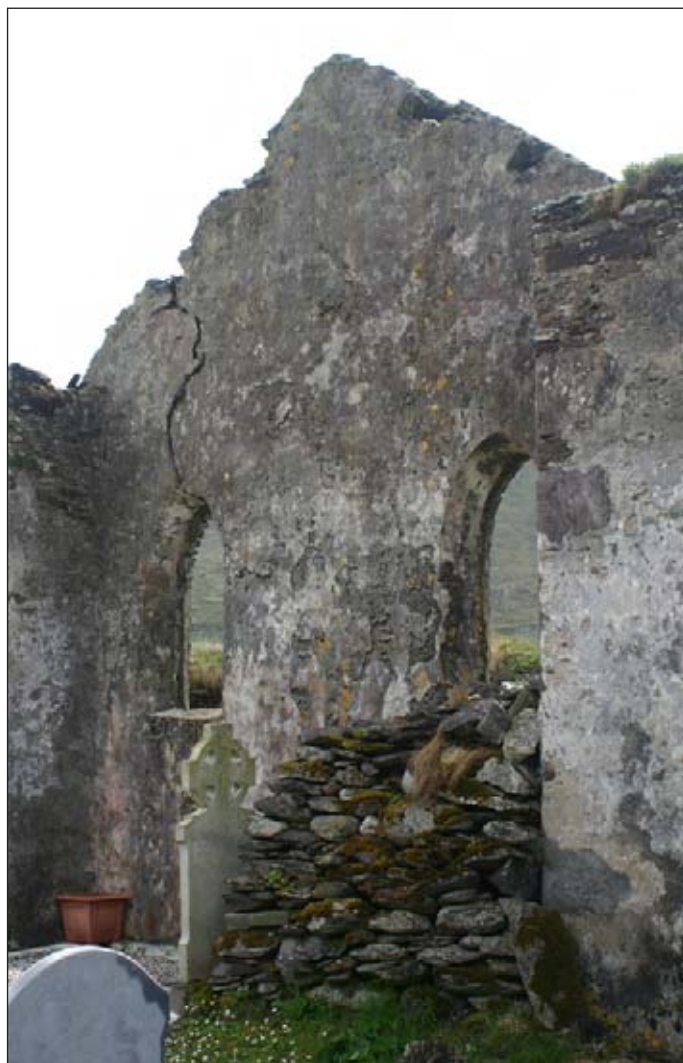
The southwestern corner of the wall is in poor condition with a vertical crack extending from present ground surface for the full height of the wall.

Another vertical crack can be seen extending from the centre of the pointed window ope for the remainder of the wall height.

Plate 19: View of southern wall of 19th century church. Note large vertical crack extending upwards from easternmost window ope

A structural survey should be undertaken to determine the exact state and condition of the southern wall, and if the vertical cracks poses a threat to the immediate stability of the wall and windows.

- A structural survey of the 19<sup>th</sup> century church should be undertaken to determine the exact state and condition of the southern wall and if the vertical cracks poses a threat to the immediate stability of the wall and windows, as well as outlining the impacts it may have on the Medieval church.

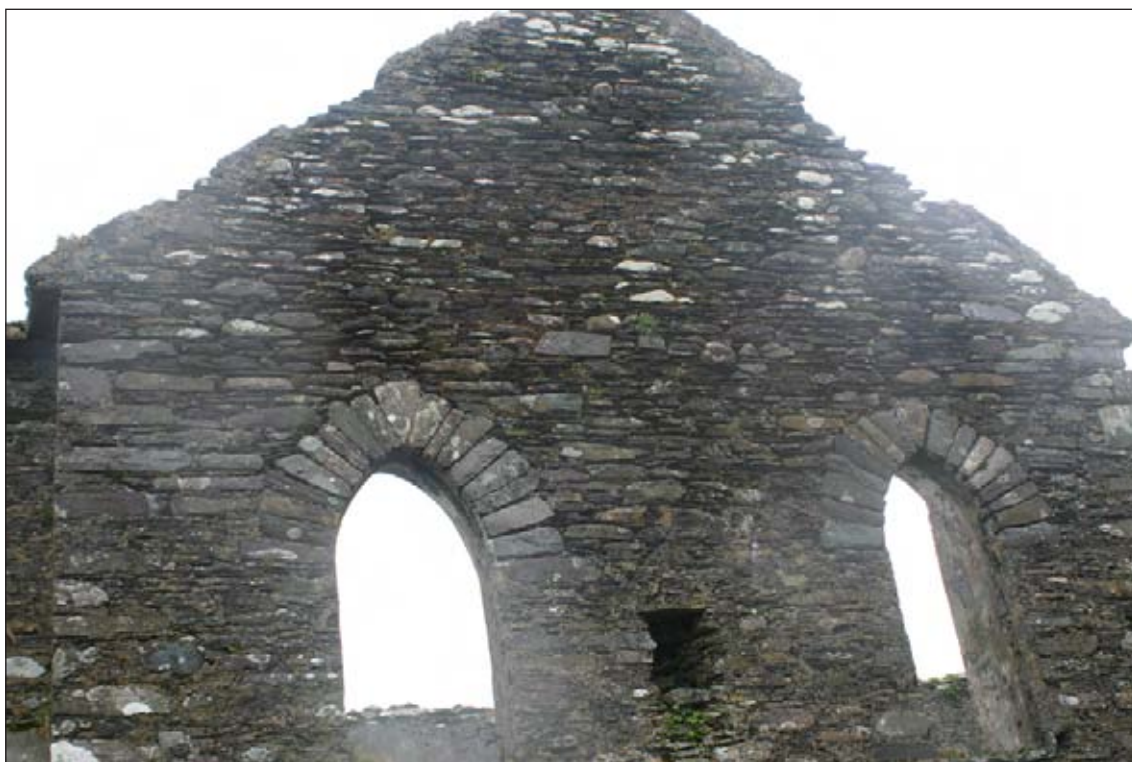
The exterior of the southern wall forms the northern wall of the Medieval church (Plate 20). The northern wall of the latter was reconstructed during the construction of the later church in the 19<sup>th</sup> century.

Plate 20: Exterior view of southern wall of 19th century church which forms the northern wall of the Medieval church

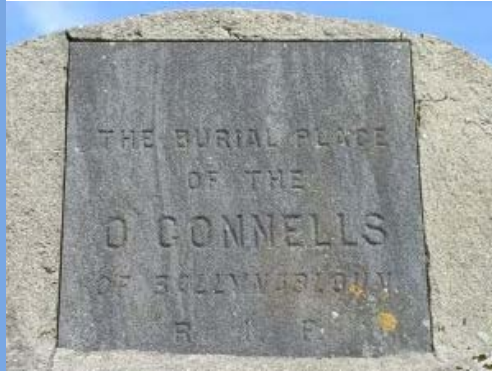
Surname	o connell
Tomb ID	283
Collapsed	<input type="checkbox"/>
Open	<input type="checkbox"/>
Rendered	<input checked="" type="checkbox"/>
Photo No	SS851064
Photo

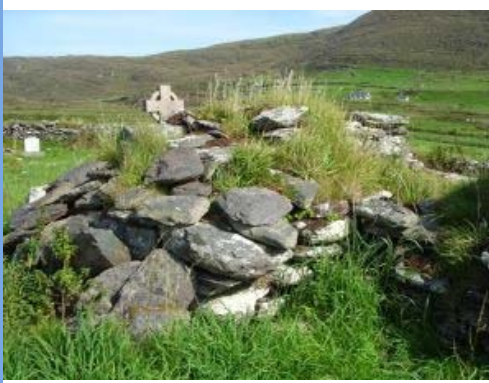
Tomb ref. no. 285 is in an early state of collapse. Several stones have slipped from their original position and the grass overgrowth can only hasten its demise (Plate 5).

<b>Tomb ID</b>	285
<b>Collapsed</b>	<input type="checkbox"/>
<b>Open</b>	<input type="checkbox"/>
<b>Rendered</b>	<input type="checkbox"/>
<b>Notes</b>	
<b>Photo No</b>	101-1066
<b>Photo</b>

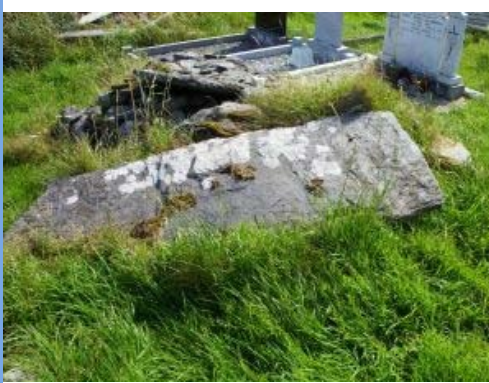
<b>Tomb ID</b>	287
<b>Collapsed</b>	<input checked="" type="checkbox"/>
<b>Open</b>	<input type="checkbox"/>
<b>Rendered</b>	<input type="checkbox"/>
<b>Notes</b>	overgrown
<b>Photo No</b>	101-1068
<b>Photo</b>

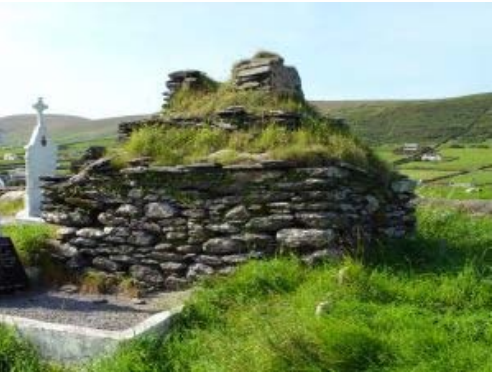
Tomb ref. no. 301 is in a reasonable condition and is the best preserved of the unnamed tombs. The render is fully intact though several cracks are evident. Weathering of the render has resulted in a mottled type appearance to the structure.

Tomb ID	301
Collapsed	<input type="checkbox"/>
Open	<input type="checkbox"/>
Rendered	<input checked="" type="checkbox"/>
Notes	
Photo No	101-1083
Photo
