Archaeological Survey,
Killury Graveyard,
Lissycurrig,
Co. Kerry.

September 2007

Client: The Heritage Office,
Kerry County Council,
County Buildings,
Ratass,
Tralee,
Co. Kerry.

RMP No.: KE015-044

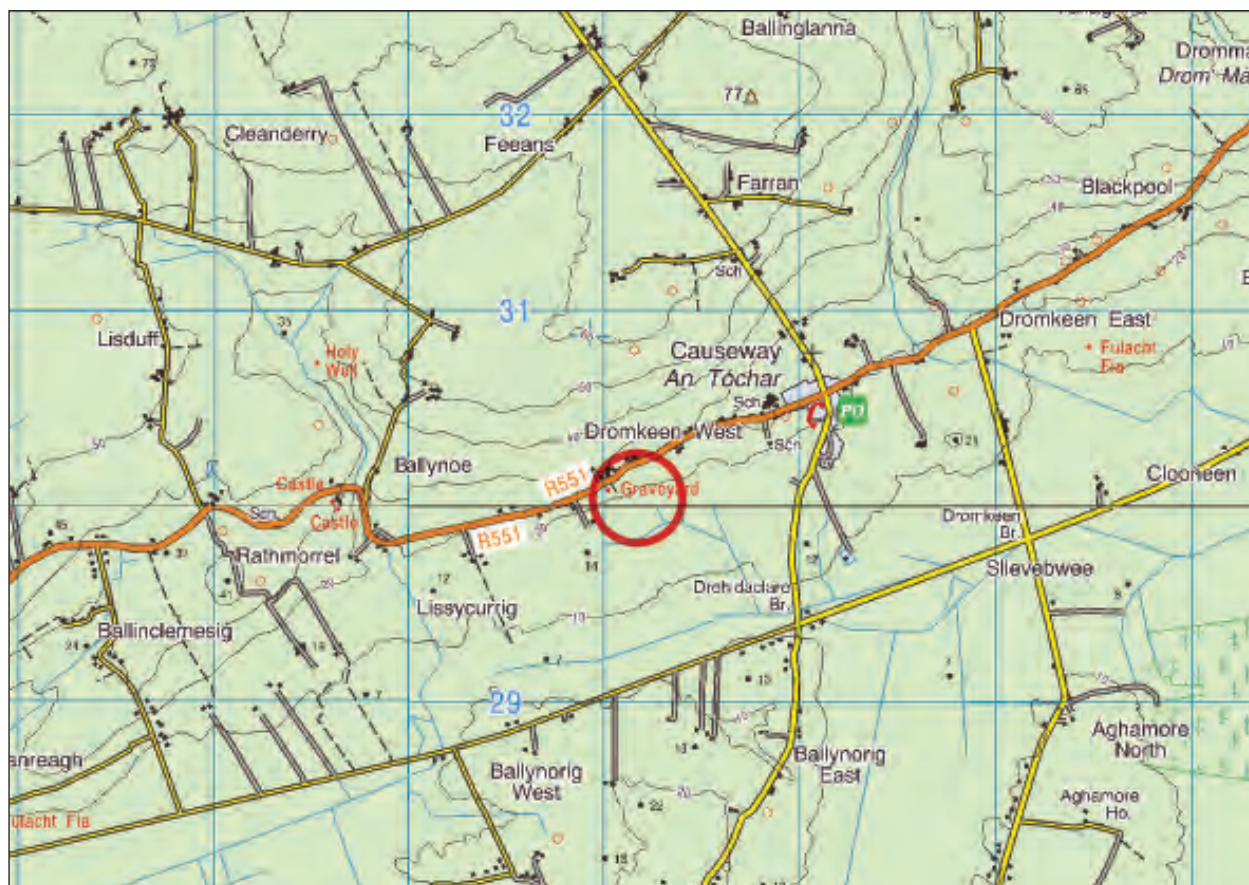
Figure1: Plan of Killury Church and Graveyard 2007.

Killury graveyard was surveyed using a Trimble Pro X-H GPS (Figure 1). The survey is linked to GPS and tied into the National Grid. The graveyard plan was produced using Adobe Illustrator. Reference numbers mentioned in the main body of the report relate to the ID point given when the survey was undertaken and these numbers are illustrated on the graveyard plan (see attached A3 drawing). A digital photographic record and surname database was also compiled to complement the cartographic survey (Appendices 1-5). Photographs of the features within the graveyard are referenced in the appendix and all photographs are provided on the attached disc.

The location of the church was measured carefully from the 1st edition of the Ordnance Survey map and overlaid on the site layout plan for the graveyard.

The church is shown in the north of the graveyard, to the southeast of the centrally disposed entrance gate.

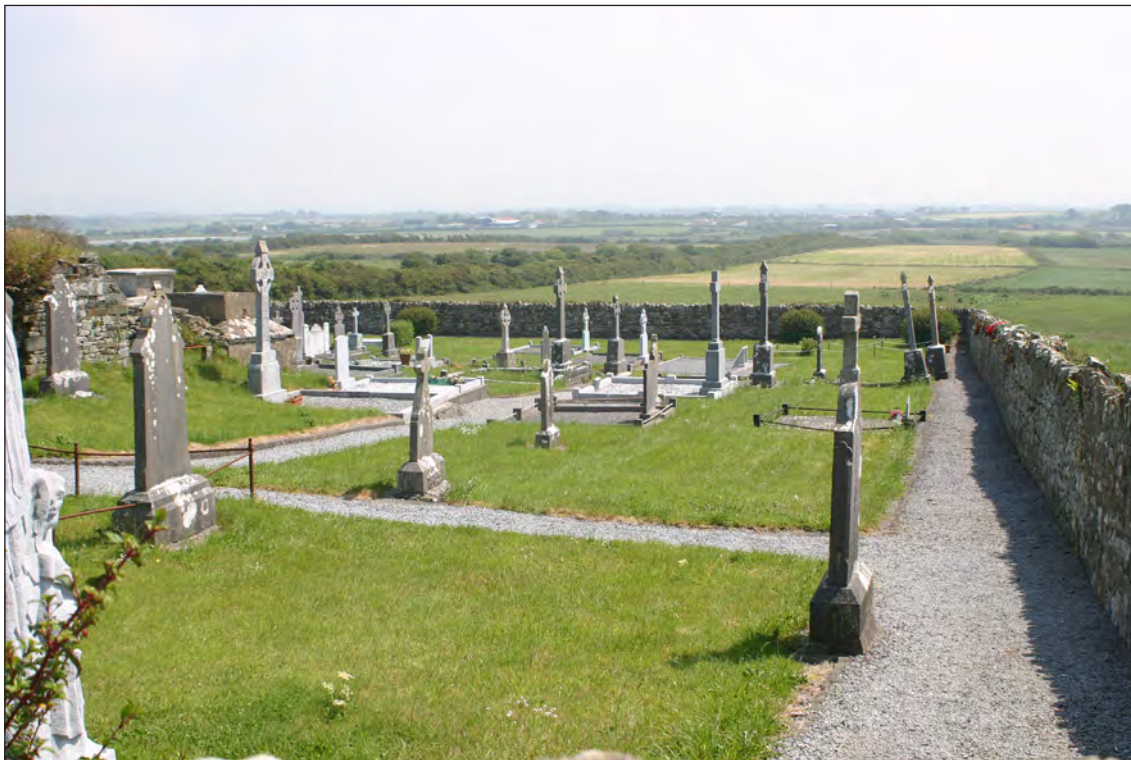
Plate 1: View of Killury graveyard taken from northeast

Killury graveyard is located in the townland of Lissycurragh, c.1km southwest of Causeway village (Figure 2, Plate 1), where it is situated on the southern side of the R551.

This pathway extends around main concentrated area of the tombs as well as some graves located in the west of the graveyard (Plate 1).

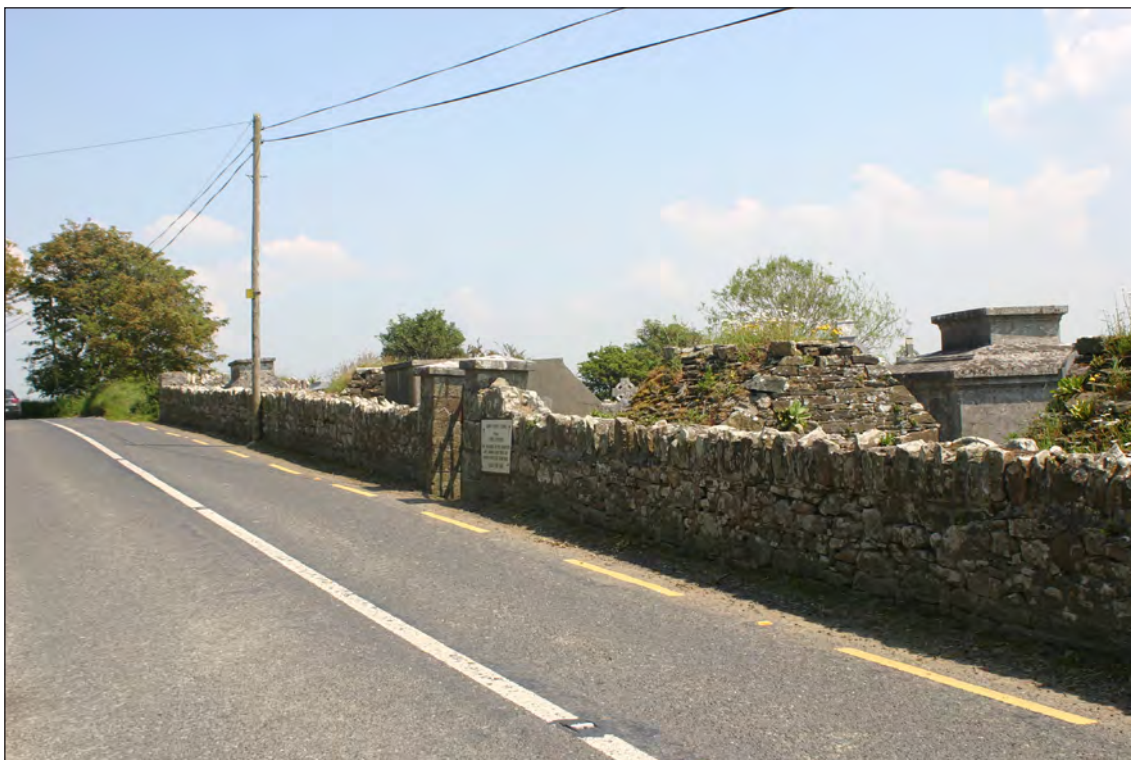
Plate 5: View of northern boundary wall taken from northeast

The graveyard is bounded by a limestone wall which is well pointed with cement (Plate 5).

Cow and calf coping exists on all sides of the boundary wall.

The boundary averages 1.4m in height and 0.4m in width.

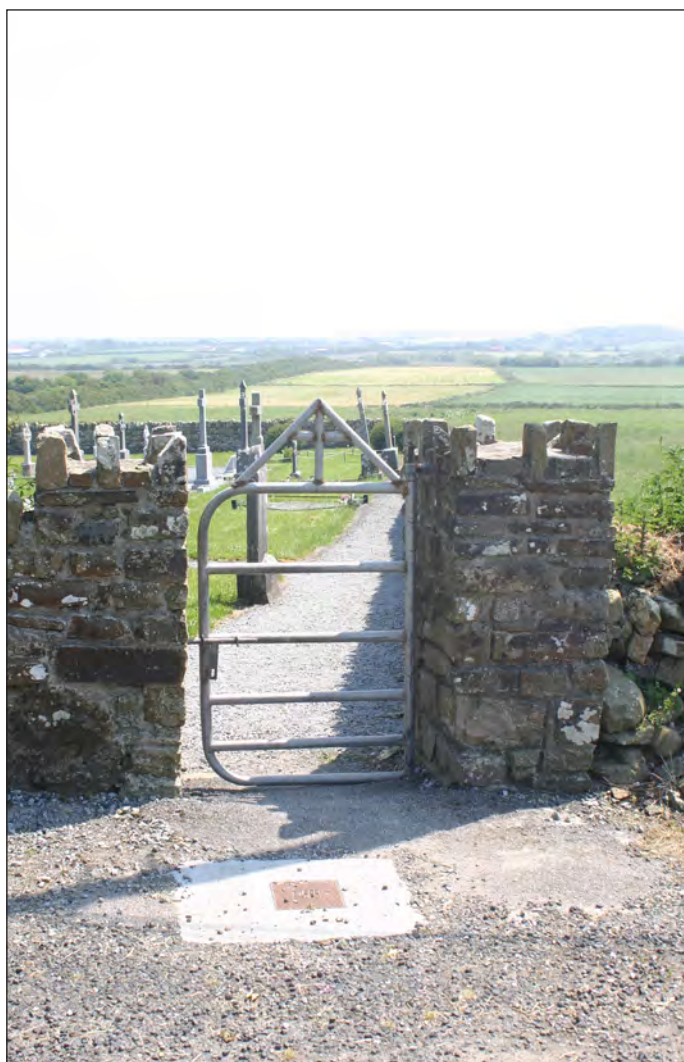
Plate 6: Exterior view of westernmost entrance gate to graveyard, taken from north

The westernmost gate (Plate 6) comprises an adapted farm gate set between two piers pointed with cement and topped with alternate vertical coping.

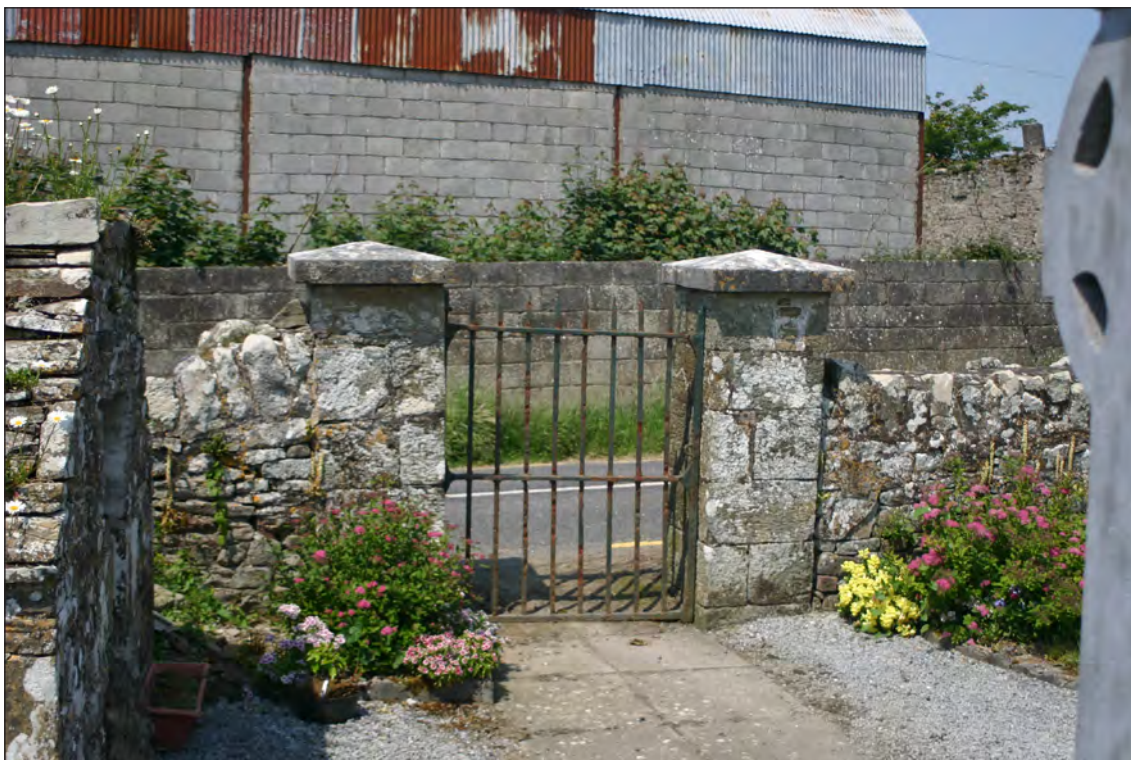
Plate 7: Interior view of easternmost entrance gate to graveyard, taken from south

The centrally disposed gate is most likely the original entrance to the graveyard.

An original 19th century iron gate is set between two capped limestone piers (Plate 7).

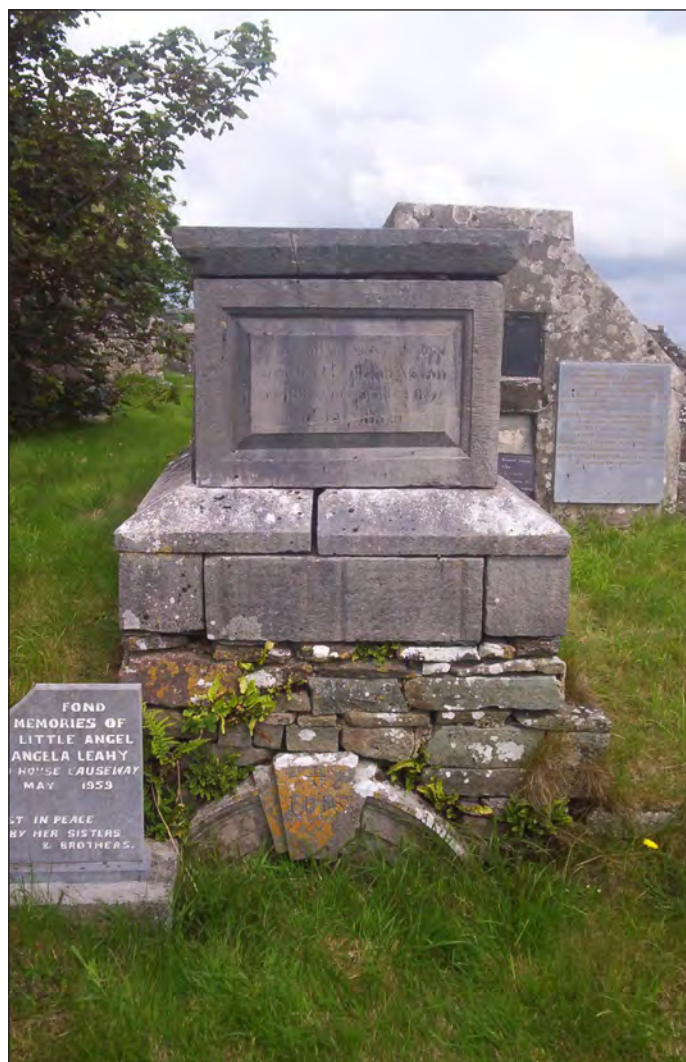
Plate 8: View of earliest named tomb, dating to 1776 and recording the death of John Nolan, taken from west

The earliest tomb dated to 1776 and recorded the death of John Nolan (Plate 8).

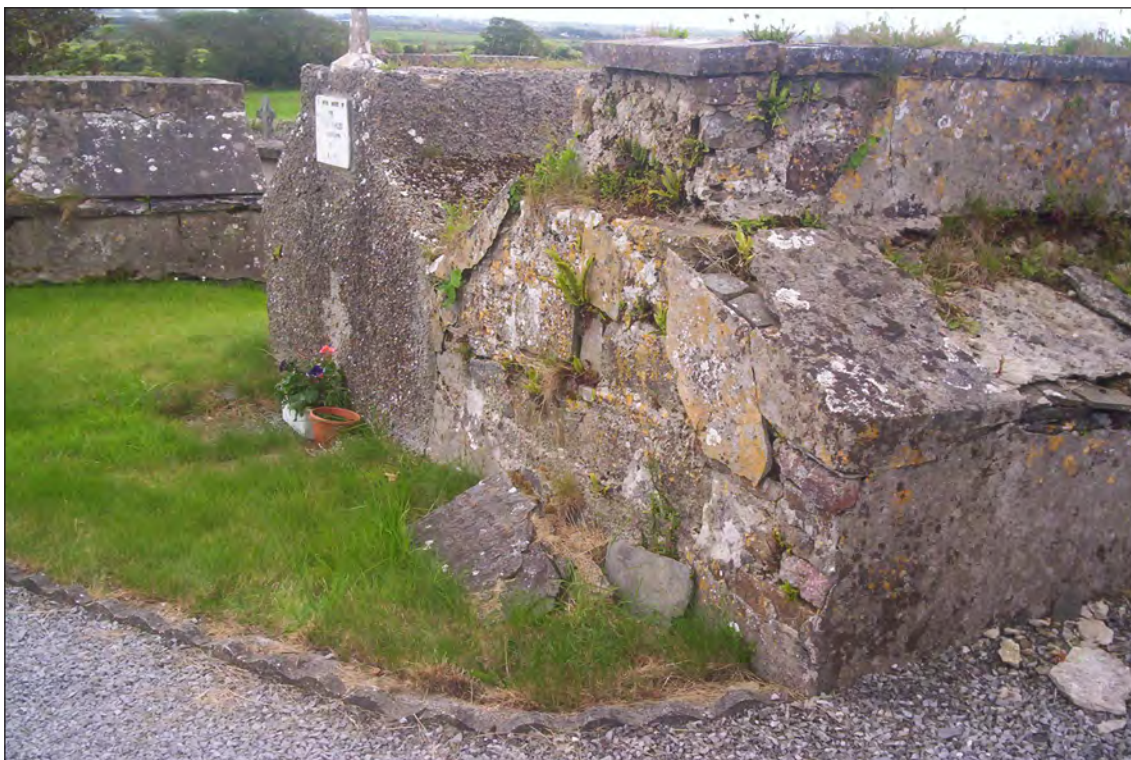
Plate 9: View of damaged named tomb of John Lawlor, taken from northeast

A large crack is visible in the render of the tomb of John Lawlor (ref.no. 329) while the render is falling off in other places. The name plaque itself has fallen from the tomb (Plate 9).

The render on John Lawlor's tomb (ref. no. 329) should be repaired and the name plaque restored to its original position.

- The render on John Lawlor's tomb (ref. no. 329) should be repaired and the name plaque restored to its original position.
- The rose bush obscuring tomb (ref. no. 336) should be cut back.

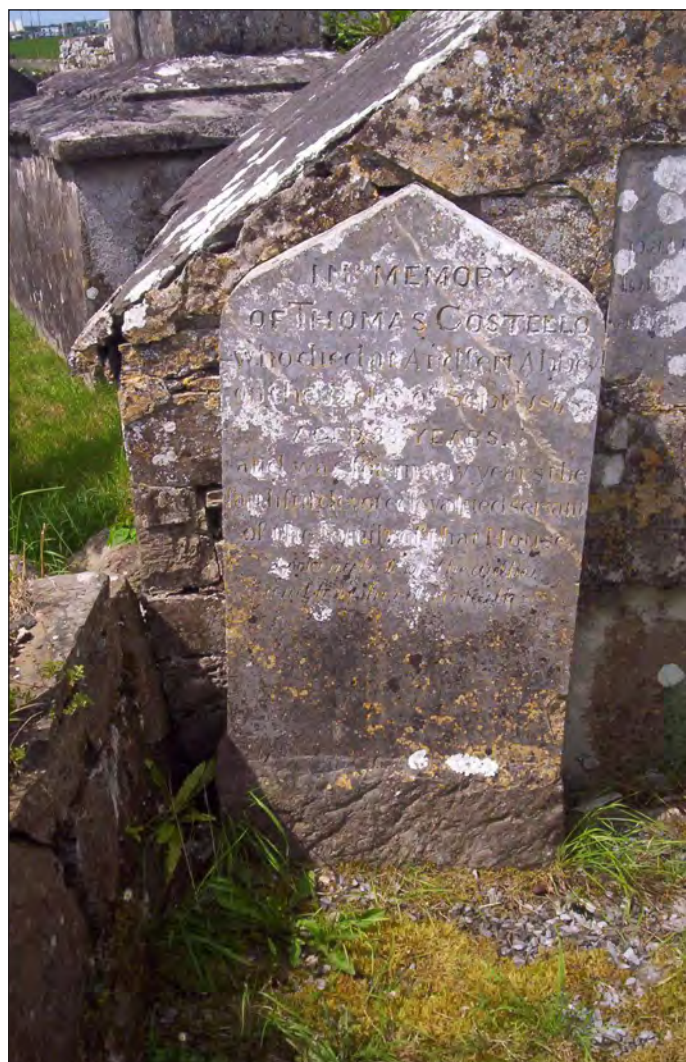
Plate 10: View of earliest inscribed headstone dating to 1848 and recording the death of Thomas Costello, taken from east

The earliest recorded date was 1848 when Thomas Costello (ref. no. 219) was interred in the graveyard (Plate 10).

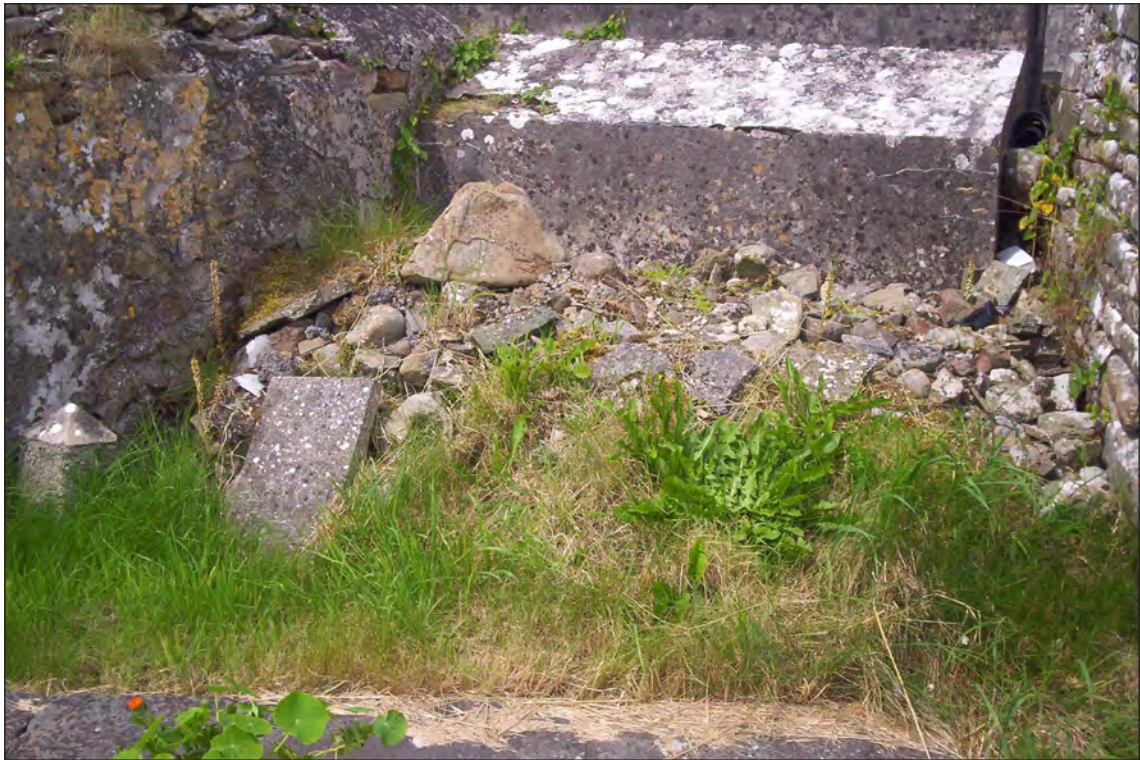
Plate 11: View of mound of rubble located amongst the tombs at the eastern extent of the graveyard, taken from south

Given the apparent space available for burials today, it is likely that there were many more unhewn gravemarkers but they may have been mistaken as rubble during the voluntary clean-up of the graveyard during the 1990's.

A large pile of rubble is situated amongst the tombs towards the east of the graveyard (Plate

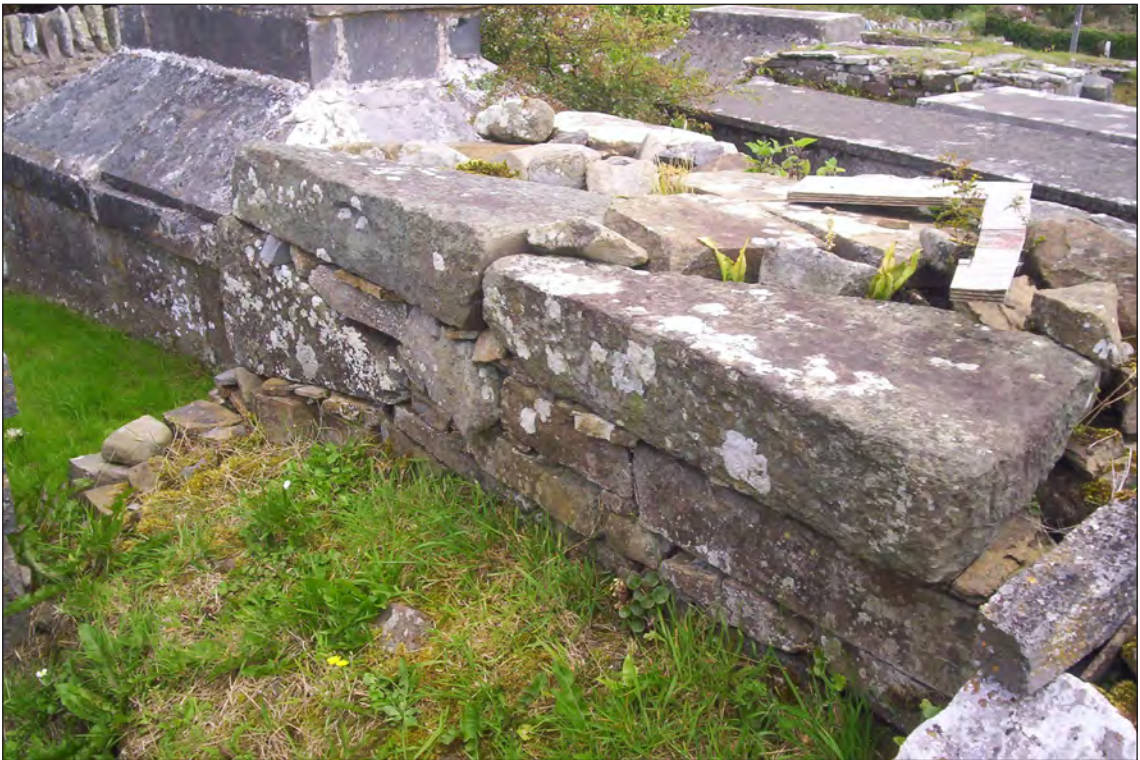
Plate 12: View of possible architectural fragments forming structure of unnamed tomb (ref. no. 267), taken from northwest

Two possible architectural fragments (Plate 9) were identified as part of the construct of a named tomb (ref. no.267).

It is possible that these stones were originally part of the church which is no longer extant at the graveyard.

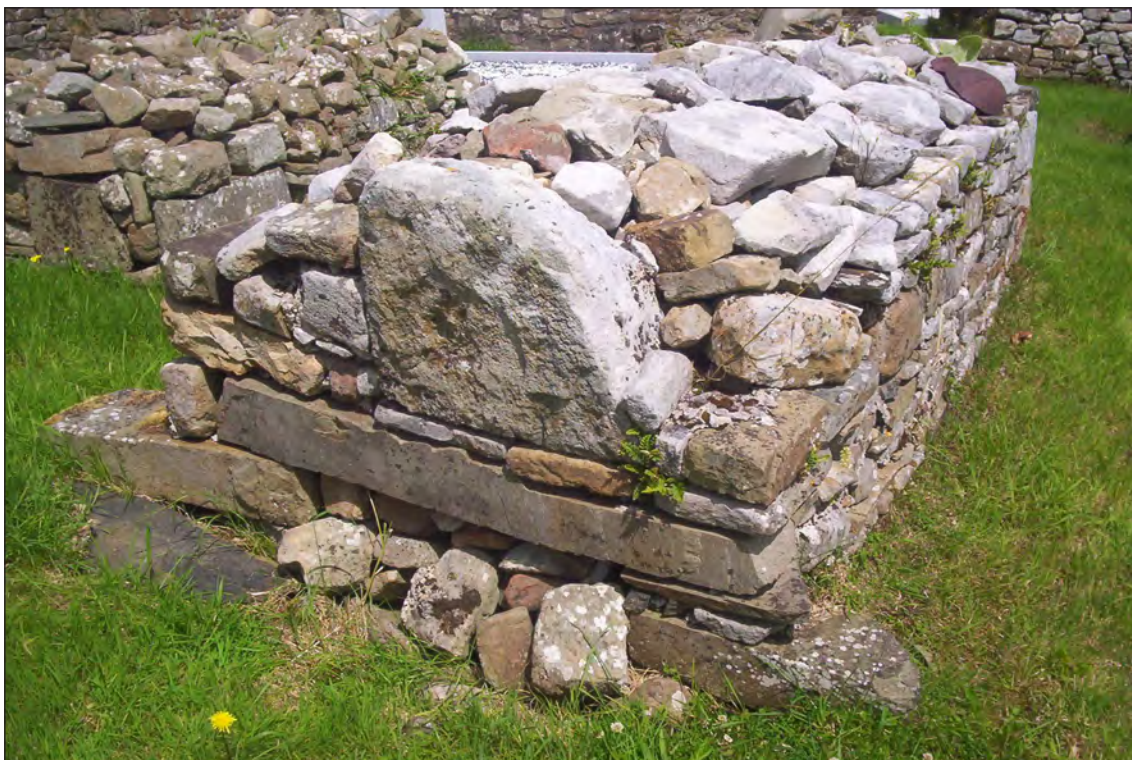
Plate 13: View of possible architectural fragment forming structure of unnamed tomb (ref. no. 283), taken from southwest

Another possible architectural fragment was identified on unnamed tomb (ref. no. 283).

The large limestone stone is roughly wedge-shaped and has two regular, linear sides with one curving, rounded side (Plate 12).

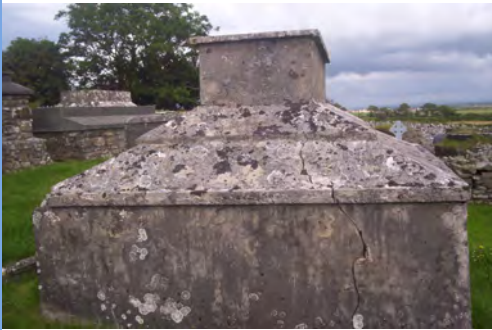
Tomb ID	303
Photo No	5299
Photo

A large crack is visible in the render on the west side of an unnamed tomb (ref. no. 303).

The render on tomb ref. no. 303 should also be made good.

- The render on unnamed tomb ref. no. 303 should also be made good.
- Construction of new tombs should not be allowed and others requiring repair should be undertaken using best practice. An information booklet should be provided on this.
