Archaeological Survey,
Kilnaughtin Church and Graveyard,
Carhoona,
Tarbert
Co. Kerry.

September 2010

RMP No.: KE003-008 Church and
KE003-008001 Graveyard

Written by: Laurence Dunne

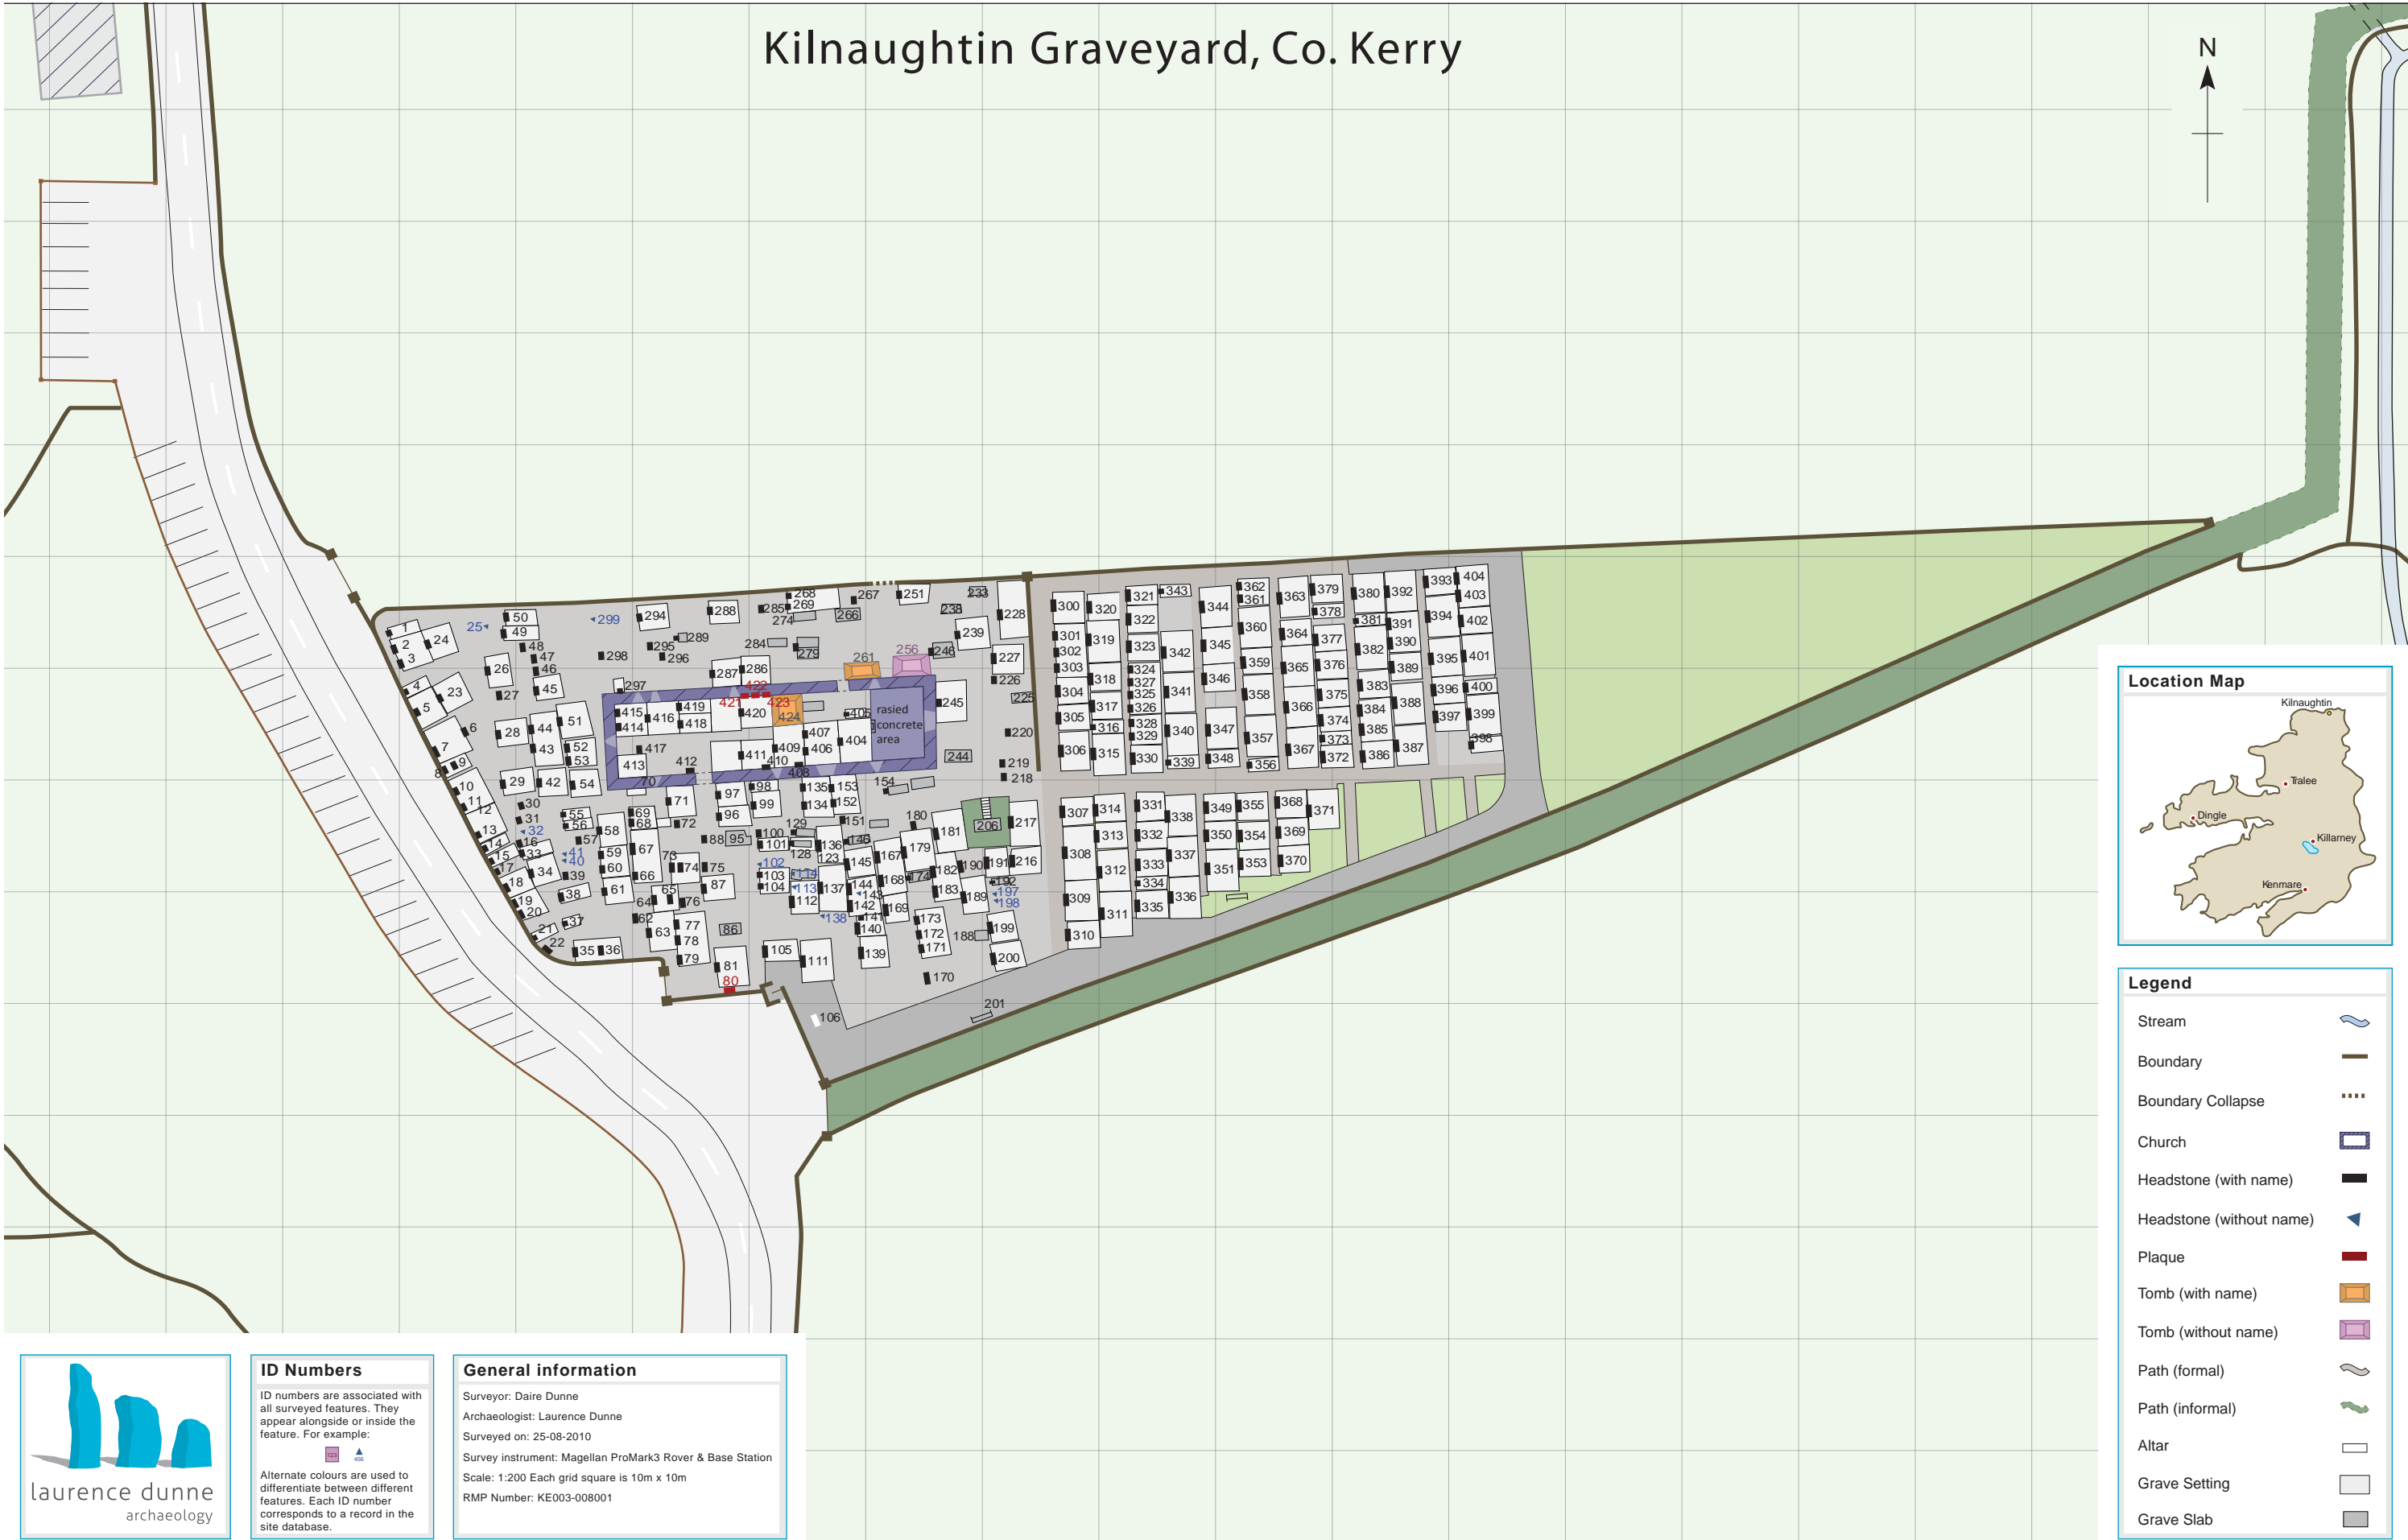
There are seven wall plaques in Kilnaughtin, five of which (70, 413, 421, 422 and 423) are fixed onto the walls of the medieval church (Figure 5).

Figure 5: Archaeological survey plan of Kilnaughtin Church and Graveyard, 2010.

There should be no memorial plaques fixed onto the fabric of the church and no further ones should be allowed.

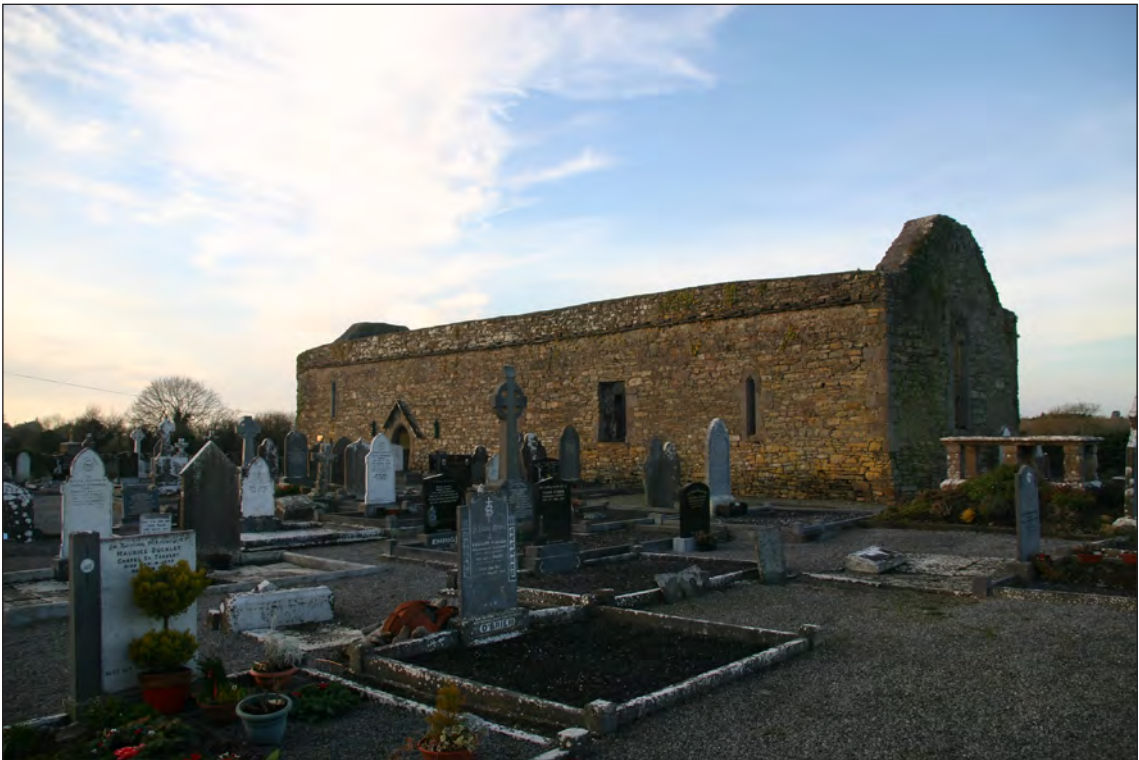
Plate 2: View of Kilnaughtin church and graveyard from north

The graveyard and church have been cleaned up in the recent past and all grass removed to be replaced by gravel between all the graves, tombs and within the church (Plate 2). A new section of burial ground has been added to the east end giving the graveyard a narrow wedge shaped appearance (Figure 5). The approach to the graveyard from north and south is very good with ample parking provided for and marked out (Plates 1-3).

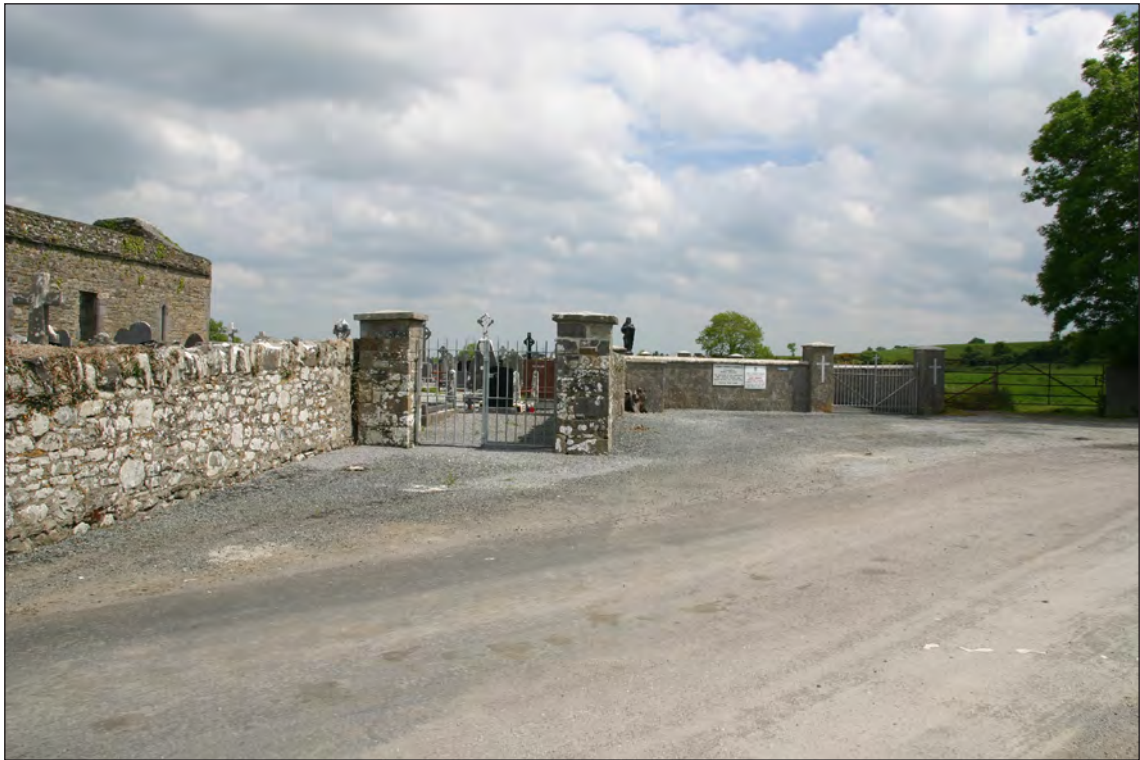
Plate 3: Entrance approach view of Kilnaughtin church and graveyard from west

Boundary walls around the older western area of the graveyard are constructed with uncoursed rubble limestone bedded in mortar and capped here and there with 'soldiers' and are generally in excellent condition (Plate 3). However, along the north-eastern section the boundary is lower and covered with a copious growth of ivy and also slightly damaged and poorly repaired (Plate 4).

There are two vehicular entrance gateways providing separate access to the old and new areas of the graveyard. Independent able-bodied pedestrian access is also provided for by a swing-stile to all areas. The gates and stile are in excellent condition (Plates 3 & 6). There is an outdoor altar (106) and seating area (201) at the southern corner of the graveyard (Plate 6 and Figure 5).

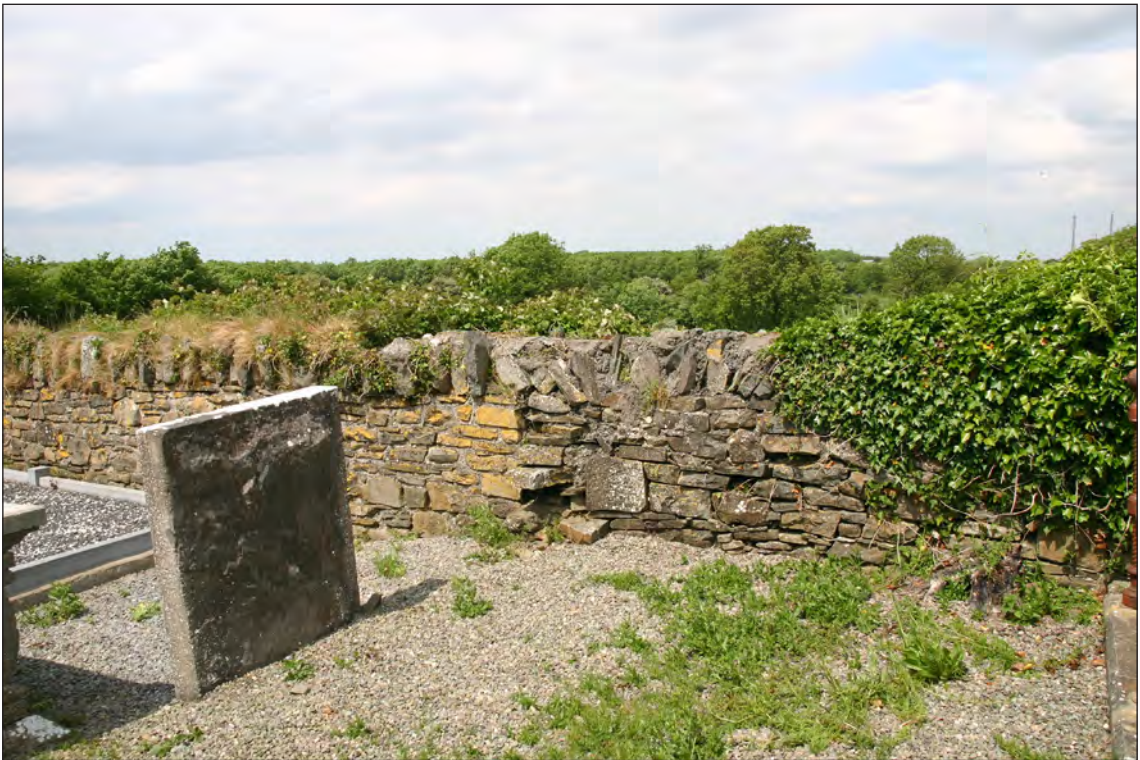
Plate 4: View of northern section of boundary wall. Note poor repair and ivy growth

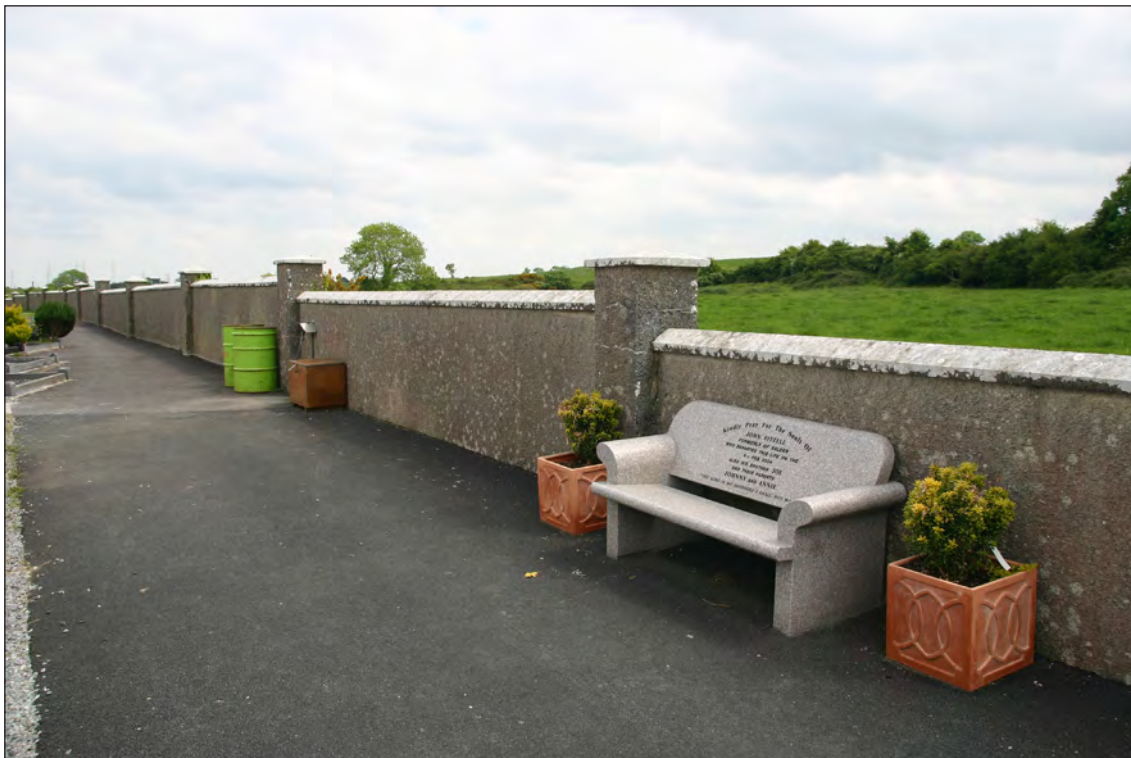
The boundary wall around the new eastern end of the graveyard is constructed with concrete blocks in sections between taller capped piers (Plate 5).

Water and waste collection bins are also provided (Plate 5).

Plate 5: View of pathway along southern boundary of new section of graveyard. Note dedicated bench seating, water tap and waste bins

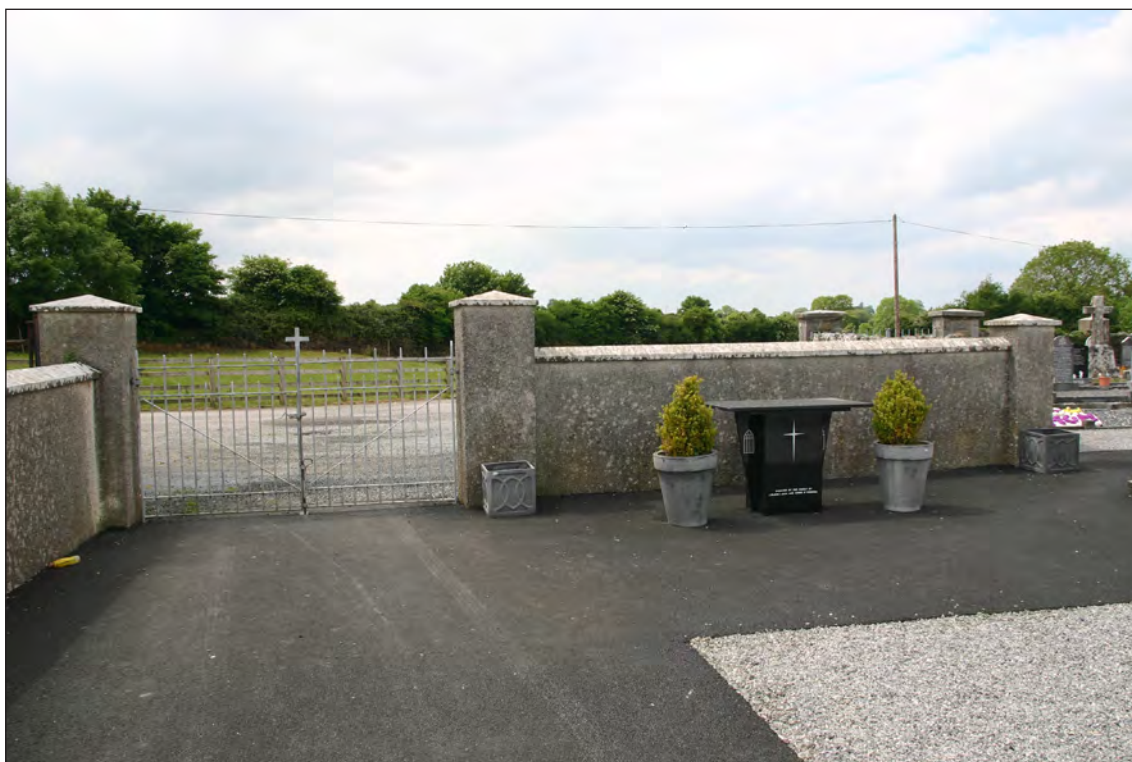
Plate 6: Interior view of entrance gateway to new section of graveyard at Kilnaughtin. Note tarred vehicular accessway and modern altar.

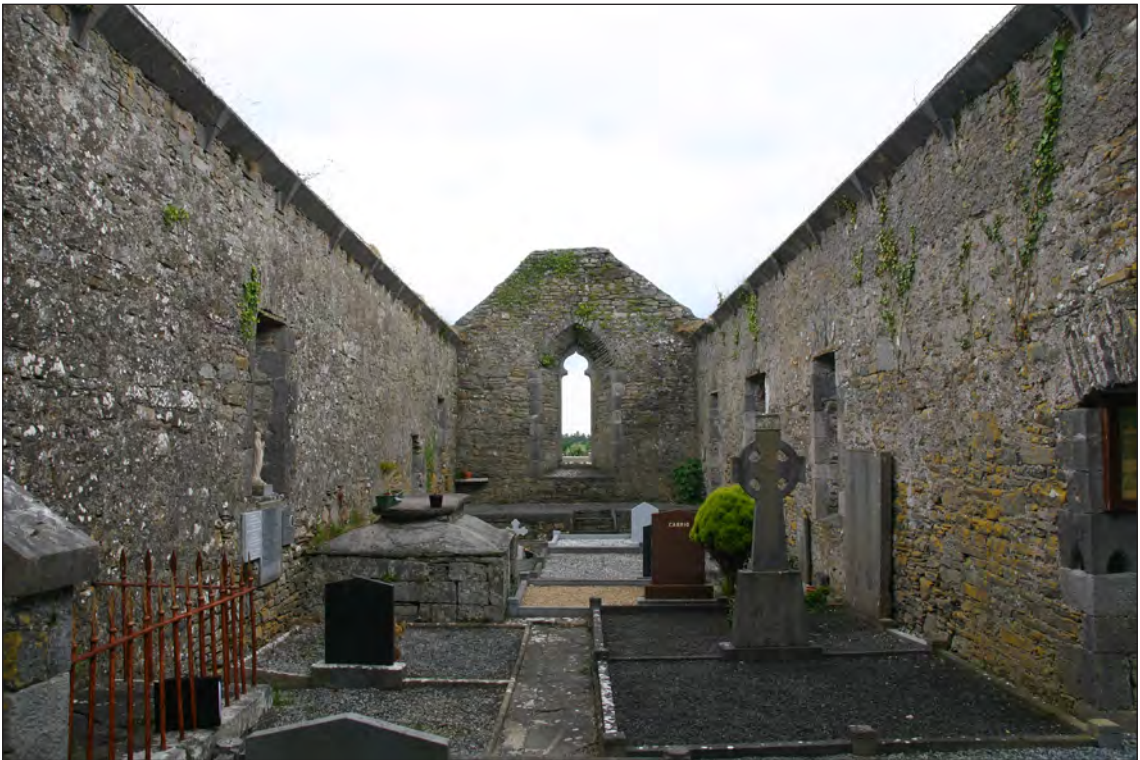
Plate 8: View of west chancel area of Kilnaughtin Church. Note extent of burials and inappropriate concrete raised area beneath east window

No further burials should take place inside the church.

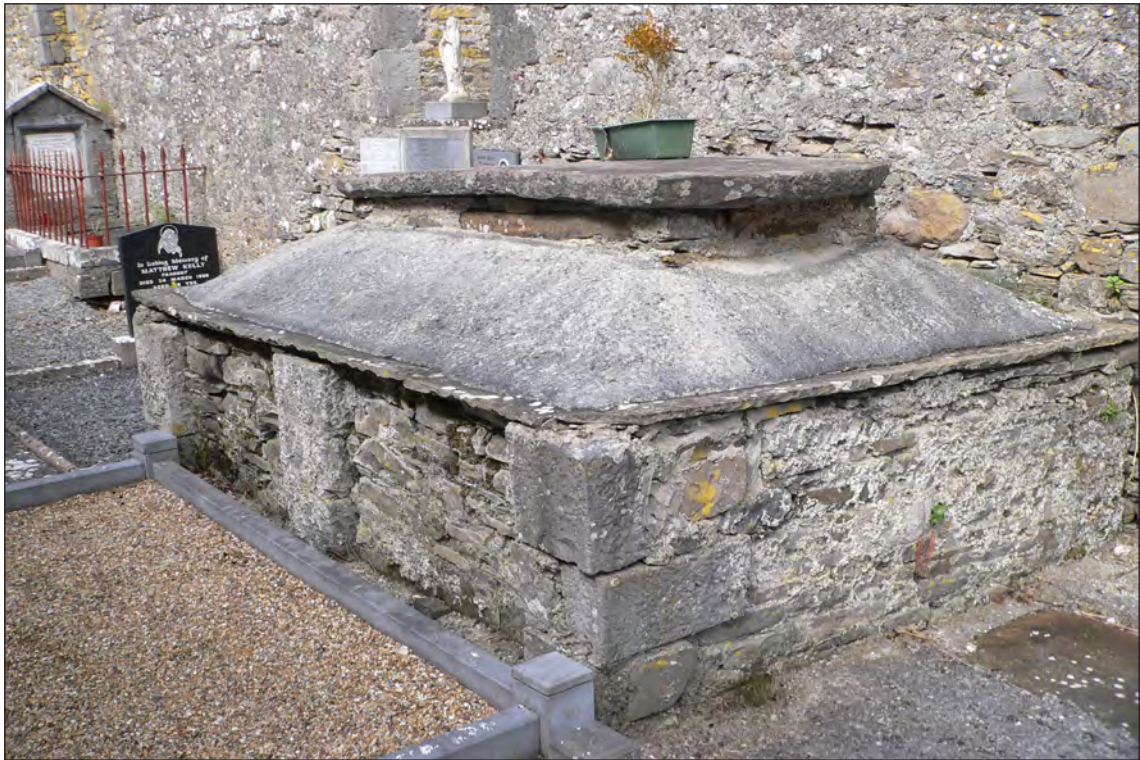
Hamilton tomb, is in the church (Plate 8). The unnamed tomb (256) and the Hamilton tomb (424), Plates 9 -10) require limited masonry repairs and re-rendering. The Martin tomb (261, Plate 11) is of ashlar limestone and requires minor masonry repairs.

Plate 9: View of Hamilton tomb (424) in Kilnaughtin Church

The unnamed tomb 256 and the Hamilton tomb 424 should be repaired and re-rendered. The ashlar Martin tomb (261) should also be repaired. The tombs should be repaired and re-pointed sensitive to their original construction. The render should be replaced sensitive to the original construction. This work may require Ministerial Consent.

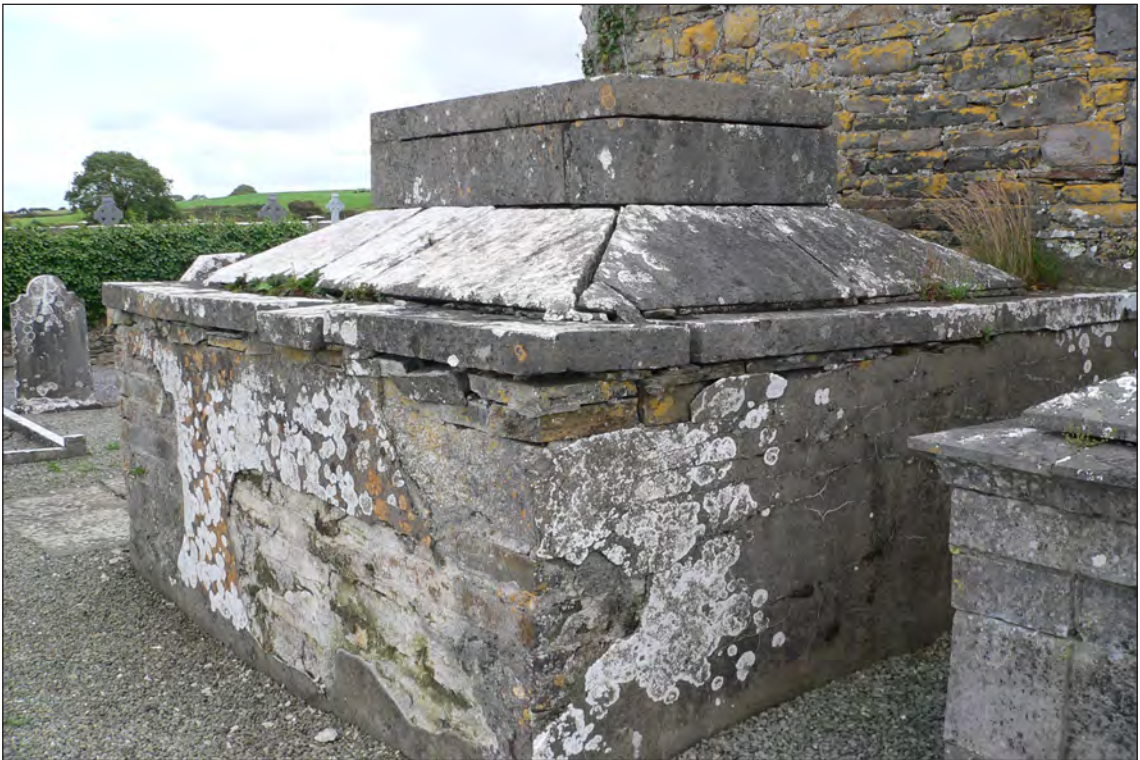
Plate 10: View of unnamed tomb (256) from west

It is likely that local information would furnish the name of the unnamed tomb and this information should be collected.

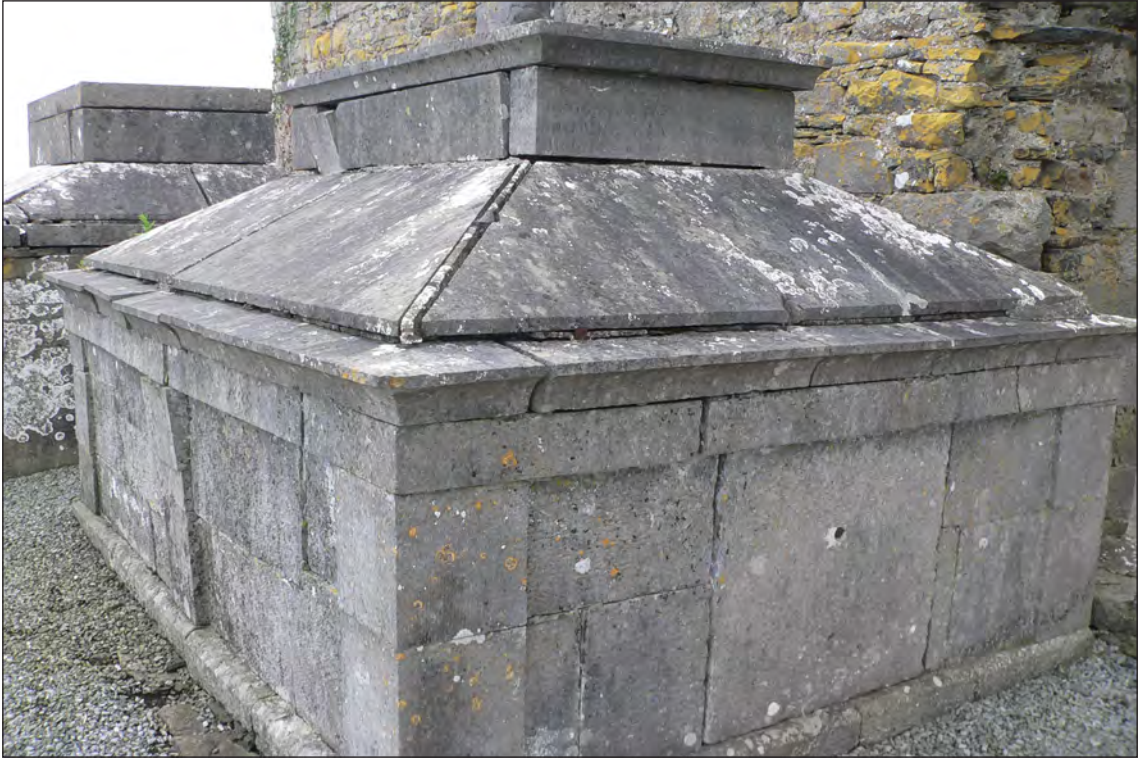
Plate 11: View of Martin tomb (261) from west

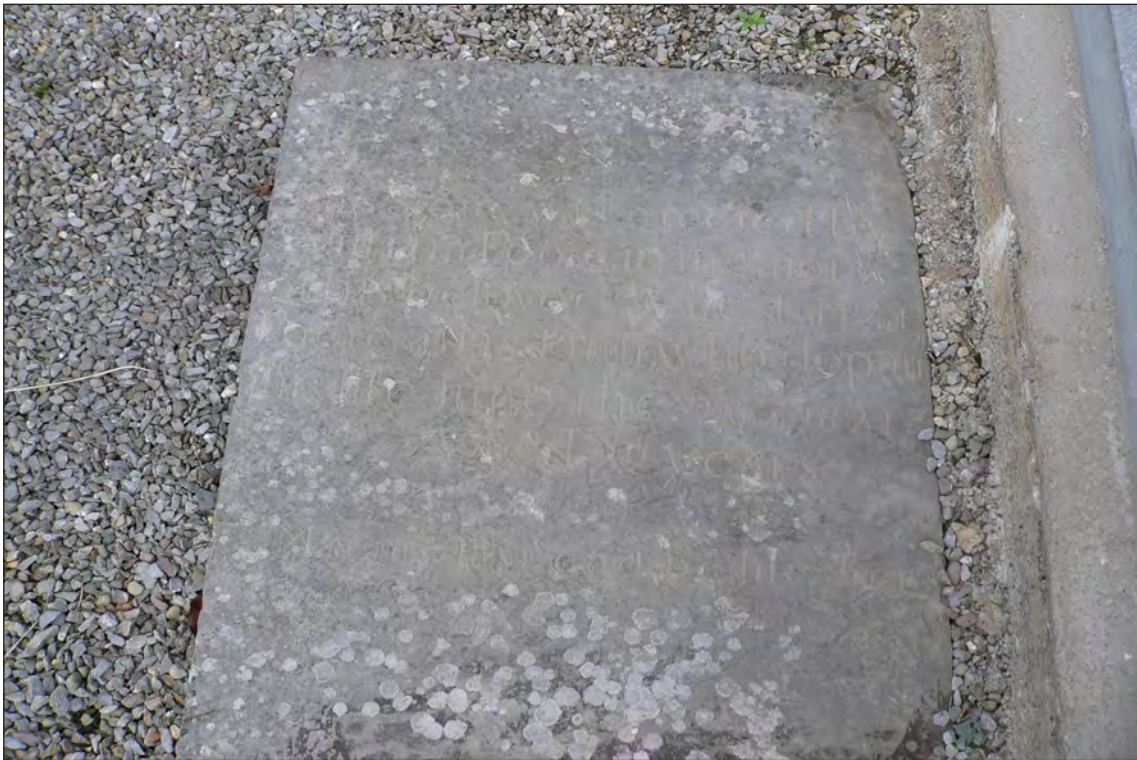
Plate 12: View of grave slab of the Foote family (274)

A total of 280 named headstones (HN) were recorded in Kilnaughtin graveyard of which ten are simple iron crosses while there are seven large rectangular grave slabs and two table graves (Plates 12 & 13). Many of the headstones within and around the church i.e. in the old graveyard contain the earliest headstone dating from late 18th and 19th centuries (Plates 14- 15). Twelve of the grave markers are large rectangular slabs from the 19th century. Otherwise the dominant graves are modern, typically formal grave setting and a headstone. A number of inscribed graves record mariners, one of which (412) to the memory of Charles Bulreel or Bulteel, is built into the south elevation of the interior of the church (Plate 16). Curiously, there is a second memorial (267) to the same midshipman beside the northern boundary (Figure 5).

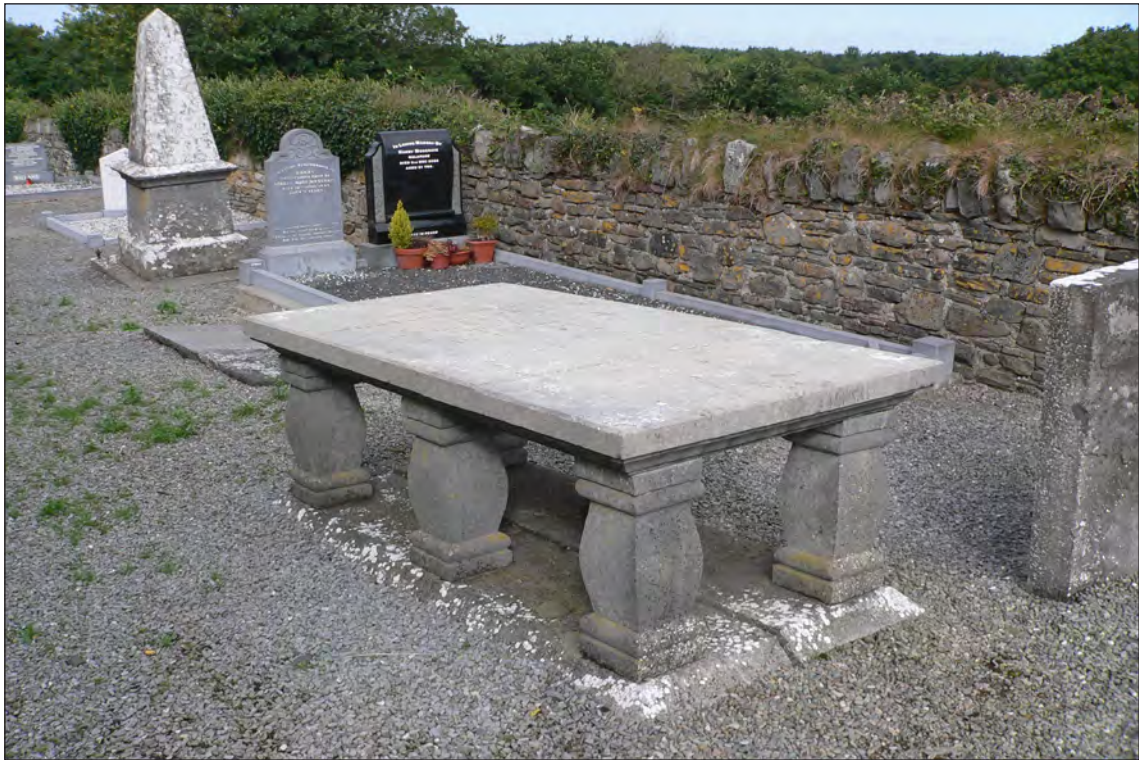
Plate 13: View of table grave of Henry Chown, 1854 (266)

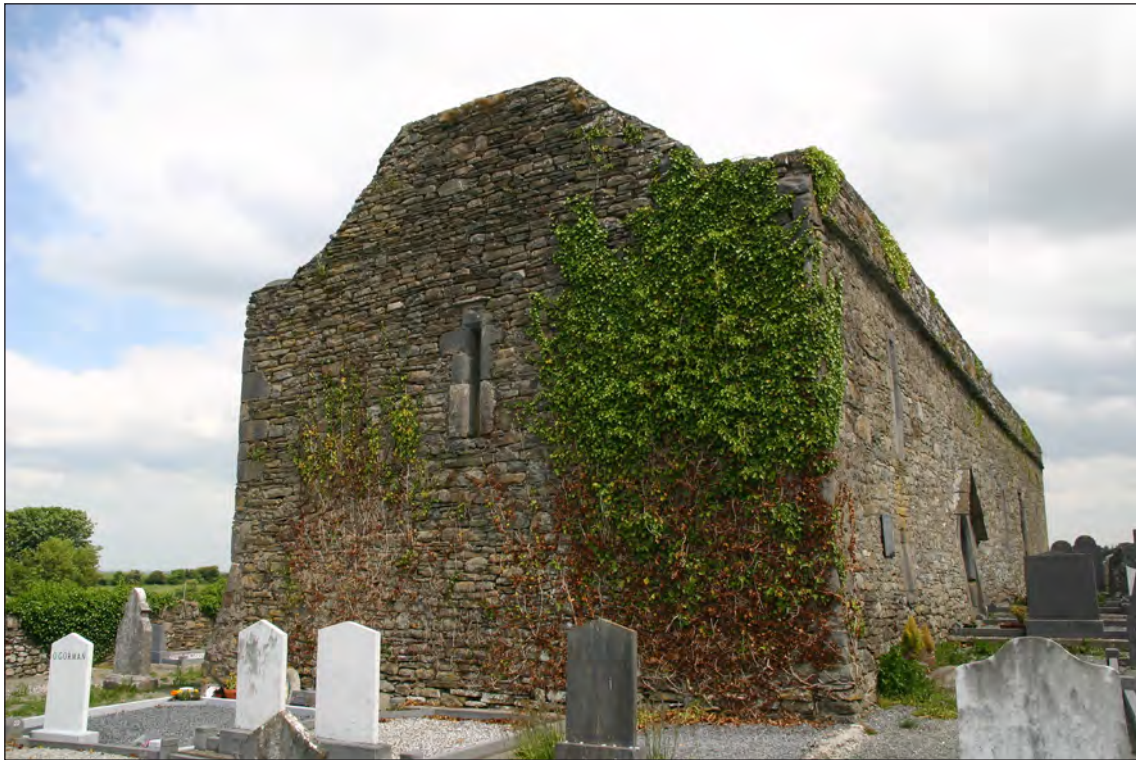
Plate 17: View of Kilnaughtin Church from south west. Note ivy growth on west gable

- The ivy and other growth now re-establishing itself on the exterior west gable and elsewhere should only be fully removed as the primary element of an agreed strategy of repairs and other conservation and restoration works. Otherwise ivy and other growth should be simply cut back and maintained at a controllable level.

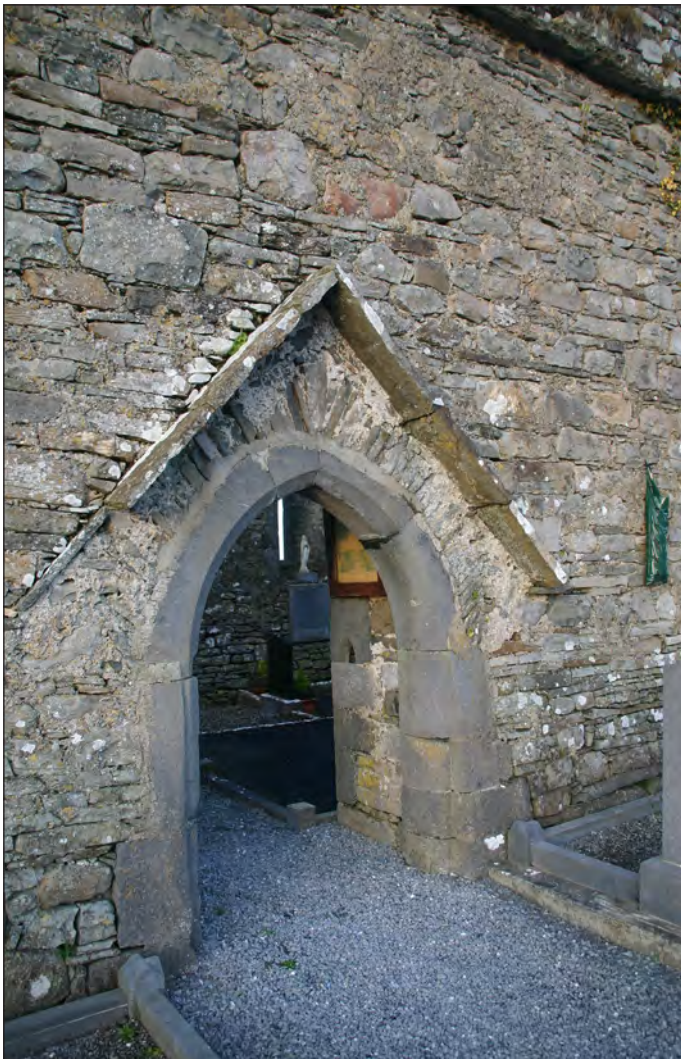
The main doorway is situated on the south elevation towards the west end. The pointed doorway is constructed of dressed limestone and has a projecting hood or canopy of undressed flagstone over it (Plate 18).

Plate 18: View of entrance doorway on south elevation. Note featured canopy or hood over

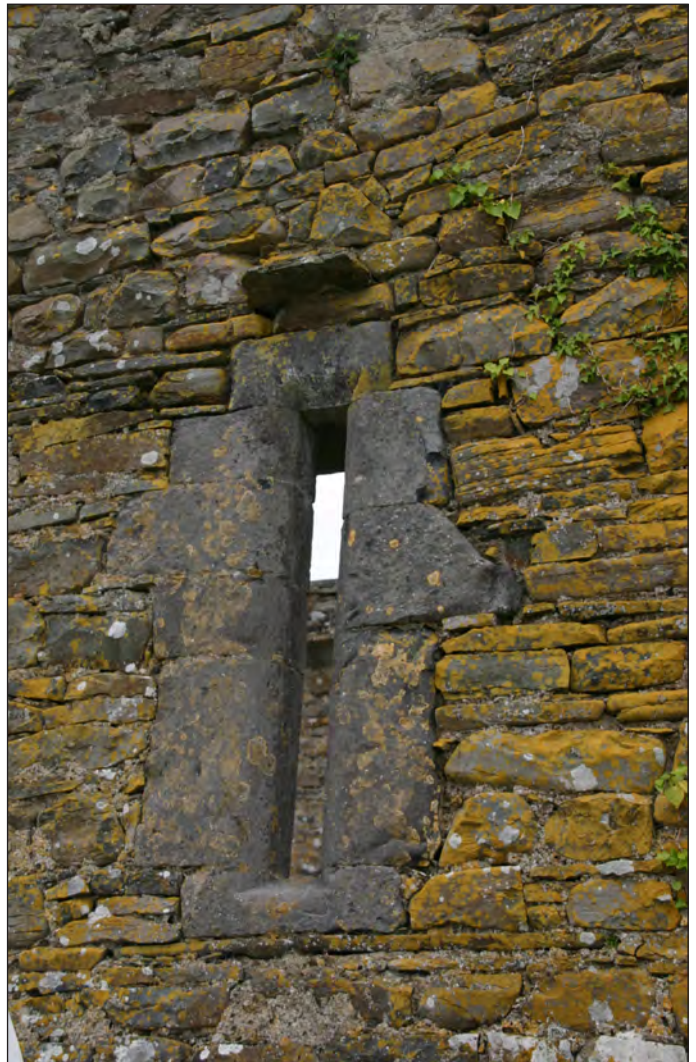
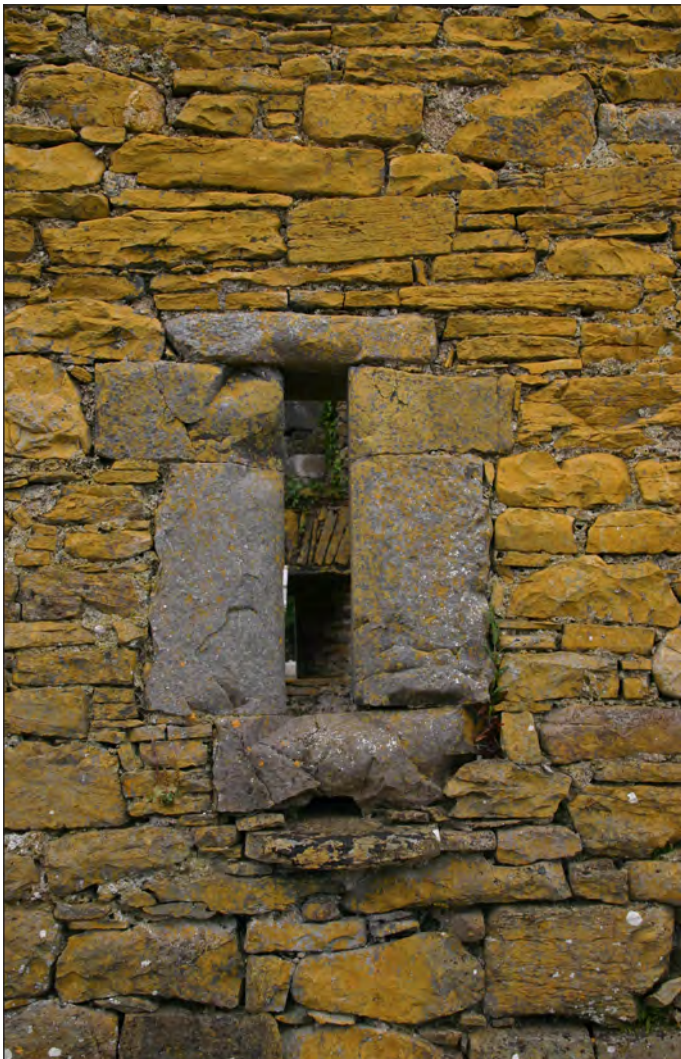
Plate 20: View of small narrow flat lintelled window. Note water outlet beneath cill

Plate 21: View of inner eastern side of doorway on south elevation. Note double-entry stoup, similar to Carrigafoyle and Aghavallen churches

On the interior right hand angle of the doorway is a neat double entry bi-partite stoup, 600mm x 380mm x 400mm. The bottom stone of which forms the basin while the uppermost has two pointed arched entry apertures, 140mm wide x 130mm high with chamfered outer edges (Plates 21 & 28). The stoup is identical to the damaged one at Carrigafoyle Church and the broken one at Aghavallen (Dunne 2010). This type of stoup is not common in Kerry, none are known from the Dingle or Iveragh peninsulas. However some examples do exist from around the country; at Clonlea and Kilfarboy Co. Clare, Kilcooley Abbey and Toomyvara Priory, Co. Tipperary and Clontuskert, Co. Galway (Timoney 1971, 76-77).

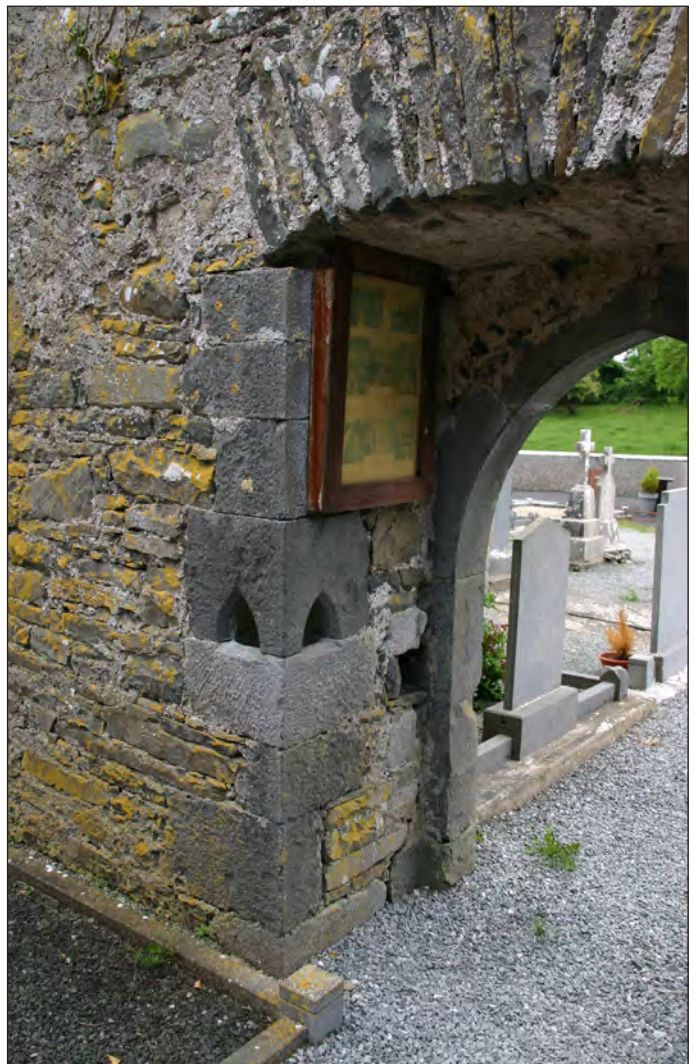
Plate 22: Interior view of western limits of Kilnaughtin Church. Note projecting corbels and upper windows and cupboards of loft or gallery

The western end of the church had a 5.5m loft or gallery as is evidenced internally from the support corbels, beam holes, larger upper windows and intra mural cupboards (Plate 22). The west gable has a narrow flat lintelled rectangular slit window set within a stepped straight sided embrasure. A reused dressed limestone is built into the base of the north side of the embrasure and has a hemisphere cut from its base. This stone may have formerly been used as a porthole or alms-stone similar to Carrigafoyle Church (Plate 27).

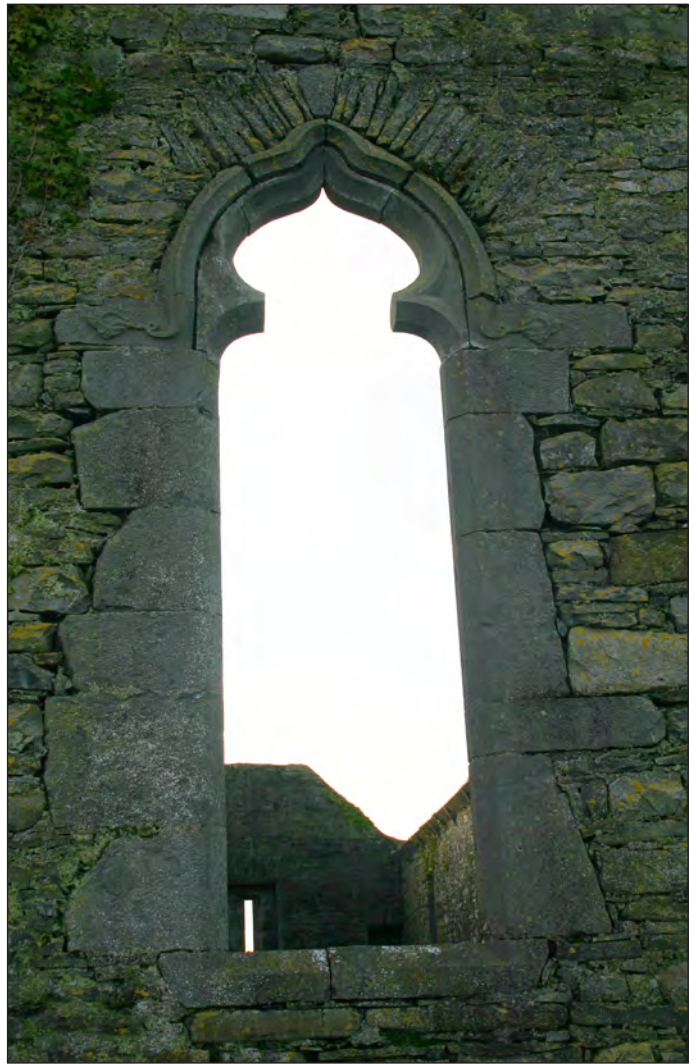
Plate 24: Close up exterior view of ogee head of east window. Note vine-leaf motifs to terminals of hood moulding. Further note missing centre mullion

The east gable is centrally pierced by a substantial ogee headed twin-lit 15th or possibly 16th century window whose mullion has disappeared (Plates 8 & 23). Externally the east window features a hood moulding whose terminals are completed in a wonderful flourish depicting a vine leaf motif (Plate 24). Internally the east area of the church has a large ugly concreted area with steps up to it. A rectangular shelf slab projects from the north-east corner near a small possible aumbry on the north elevation (Plate 25). Opposite on the south wall and now unfortunately level with the modern raised concreted area is a cinquefoil piscina (Plate 26).

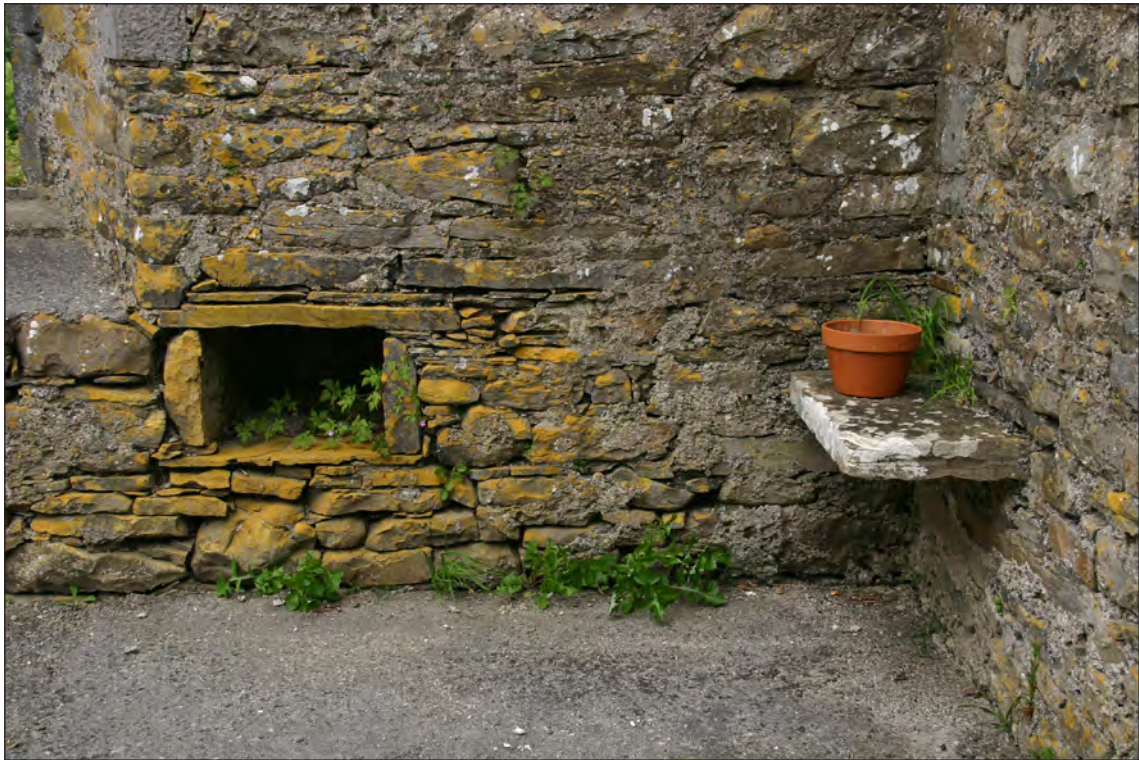
Plate 25: View of north–east corner of interior of Kilnaughtin Church. Note aumbry and projecting stone shelf

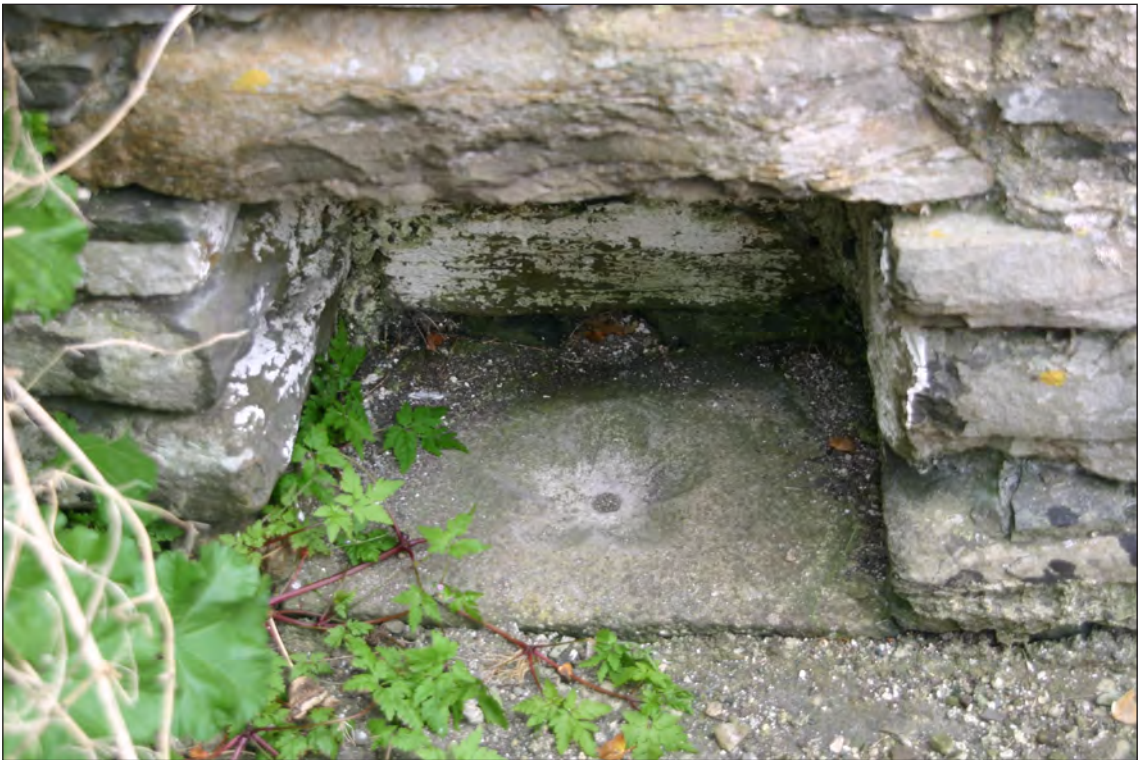
Plate 26: View of cinquefoil piscine on south elevation at east end of church

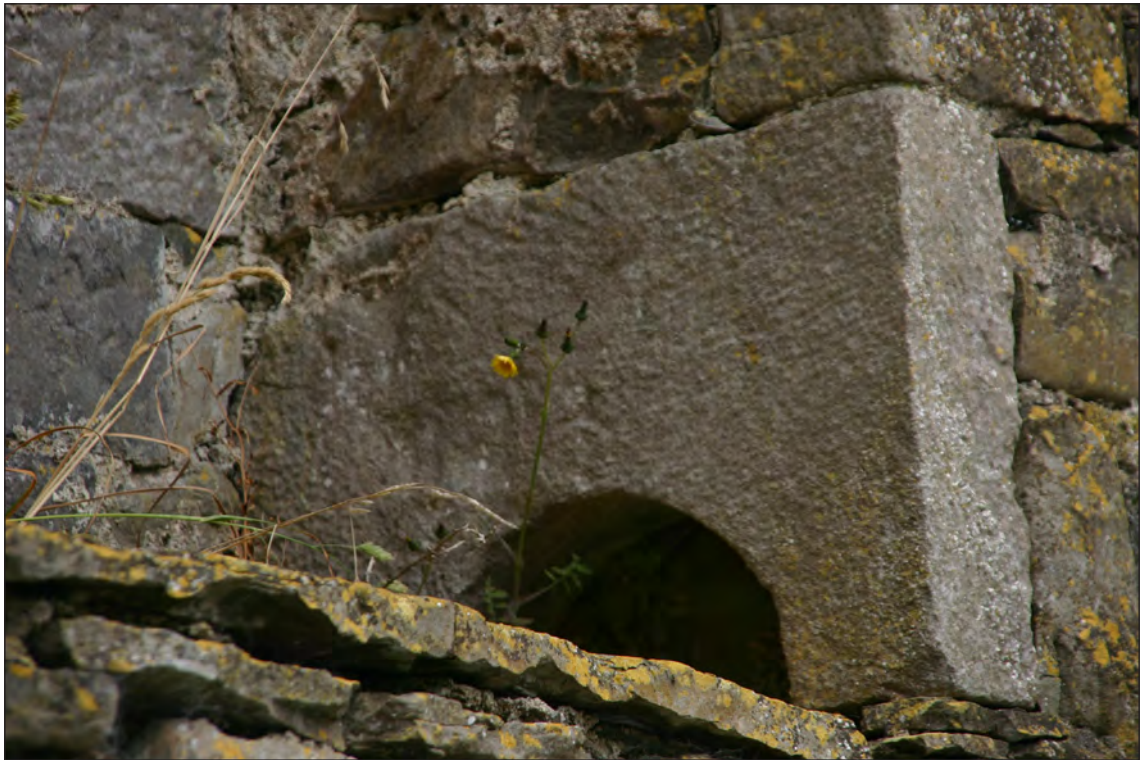
Plate 27: View of re-used dressed and cut stone on north side of embrasure of window on west gable. Possibly originally used as alms-hole stone similar to Carrigafoyle Church
