Archaeological Survey,
Kilnaughtin Church and Graveyard,
Carhoona,
Tarbert
Co. Kerry.

September 2010

RMP No.: KE003-008 Church and
KE003-008001 Graveyard

Written by: Laurence Dunne

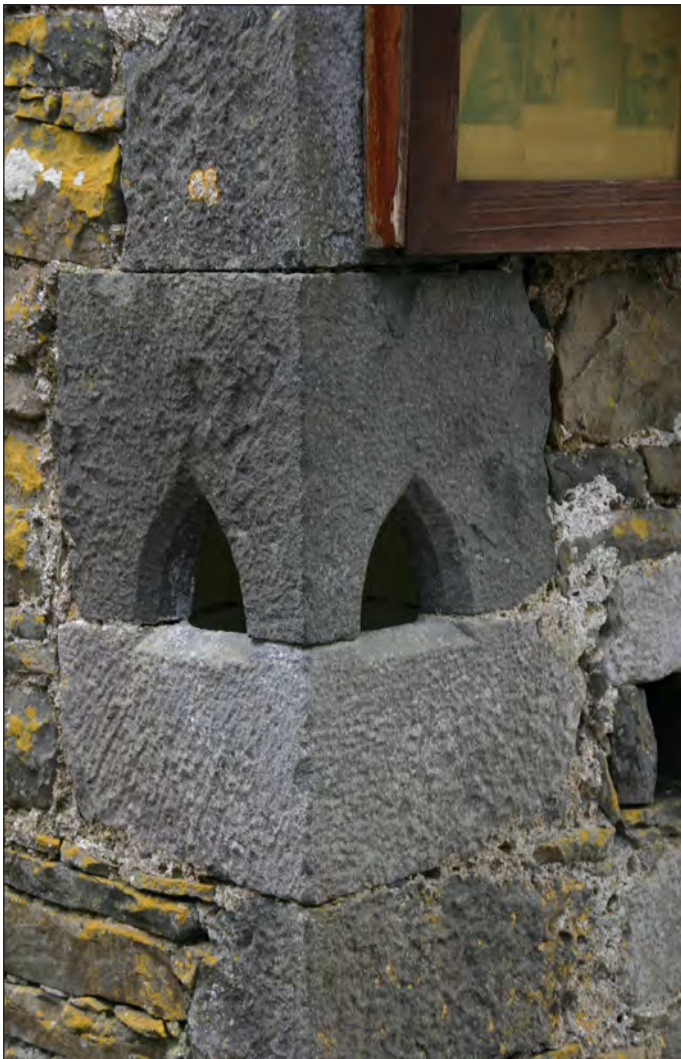
Plate 28: Close up view of double-entry stoup in Kilnaughtin Graveyard

On the interior right hand angle of the doorway is a neat double entry bi-partite stoup, 600mm x 380mm x 400mm. The bottom stone of which forms the basin while the uppermost has two pointed arched entry apertures, 140mm wide x 130mm high with chamfered outer edges (Plates 21 & 28). The stoup is identical to the damaged one at Carrigafoyle Church and the broken one at Aghavallen (Dunne 2010). This type of stoup is not common in Kerry, none are known from the Dingle or Iveragh peninsulas. However some examples do exist from around the country; at Clonlea and Kilfarboy Co. Clare, Kilcooley Abbey and Toomyvara Priory, Co. Tipperary and Clontuskert, Co. Galway (Timoney 1971, 76-77).

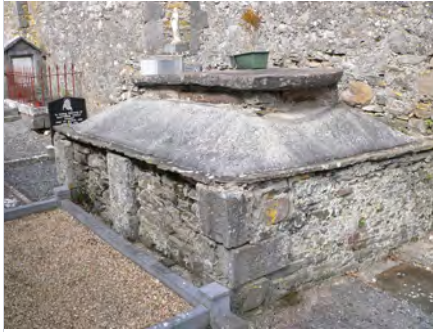
Surname:	HAMILTON
Tomb No:	424
Photo No:	155_0275 & 276
Photo:

Notes:	
Collapsed	N
Open	N
Rendered	Y
Overgrown	N

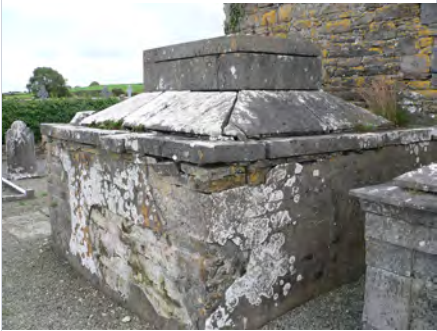
Tomb No:	256
Photo No:	155_0142
Photo:

Notes:	
Collapsed	N
Open	N
Rendered	Y
Overgrown	N
