**Project code:** KCCG11  
**Client:** Kerry County Council  
**Date:** July 2011

## **Archaeological Survey of Kilquane Burial Ground, Feohanagh, County Kerry**

**Surveyors:** Ann Frykler & Robert Hanbidge  
**Report Author:** Robert Hanbidge

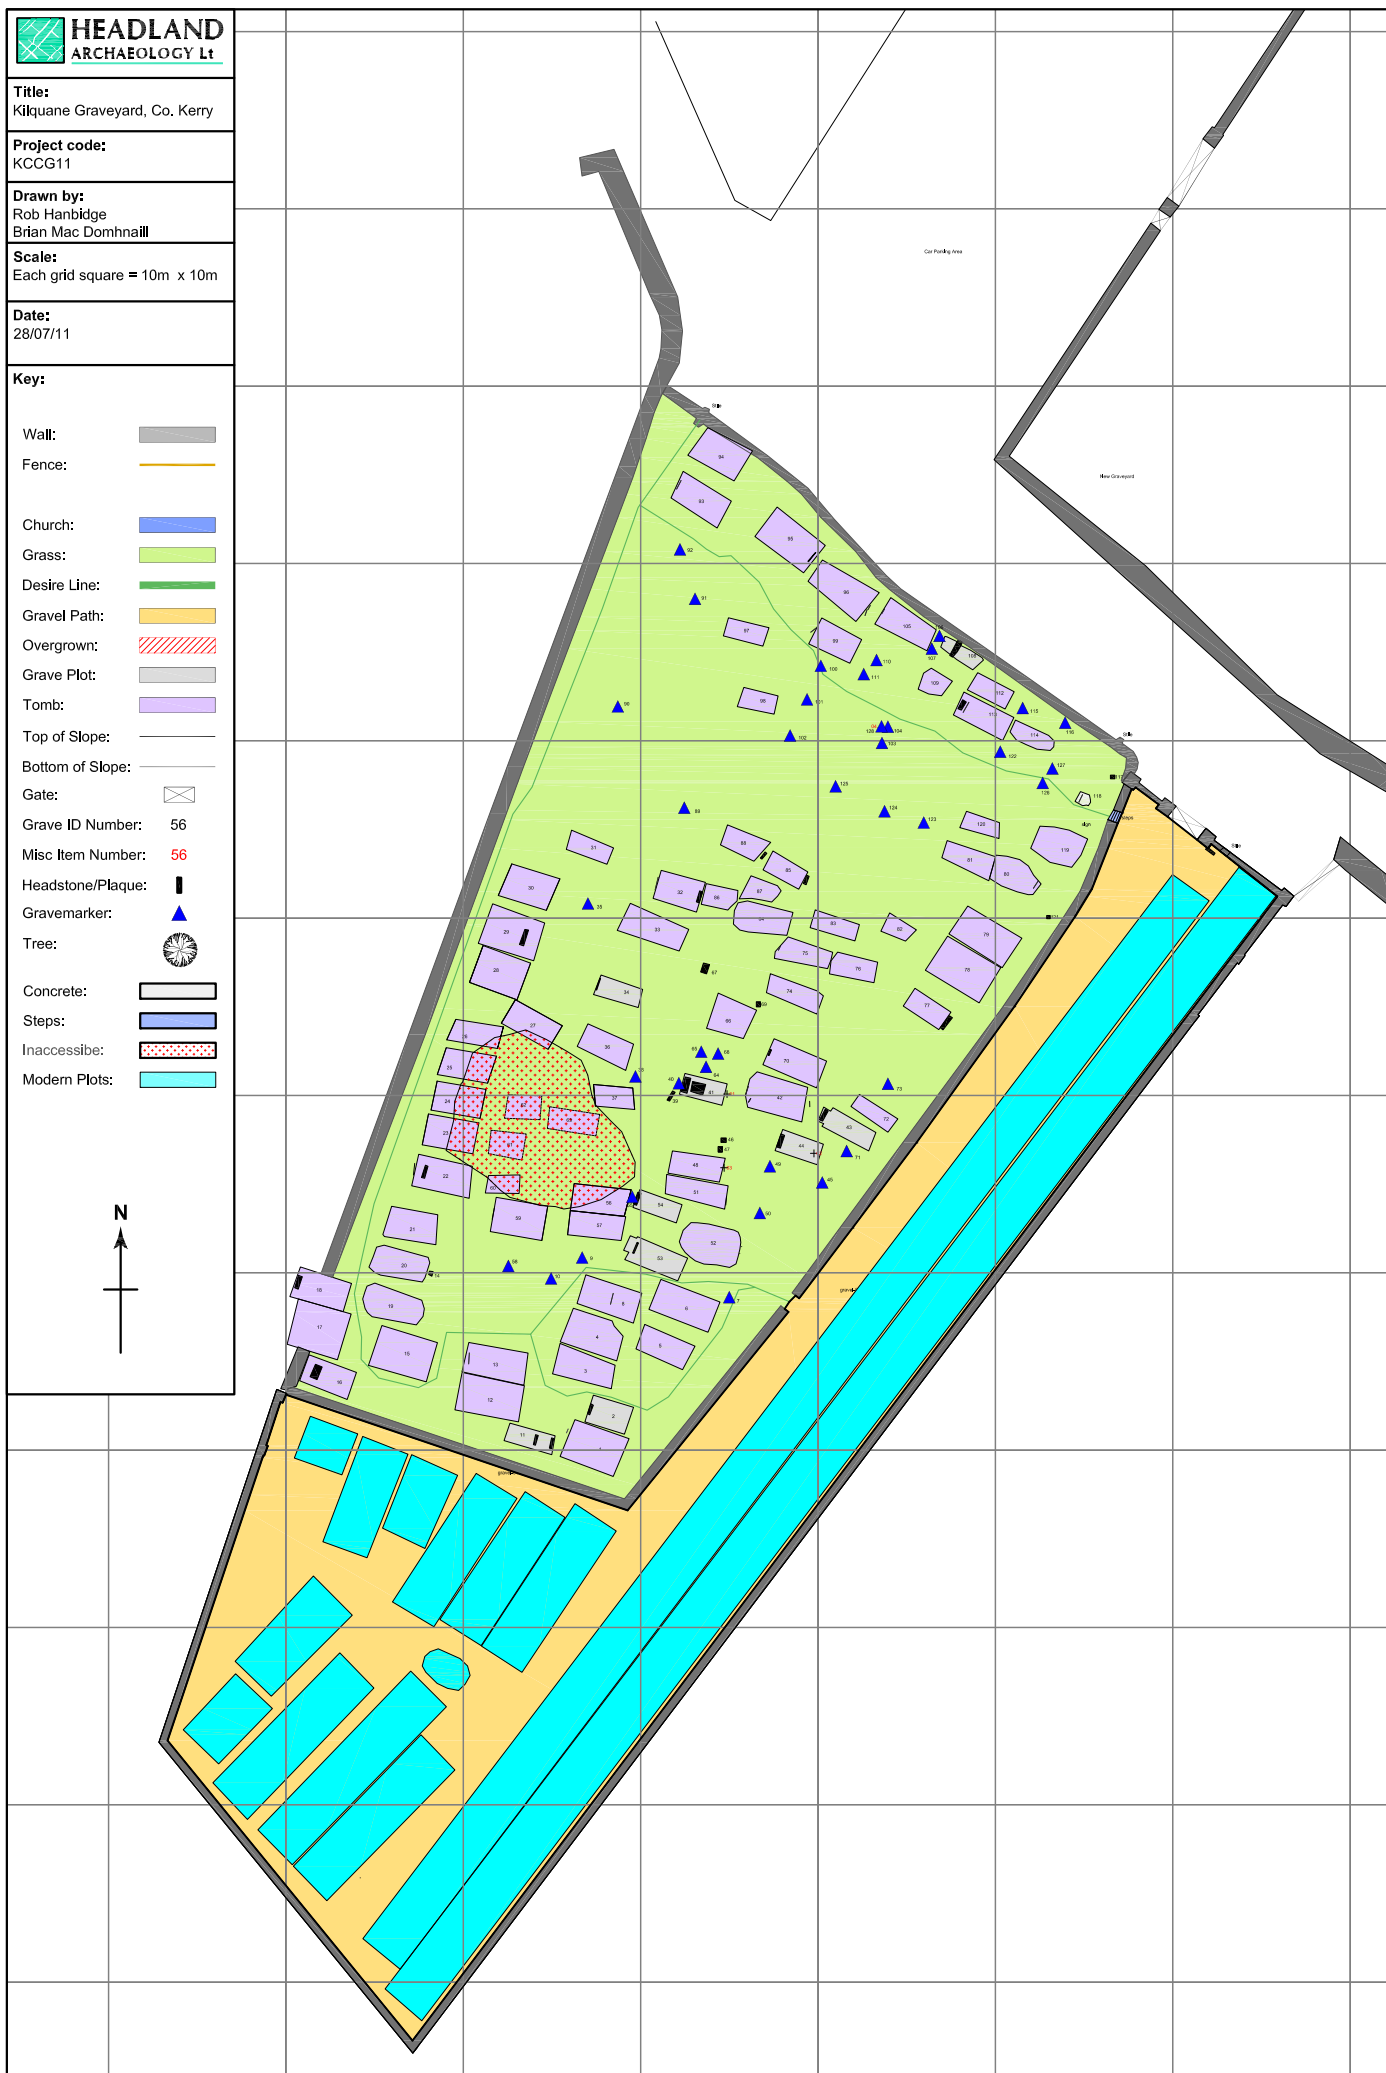
Figure 4 -Archaeological survey plan of Kilquane Graveyard, 2011.

An electronic survey was conducted on the Irish National Grid using a Trimble GPS & GLONASS R6 base and rover. The GPS was supplemented with a Leica TCR407 Total Station and Panasonic Toughbook Rugged Tablet PC with Penmap software when necessary due to tree cover and any resulting loss in GPS signal. All grave plots, gravemarkers, headstones and tombs were surveyed in plan as were any structural remains, boundary walls, openings, paths and desire lines. Finished survey files were exported to AutoCAD where final edits were made. A digital copy of the drawings is provided on DVD (Appendix 5).

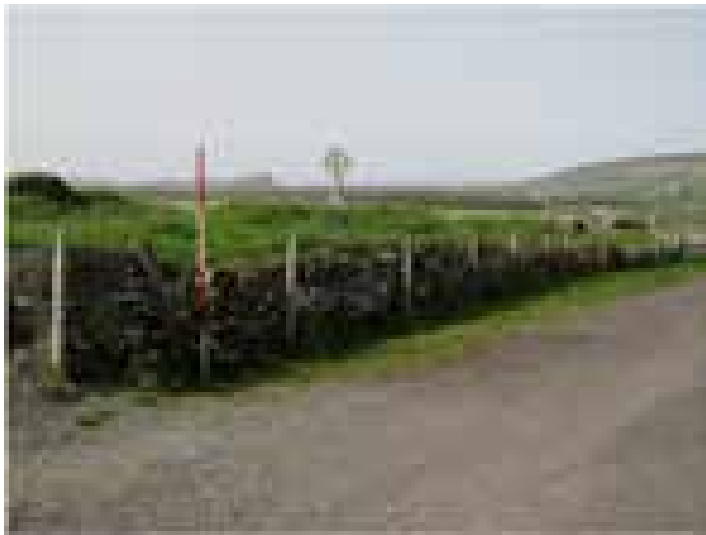
Plate 1-View of north-eastern boundary

The boundary walls surrounding the historic section of the graveyard consist of two types: those to the northeast and west are drystone walling while those to the southeast and southwest consist of mortared rubblestone with rubblestone and flagstone coping (Plates 1-4). Roughcast rendered walls with render coping and roughcast rendered piers enclose the graveyard extension. Roughcast rendered piers flank the entrance with rendered capping.

For the most part the walls appear stable with very little vegetation on their interior elevations. The occurrence of distinctive pale lichens are a frequent feature of the walls and compliment their charm and character.

General maintenance to ensure the walls remain stable.

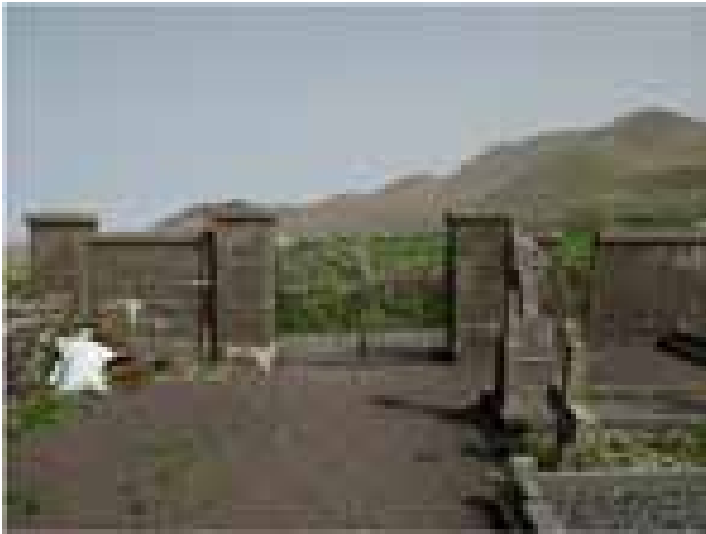
Plate 5-View of entrance from southwest

The primary entrance which is located along the north-eastern boundary of the graveyard extension consists of a pair of roughcast rendered square-profile piers surmounted by render capping supporting double-leaf wrought-iron gates. The piers survive in good condition with occasional cracks to the external rendering.

General graveyard maintenance.

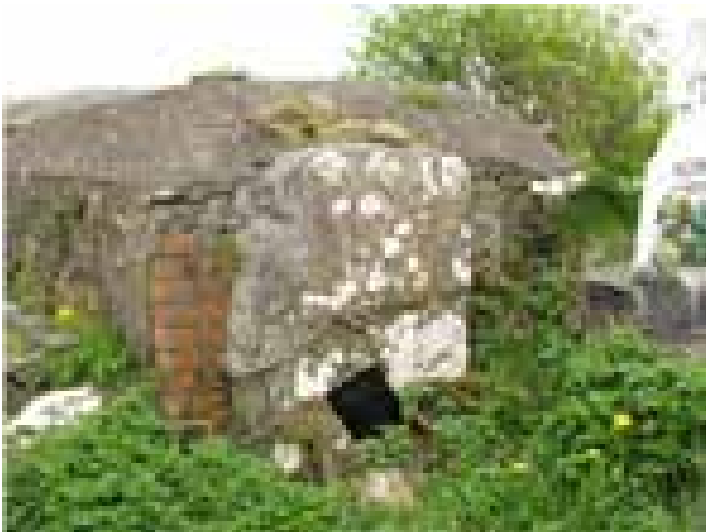
Plate 11-View of tomb (Grave No. 1), from west

There are 14 named tombs present at Kilquane Graveyard which are concentrated in the south-western half of the graveyard. Generally these tombs are modest in their construction and consist of rectangular structures, usually built from rubblestone although some have red brick detailing and are externally rendered. Some of the tombs are in good condition and have recently had their entrances resealed, e.g. Grave No. 1 (Plate 11).

Although some of the tombs have been conserved, many of the named tombs, especially those constructed from drystone walling are in need of immediate repair and sealing of the entrances to prevent further disturbance.

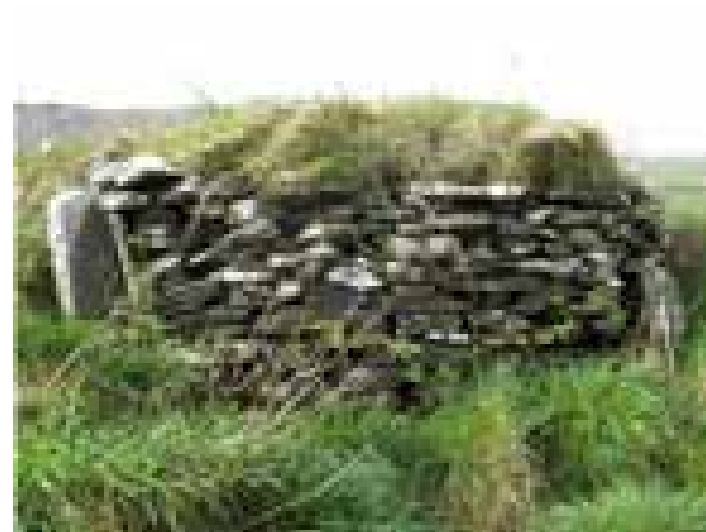
Plate 12-View of tomb (Grave No. 85), from north

Some tombs are more vernacular in their design and construction methods as they are built from drystone walling. These are not in as good condition as the mortared tombs and often have grassy overgrown roofs, e.g. Grave No. 85 (Plate 12) (this tomb is also unusual as the headstone inscription faces into the tomb). One such tomb in good condition is Grave No. 59, which has had some conservation work carried out (Plate 13). This tomb is an excellent example of a vernacular tomb using locally sourced materials and a modest design. Its grass roof forms part of the historic character and is a distinguishing element of this graveyard.

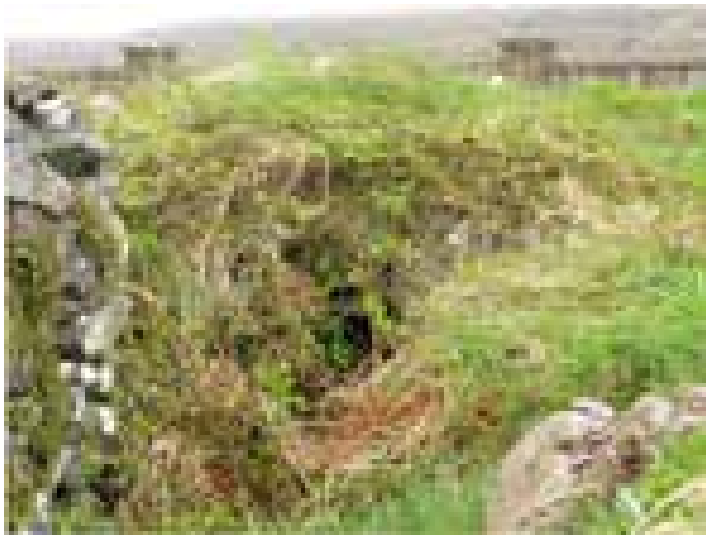
Plate 17-View of open entrance to tomb (Grave No. 5),  
from west

There are approximately 58 unnamed tombs within Kilquane Graveyard. Larger portions of the central southern half of the historic graveyard were inaccessible as they were unsafe to enter. Collapsed and partially collapsed tombs together with overgrowth made defining tombs and gaps between tombs impossible, e.g. Grave No. 87 (Plate 14). These tombs are also of vernacular value as many are constructed from drystone walling, with flagstones forming lintels for the roof which is also often grass covered. A minority of these tombs are in fair condition and there are some noted variations from the general design of rectangular structures; e.g. the tomb of Grave No. 52 is oval in shape (Plate 16). Several of the tombs are also in need of resealing to prevent further disturbance e.g. Grave No. 5 (Plate 17).

The majority of the tombs are in need of immediate repair with many partially collapsed creating extremely deep voids (over 1.5 m in depth). The unstable nature of the drystone walling at these collapsed tombs renders it impossible to gain access to them safely. .

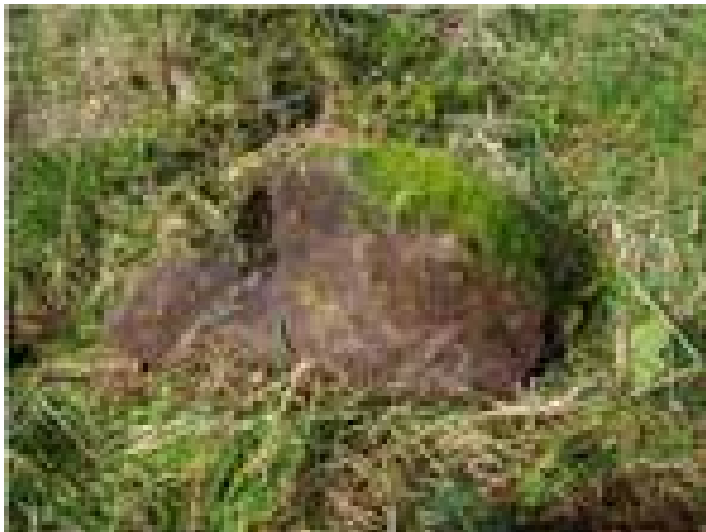
Plate 27-View of Miscellaneous No. 04 (Grave No. 128)

*Miscellaneous No. 04:* Small cross slab forming gravemarker for Grave No. 128 (Plate 27). The cross is partially buried and it appears that one arm of the cross is broken off.

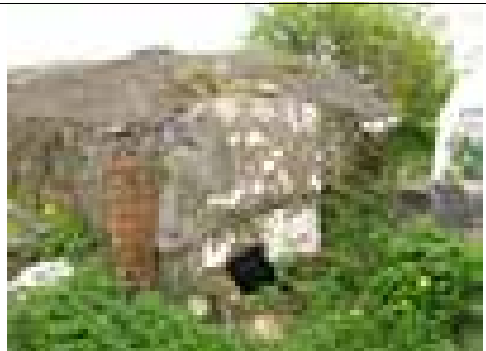
Grave_No	Family Name	Photo_Name
1	Ui Bheaglaoich	IMG_0009
<b>Notes</b>		
Tomb with brick and concrete repairs

- Any repointing of the tombs should use the appropriate (lime) mortars with flush or recessed pointing. Ribbon pointing must be avoided as its use would damage the tombs historic character.

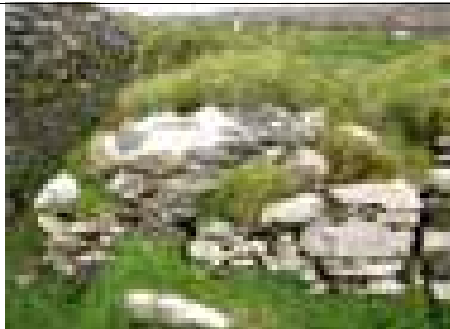
Grave_No		Photo_Name
3		IMG_0016
<b>Notes</b>		
Heavily overgrown tomb, recently fixed with concrete to prevent further collapse

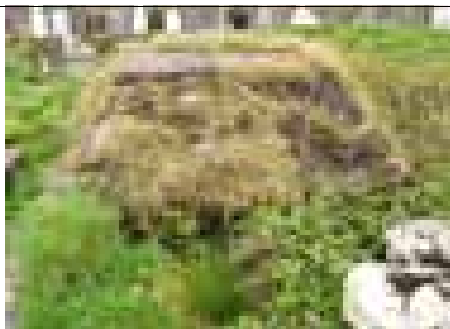
Grave_No		Photo_Name
5		IMG_0020
<b>Notes</b>		
Heavily overgrown tomb, open in west

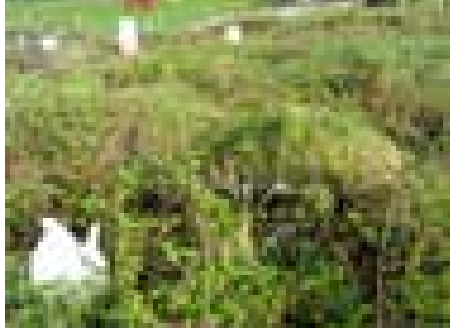
Grave_No		Photo_Name
63		IMG_0132
<b>Notes</b>		
Heavily overgrown and partly collapsed tomb, due to excessive overgrowth tomb is drawn by hand in survey
