**Archaeological Survey,
Kilsarkan East Church & Graveyard,
Co. Kerry.**

September 2007

Client: **The Heritage Office,
Kerry County Council,
County Buildings,
Ratass,
Tralee,
Co. Kerry.**

RMP No.: **KE049-086**

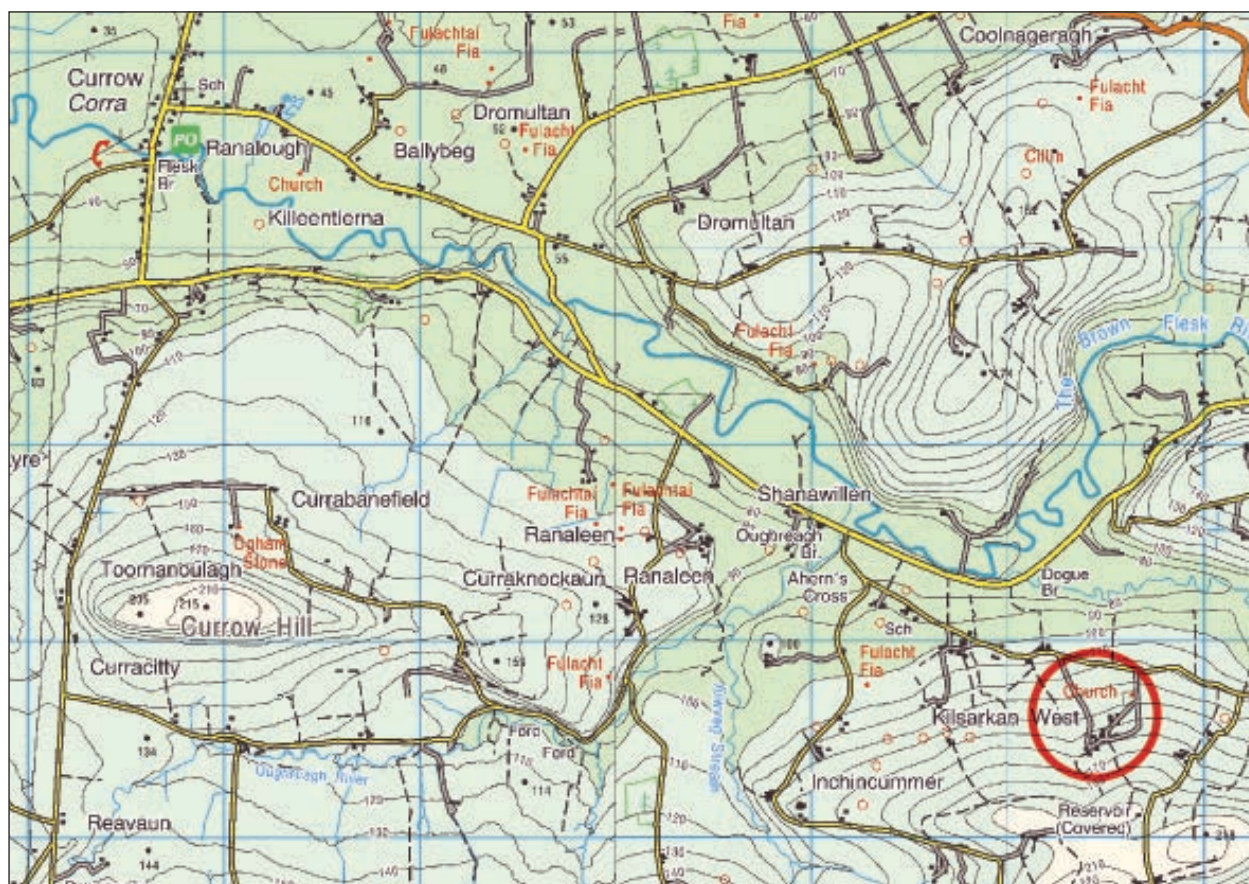
Figure 1: Plan of Kilsarkan Church and Graveyard 2007.

Kilsarkan East church and graveyard was surveyed using a Trimble Pro X-H GPS (Figure 1). The survey is linked to GPS and tied into the National Grid. The graveyard plan was produced using Adobe Illustrator. Reference numbers mentioned in the main body of the report relate to the ID point given when the survey was undertaken and these numbers are illustrated on the graveyard plan (see attached A1 drawing). A digital photographic record and surname database was also compiled to complement the cartographic survey (Appendices 1-4). Photographs of the features within the graveyard are referenced in the appendix and all photographs are provided on the attached disc.

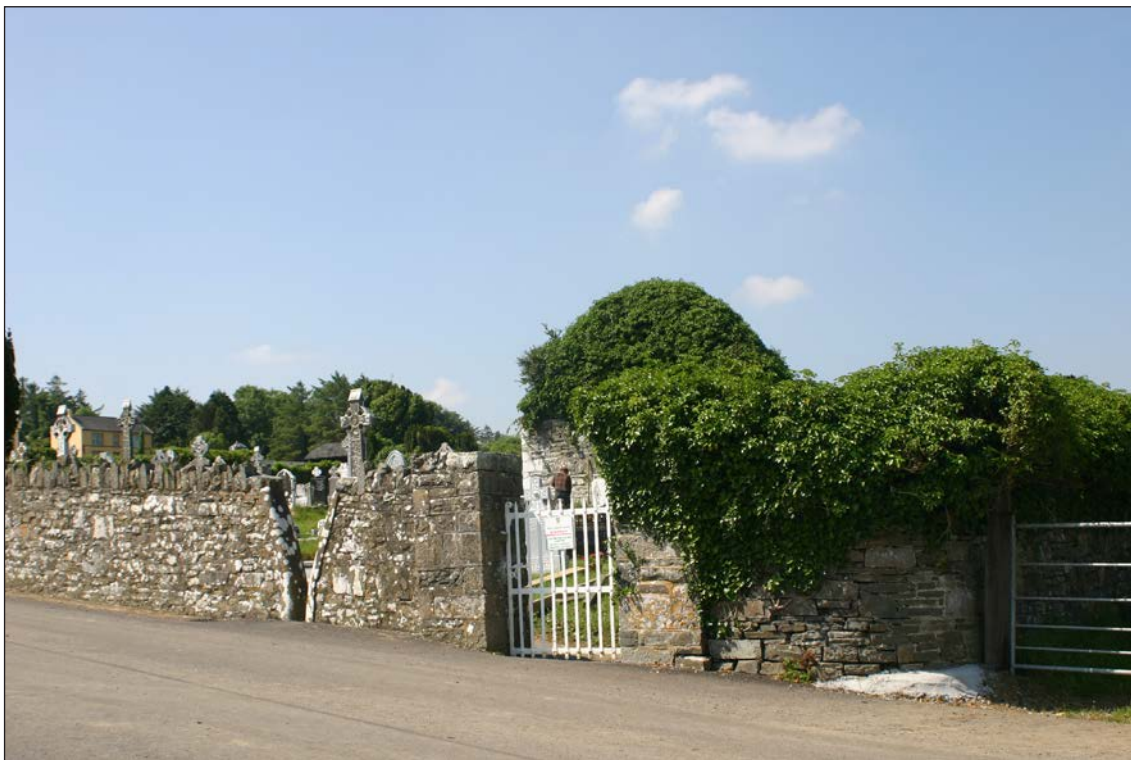
14 Kilsarkan Mortar Bowl (Figure 6)

A complete limestone mortar was noted on a pathway under a modern shelter-prayer area in the NW corner of the graveyard. The mortar was in use as a receptacle for night-lights.

When noticed by the writer the mortar was being used for night-light burning that has unfortunately cracked the artefact through. The wax from the candles has also penetrated through the crack and a substantial number of melted candles adhere to the interior base of the bowl while the remainder of the interior shows obvious smoke staining as well.

The mortar is well proportioned featuring four evenly disposed rounded rim lugs that taper into the side of the bowl like inverted noses. One of the lugs has a slight pouring channel. There is fine vertical tooling on the exterior while the side walls of the interior are nicely ground (Figure 6).

The bowl stands on a low circular plinth 7mm high and 110mm in diameter.

The mortar has a max exterior width of 230mm (including lugs) with a bowl width of 173mm. The internal diameter of the bowl is 125mm which is the same as the exterior height and an internal depth of 100mm.

Figure 6: Illustration of mortar bowl recorded within Kilsarkan graveyard.

It is recommended that the complete mortar bowl be cleaned and conserved by a professional licensed conservator and the artefact placed in a secure establishment like the Kerry County Museum.

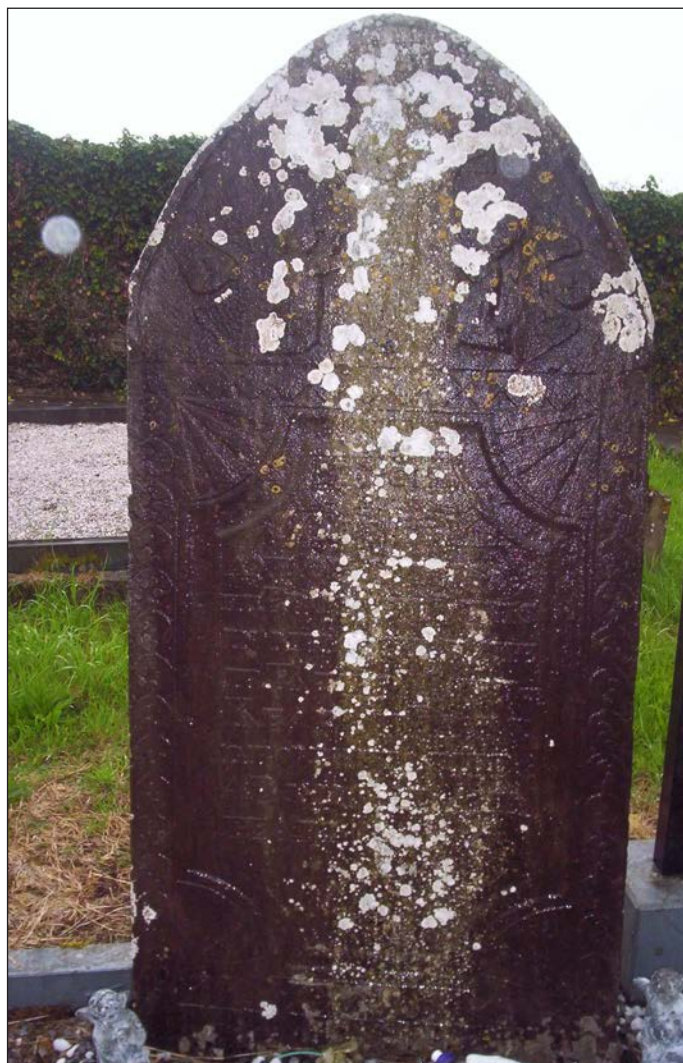
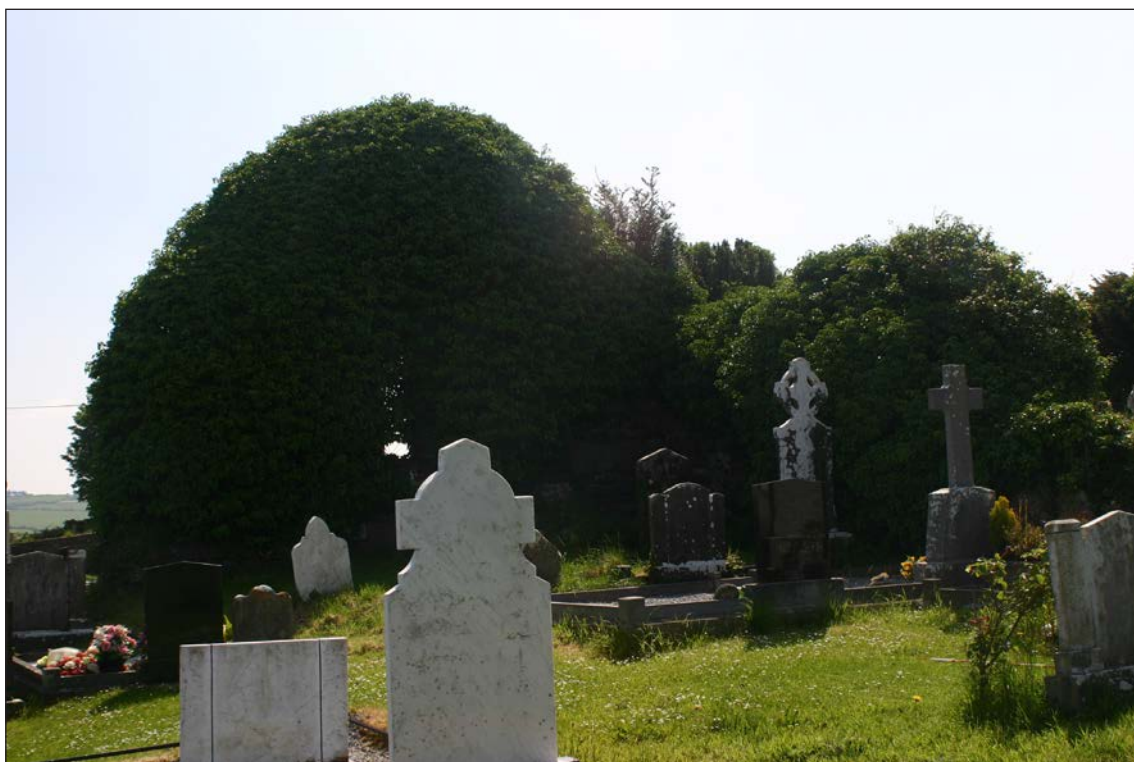
The church is in a poor state of preservation with only the eastern and most of the southern elevations remain upstanding (Plate 8).

The exposed interior area of the church contains many graves and a large pile of rubble masonry is pile in the southeast corner of the church.

Plate 8: Interior view of extant walls of Kilsarkan church, taken from northwest

The ruined church should be preserved and protected. The building should be securely fenced off during construction works in case of accidental damage.

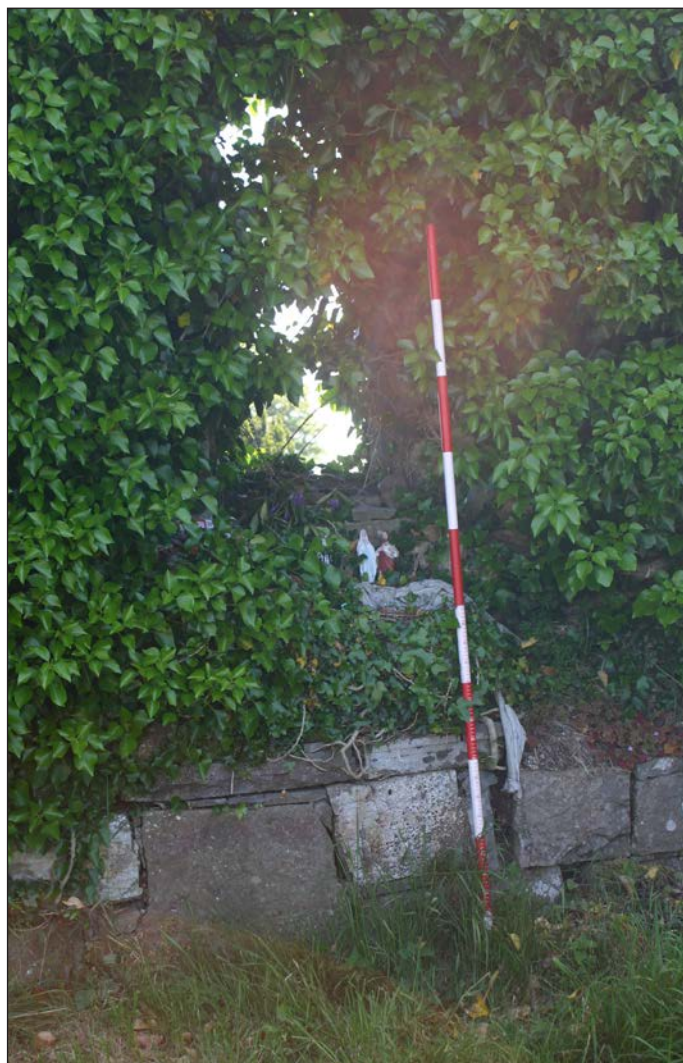
The window ope is completely trapped by ivy.

It is composed of a single pointed limestone head with a single rebate evident and sockets for window iron also visible.

The window sill is currently being used as a makeshift altar with deposits of holy statues and rosary beads present (Plate 9).

Plate 9: Interior view of overgrown window ope in east gable, taken from west

The vegetation cover should be removed under archaeological supervision and the exposed fabric recorded. Samples of *in situ* fabric, stone, mortars, renders etc should be recorded and

removed. Where possible and in principle, all original fabric should be re-used or similar substitutes sourced and matched.

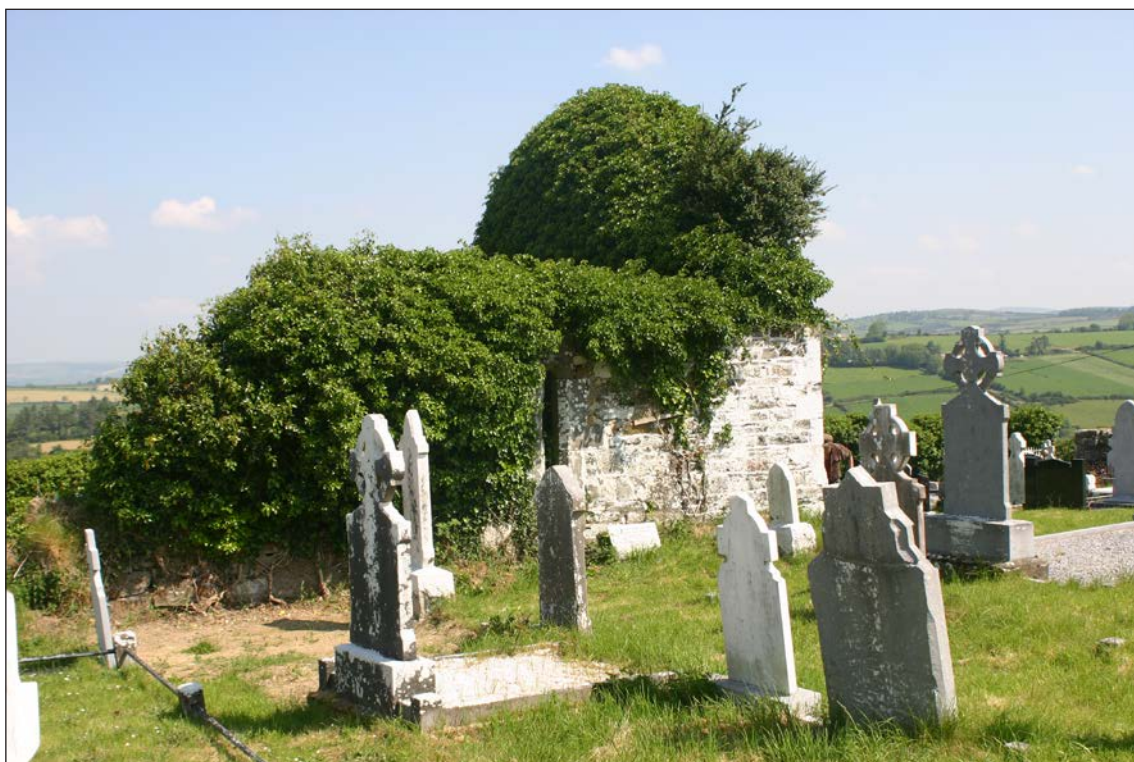
The remnants of the southern elevation is a denuded, tapering wall which rises from 1m, on what survives of the western end, to full height at the eastern end (Plate 10).

The quoinstones evident on the southeast corner of the elevation are contemporary with the surviving window. A heavy growth of ivy covers the walls.

Plate 10: Exterior view of southern elevation, taken from southwest

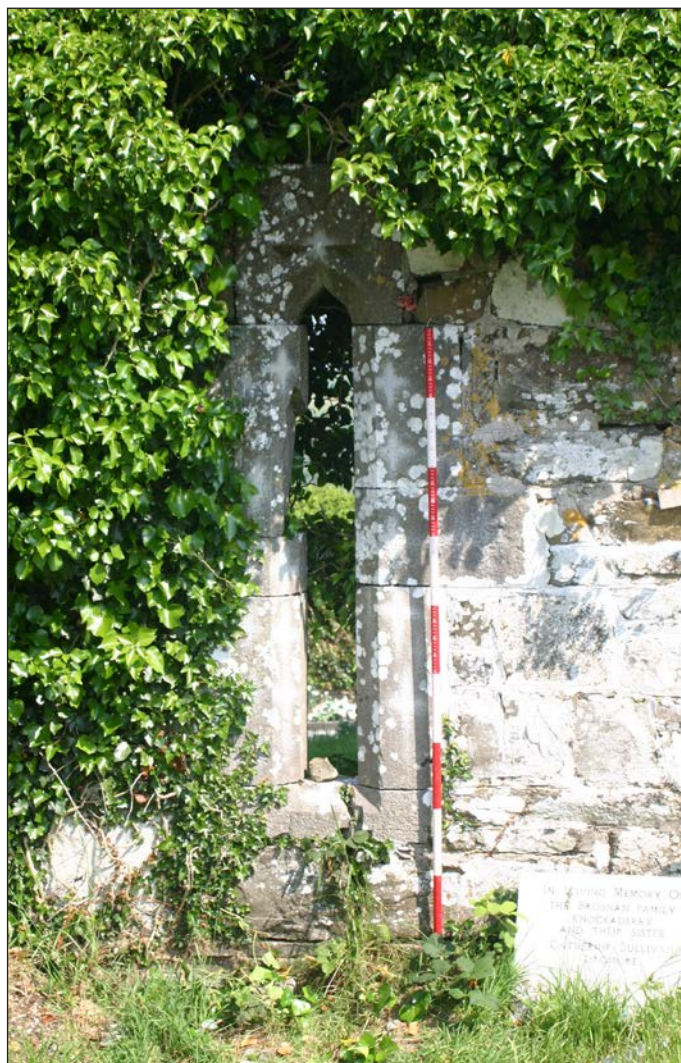
A single ogee headed cut limestone window ope is present in the southeast corner of the wall (Plate 11). This window is interesting and unusual as a *sheelagh-na-gig*, KE048-086:05, forms the apex of the window.

However, in recent years, a custom seems to have evolved where the window has become a stopping point while saying the rosary and a cross is then scratched with a stone by the devotee at several locations on the window's side stones and indeed on the *sheelagh* but in particular on the sill stone which is also unfortunately cracked through (Plate 12 & 13, Figure 5) A rough stone is placed on the window sill for this purpose.

Plate 11: View of window in southern elevation, taken from south. Note the crude, cross shapes carved when doing prayer rounds at the church and graveyard.

The practice of scratching the window and *Sheelagh-na-gig* with a cross shape should be immediately stopped to prevent more irreparable damage. Parishioners should be informed that the use of the stone to carve the shape of the cross on the window as well as to deface the *sheelagh-na-gig* is no longer permitted. Prayer rounds can still be maintained but without this invasive ritual.

The southern window ope should be protected in the short term by excluding access to it by temporary fencing and by propping.

Repairs of this window should be undertaken as a matter of urgency to prevent its total collapse.

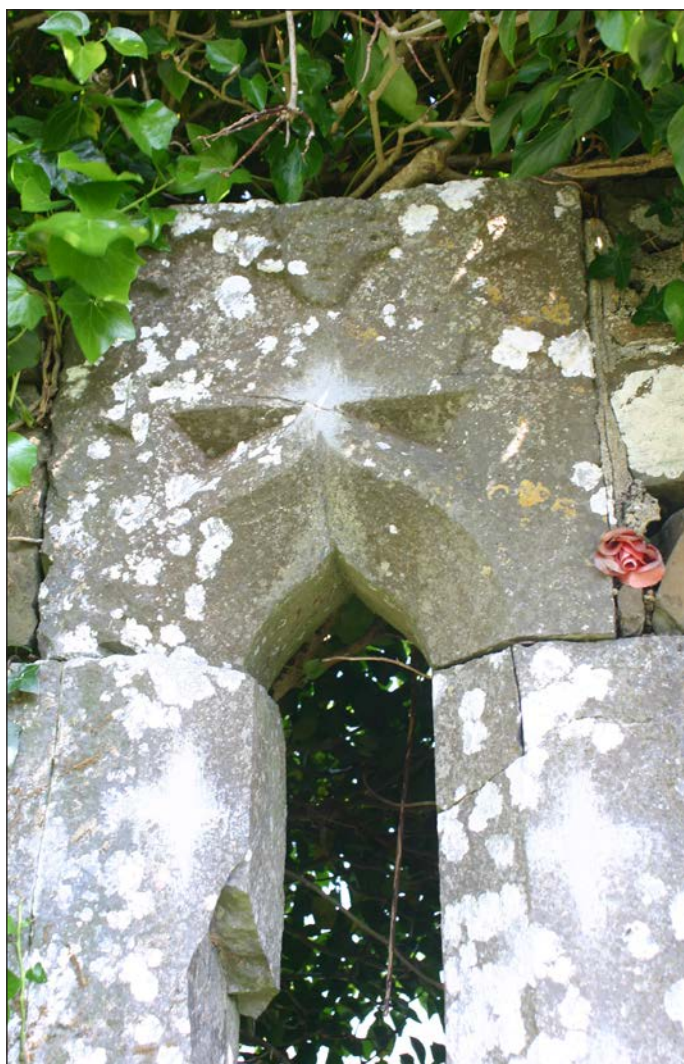
Plate 12: View of sheelagh-na-gig forming apex of window ope in southern elevation

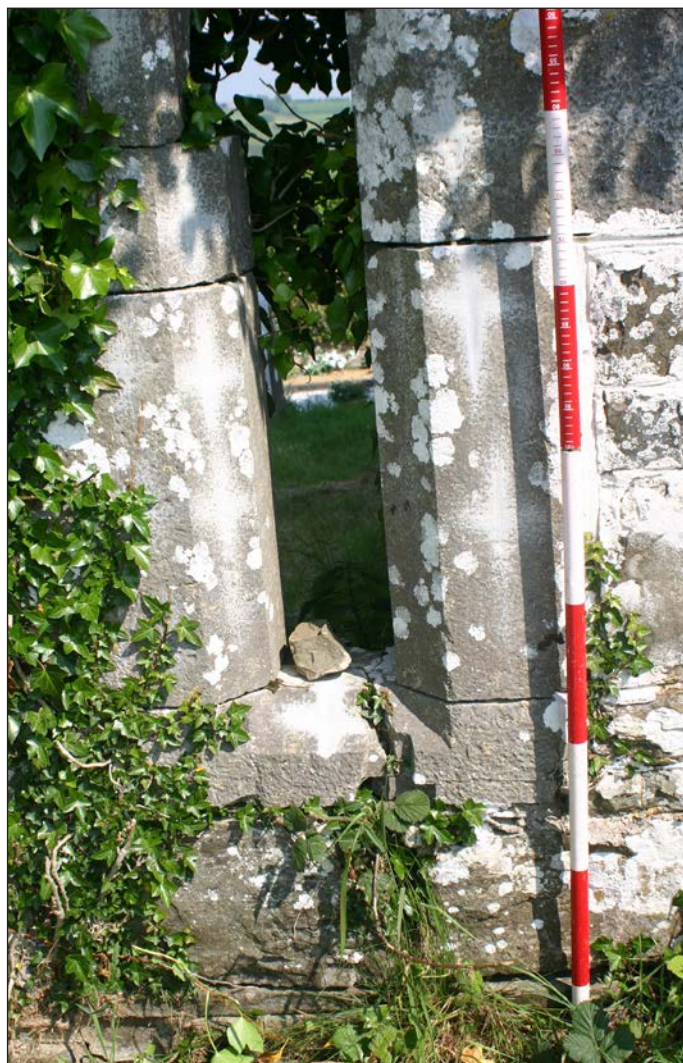
On the interior the splayed embrasure of the *sheelagh* window has been mostly robbed out as well as other side fabric material. The inner head of the window and surrounding masonry are all missing. Consequently there is very little support fabric remaining and the window is in a dangerous state of repair and is in immanent danger of collapse as it appears that it is only the ivy that is retaining it.

Plate 13: View of damaged window sill of window in southern elevation, taken from south
