Archaeological Survey,
Lisselton Church and Graveyard,
Loughanes,
Listowel,
Co. Kerry.

September 2010

Client: The Heritage Office,
Kerry County Council,
County Buildings,
Ratass,
Tralee,
Co. Kerry.

RMP No.: KE005-066 and 067

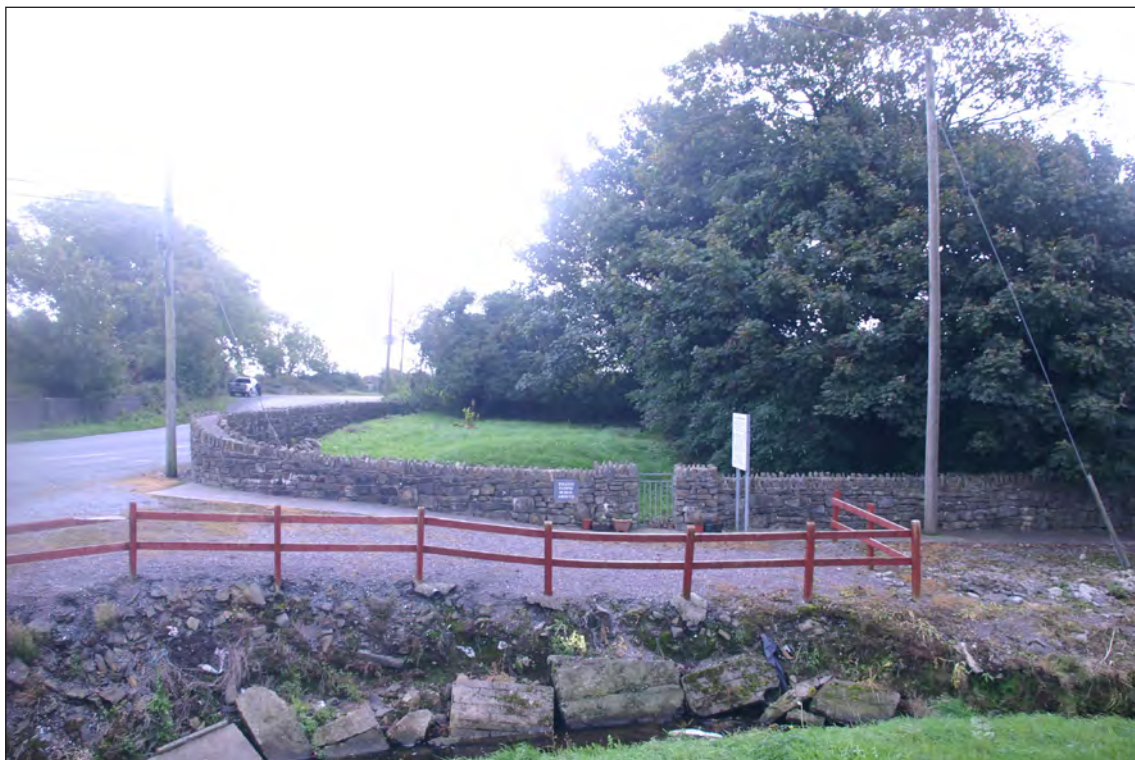
The Children's Burial Ground (CBG), is situated along the roadway and is separated physically and liminally from the graveyard by an active stream (Plates 2 & 3). A small bridge and trackway provides access to the graveyard over the stream and then extends along two sides of the pentagonal shaped graveyard providing entry to a farm at the south-west corner and a private residence at the north-east.

Plate 2: View of Children's Burial Ground from Lisselton graveyard. Note stream in foreground and further note precarious nature of fence with breakage and bases of wooden posts falling into stream

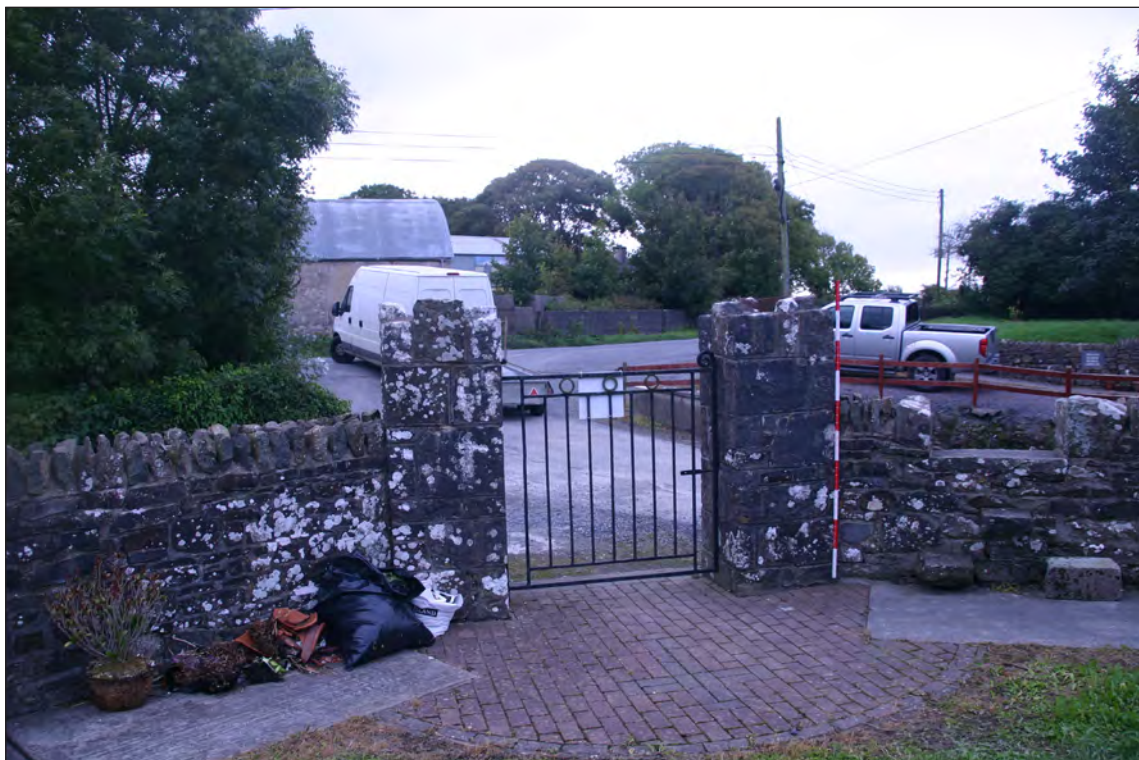
There is no water tap provided, visitors collect water from the stream or bring their own. Similarly no refuse collection facilities are provided, visitors either bring rubbish away themselves or leave it immediately inside the entrance gate (Plate 4).

Plate 4: View of interior of entrance gate and stile at Lisselton graveyard. Note rubbish stored on left

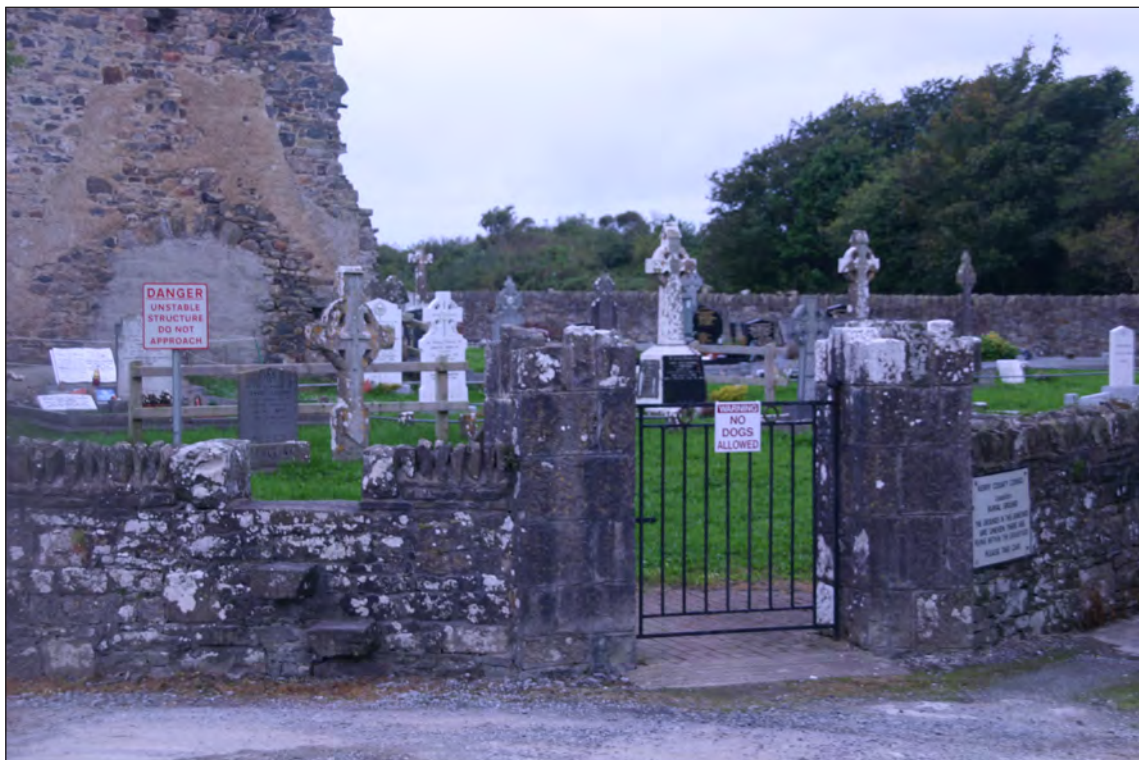
Entry into the graveyard is gained through a single modern wrought iron black painted gate at the eastern limits of the graveyard (Figure 4). The gate, which is in good order, is set between two taller square piers of ashlar stone. Able-bodied pedestrian access is also provided for by a three stone stepped-stile accommodated in the boundary wall beside the gate. Both gate and stile are in excellent condition (Plates 4 & 6).

Plate 6: Exterior view of entrance gateway at Lisselton graveyard. Note stepped stile and inappropriate signage on gate

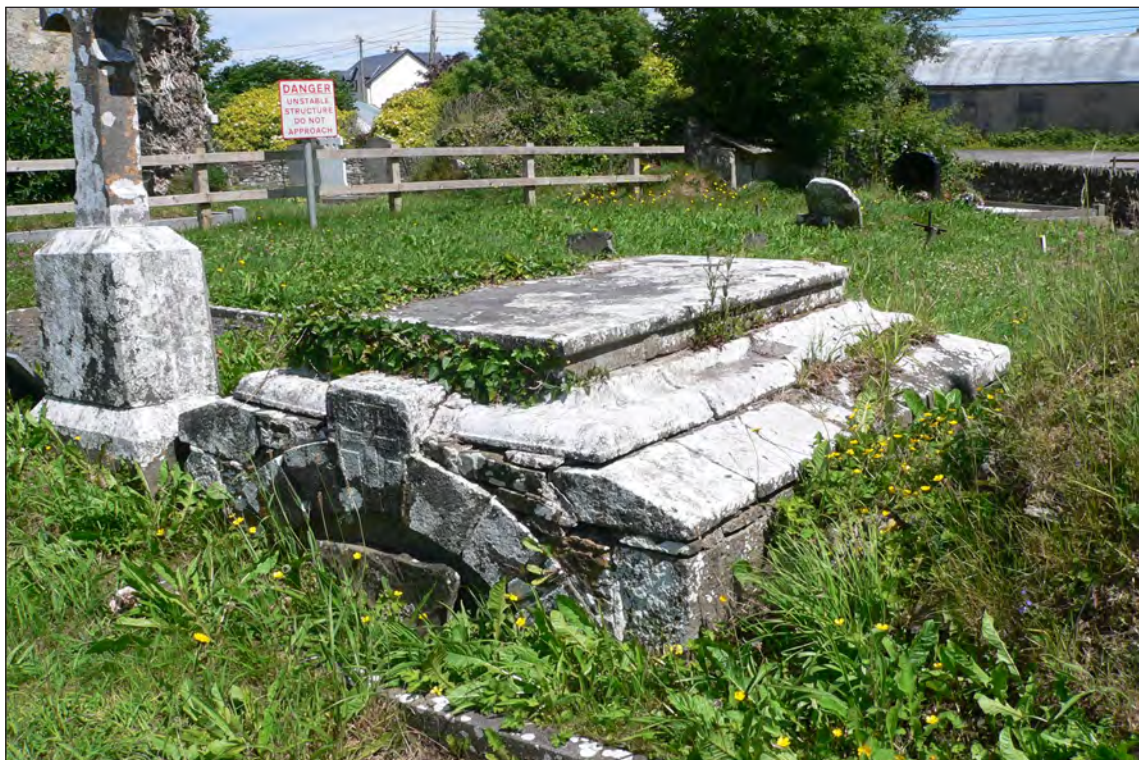
Plate 8: View of tomb 199 from south-west

The vegetation growth on Tombs 174, 179, 184, 199 & 209 should only be fully removed as the primary element of an agreed inclusive strategy of repairs and other conservation and restoration works. The ivy and other tree growth should first be cut back short so that a more critical evaluation on the steps necessary to undertake the repairs can be undertaken.

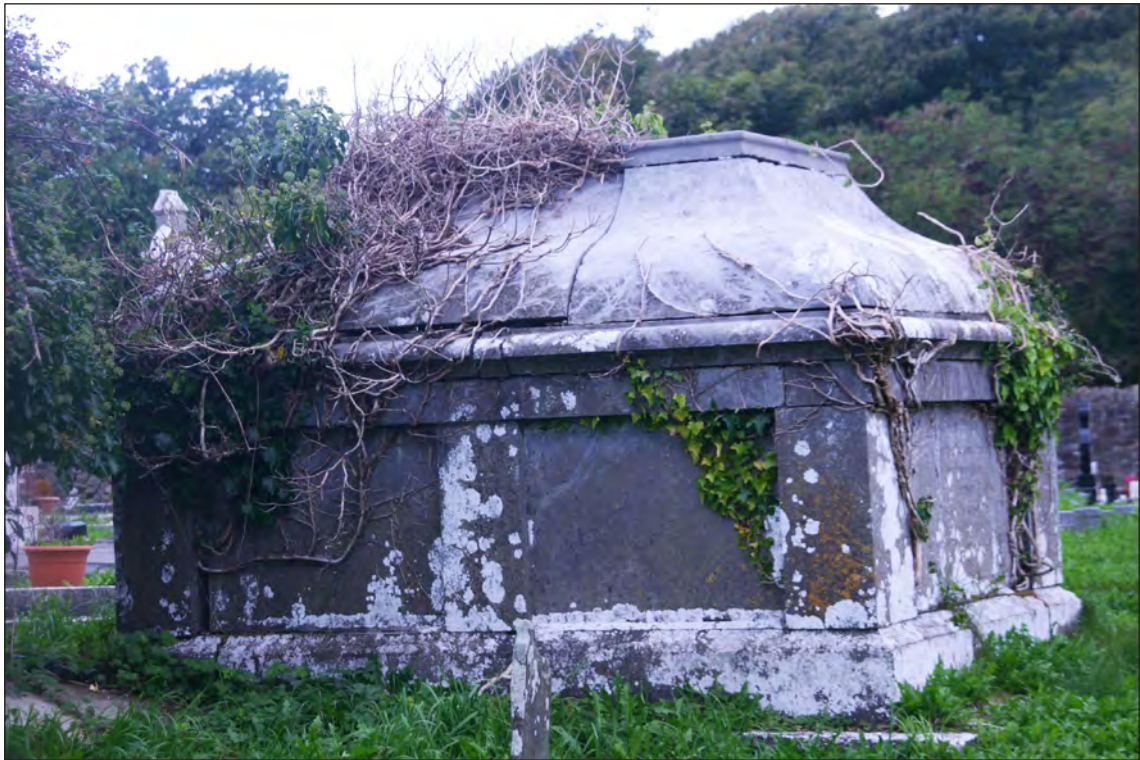
Plate 9: View of the Raymond tomb (174) from south

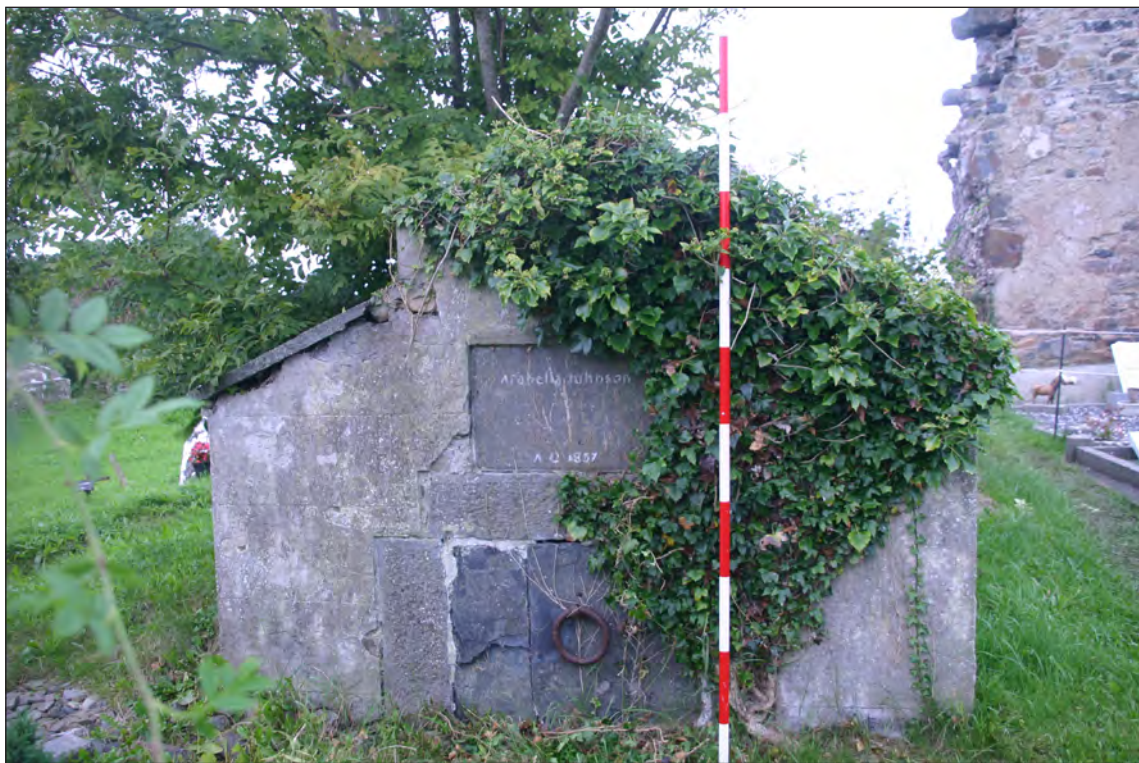
Seven named tombs (159, 164, 174, 179, 184, 199 and 209) were recorded in varying states of preservation (Figure 4). Three of these tombs, Collins 159, Lyons 164 & the illegible 199, are in very good condition (Plate 7) although there is some ivy growth on tomb 199 (Plate 8). The Raymond tomb (174) is also only partially covered with growth, however root action has managed to force itself between the masonry joints and thus accelerate its demise (Plate 8). The Johnson tomb (209), dating to 1837, comprises a rendered 'strong-box' type tomb and has a very vibrant growth of ivy and a well established ash tree growing out of it (Plate 9). A similar situation occurs at the Leonard tomb (179). Tomb 184 built of rubble stone is very overgrown with much of its upper fabric loose. The name on the tomb 184 is currently illegible (Plate 10).

Plate 10: View of Johnson tomb (209) from east

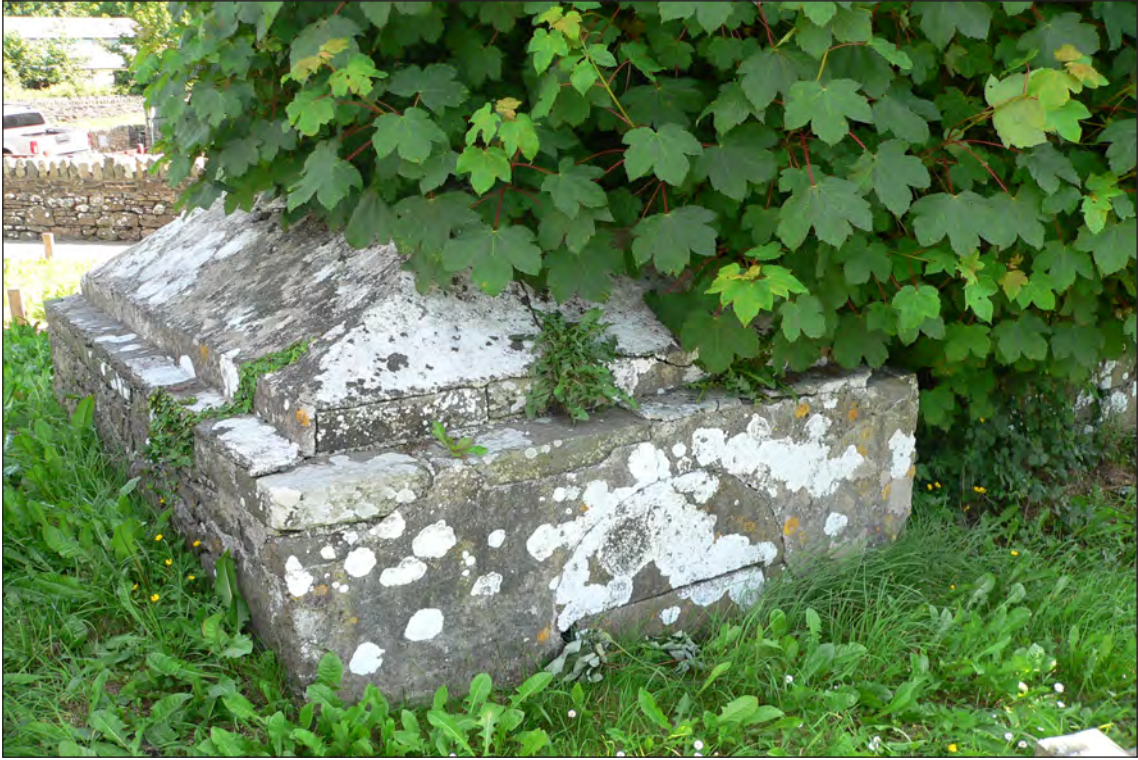
Five unnamed tombs (169, 188, 189, 198 & 204) were recorded in various states of preservation (Figure 4). All are constructed with rubble limestone. One tomb (189) is currently partially free of growth but without restoration works to its immediate neighbour (188) which has a sycamore tree growing on it, tomb 189 will be negatively impacted in the near future (Plates 11 & 12).

Plate 11: View of tomb 189 from north

The vegetation growth on Tombs 169, 188, 189, 198 & 204 should only be fully removed as the primary element of an agreed inclusive strategy of repairs and other conservation and restoration works. The ivy and other tree growth should first be cut back short so that a more critical evaluation on the steps necessary to undertake the repairs can be undertaken. This work should be undertaken with expert archaeological advice and guidance.

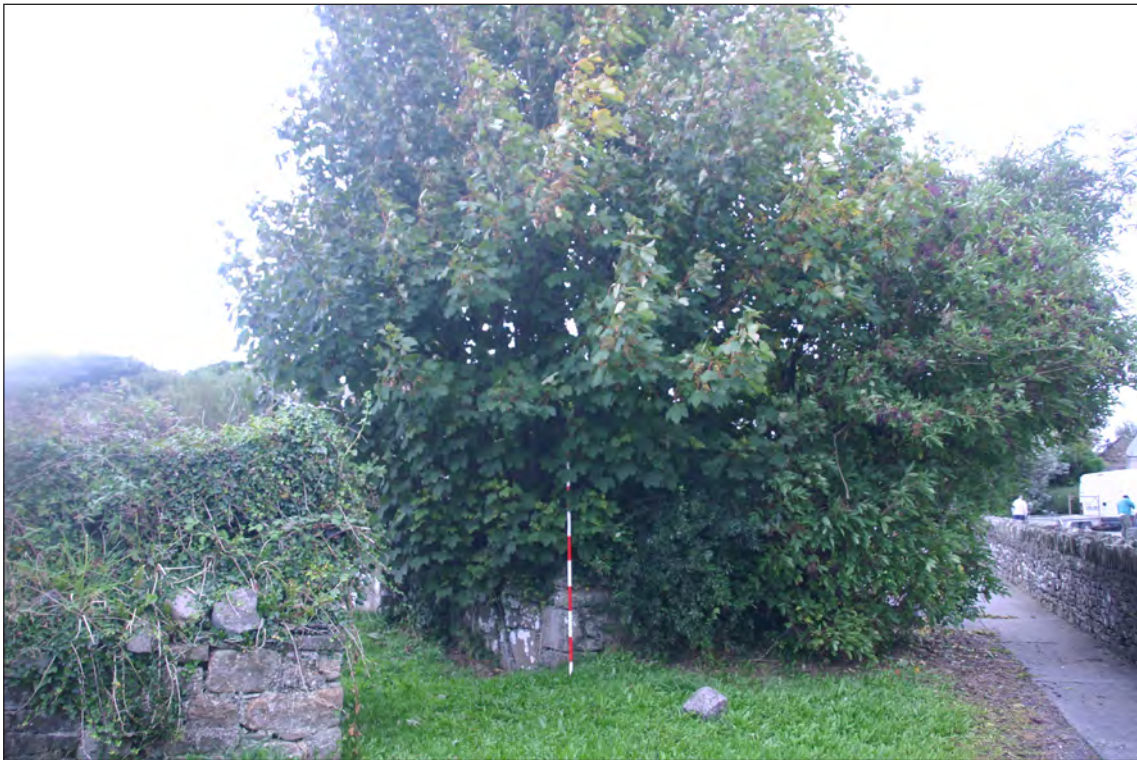
Plate 12: View of tomb 188 from west

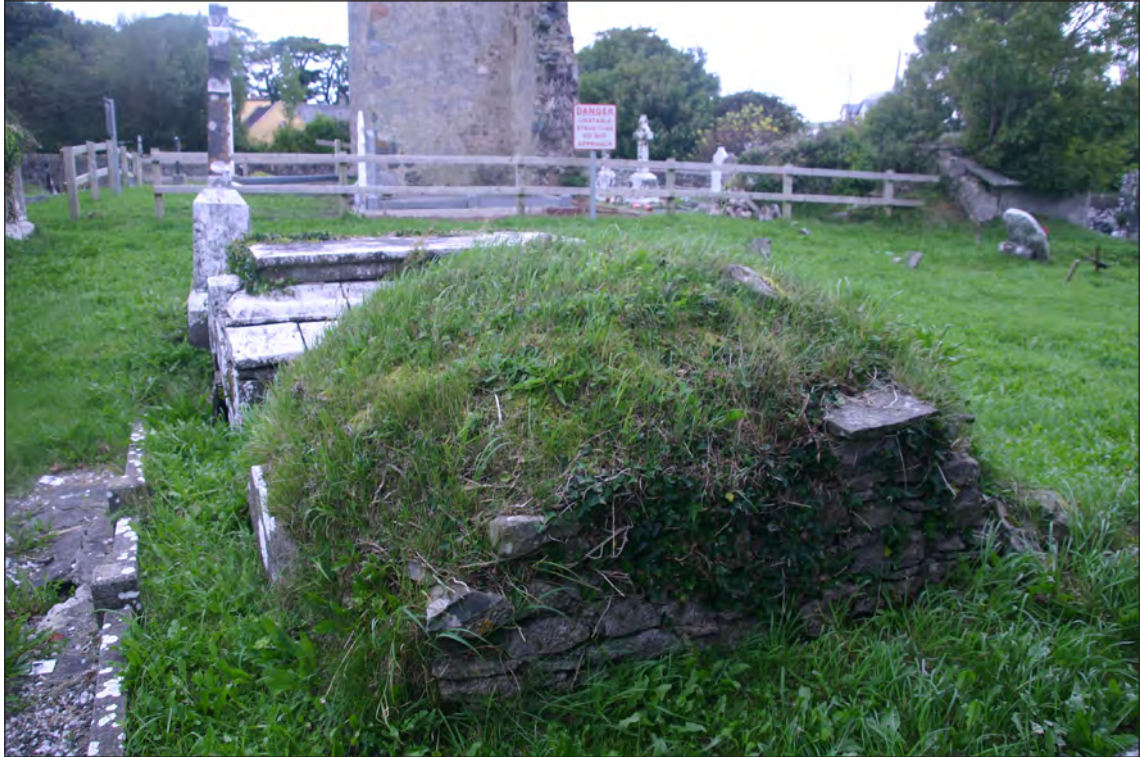
Two of the other unnamed tombs (198 and 204) are now reduced as much of their outer stone fabric has been robbed out. Grass has now established itself on them (Plate 13). Tomb 169 is constructed with rubble stone to courses. Much of it is covered by dense ivy (Plate 14). It is possible that the burial details are obscured by the growth as indeed is also the case with the other unnamed tombs.

Plate 13: View of denuded tomb 198 from south

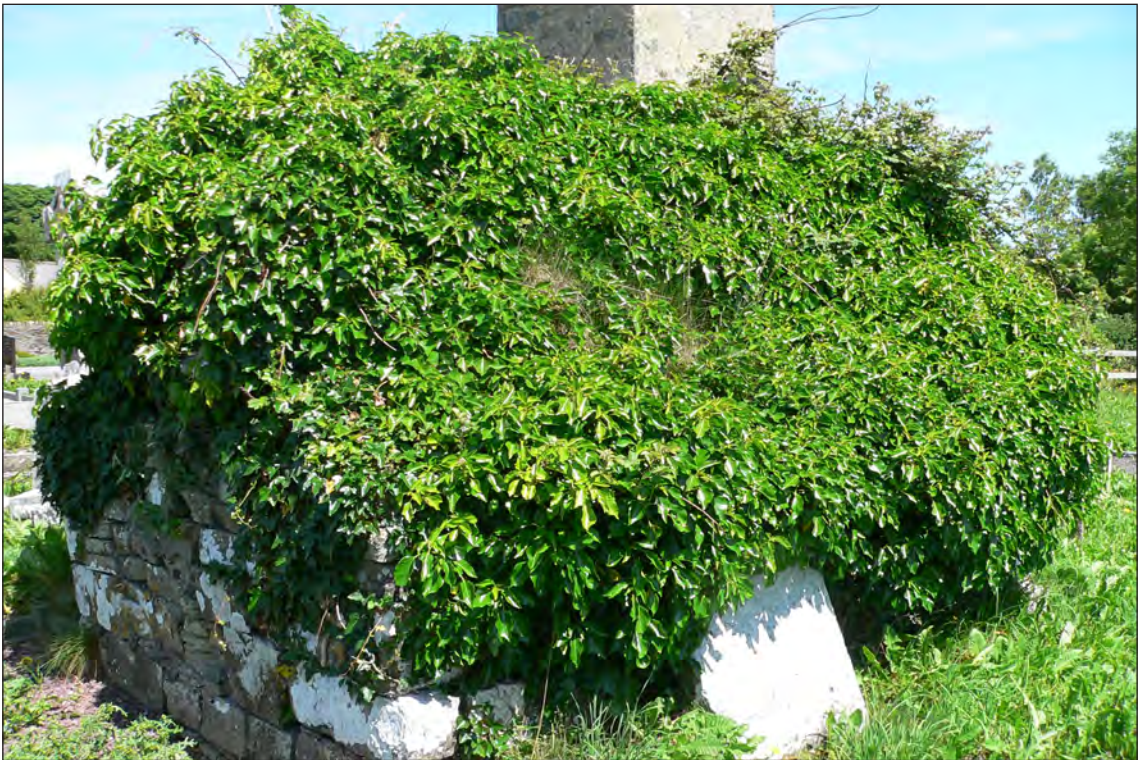
Plate 14: View of tomb 169 from south-east

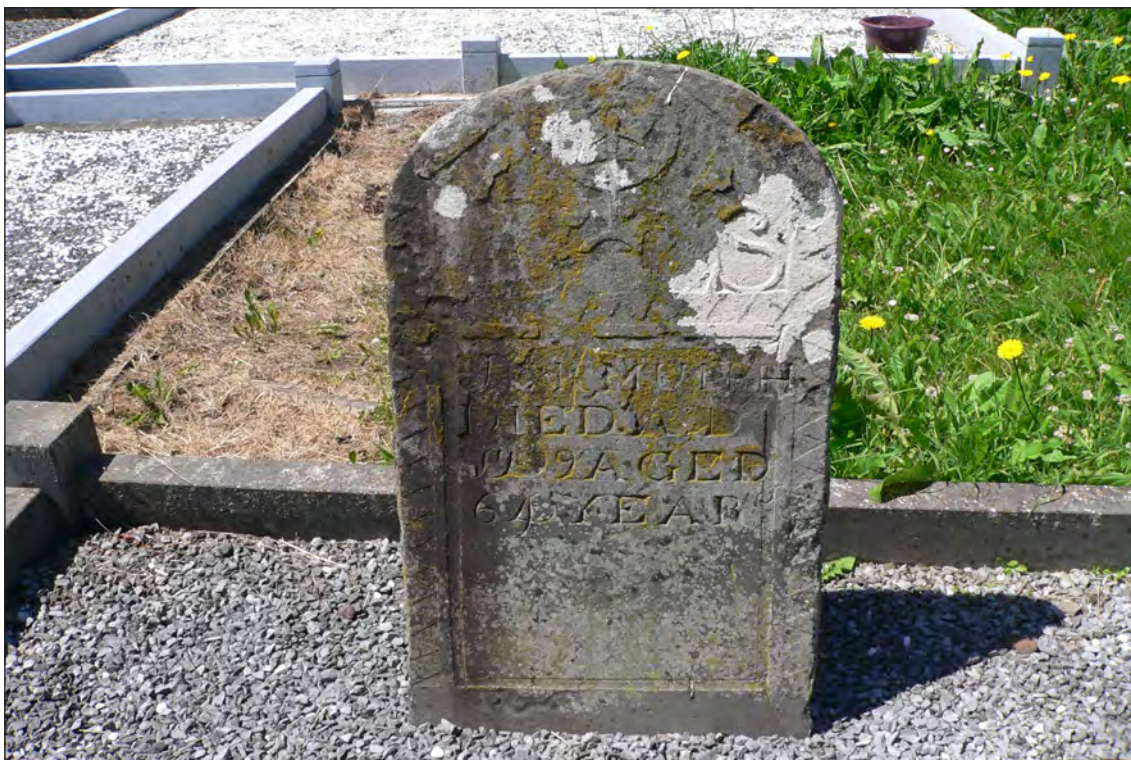
The oldest recorded headstone recorded in the course of this survey, No. 98 was J.. Murphy dated to 1799. The first nine of the date inscription is spalled but enough survives to determine it as a nine to a high level of confidence (Plate 15). A similar type headstone, No. 96, one of three in Lisselton that were most likely made by the same mason, records the death of Pat Sweeney in 1804 (Plate 16). The third headstone, No. 87, is also slightly broken (Plate 17). The outer fabric lamination of these early headstones is flaking off resulting in the partial loss of the inscriptions.

Plate 15: View of earliest recorded headstone, J... Murphy from 1799

The early similar headstones, 87, 96 and 98 discussed above and 108 should be further researched to determine the exact inscriptions on them as these headstones are most likely contemporaneous with the first decades of the life of the church.

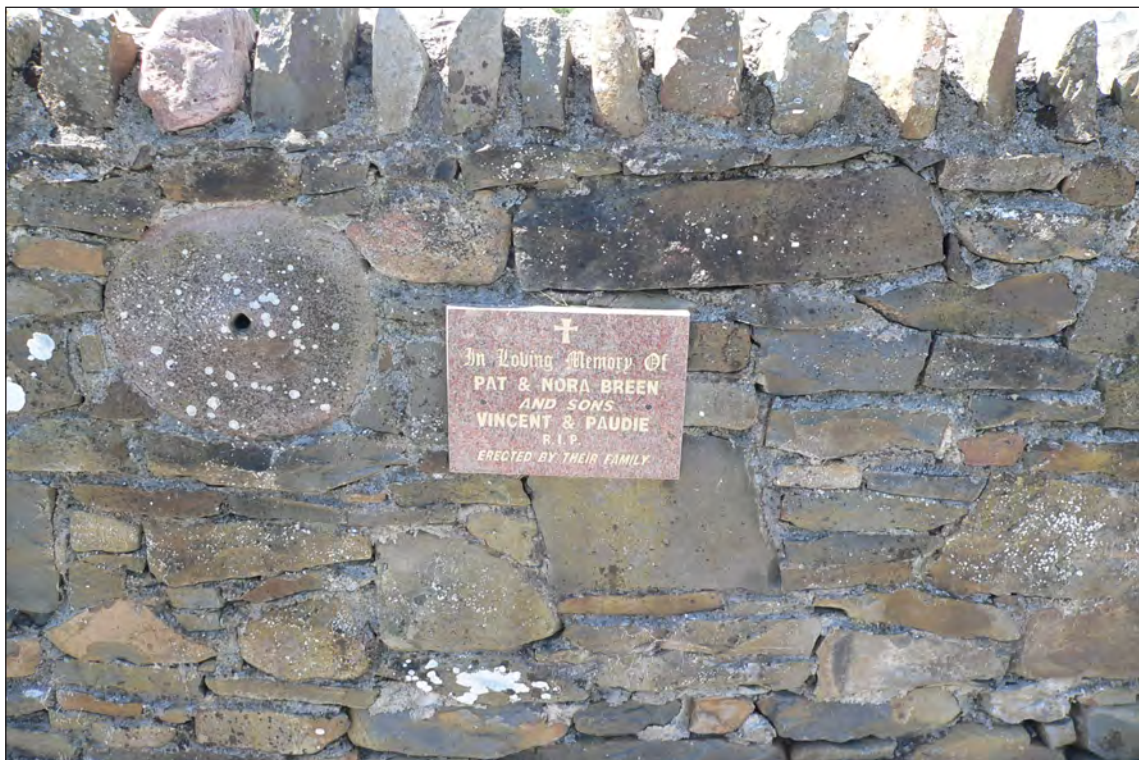
A rotary quern stone has been built into the boundary wall of the graveyard at the western end beside a wall plaque (Figure 4 & Plate 20). Hand operated rotary querns have a long currency of use between the early medieval period until the 19th century. The original provenance of the quern has not been established.

Plate 20: View of rotary quern (299) and Breen plaque (148) built into western boundary wall

The original provenance of the rotary quern should be established

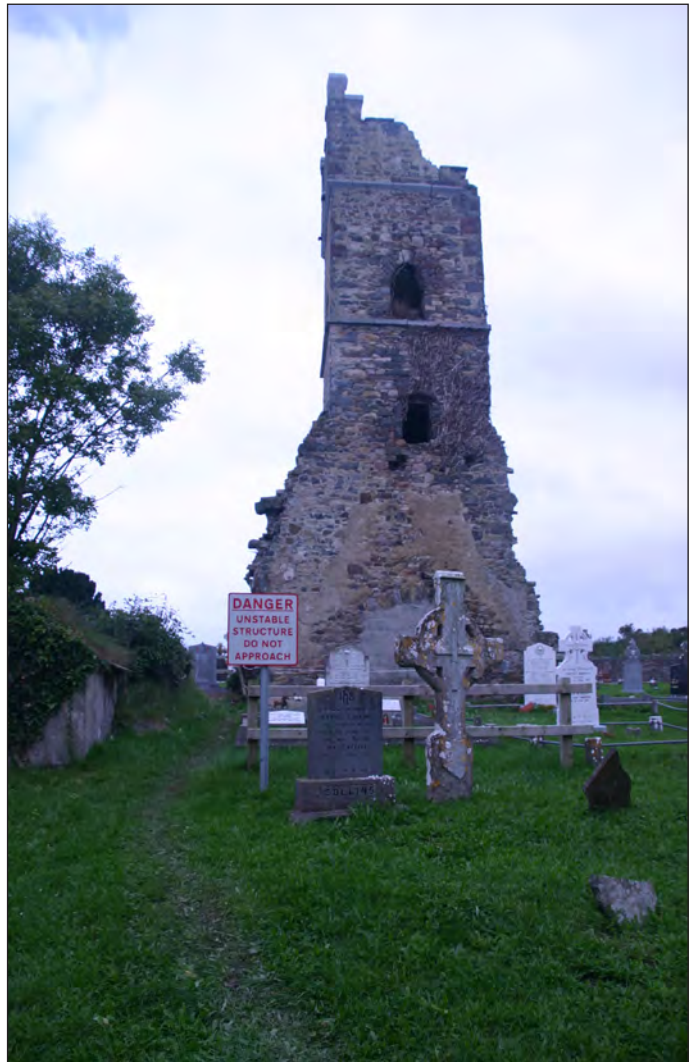
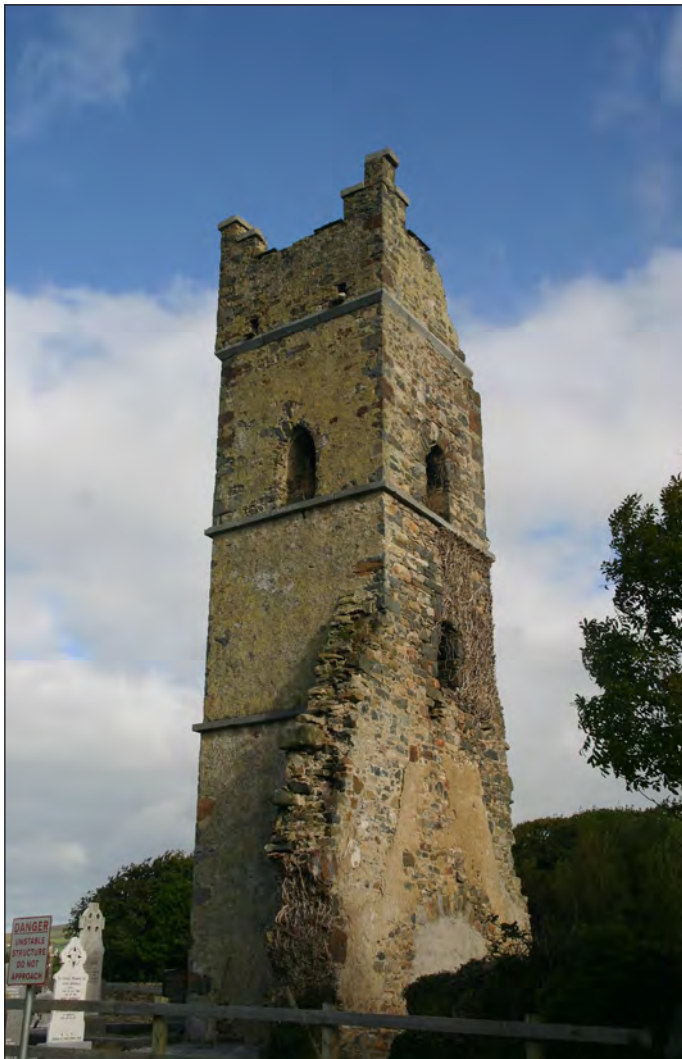
The ragged remains of the west elevation of the nave of the church, where it connected to the tower, survive as truncated nibs at the north and south corners of the east elevation. These ragged nibs may act as incidental buttresses to the tower (Plates 22 & 26). The tower has three levels that are architecturally identified on the exterior by projecting string courses of squared dressed limestone to first and second floors and chamfered dressed limestone under the uppermost parapet level. Two water spouts carry rainwater from the parapet above the chamfered string course on the south elevation (Plate 22).

Plate 22: View of south-east angle of tower. Note ragged remains of nave of church acting like buttress

The surviving church tower should be repaired and made safe. The work should be carried out following the completion of a standing building conservation survey, inside and out, including elevations and plans of the structure as well as a detailed method statement and health and safety issues. It is clear that the removal of the vegetation has accelerated the demise of the tower. Whatever protection that the ivy gave is now gone and joints and other structural cracks and other issues are now exposed to the weather. The repair works need to be carried out as a matter of urgency.

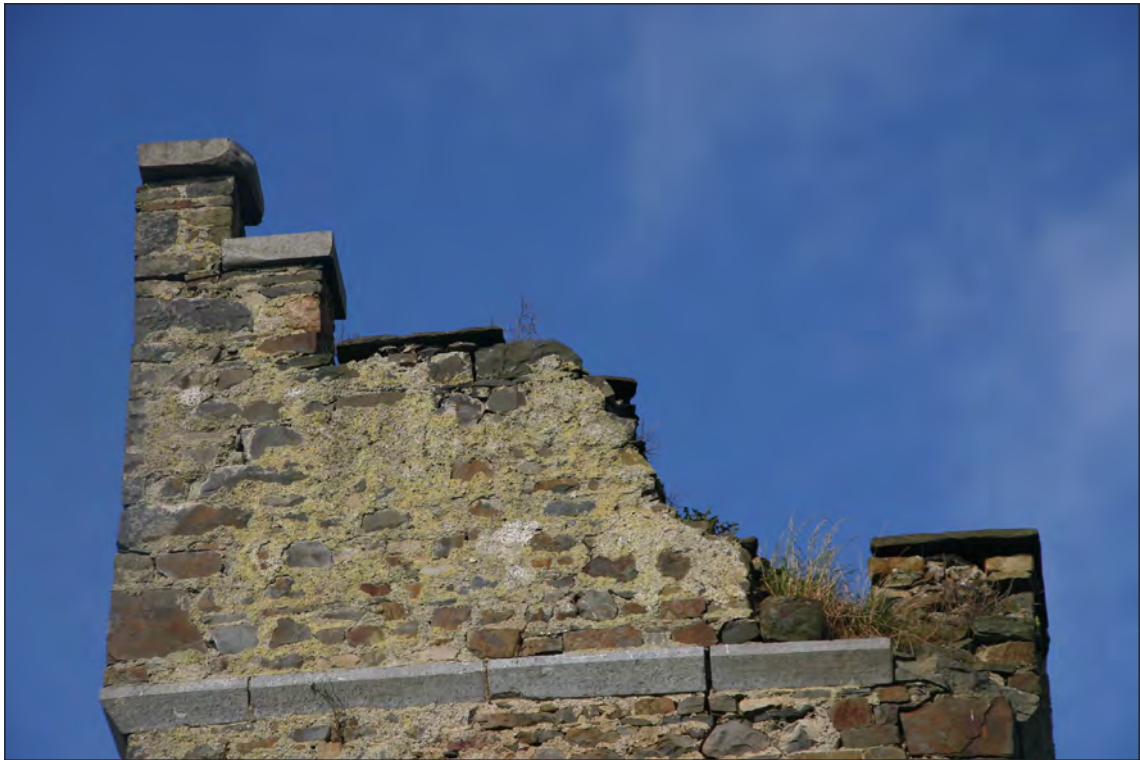
The east elevation survives to full height although the north east corner parapet crenellations have collapsed. The two-stepped crenellations of the parapet are capped with simple limestone flags (Plate 23).

Plate 23: View of damaged crenellations on parapet on east elevation of tower

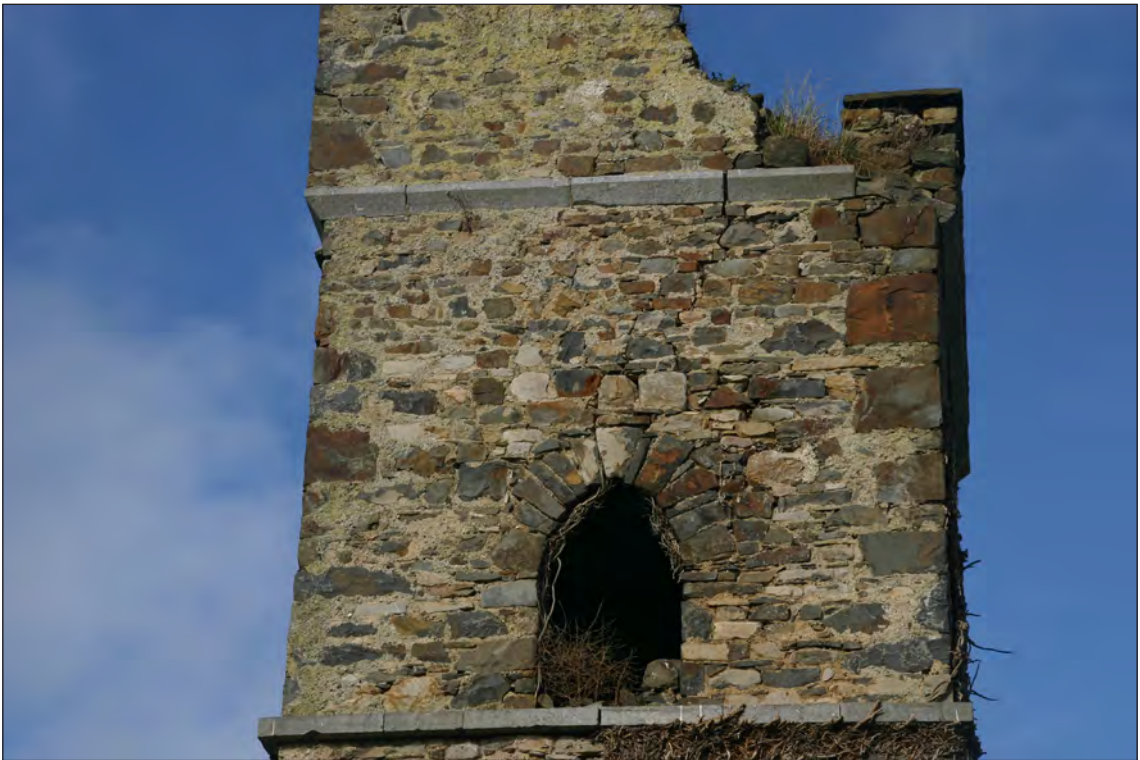
Directly above, on the second floor, is a pointed opening. A coherent visible crack extends from the opening to the collapsed area of the parapet level (Plate 24).

Plate 24: Close up view of 2nd floor and upper limits of east elevation. Note coherent crack in masonry extending to window opening from parapet collapse area

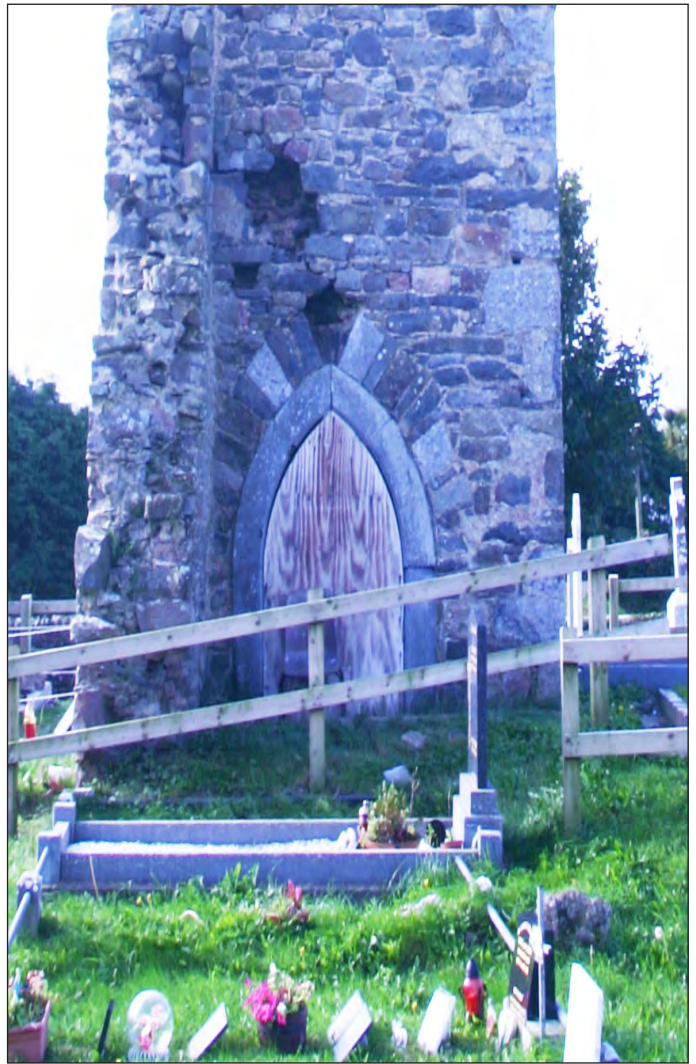
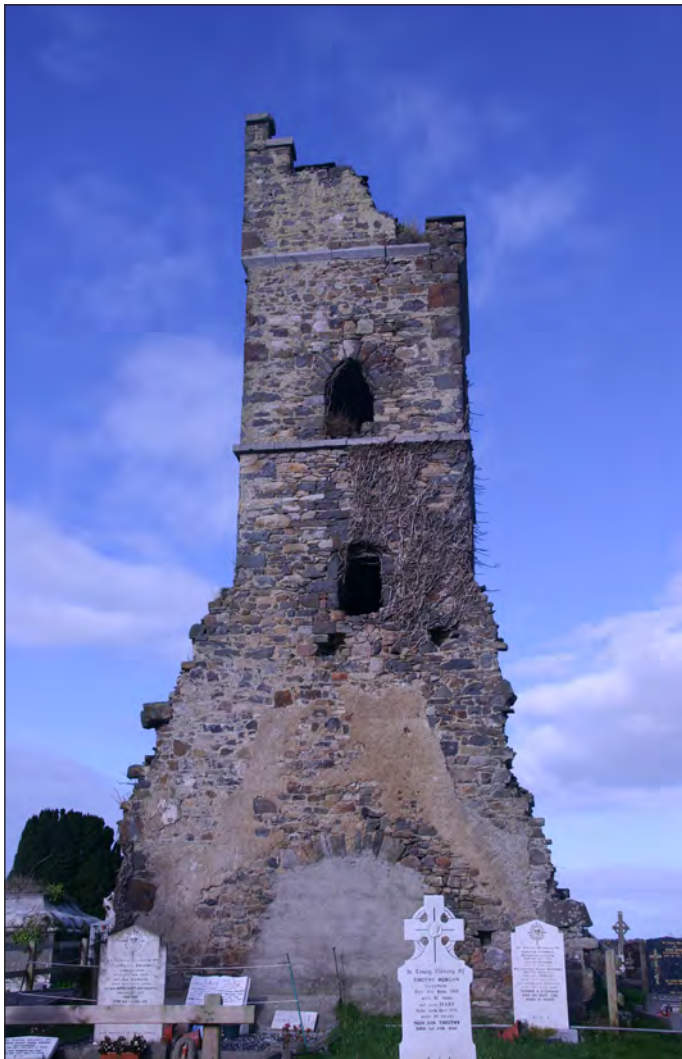
The western tower or belfry of a late 18th century First Fruits Church of Ireland is all that survives of this edifice (Figures 4 & 5). The tower stands to full height albeit the north-eastern corner of the crenellated parapet has collapsed and a serious crack extends from the collapsed area down to the 2nd floor window on the east elevation (Plates 21-24). The tower is denoted on entering the graveyard on visible signage as a dangerous building with instructions not to approach (Plate 21). A temporary un-inhibiting wooden fence has also been constructed around the tower (Figure 4). The entrance into the tower is located on the north elevation. It is closed off with plywood that prevented access for the course of this survey. The entrance comprises a two-centred pointed doorway of punch dressed and edge draughted limestone. Immediately above which are three voidings or

gaps in the outer masonry, one of which is the loss of the keystone or uppermost voussoir of the pointed arch underneath which the dressed limestone doorway is constructed (Plate 25).

The ragged remains of the nave of the church extend to approximately mid-point on the first floor level (Plate 27). There is a blocked up and cemented archway that originally provided access from the ground floor tower space into the nave (Plate 26). Above the ground floor archway is the remains of a coherent internal scratch coat render complete with its diagonally disposed key. The finish coat survives as a few patches here and there.

Plate 25: View of boarded up entrance to tower on north elevation. Note missing keystone and other masonry voiding

Plate 26: View of east elevation. Note blocked up archway on ground level

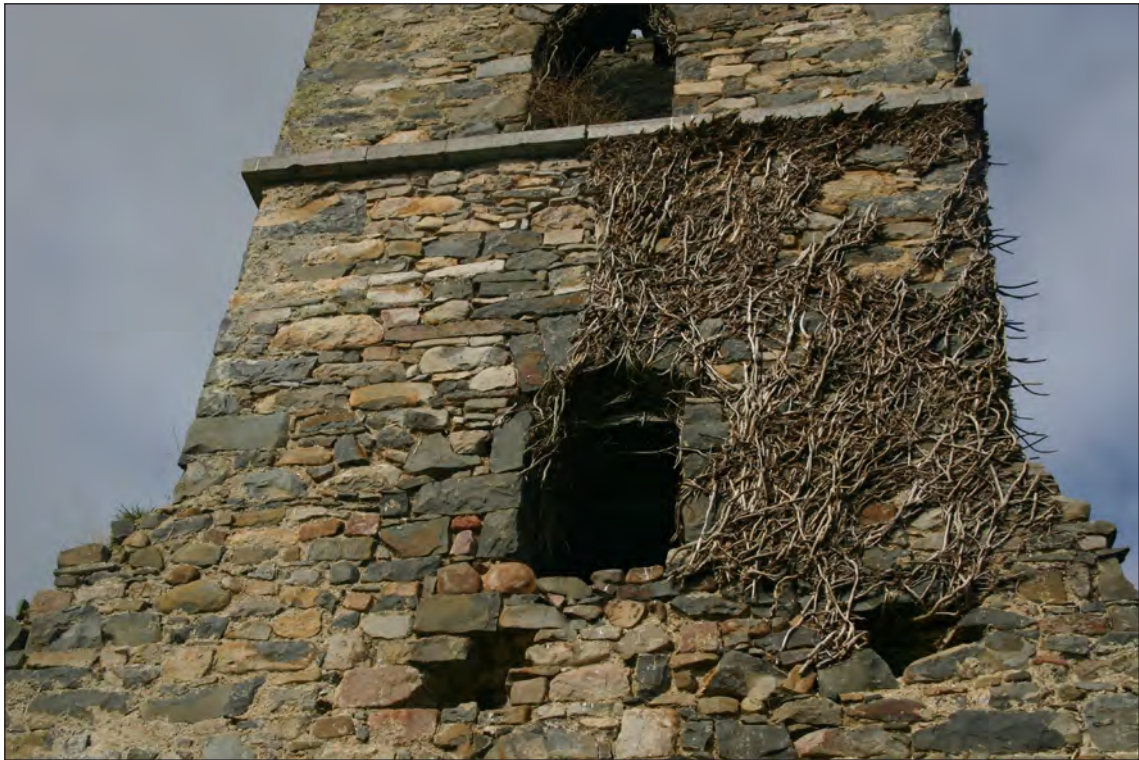
Immediately above the render and at the apex of the surviving ragged masonry of the nave is an opening with a three-centred arch. This opening most likely provided access into the upper level or gallery of the church from the first floor. Two areas of voiding are also visible beneath the opening. The jointing between the masonry appears open and may have been scoured out. This may reflect the removal in the recent past of vegetation growth on the tower. The remains of which are still clearly visible (Plate 27). Removal

of extensive vegetation from buildings also affects the jointing and can undermine the masonry.

Plate 27: View of 1st floor level of east elevation. Note remains of recently removed vegetation, poor nature of masonry joints and voidings
