Date: October 2009

Project code: TGSK09

Archaeological Survey, Molahiffe Graveyard, Castlefarm, Co. Kerry.

RMP No.: KE048 036

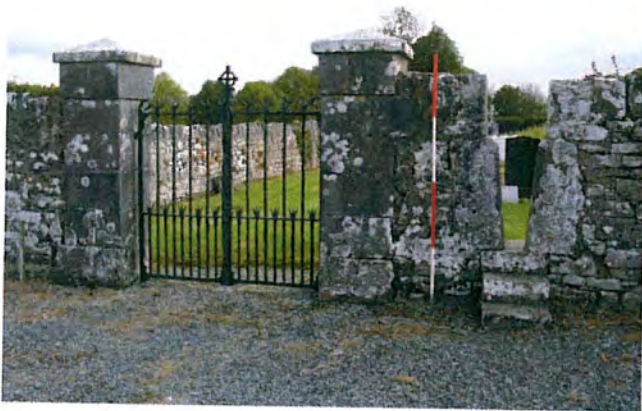
Plate 01 - Gate with stile from outside, facing east.jpg

The boundary around the graveyard comprises a coursed rubble stone wall with vertical rubble coping stones. There is a gated entrance in northern end of the western wall (plate 1).

No areas of collapse or breaches within the boundary were visible. Limited amounts of vegetation were observed growing along and within the walls. Greater amounts were observed in the southern wall.

Vegetation should be controlled on a regular basis to avoid eventual degradation and collapse of the wall.

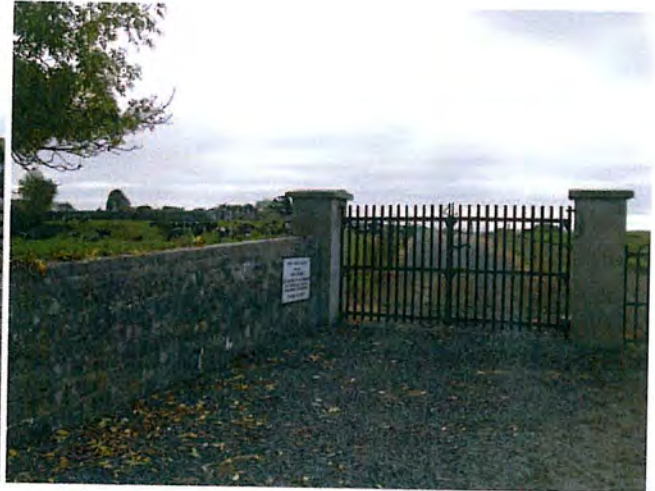
Plate 02 – Entrance from main road, facing south-east.j...

The initial access to the graveyard is through a gate off the main road which leads to a gravel through-way up to the boundaries of the graveyard proper (plate 2). Entrances are located in the northern end of the west wall, consisting of a gated pedestrian entrance and a stile to right of it.

The entrance gate to the graveyard is in good condition and clear of any obstructions.

The gates should be treated for rust and painted as and when such measures are needed.

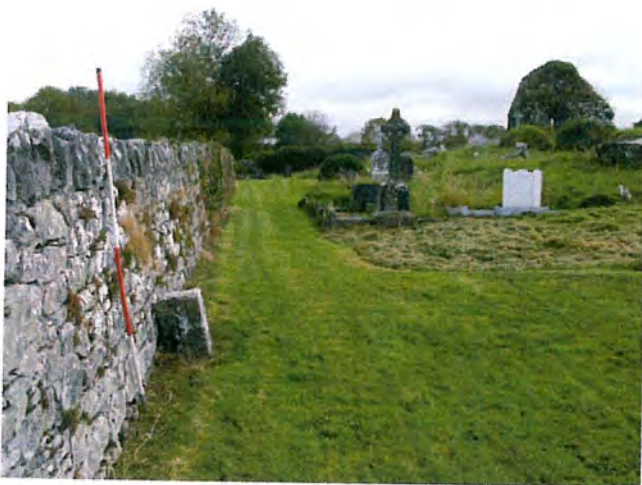
Plate 03 – Area of shortly trimmed grass used as path ...

No pathways exist within the graveyard. At the time of the survey the grass running the length of the walls was cut and acted as a path around the periphery of the graveyard as these areas are free of any visible graves or obstructions (plate 3).

It would be possible to lay a gravel pathway around the periphery of the graveyard where the ground is free of obstructions, however when mown as at the time of the survey this area provides sufficient access. The inner area of the graveyard is very uneven and full of overgrown tombs and graves making laying of pathways very difficult (plate 4).

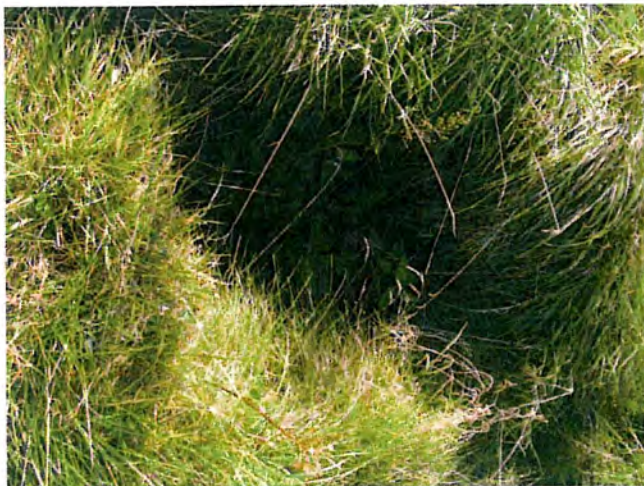
Plate 05 – Grave no. 075, collapsed tomb.jpg

There are 49 tombs located within the graveyard. These by and large dominate the centre of the graveyard and the south-east corner. The majority of these tombs are very overgrown many of which are very hard to identify and a small percentage have collapsed, making the ground hazardous under foot e.g. grave no's. 075 and 088 (plates 5 and 6). Any tombs located around the periphery of the graveyard seem to be in better condition and not as overgrown, in some cases due to better maintenance and others due to their location away from the collapsed church walls e.g. grave no. 070 (plate 7). One particular area located in the south-east of the graveyard seems to have been treated with a broad spectrum weed killer (Plate 25).

An extensive clearance of vegetation is recommended on the majority of the tombs located throughout the graveyard. Any collapsed tombs should be assessed with urgency e.g. grave no's. 075 and 088 (as mentioned above) as these are a serious health and safety issue to any visitors to the graveyard. Good conservation practices should be followed using the principle of repair rather than replacement. However, additional material can be used where necessary to reinforce or support the existing material. If repairs are deemed necessary in the future then appropriate materials should be used, i.e. lime mortars and not hard cement as was used on grave no. 136 (plate 8), where this has compromised the appearance of the structure and the new concrete has also come into contact with the east wall of the church (plate 9).

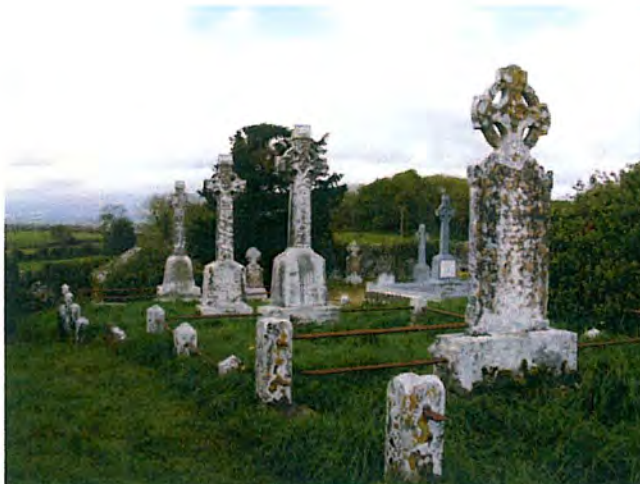
Plate 13 – Photo showing High Cross style headstones,...

There is a wide variety of headstones and grave plots throughout the graveyard that range in date between the early 19th century and early 21st century. The oldest determinable grave is a plot with a high cross style headstone (Grave no. 113) erected by Patrick Leyne for himself and his sons in 1813 but later remodelled in 1902 (plates 10 and 11). The plot itself is cut into the northern side of the up-standing east wall of the church (plate 12). The graves conform to a rough plan with the vast majority of the headstones facing east. Graves of the name O'Sullivan, O'Connell and Daly make up a large percentage of the overall named headstones and grave plots. There are a large amount of high cross style headstones throughout the graveyard and there is a particular concentration in the south and west e.g. grave no's. 043, 045, 068, and 069 (plate 13).

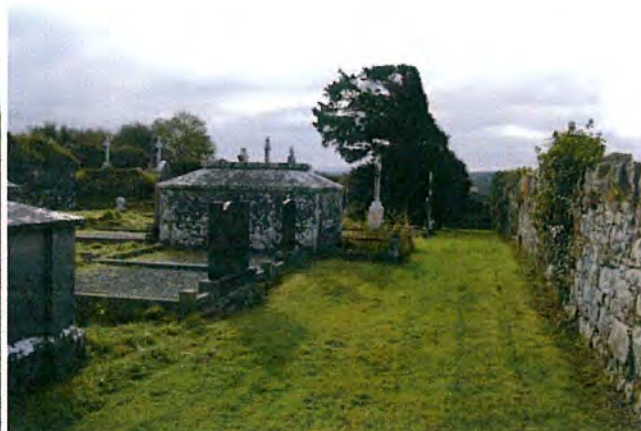
Plate 14 – Photo of maintained graves at western end o...

In general the headstones and grave plots around the periphery of the graveyard are in good condition and as such should not be interfered with (plate 14). But as mentioned above the middle part of the graveyard is very overgrown and needs to be maintained more carefully to avoid any accidents with overgrown plots and headstones (plate 15).

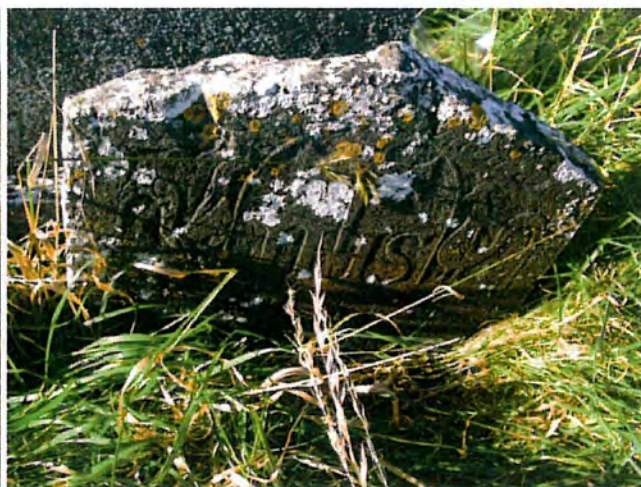
Plate 16 – Grave no. 024, broken headstone.jpg

The detail on most of these has been eroded away over time and in some cases the headstones themselves are broken e.g. grave no's 024 and 049 (plates 16 and 17). One headstone (Grave no. 140) was found to be displaced and turned on its side up against an overgrown tomb (plate 18).

Vegetation and debris should be cleared away from headstones where applicable.

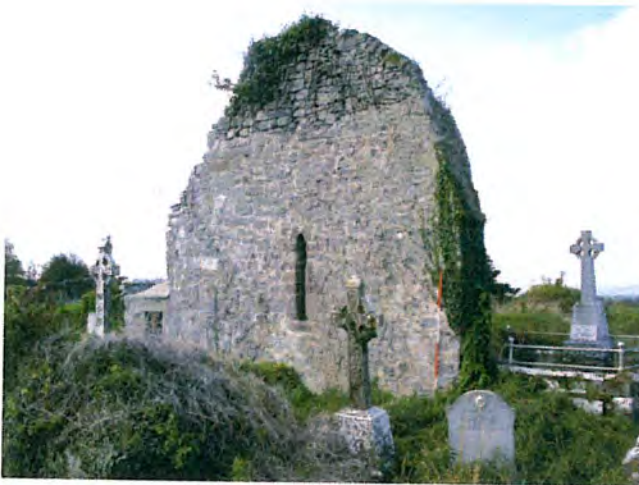
Plate 19 – Exterior elevation of east wall of church, faci...

Of the surviving remains of the original church only the east wall is still fully up-standing (plate 19 and 20) as well as a small piece of the southern wall which is very overgrown (plate 21). The centre of the graveyard where the remainder of the church would have been is on slightly raised ground but is very overgrown and may indicate that the collapsed walls of the church are now buried under a new layer of topsoil which has built up over time. The wall consists of roughly dressed mortared rubble stone with a gable, to east of graveyard, surviving to height of c.6m, with a maximum thickness of c. 1m. A single lancet window opening survives, having a dressed stone sill, surround and archivolt to the exterior (east) elevation (plate 23) and a deeply recessed hollow chamfered reveal to the interior elevation having dressed limestone surrounds and radiating voussoirs (plate 24).

Steps should be taken to secure the ruin from further collapse through the control of vegetation from on the walls and the re-pointing the structure where feasible.
