Archaeological Survey,
Nohoval Graveyard,
Tralee,
Co. Kerry.

August 2010

Client: The Heritage Office,
Kerry County Council,
County Buildings,
Ratass,
Tralee,
Co. Kerry.

RMP No.: KE039-014

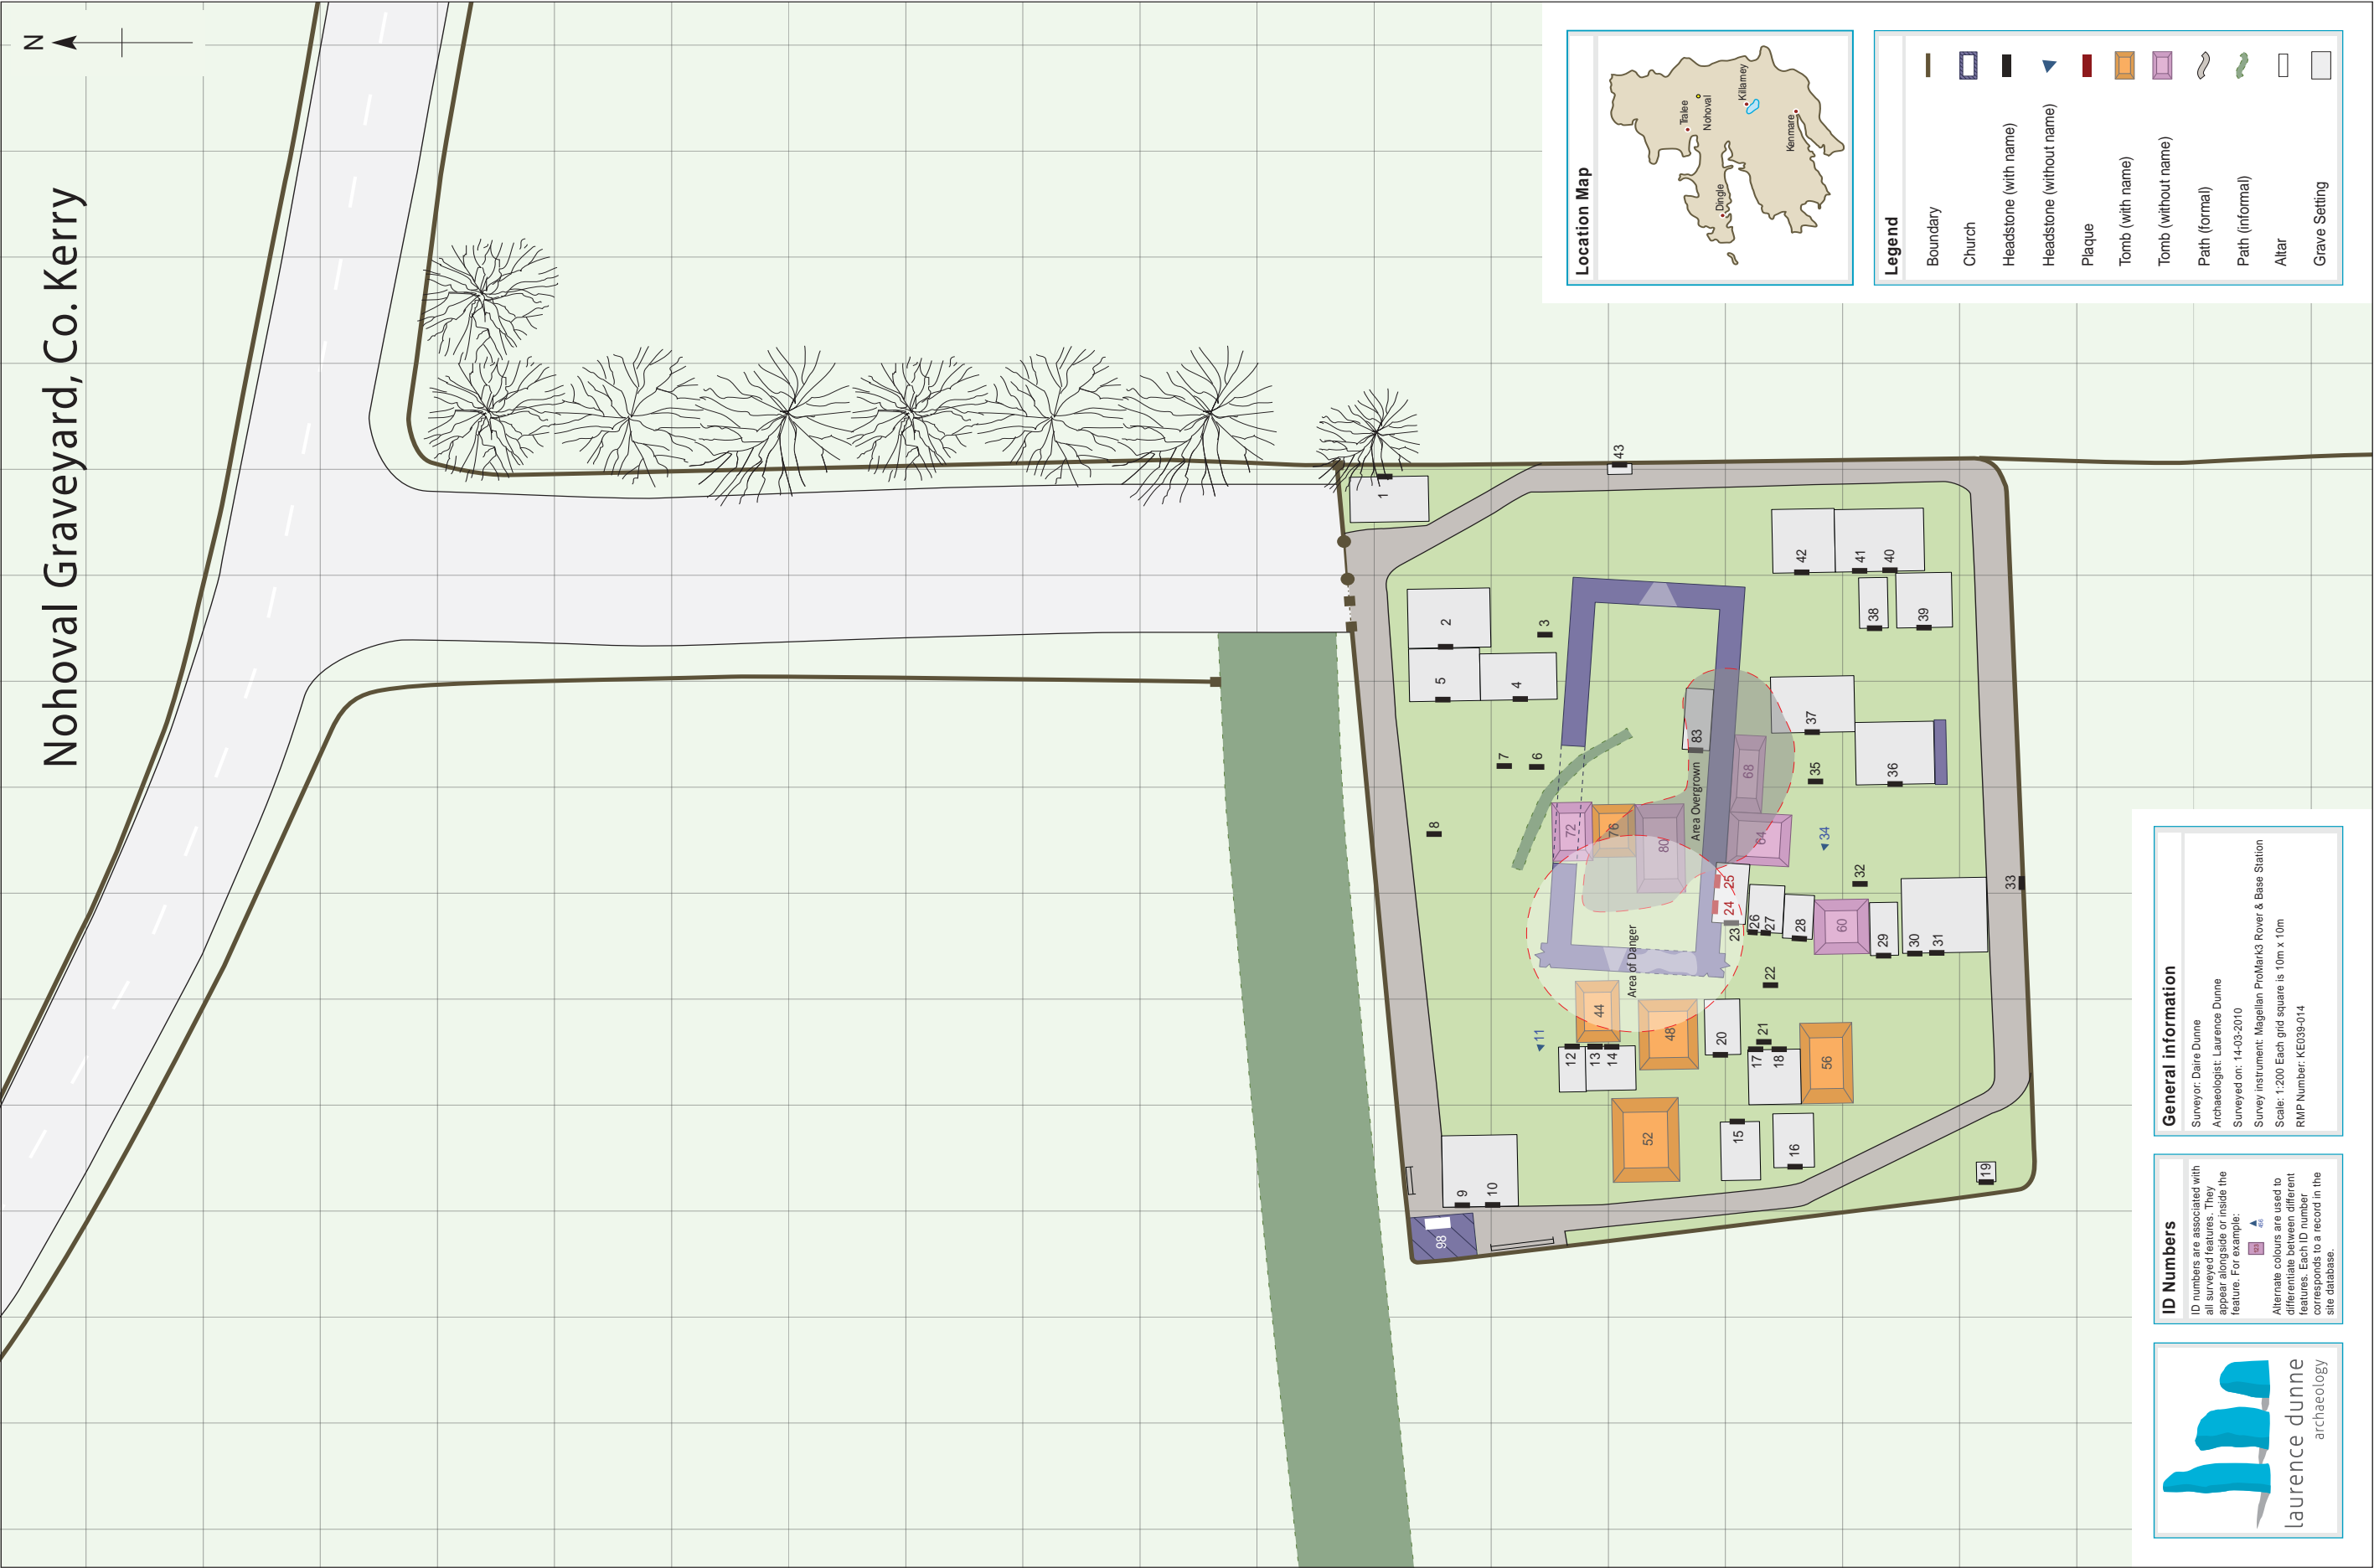
Figure 4: Nohoval graveyard survey layout plan 2010.

Two unnamed graves (HWN, Nos. 11 & 34), comprising an unhewn stone gravemarker and a simple iron cross, were recorded within the graveyard (Figure 4 & Plate 2). Rust is now evident on the white painted iron cross.

The west gable of Nohoval Church, if left as is, will collapse down around and on top of tombs 44, 48 and grave setting 20 (Figure 4).

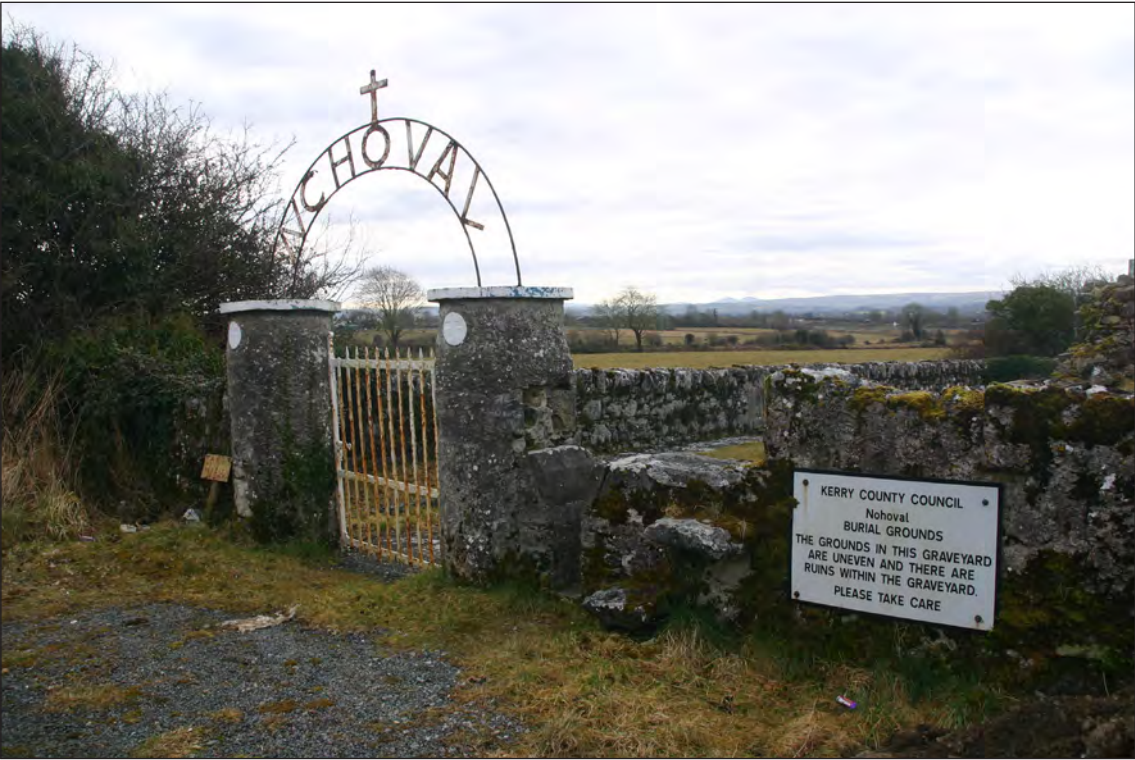
Plate 4: Exterior view of entrance to Nohoval Graveyard from north-west. Note unkempt overgrown and untended nature of exterior

Entry into the graveyard is gained through a single wrought iron white painted gate in need of maintenance attention. Rust is prevailing-otherwise the gate is in good order. The gate is set between two taller circular limestone piers with flat concrete capping. The piers are surmounted by the word Nohoval in a dilapidated wrought ironwork that is also in need of repair and maintenance as part of the letter 'O' has disappeared. The gate piers have been raised to accommodate the wrought ironwork (Plates 4-5).

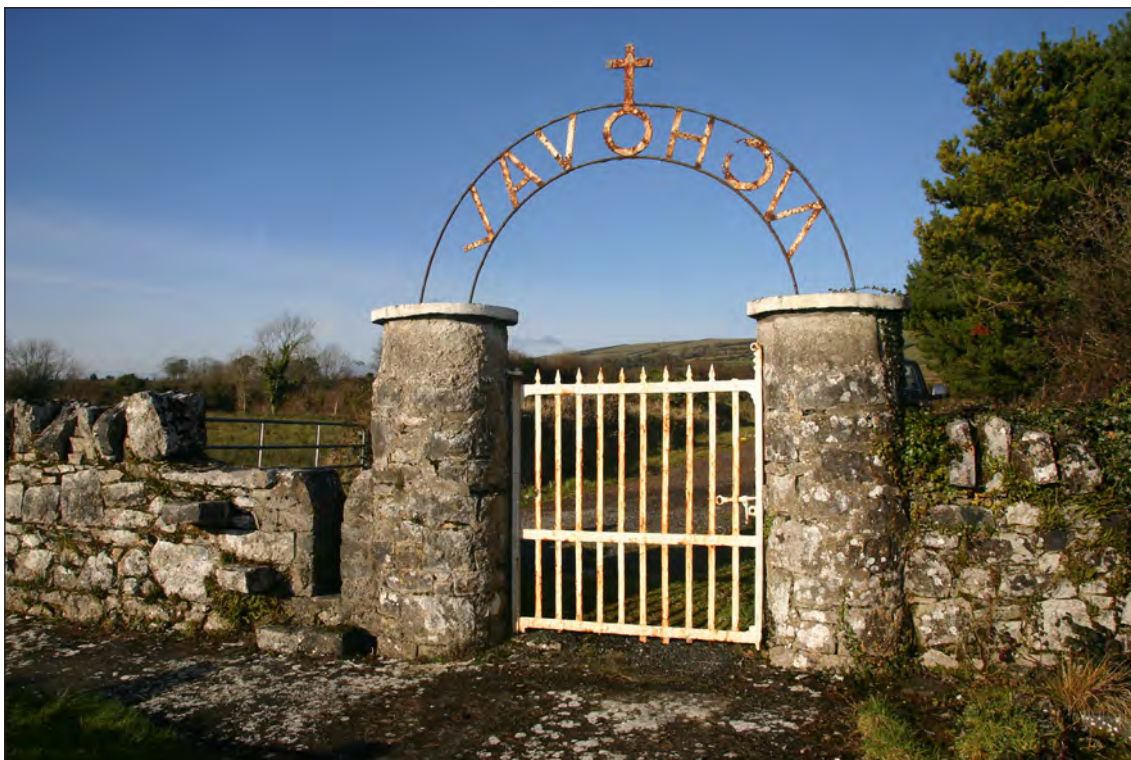
Plate 5: View of interior of Nohoval Graveyard entrance gate and stepped stile from south

Able-bodied pedestrian access is also provided for by a stone stepped-stile and a squeeze-stile accommodated in the boundary wall beside the gate. Both are in good condition.

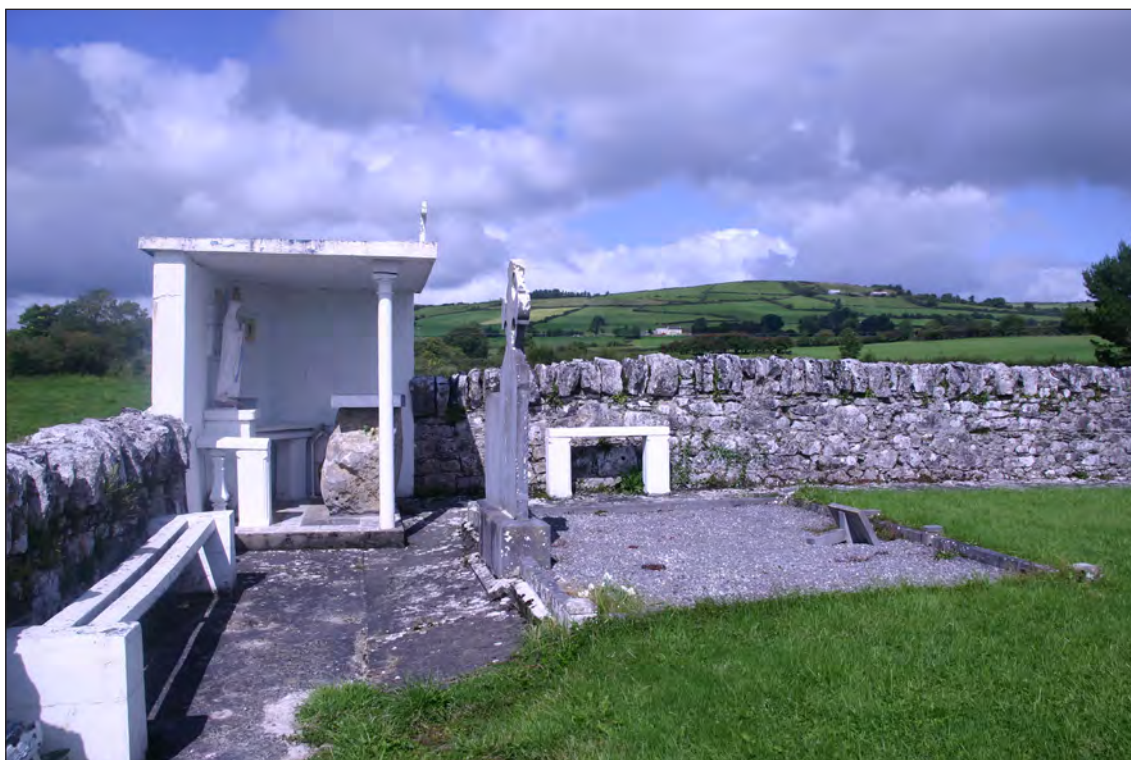
Plate 6: View of modern shelter / altar and seating area at south west corner of Nohoval Graveyard from east

A modern covered shelter/altar structure with seating is situated at the northwest corner of the graveyard on the pathway. The shelter has a number of statues within it with particular devotion to Mary. Three other statues are set within a wooden triptych. The modern altar comprises a simple cross inscribed boulder with a rectangular cut limestone slab. Concrete bench seating is also provided outside the shelter / altar area (Plate 6).

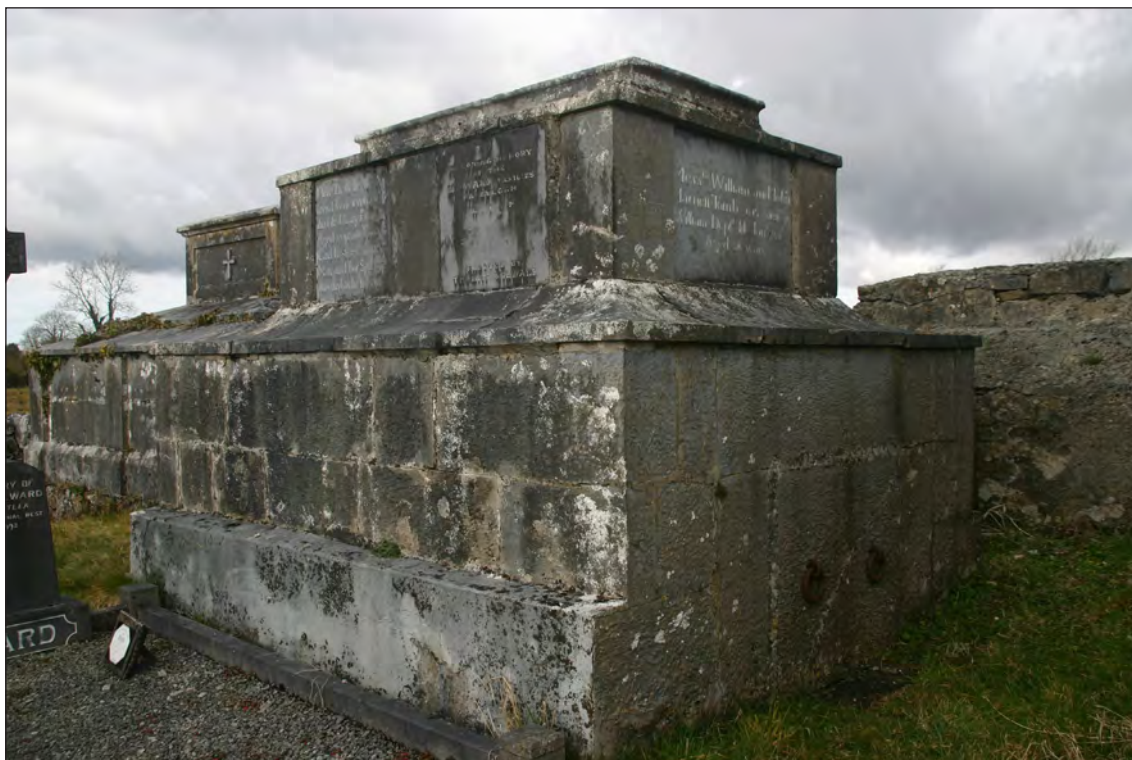
Plate 7: View of the Harnett tomb (48) and Tuomey tomb (52) from south east

Tombs 48 and 52 are built with ashlar limestone and in good order (Plate 7) while Tomb 56 belonging to John Flaherty and dating to 1953 is entirely cement rendered and recently painted grey. Tomb, 44, (O'Connor family tomb), comprises a low tomb of rubble limestone, partially coarse rendered and in need of minor repairs (Plate 8). The fifth named tomb, (76)-Wm Looney, 1826, is situated within the limits of the ruin of the church and sandwiched between two unnamed denuded tombs. It is constructed of rubble limestone and partially overgrown with a vigorous growth of shrubs and briars.

The Harnett family tomb (48) is the earliest and dates to 1810 or 1815 (Plate 7).

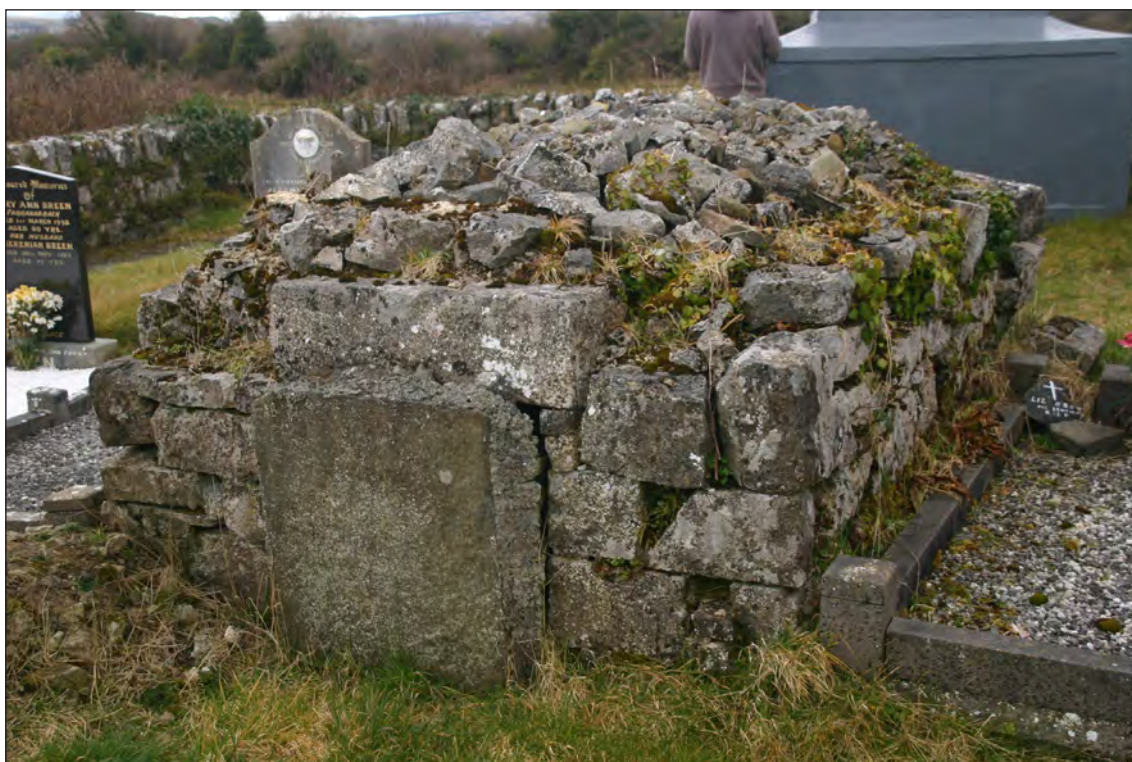
Plate 9: View of unidentified partially reduced tomb (60) from east

Five unnamed tombs were recorded in various states of preservation. All are constructed with rubble limestone. One tomb (60) is currently free of growth but without restoration works the growth will re-establish itself and negatively impact the tomb (Plate 9). Tomb 64 is partially overgrown with briars and other growth and if left unchecked will

Focused targeted archaeological refurbishment and conservation work should be undertaken of the collapsed tombs. All open and exposed tombs should be fully repaired and sealed. This work should be undertaken with expert archaeological advice and guidance.

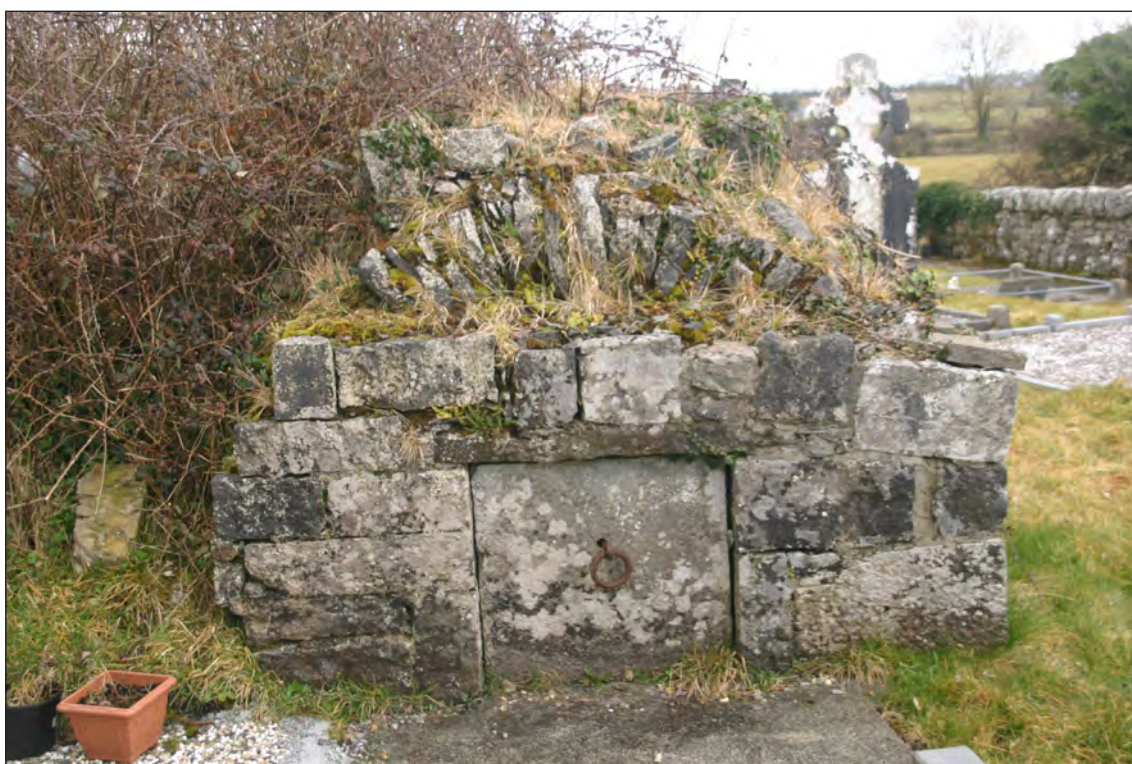
Plate 10: View of unidentified partially reduced tomb (64) from west

be negatively impacted in the near future (Plate 10). Two of the other unnamed tombs (68 & 80) are also completely covered in dense vigorous growth and are in a collapsed tumbled state (Plates 11 & 12) while the fifth unnamed tomb (72) within the church is now reduced to a low grassy raised area.

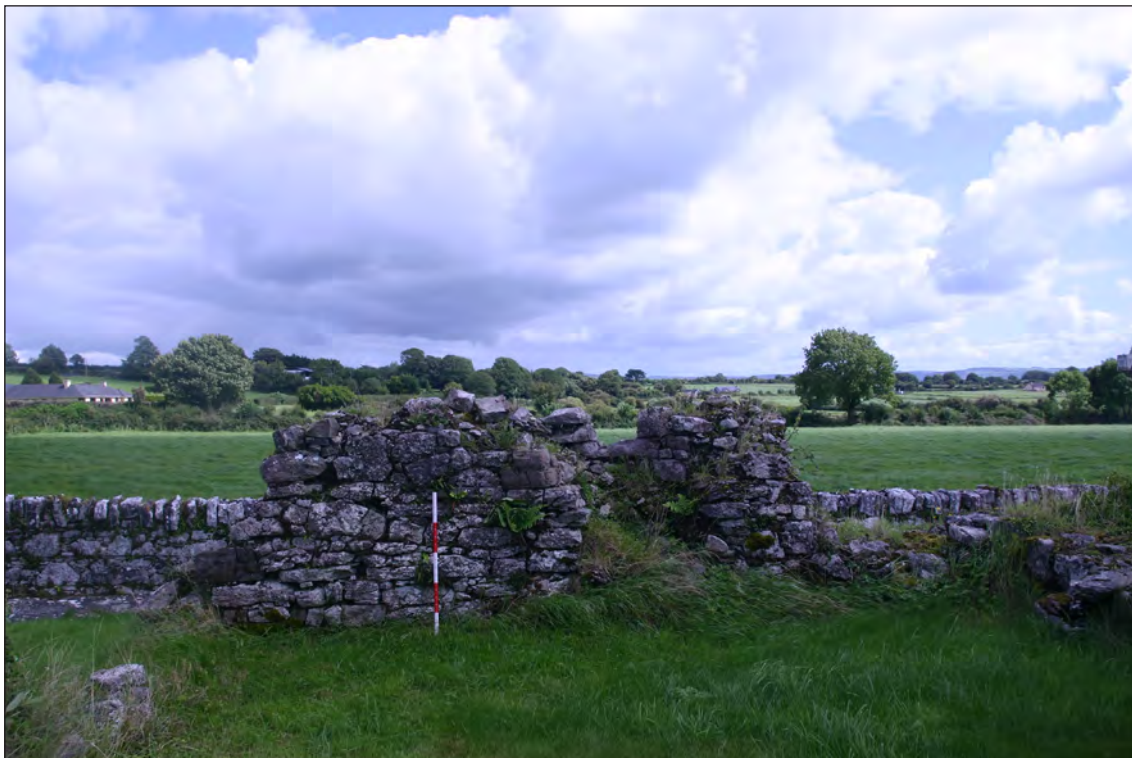
Plate 13: View of relict remains of interior of elevation of east gable of Nohoval Church from west

Only the central lower area of the east gable survives including the ragged robbed out remains of a splayed window embrasure (Plate 13). Only two dressed and chamfered side stones survive.

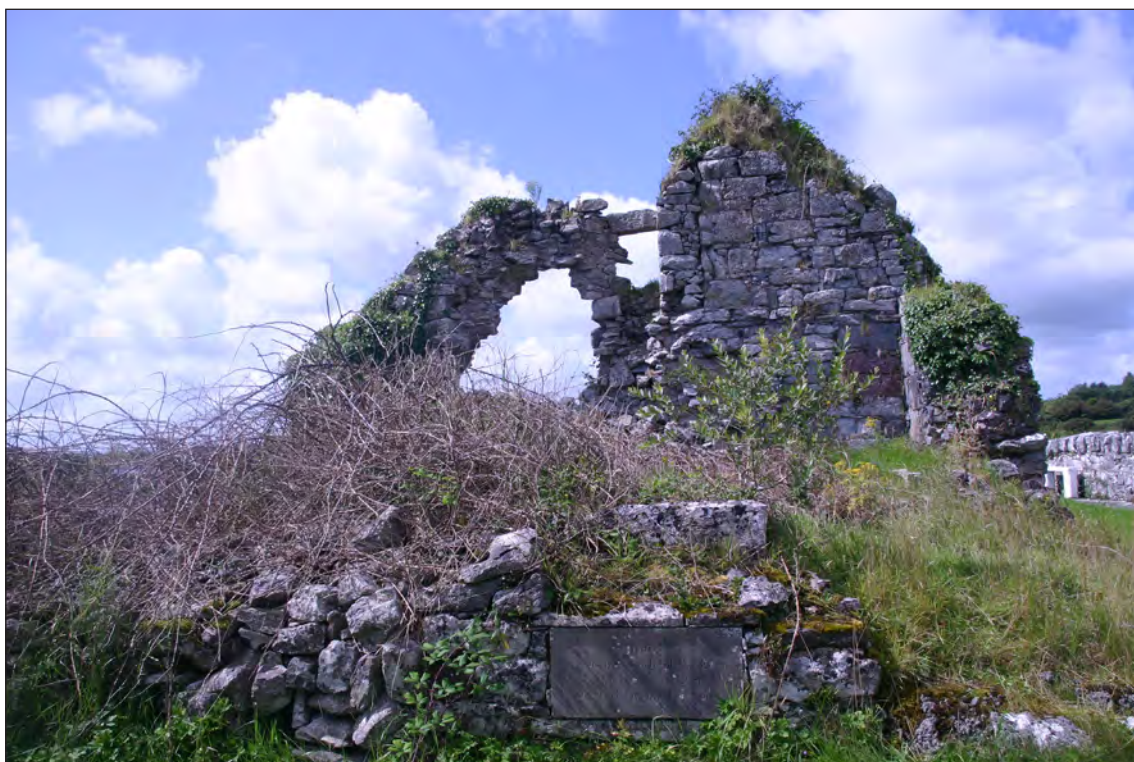
Plate 14: View of ragged upstanding west elevation of Nohoval Church. Note overgrowth and reduced tombs in interior

been tidied up. Three dilapidated tombs and a single grave setting are located within the interior and are much overgrown. There is no visible evidence for an entrance doorway. The church is constructed with uncoursed rubble limestone bedded in lime mortar. Some squared and dressed ashlar blocks are also evident here and there on the west gable.

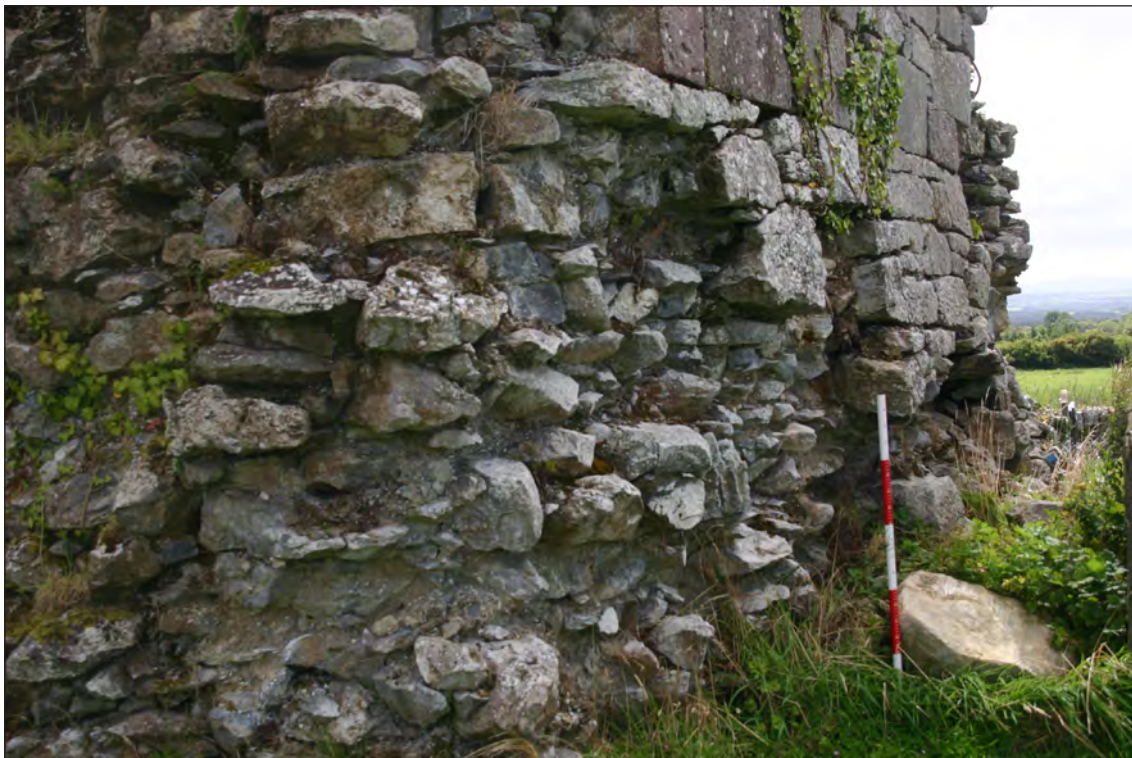
Plate 15: Close up view of ragged, collapsing, robbed out and recently fallen masonry at the exterior north-west corner of Nohoval Church

At the outset the west gable is extremely dangerous and immanently liable to collapse. Several recently collapsed large blocks were recorded at the north-west corner of the structure (Plate 15). The gable almost survives to full height and was lit by a single central light with a splayed embrasure. The flat lintel of the window still miraculously survives (Plate 16). Immediately beside the largely robbed out window is a large ragged robbed out breach (Plates 2, 3, 14, 16-22). Part of the lower limits of the breach has been partially replaced with collapsed masonry (Plates 19, 21-22).

The west gable should be repaired as an extreme matter of urgency. If this is not possible then the gable should be judiciously reduced as it is immanently about to collapse. The west gable of the church should be entirely fenced off for health and safety

No conservation restoration or reduction works should be undertaken without prior laser scanning-internally and externally of the west gable.

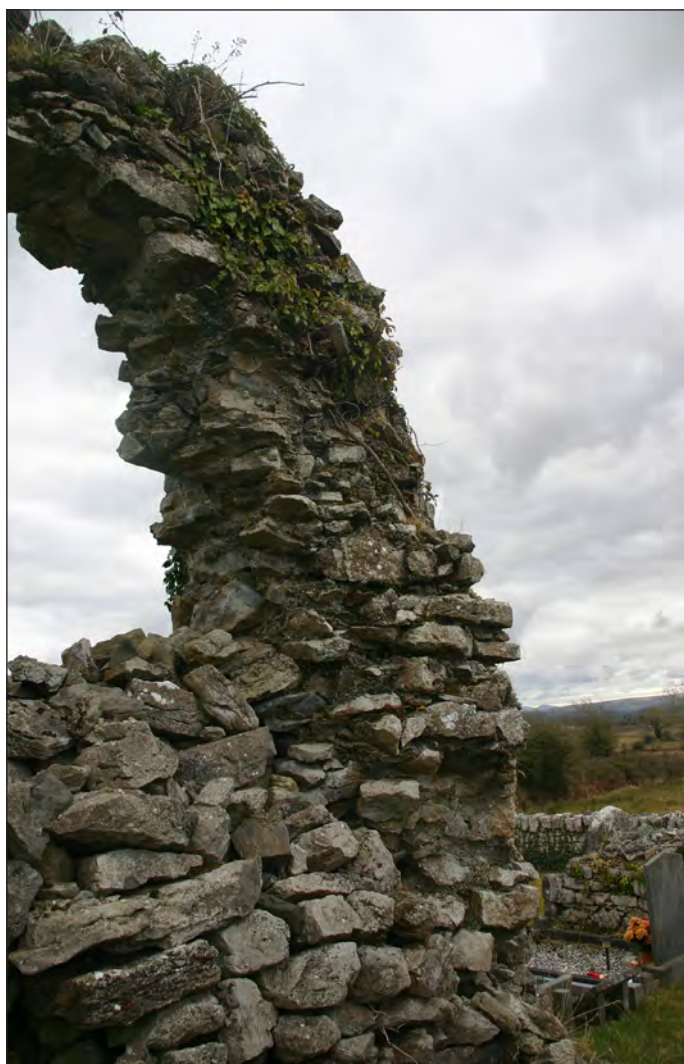
Plate 22: View of remains of supporting side buttress at south west corner of Nohoval Church

Originally the west gable was supported by two side buttresses on the south and north, portions of both survive to a greater degree at the south and to a much lesser degree at the north where only a single dressed stone survives. Otherwise the north buttress comprises of a ragged projecting core of rubble. The southern corner buttress survives better with a number of its dressed masonry still present including a number of its topmost chamfered string (Plates 22-23). There is no doubt that without these two buttresses, the west gable would have collapsed previously.
