Archaeological Survey,  
O'Braonainn Graveyard,  
Tralee,  
Co. Kerry.

August 2010

Client: The Heritage Office,  
Kerry County Council,  
County Buildings,  
Ratass,  
Tralee,  
Co. Kerry.

RMP No.: KE030-018

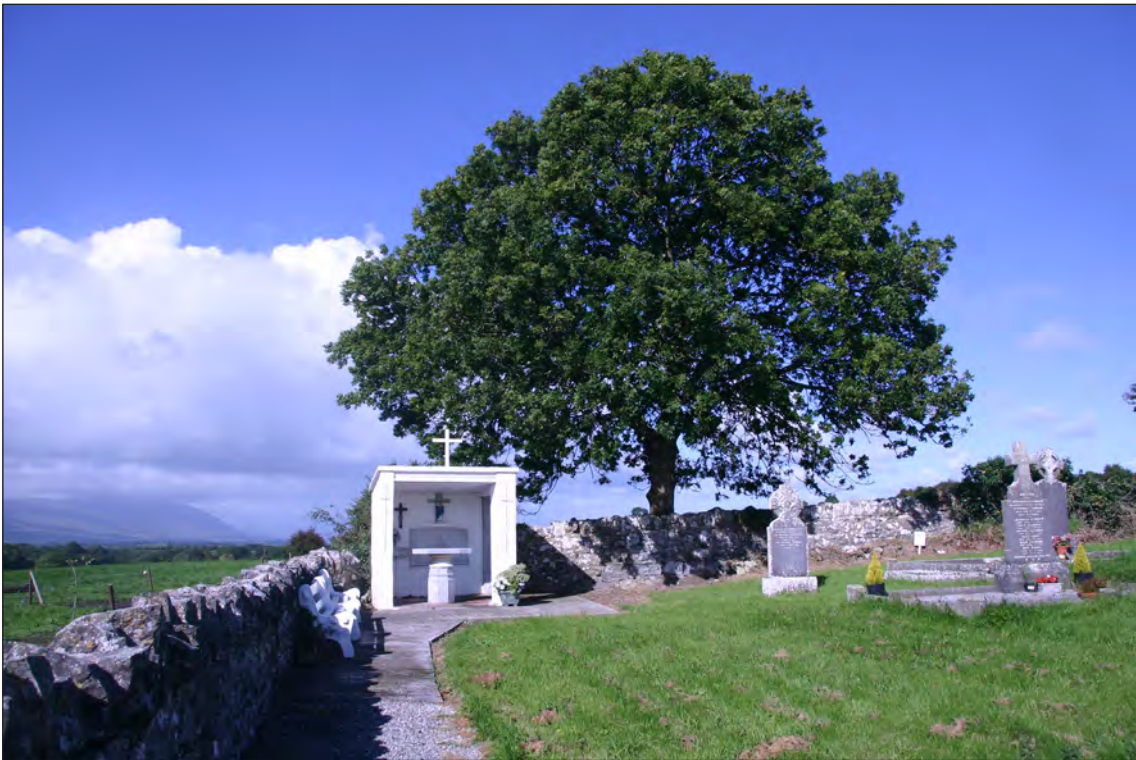
**Plate 2:** View of interior of south-western limits of O'Brennan Graveyard from east.  
Note Slieve Mish Mountains of Dingle Peninsula in background

In general the graveyard internally is kept neat and tidy especially around the southern perimeter concrete pathway with the grass well managed (Plate 2). Other informal grassy paths extend around the other three boundary walls. However, the interior of the graveyard has no defined paths and is very bumpy and irregular and covered in deep grass with some briar as well, making the interior very difficult to negotiate (Plate 3).

There is a formal concrete path in excellent condition that extends along the southern internal perimeter of the graveyard (Plates 2). An informal grassy pathway, kept low but grass cutting, extends along the W, N and E boundary (Plates 4 & 5 and Figure 5).

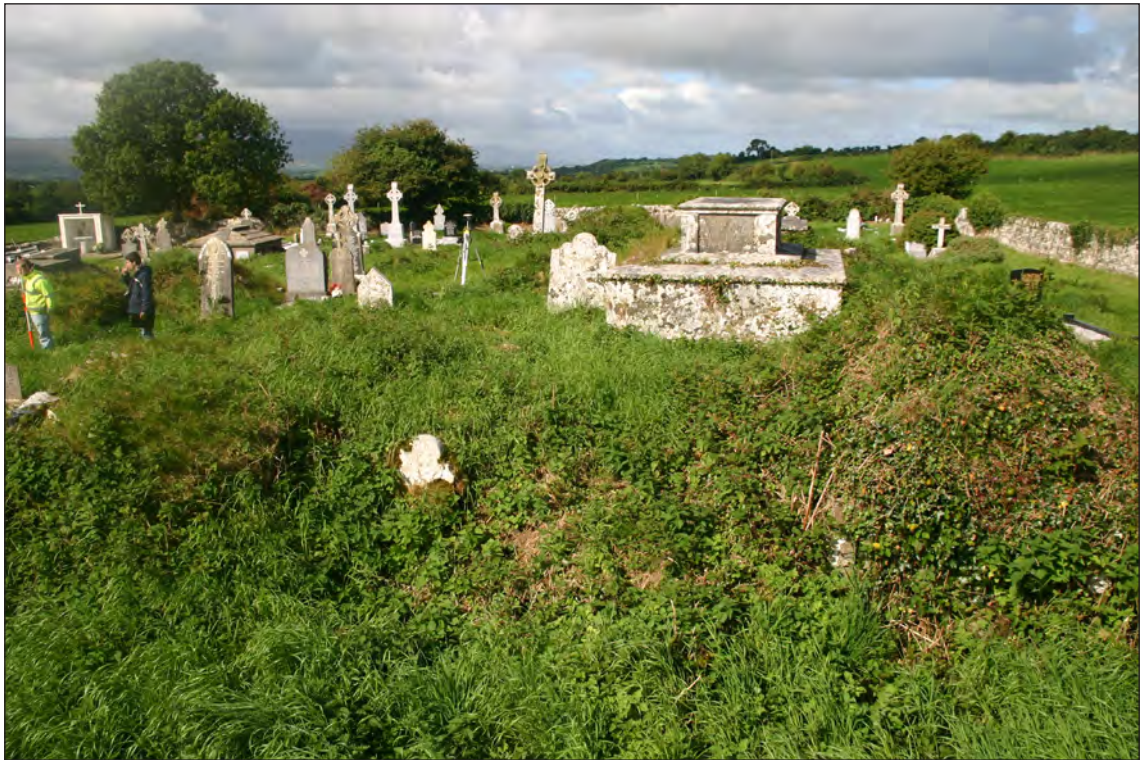
**Plate 3:** View of interior of O'Brennan Graveyard from east

The existing formal and informal perimeter pathway services much of this small graveyard. However, the interior is devoid of any pathways formal or informal and it is overgrown, bumpy and very difficult to traverse (Plate 3).

The interior dense grass and briars should be cut back short and maintained at this low level. Some internal informal paths could then be created to gain access to the interior.

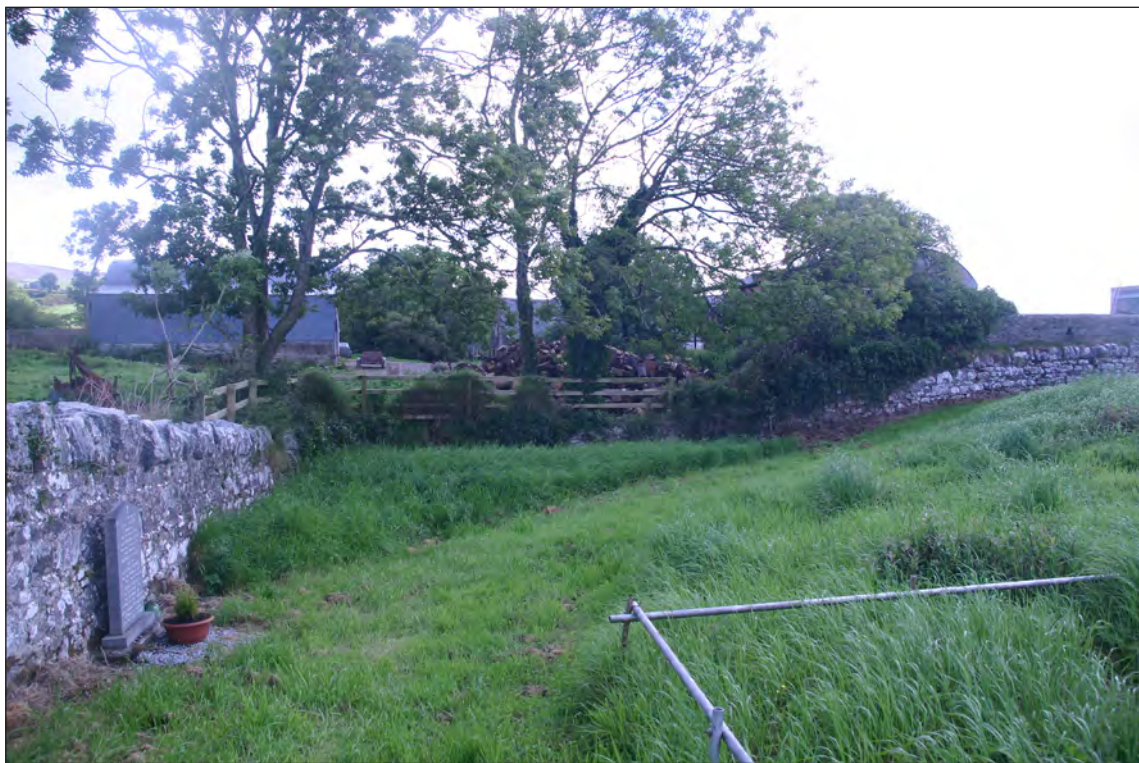
**Plate 4:** View on north-east corner of O'Brennan Graveyard. Note sharp fall of ground. Further note informal grassy path

There is no remains of this cave today however, there is a large distinct depressed area at the north east corner of the graveyard that may reflect this cave (Plate 4).

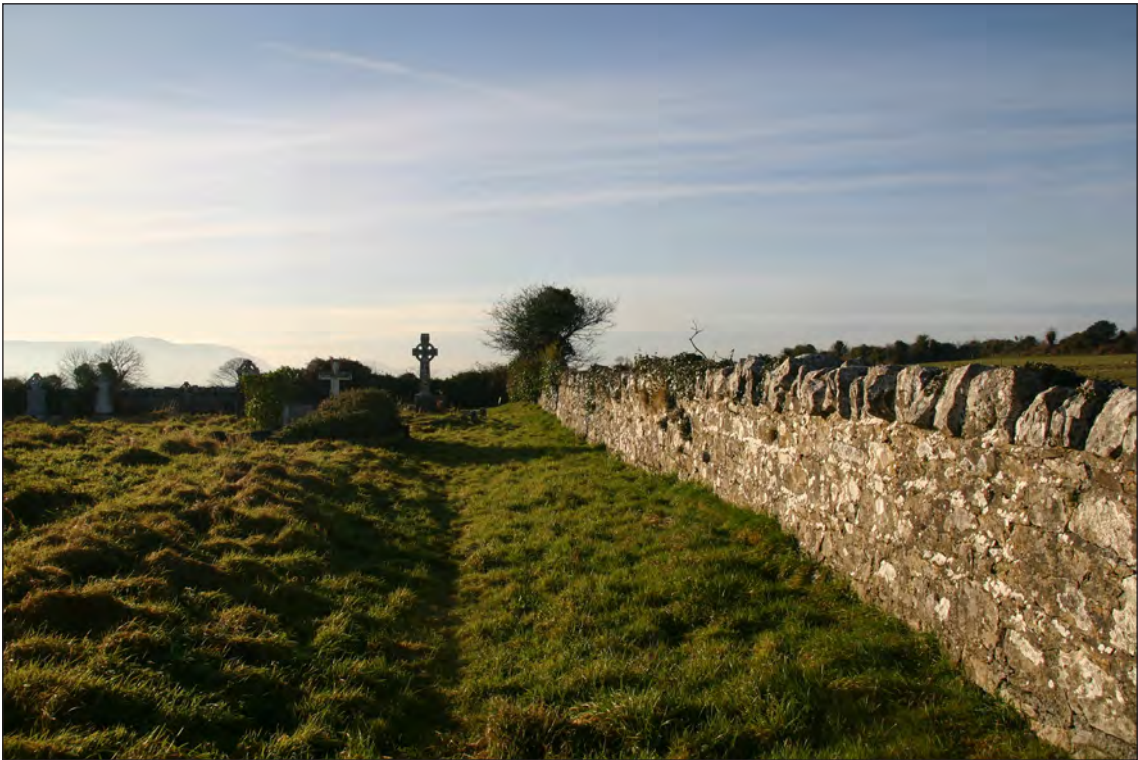
**Plate 5:** View of northern limits of O'Brennan Graveyard. Note informal grassy path and boundary wall

Boundary walls of this small rectangular graveyard are constructed with rubble limestone built to courses and bedded in mortar and capped with 'soldiers' and are in excellent condition. The walls are 1.2m high internally. The W and N boundary walls are almost entirely covered in ivy but otherwise in good condition although a whitethorn tree encroaches mid way along the west boundary wall (Plates 2 & 5). Kerry County Council put in some small *No Dumping* signs at the W and N walls.

The ivy should be removed from the boundary walls.

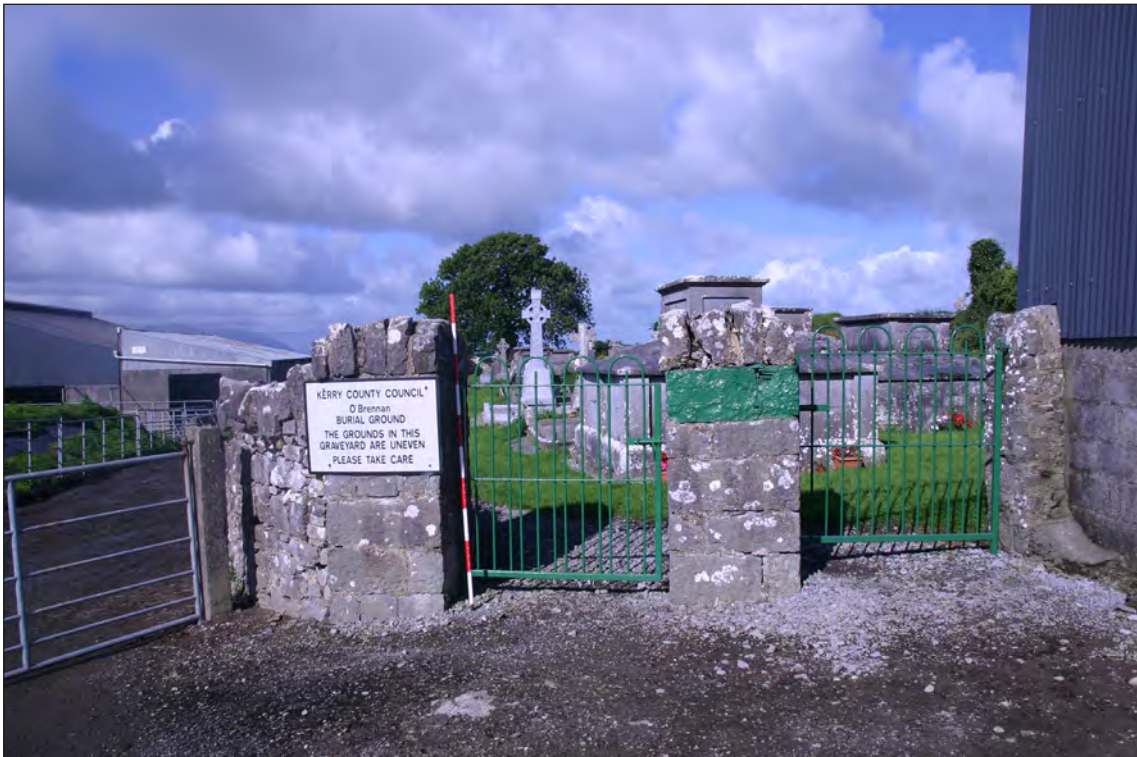
**Plate 6:** View of entrance gates to O'Brennan Graveyard from east

Entry into the graveyard is gained through a pair of modern green painted iron gates set between three square piers of coursed squared limestone blocks capped with soldiers and contemporaneous with the boundary walls (Plate 6). The gates open easily and freely.

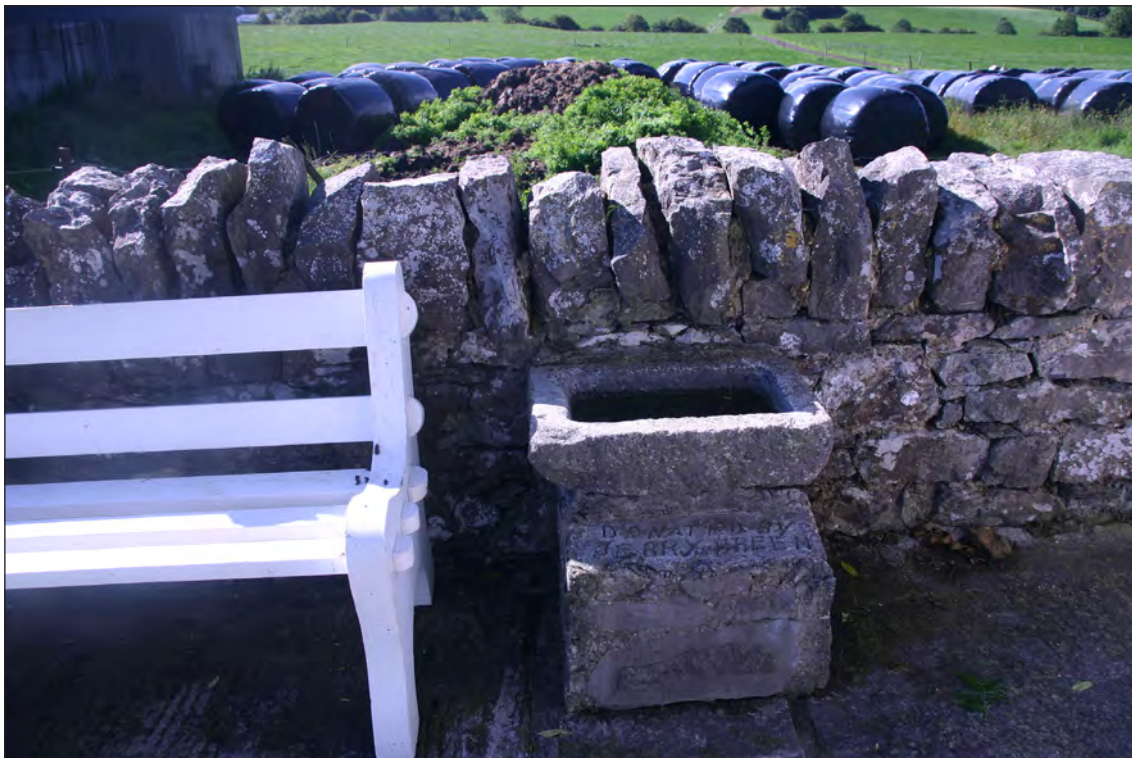
**Plate 7:** View of rectangular limestone stoup or basin (300) at south-west corner of O'Brennan Graveyard

A modern covered shelter/altar structure (305) with seating is situated at the northwest corner of the graveyard on the pathway. Concrete bench seating is also provided outside the shelter / altar area (Plates 2). Alongside the altar against the S boundary wall is a rectangular stone stoup or basin (300), 0.61m L x 0.37m W x 0.15m D, placed on a low rubble limestone plinth with the words *Donated by Jerry Breen* inscribed in cement (Plate 7). Internally the stoup/ basin measures 0.465 L x 0.23m W x 0.095m D. There is some punch dressing here and there on the inside while the exterior is roughly trimmed.

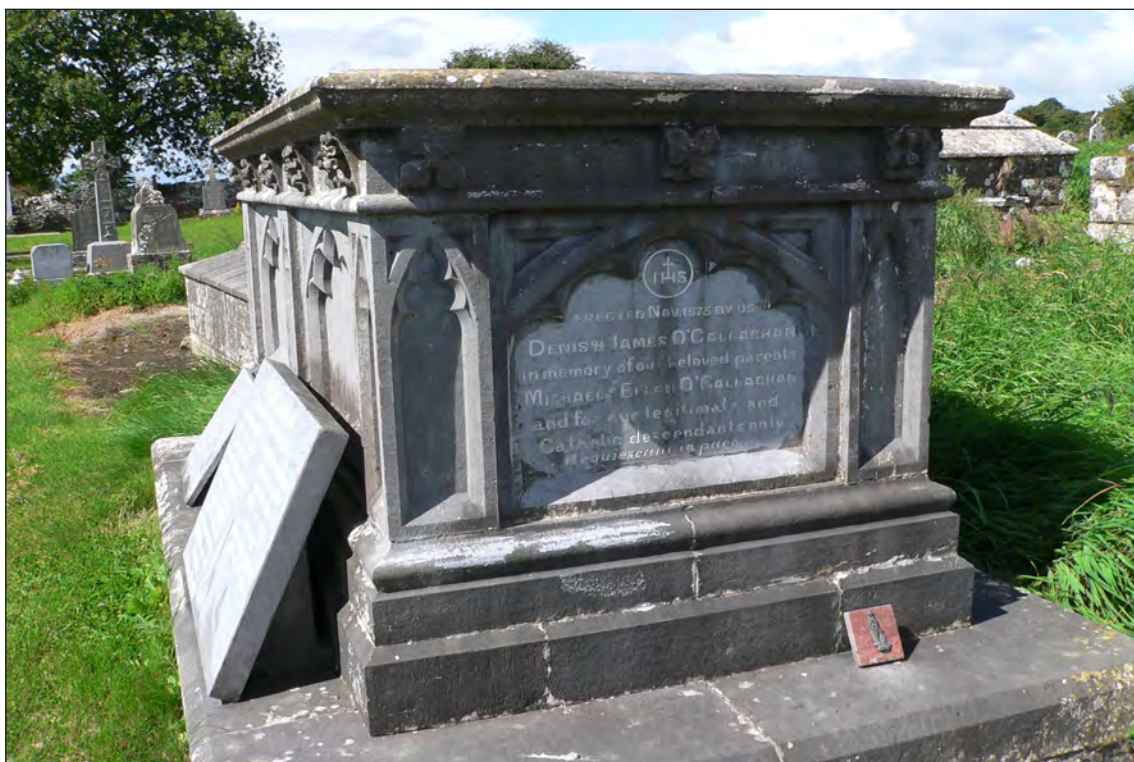
**Plate 8:** View of chest-type tomb (186) of O'Callaghan family at O'Brennan Graveyard

There were nineteen named tombs recorded, largely in a good state of preservation (Appendix 1). The majority are 'strong-box' type and there is a very fine rectangular chest tomb also, built with ashlar limestone (Plate 8).

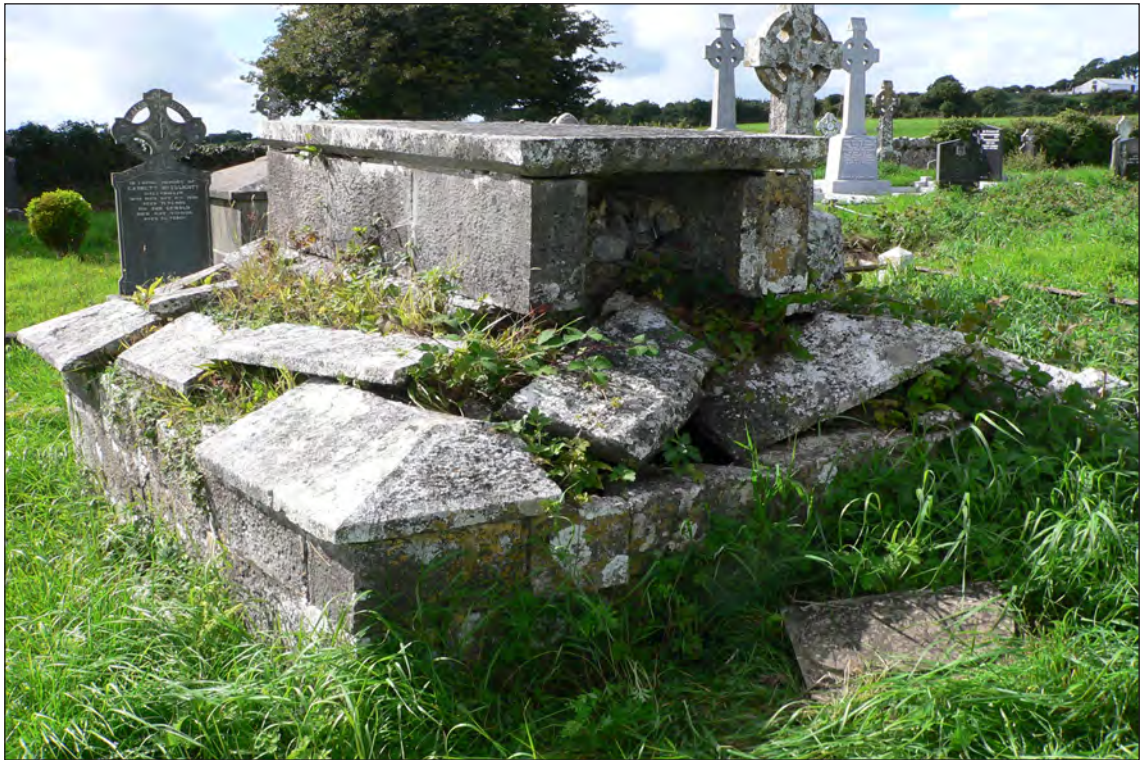
**Plate 9:** View of the partially collapsed O'Connor tomb (257) from east

Twelve of the tombs are built with ashlar limestone of which ten are in very good order. However, ashlar tombs (110 and 257) are partially collapsed and broken (Plates 9 & 10). The seven other named tombs comprise two small rectangular low types (212 & 232), both of which require repairs to their sides. One tomb is illegible and survives as a grassy overgrown mound (Plate 11). Another rendered tomb (181) is interesting in that it has embolded on it in concrete that it was repaired by Patrick Fitzmaurice in 1916 (Plate 12). Presently it is partially overgrown and its render is cracked and in need of attention. The other named tomb (191) survives as a grass covered mound in need of serious repairs (Plate 13).

Tombs 110 and 257 should be repaired. The haunches of tomb 110 are particularly bad and collapsed. Tomb 257 is covered in ivy and briars while its haunches are also damaged. The sides of the small rectangular tombs, 212 & 232, should be repaired and re-rendered. The other named grassy covered tombs should be cleared of growth and assessed for further repairs and restoration. All works should be carried following individual archaeological advice and supervision.

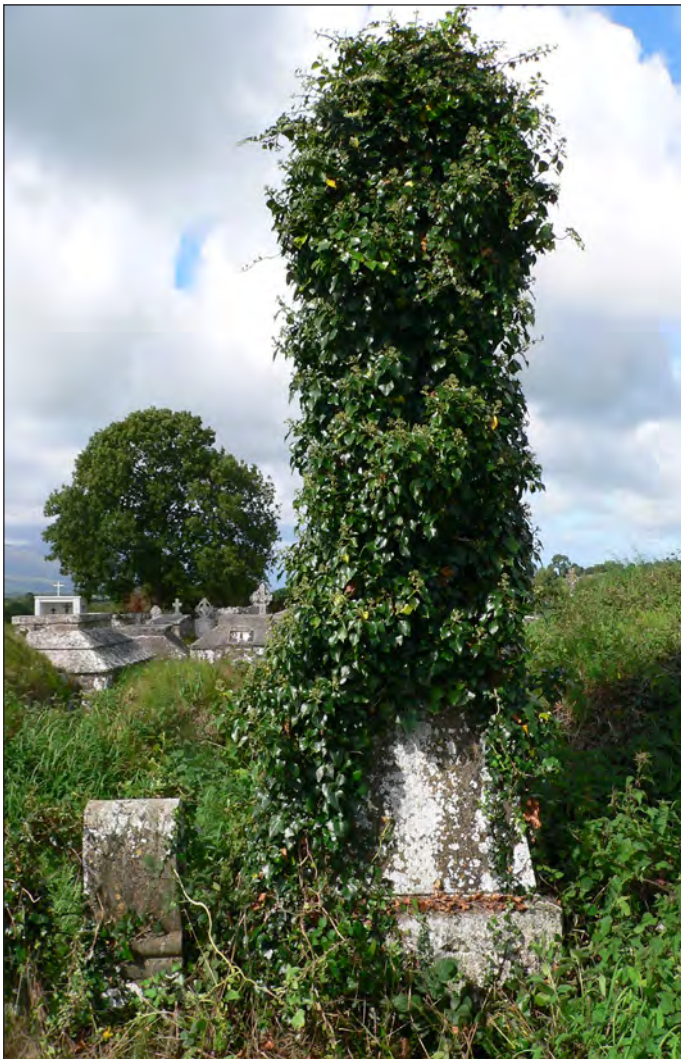
**Plate 14:** View of the completely overgrown, modern High Cross of the Ahern grave (75) from east

A total of 82 named headstones (Appendix 3) were recorded in O'Brennan graveyard. The vast majority of them are modern and in good order. However, a few in the interior of the graveyard are under pressure from un-managed growth and need to be cleared, in particular (75) a tall modern High Cross (Plate 14). Another illegible broken cross (41) should be cleaned and repaired. Apparently the oldest recorded headstone is from 1759 with the name Moor on it but it was not found in the course of this survey unless it is one of the illegible ones. The earliest named headstone recorded in this survey (151) was Maurice Hanaghlán (Hanrahan?) who died in 1786 aged 77 years (Plate 15).

The vegetation in the interior of the graveyard at O'Brennan should be cut back very low and kept that way. This will improve access into the centre and aid maintenance of the graves and tombs. After the grass has been cut back and the briars etc removed, the interior should be resurveyed and updated.

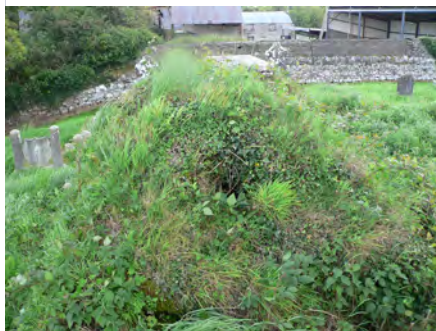
<b>Tomb No:</b>	140
<b>Photo No:</b>	154_0089
<b>Photo:</b>

Fifteen unnamed tombs (Appendix 2) were recorded in very poor states of preservation. Eight are barely manifest above the uneven ground with some masonry visible while the seven others have a higher above ground register but are still entirely covered grass, sod, ivy and briars. Tomb 140 is also partially open.

<b>Notes:</b>	
Collapsed	N
Open	Y
Rendered	N
Overgrown	Y

It would require focused targeted archaeological excavation to undertake refurbishment and conservation work of these unnamed collapsed tombs. However, initially all the tombs should be cut back and ivy and brambles removed. The rough deep grass and other vegetation in the interior of the graveyard should be cut as low as possible and the area and tombs re-evaluated by a qualified archaeologist. All open and exposed tombs should be fully repaired and sealed. This work should be undertaken with expert archaeological advice and guidance.
