Date: October 2009

Client: The Heritage Office, Kerry County Council, County Buildings, Ratass, Tralee, Co. Kerry.

Archaeological Survey, Kilduff Children's Burial Ground, Kilduff, Co. Kerry.

RMP Number: KE045 009002

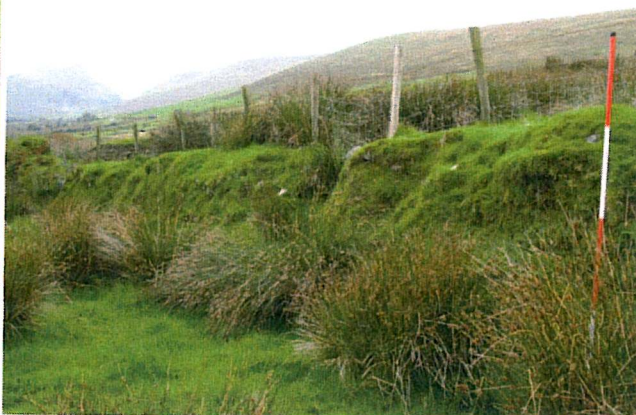
Plate 02 - Enclosing embankment to south from west.jpg

The burial ground is enclosed by the remains of rubble stone and earth boundary walls (Plate 2) with a rubble stone embankment located to the south. The walls survive largely in a ruinous state, more closely resembling rudimentary embankments than walls, with numerous breaks and areas of collapse that are mainly concentrated to the northern section (Plate 3).

The vegetation attached to the wall remains should be managed rather than removed in order to prevent any degradation of the walls and preserve the natural habitats that this vegetation provides for local wildlife.

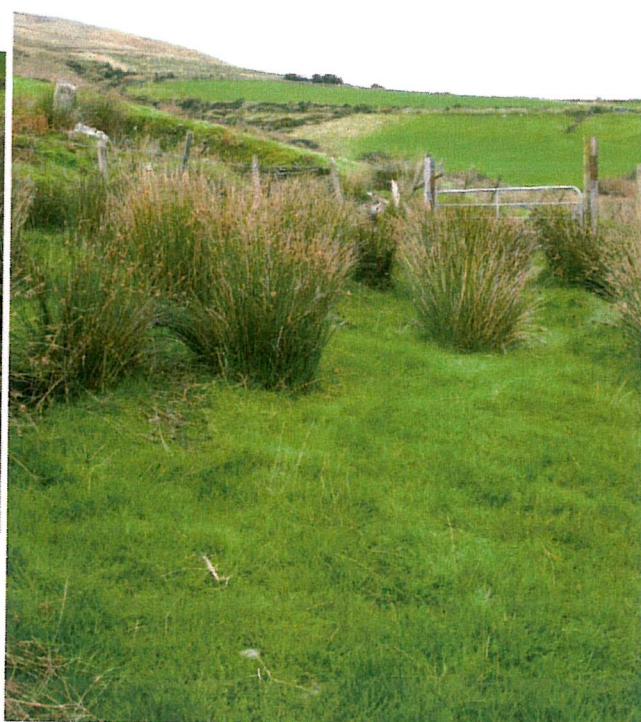
Plate 04 - Traversing trackway from southeast.jpg

There is a single track way that runs between the two gates (Plate 4), with another track way running from the southeast corner and running westward toward the nearby country road (Plate 5). The track ways are most likely used by the nearby farmer for moving livestock between fields. Interestingly the western, exterior track way is margined by an early field boundary (Plate 6) to its north side.

Control of the vegetation should be the primary concern, however the track ways appear to be in good condition and should be maintained in their current state.

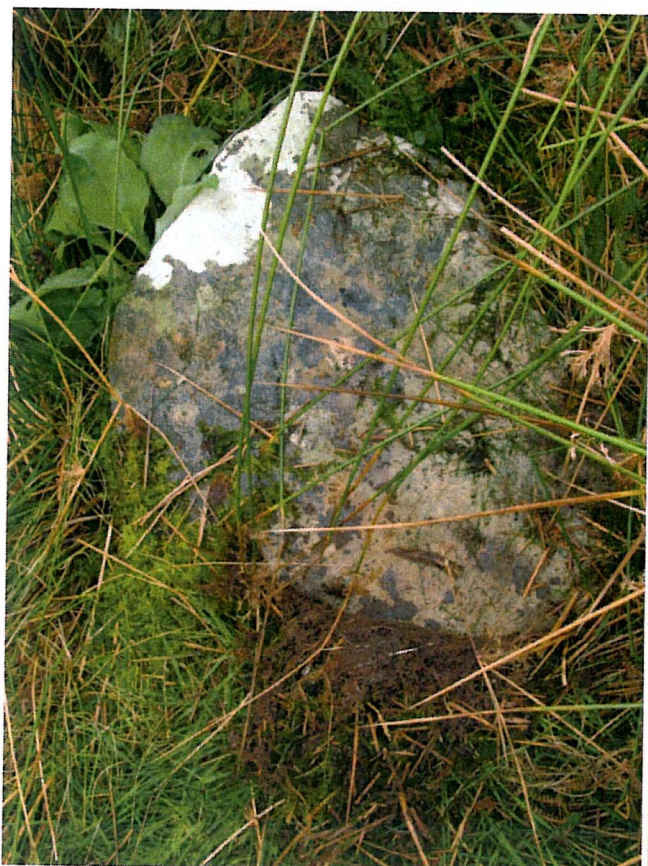
Plate 07 - Grave no. 002.jpg

Two possible gravemarkers were identified during the survey, one located to the southwest, of limestone (Plate 7) and a second just beyond the south-western corner of the boundary wall (Plate 8) which was of quartz.

Grave Number	Type	Notes	Photo Numbers
002	Grave	possible headstone, however south of burial ground	027
003	Grave	Big chunk of quartz	039

The unnamed gravemarkers are in relatively good condition despite some natural deterioration caused by weathering. Where possible, steps should be taken to prevent further degradation of this sort, namely through the control of the vegetation. This would benefit the gravemarkers in two ways, primarily by preventing root activity destabilising them and it will also ensure that they remain clearly visible thereby preventing accidental damage being caused to them by visitors to the grounds.

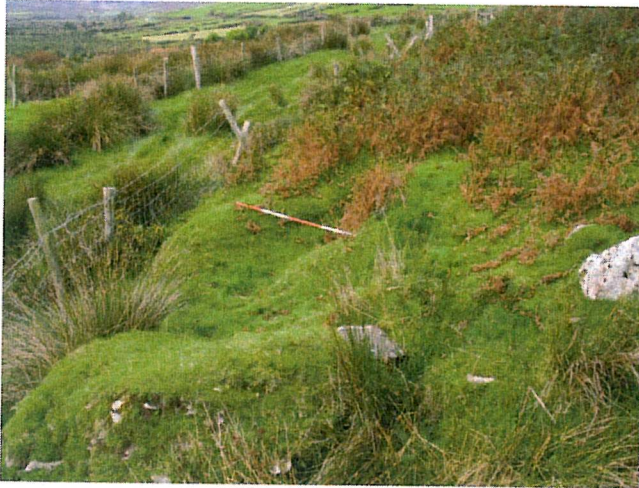
Plate 09 - Possible ruin from east.jpg

Located to the southeast corner of the graveyard are the remains of what may have been a small building or hut. These remains survive as a D-shaped mound of rubble stone and earth covered by vegetation (Plate 9). Further archaeological investigation would be required to be certain of the nature of the remains.

An archaeological investigation could be carried out on the remains in order to better classify them. Any investigation should however be carried out under strict supervision.

- Measures should be taken to secure the fragmentary building remains through the control and monitoring of all attached vegetation
- A more detailed archaeological investigation could be carried out on the site in order to better classify the possible building remains but any investigation should be carried out under strict supervision and care should be taken not to disturb any burial deposits.

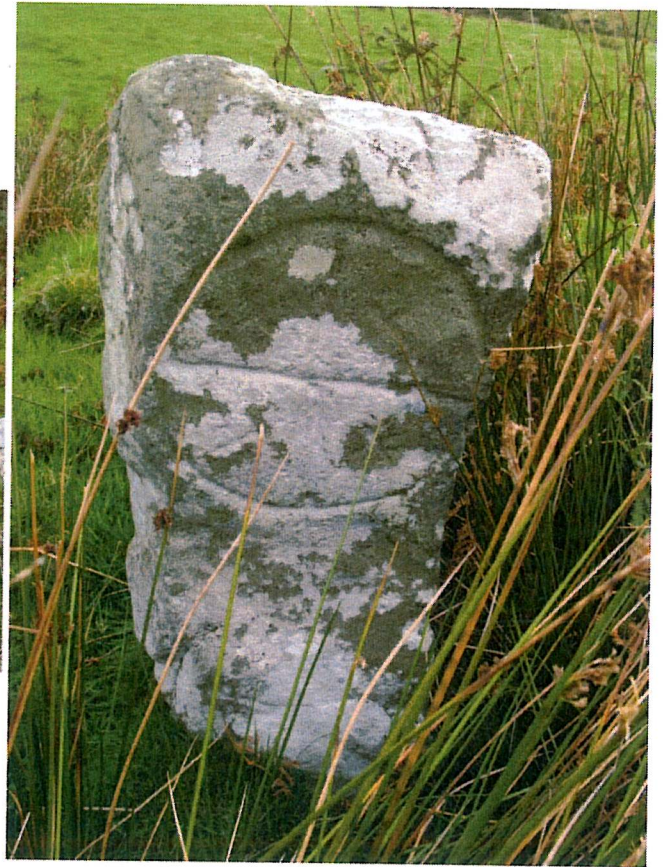
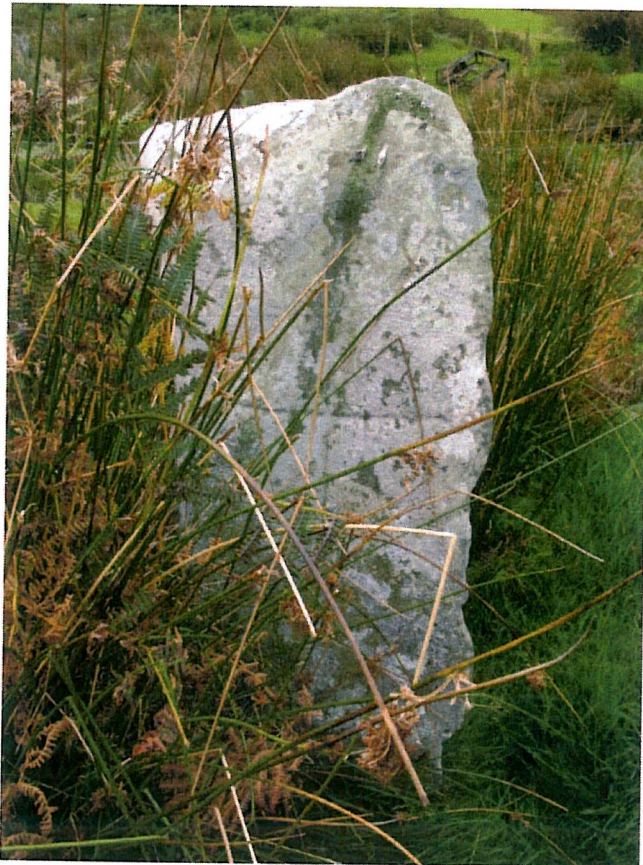
A single cross slab was identified during the survey, located toward the southeast corner of the site. The slab is in a standing position and is inscribed on either side (Plate's 10 and 11) with cruciform motifs. The slab has survived in a good condition although it has suffered a degree of wear from natural weathering processes. The slab is however located in an area of moderate overgrowth which could if unchecked destabilise the slab. The slab was likely erected at the time when the burial ground was originally in use.

Plate 10 - Cross slab from northeast.jpg

Plate 11 - Cross slab from southwest.jpg

The slab should, if possible, remain in situ and the surrounding overgrowth should be controlled to prevent its destabilisation.

- The Cross slab should be kept clear of vegetation and left in situ. The feature should however be periodically inspected to check its condition.
- Following the above recommendations, the site should periodically be inspected on a bi-annual basis to ensure that the site remains in a good state of repair.
