Archaeological Survey,
Glen (Old) Church & Graveyard,
Rathkieran,
Co. Kerry.

September 2007

RMP No.: KE096-009

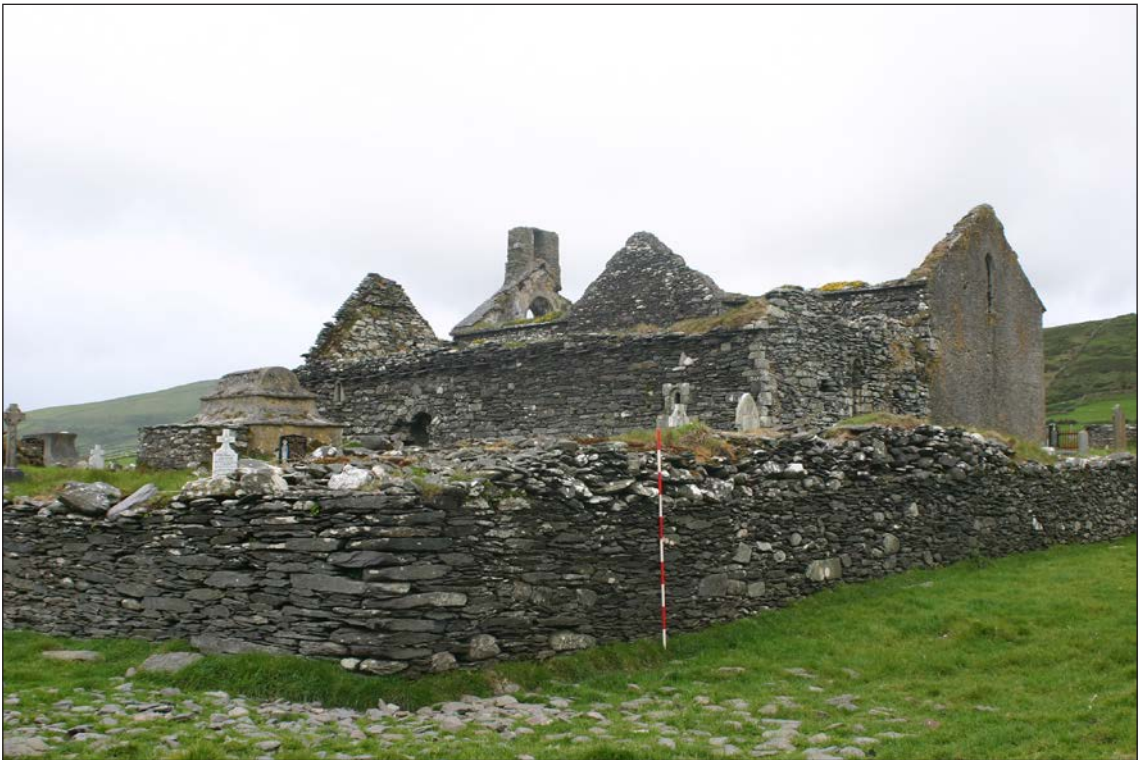
Plate 2: View of Medieval Church and boundary wall taken from southeast

The graveyard is bounded by a well built drystone wall of split local red sandstone (Plate 2).

The boundary wall varies in height from 1.5 to 2.5m and ranges in thickness from 0.5m to 1m.

This current survey undertaken in 2007 recorded a number of deteriorations in the condition of the Medieval church (Plate 2).

The upper 0.6m of the western extent of the southern boundary wall needs to be reduced and relaid.

A sheep wire fence should be constructed around the outer wall to prevent animals from rubbing off or climbing onto it.

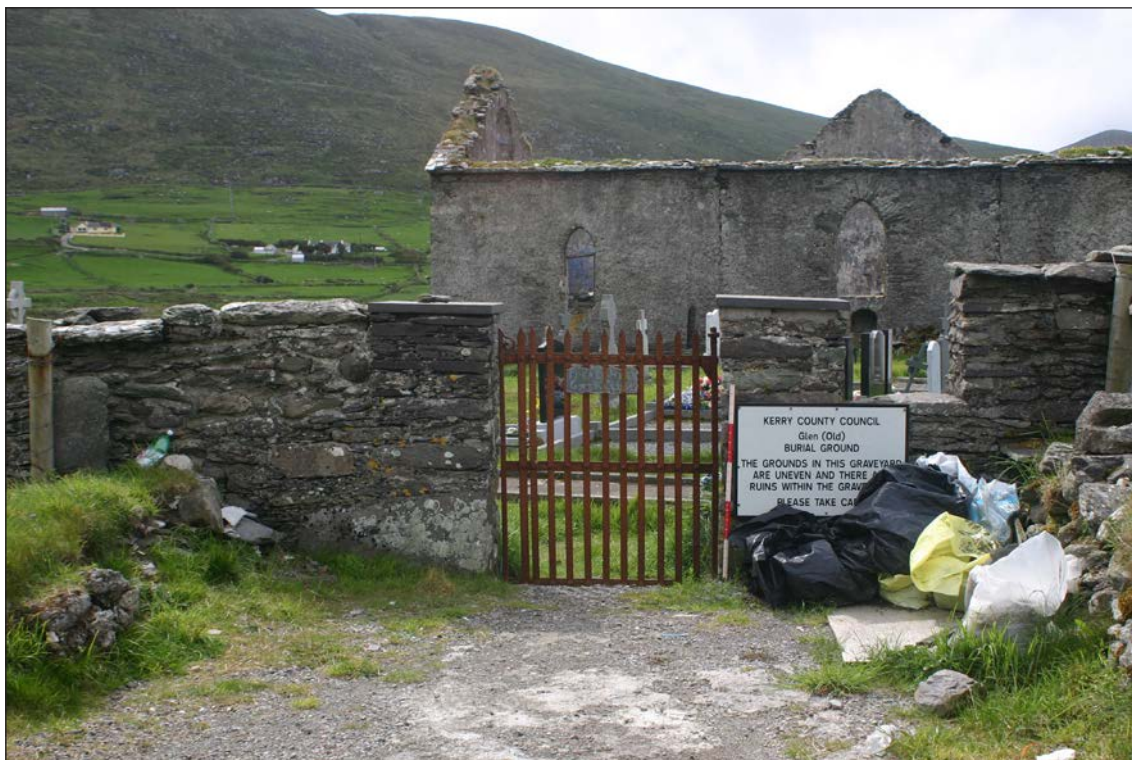
Plate 3: View of entrance gate taken from north

The original 19th century gate is in good condition (Plate 3).

It is set between two supporting stone piers with square slate coping in good condition.

A footstile is located immediately west of the gate.

It is partially damaged and in need of some repair.

The partially damaged footstile should be repaired and made good.

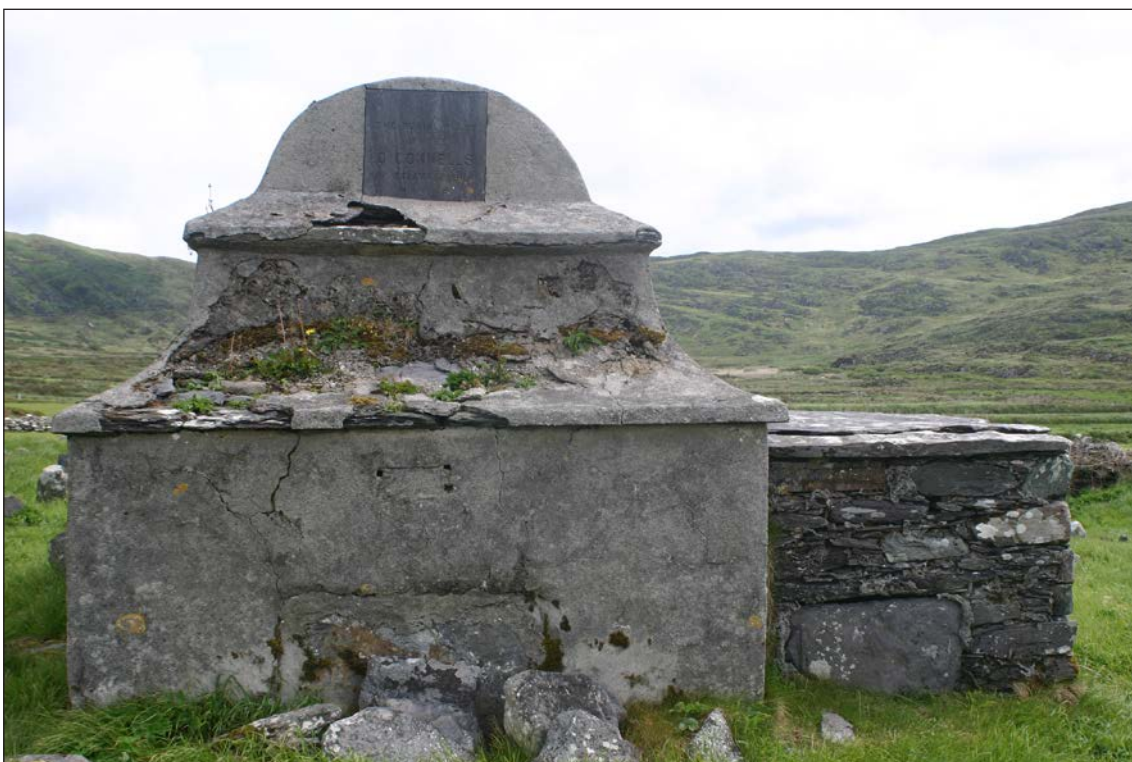
Plate 4: View of O'Connell family tomb (ref. no. 283) showing poor state of render, taken from west

The render is cracking collapsing from the O' Connell tomb (Plate 4), exposing its drystone rubble courses beneath.

The render on the O' Connell tomb should be repaired sensitive to its original construction.

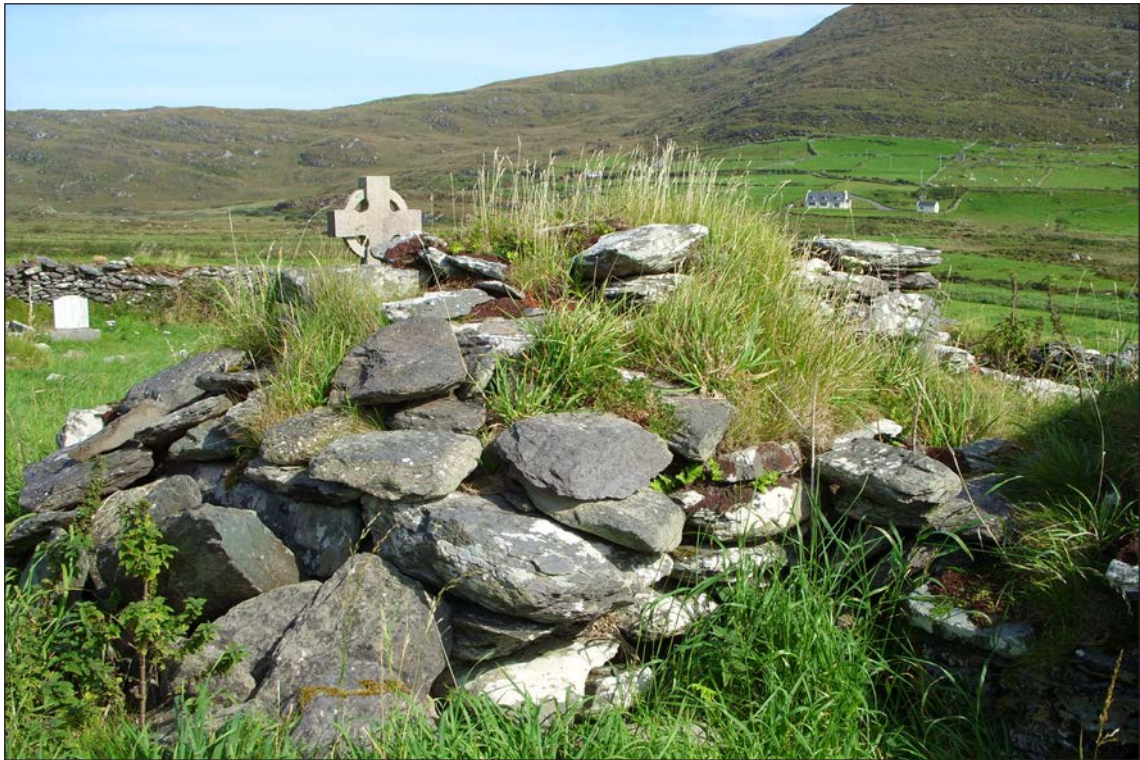
Plate 5: View of unnamed tomb (ref. no. 285) in early state of collapse taken from west

Tomb ref. no. 285 is in an early state of collapse. Several stones have slipped from their original position and the grass overgrowth can only hasten its demise (Plate 5).

The grass and bramble overgrowth on all unnamed tombs should be cut back and removed using suitable equipment, under archaeological supervision.

The structure of the tombs can then be made good, with render being replaced on the rendered tombs sensitive to their original construction and the courses of drystone tombs relaid where necessary. This work may need Ministerial Consent.

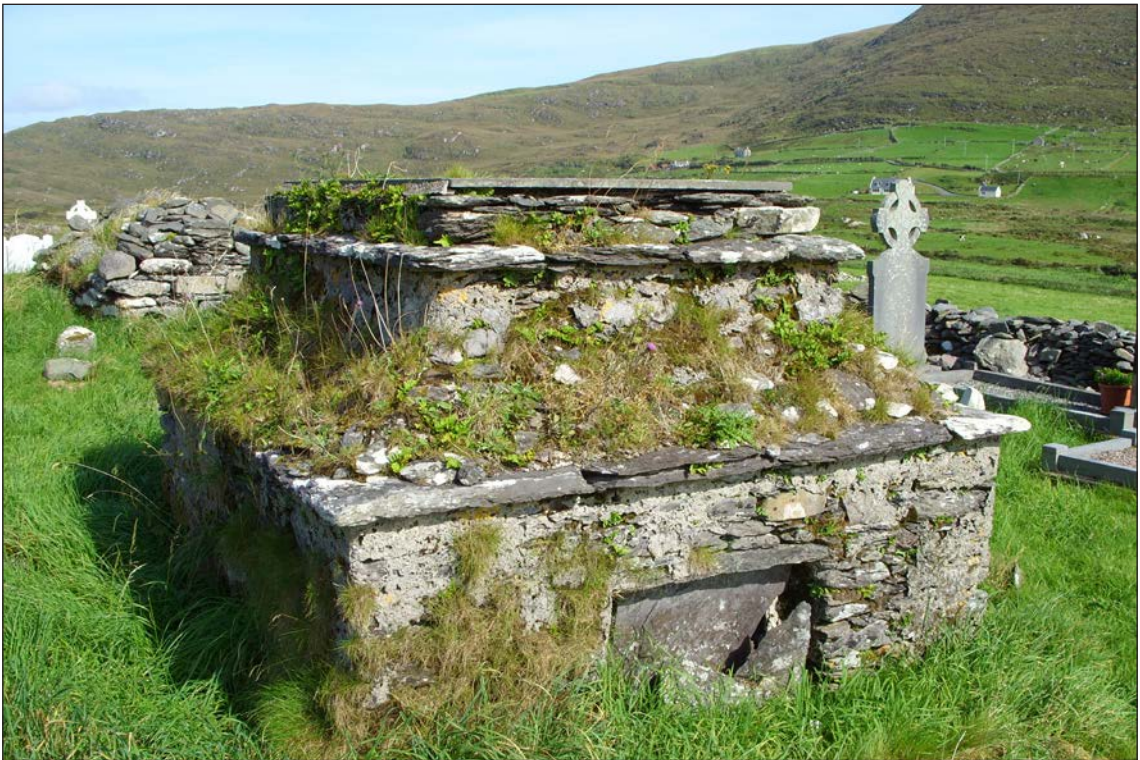
Plate 6: View of unnamed tomb (ref. no. 292) taken from northwest

Tomb ref. no. 292 is in a relatively good state of preservation. The render is partially surviving and the structure seems to be quite robust. The upper tier is partially overgrown with grass (Plate 6).

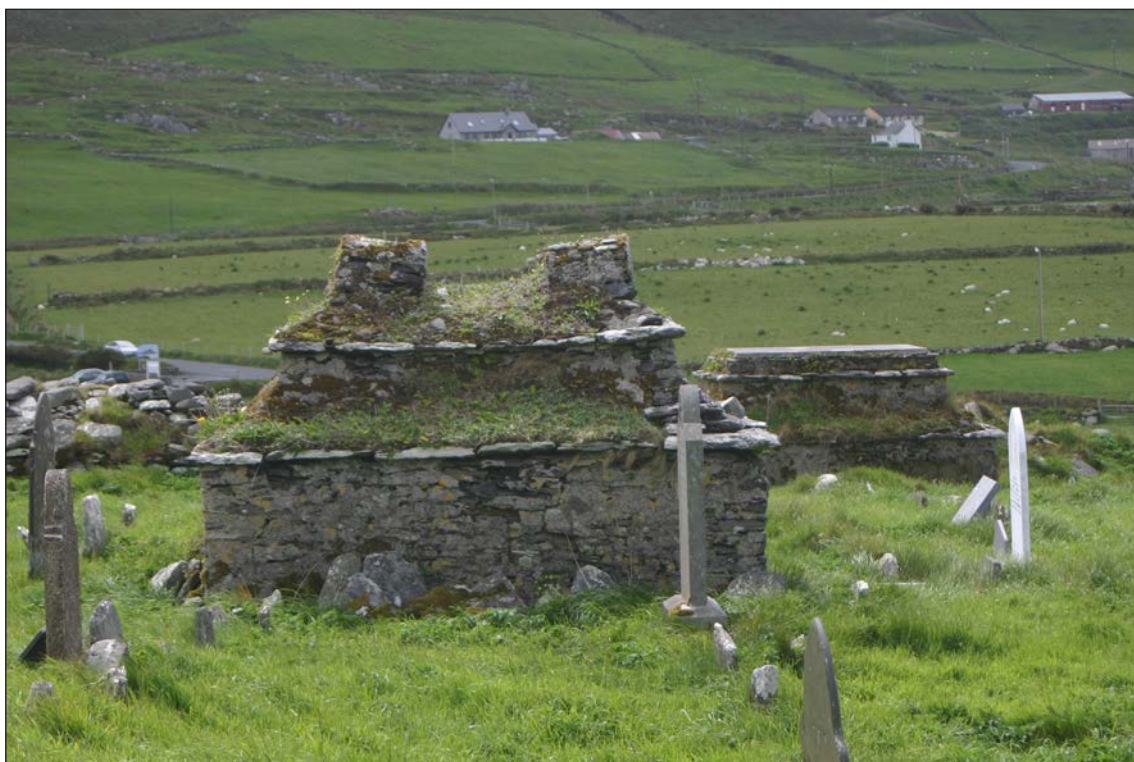
Plate 8: View of collapsing upper tier of unnamed tomb (ref. no. 300) taken from north

Tomb ref. no. 300 is in a dilapidated state and is heavily overgrown by grass on its upper tiers. The stones on the upper tiers are also loose in places and may be in danger of slipping. The uppermost tier is inwardly inclined and needs to be repaired and reinforced to prevent it collapsing (Plate 8).

The upper tier of tomb ref. no. 300 is inwardly inclined and needs to be supported to prevent

its total collapse.

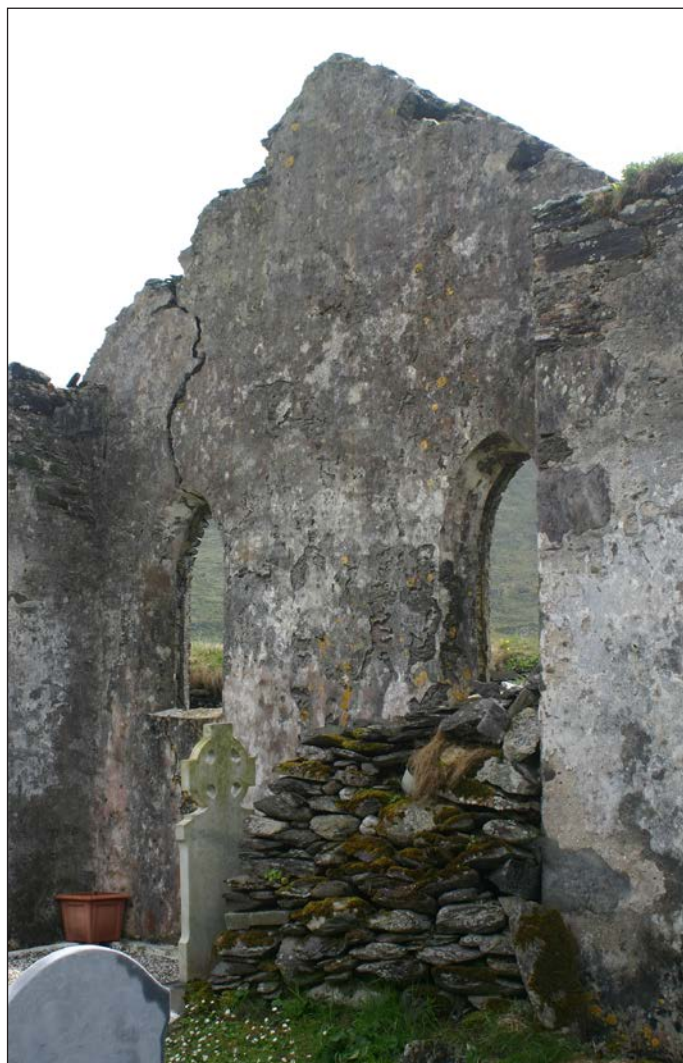
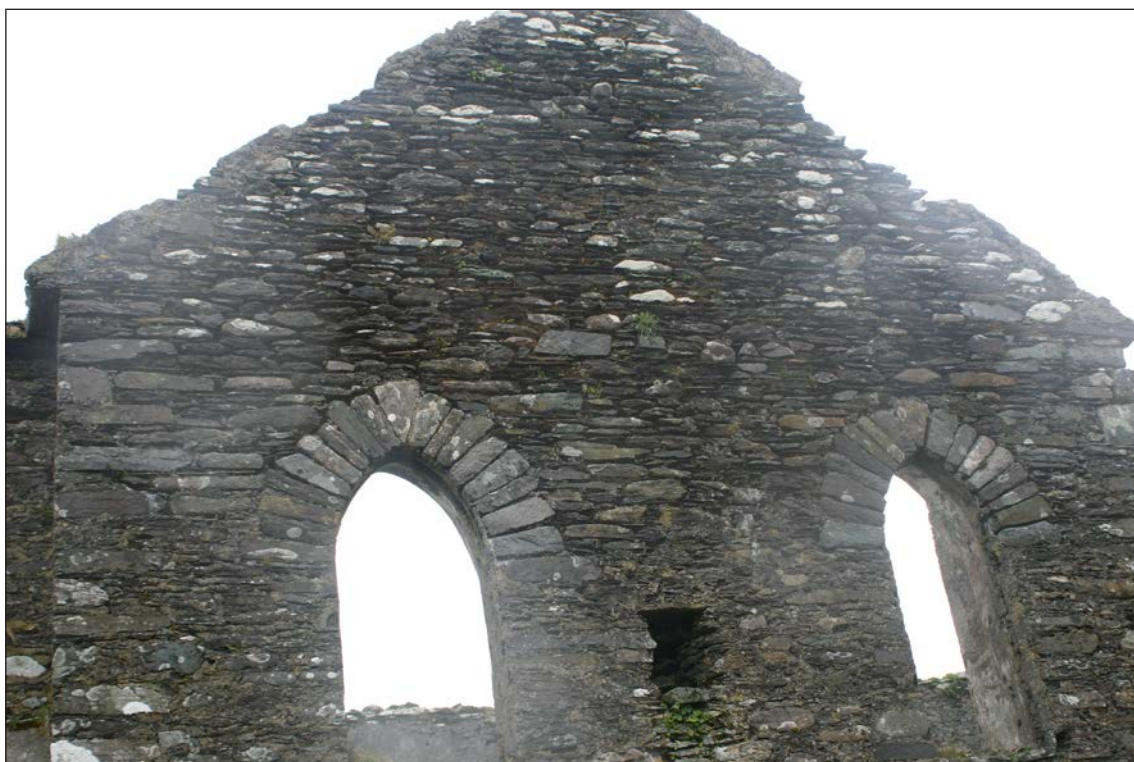
Plate 19: View of southern wall of 19th century church. Note large vertical crack extending upwards from easternmost window ope

The southwestern corner of the wall is in poor condition with a vertical crack extending from present ground surface for the full height of the wall.

Another vertical crack can be seen extending from the centre of the pointed window ope for the remainder of the wall height.

A structural survey should be undertaken to determine the exact state and condition of the southern wall, and if the vertical cracks poses a threat to the immediate stability of the wall and windows.

- A structural survey of the 19th century church should be undertaken to determine the exact state and condition of the southern wall and if the vertical cracks poses a threat to the immediate stability of the wall and windows, as well as outlining the impacts it may have on the Medieval church.
