Archaeological Survey,  
Rattoo Graveyard,  
Ballyduff,  
Co. Kerry.

March 2012

Client: The Heritage Office,  
Kerry County Council,  
County Buildings,  
Ratass,  
Tralee,  
Co. Kerry.

RMP No.: KE009-056

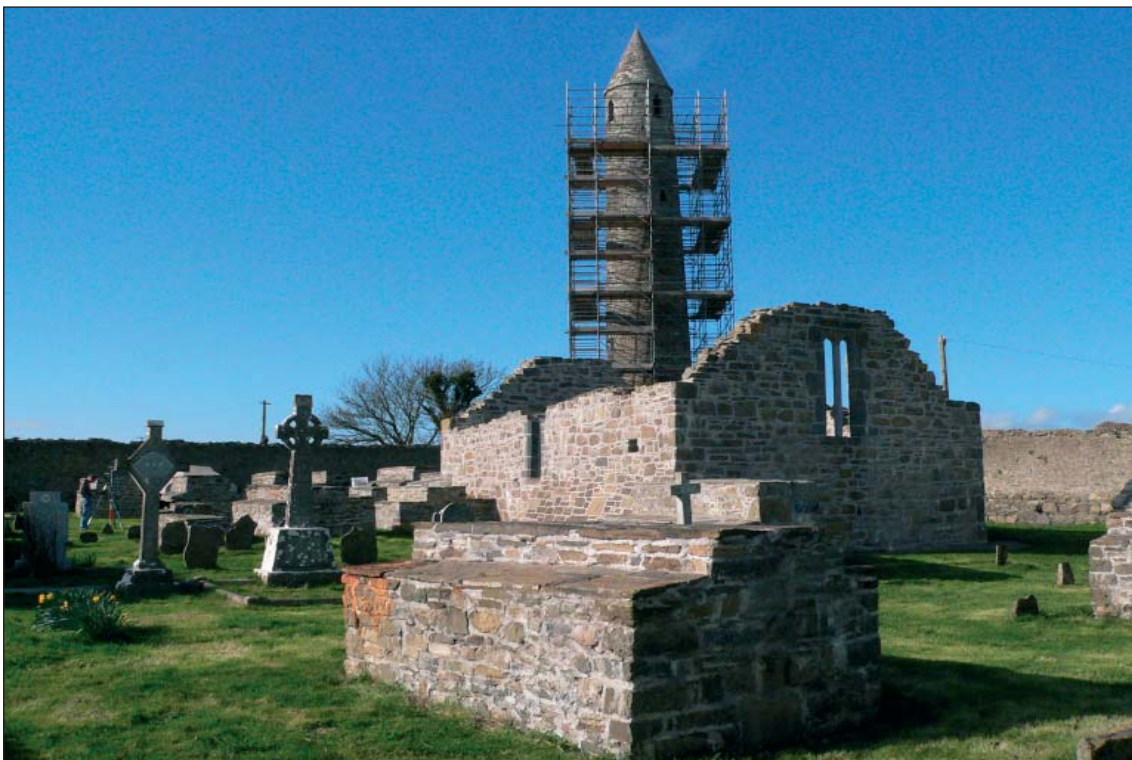
Rattoo parish church and graveyard are an integral part of a wider monastic and developed ecclesiastical complex that dates from the early medieval period that is best exemplified monumentally by the presence of one of the finest Round Towers in Ireland (Plate 2).

**Plate 2:** View of Rattoo church, graveyard and round tower from south east.

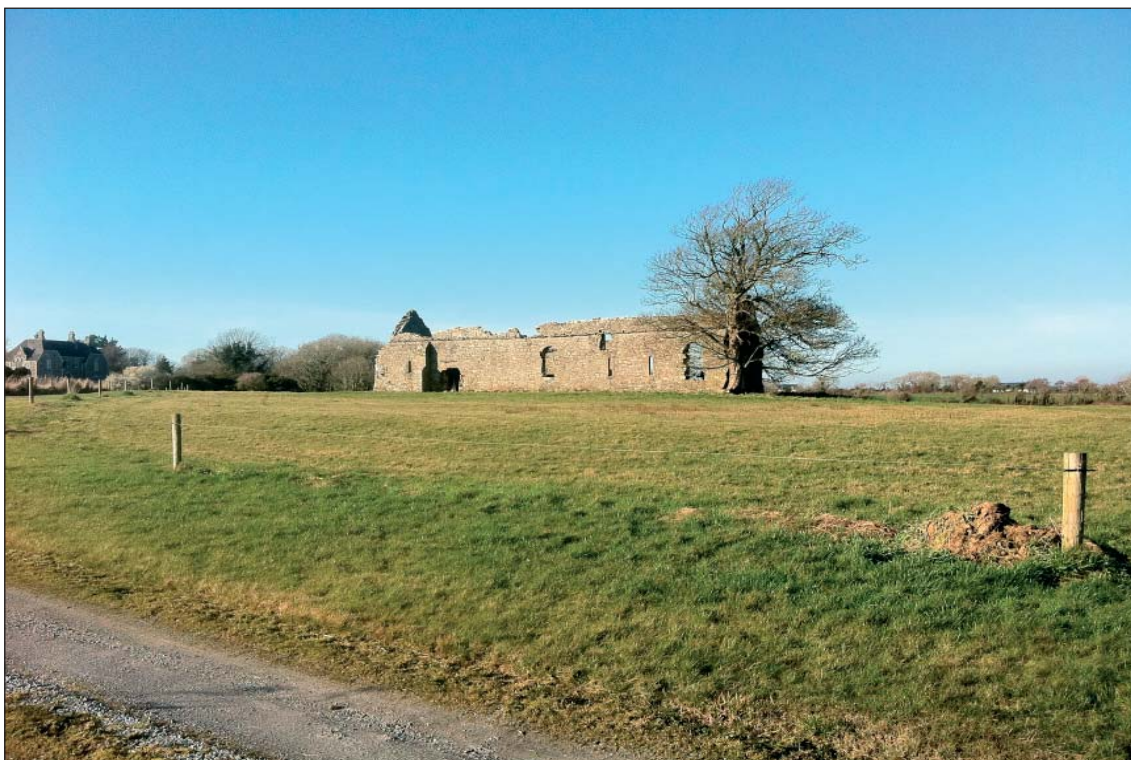
**Plate 3:** View of Arrosian abbey of SS Peter and Paul from south east.

In the adjoining demesne lands of Rattoo House is the site of a Hospital of St. John the Baptist, (*Fratres Cruciferi*), founded in AD1200. It later changed to the rule of the canons regular of St. Augustine of Arroaise and dedicated to SS. Peter & Paul (Plates 1 & 3 & Bradley 1984, 87; Tarrant & O'Connell 1990, 145).

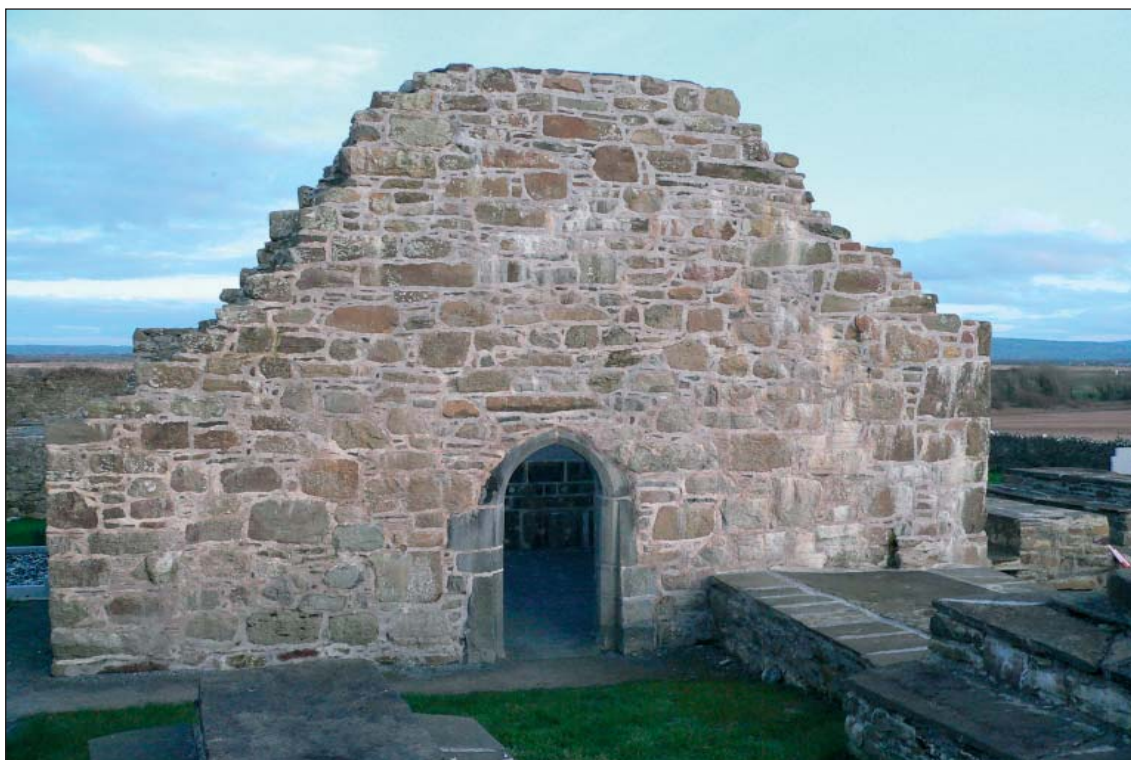
**Plate 4:** View of exterior west gable of Rattoo parish church.

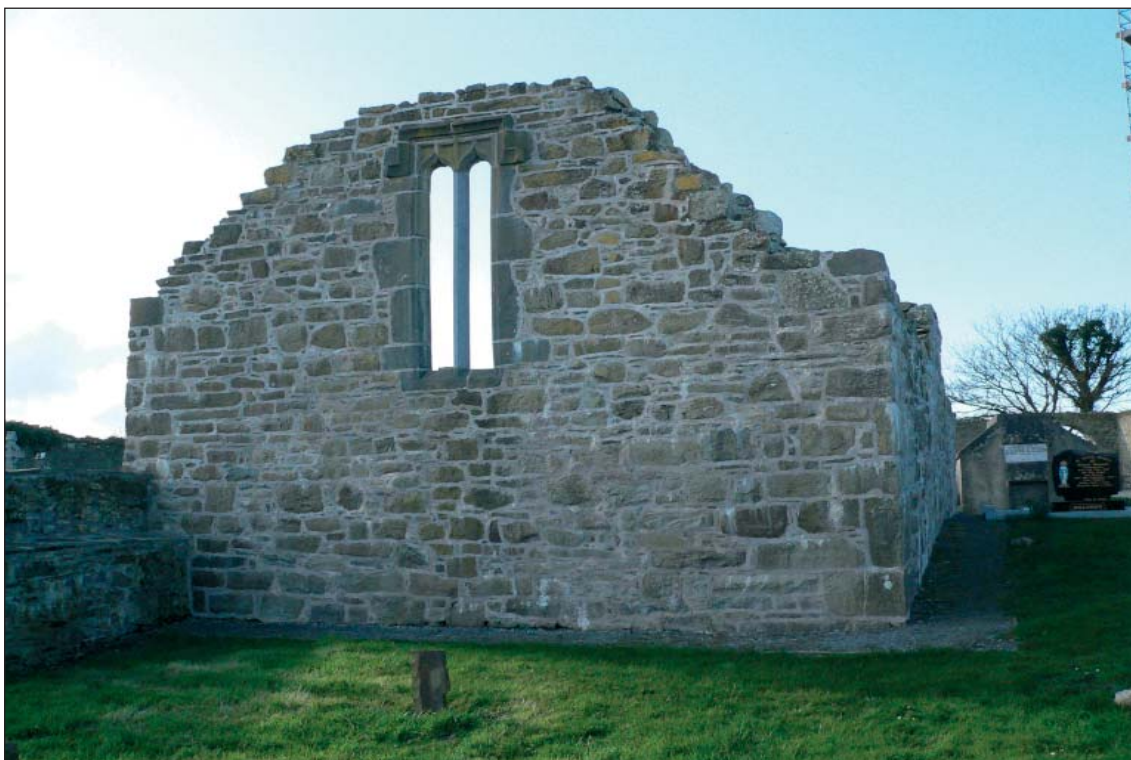
A new central mullion has been inserted in the 15th century twin light, ogee headed east window, (Plate 5 & 9).

**Plate 5:** View of exterior east gable of Rattoo parish church.

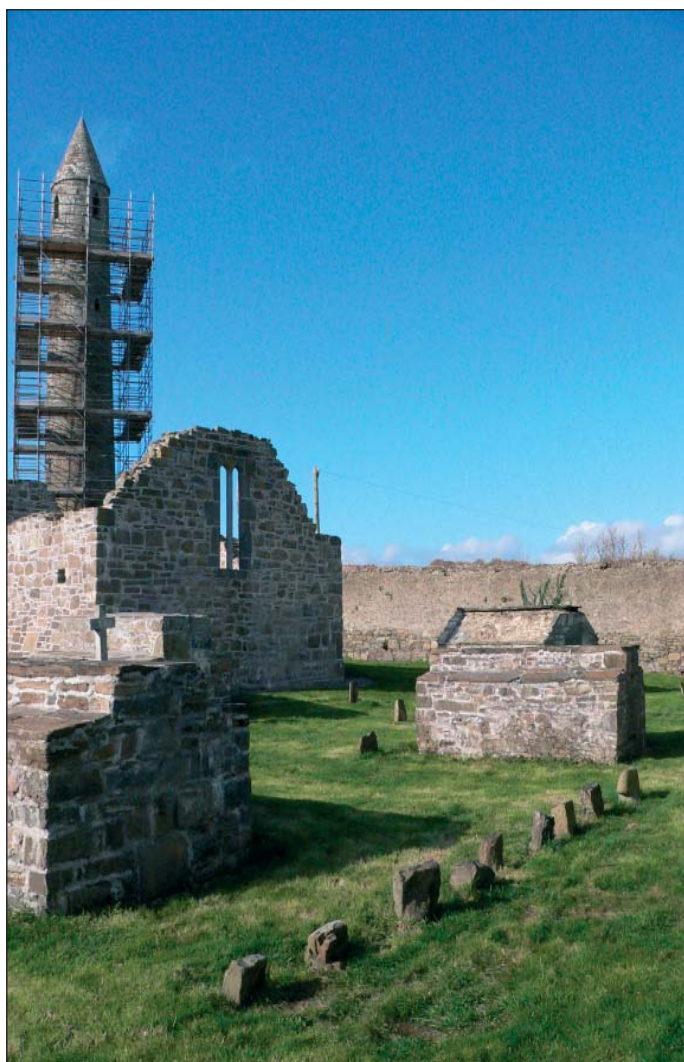
There were forty-five, (45), unnamed headstones (HWN) in total recorded in the course of this survey. The majority of the unnamed graves mainly comprise unhewn stones (Plate 6). The unnamed headstones are denoted on the plan of the graveyard as blue triangles (Figure 2). It is evident from the spatial patterning of the unnamed headstones across the graveyard that they in effect reflect an informal grave-setting in that the ground around them is usually just grass, most likely indicating that the memory of the interred person is lost.

**Plate 6:** View from south east corner of Rattoo graveyard. Note row of uninscribed gravemarkers in foreground.

The unnamed headstones and their associated informal grass covered graves should be retained and protected without further intrusion from nearby formalised grave settings. No burials should take place in these informal burial areas unless proof of ownership can be established.

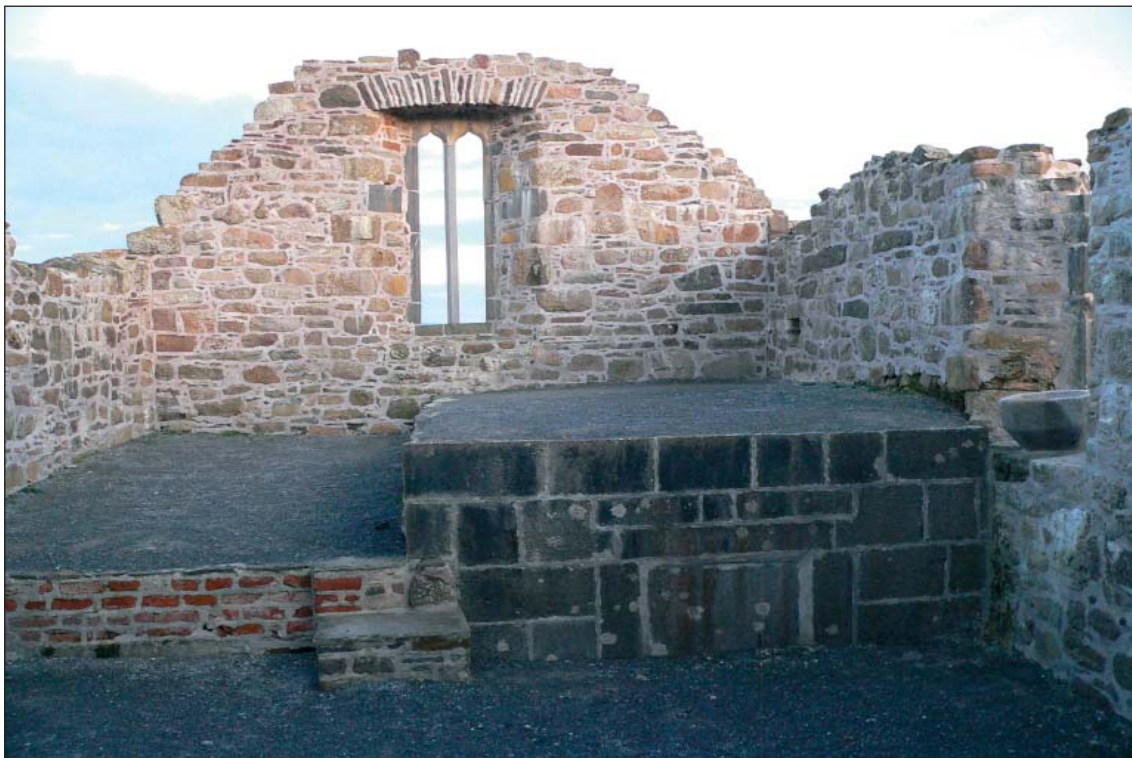
The rectangular parish church is small, 10.2m x 5.5m internally and constructed with uncoursed rubble masonry of local sandstone bedded in lime mortar. Up to 2007 the church was in poor order with the west gable propped as there was a concern that it could collapse. The east end of the interior church is raised up by two large tombs, (Plate 7).

A broken octagonal font found during the conservations works has also been repaired and positioned in the embrasure of the south window (Plates 7 & 8 x & Figure 2).

**Plate 7:** View of interior eastern limits of Rattoo parish church. Note large tombs occupying the complete area. Further note refurbished font on south window.

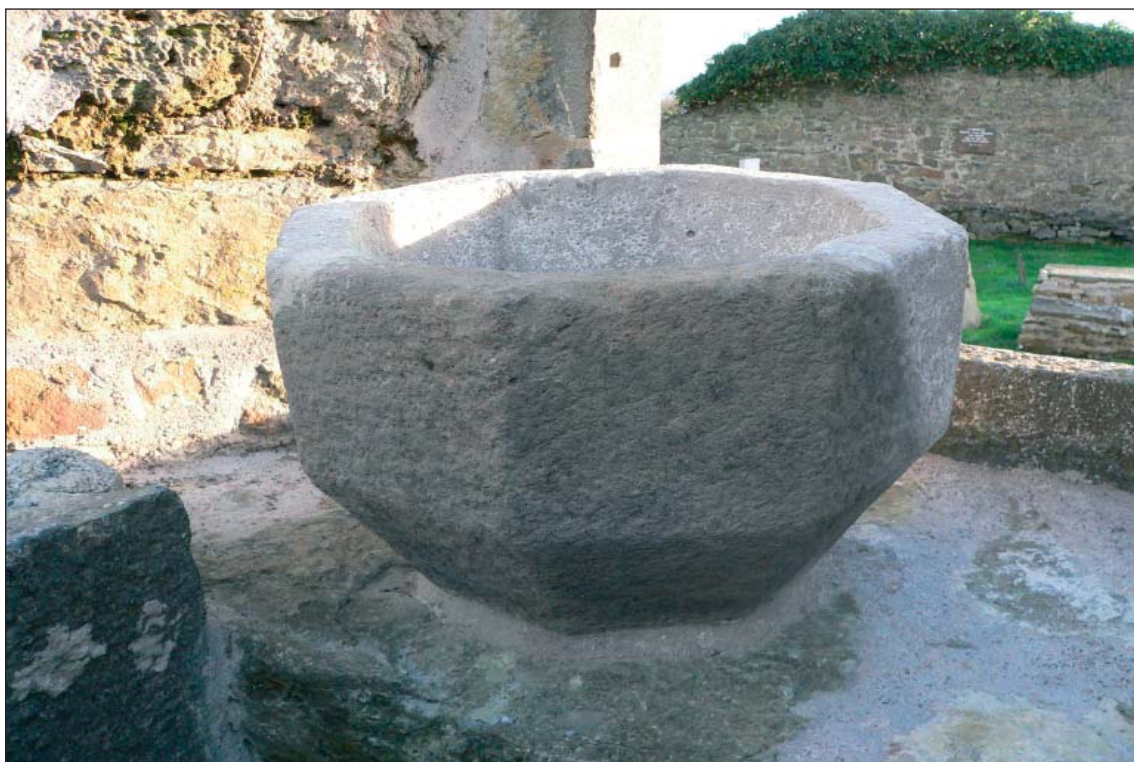
**Plate 8:** Close up image of refurbished octagonal font on sill of south window.

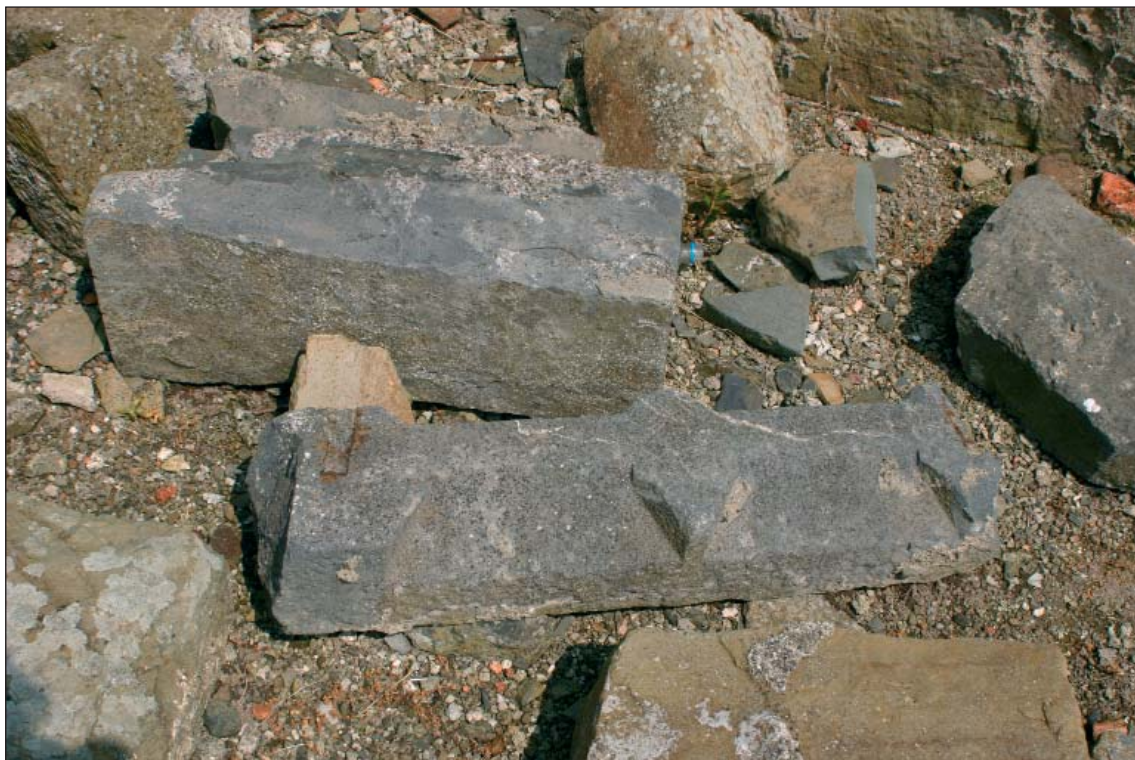
In 2007 the writer noted a number of architectural fragments strewn about the interior, including the limestone sill of a twin light window. The S window lacks its sillstone and it is likely that the ex situ sill was originally from here. A couple of limestone gutter stones were also noted as well as a fine sandstone fragment with roll moulding that lay beside the exterior of the church in the grass (Plates 10-12). The current habitat of the architectural fragments noted by the writer in 2007 are unknown but were most likely taken into the possession of the OPW.

**Plate 10:** Image of group of achitectural fragments including possible 15th Century limestone sill of twin light window recorded in interior of Rattoo church in 2007 by the writer.

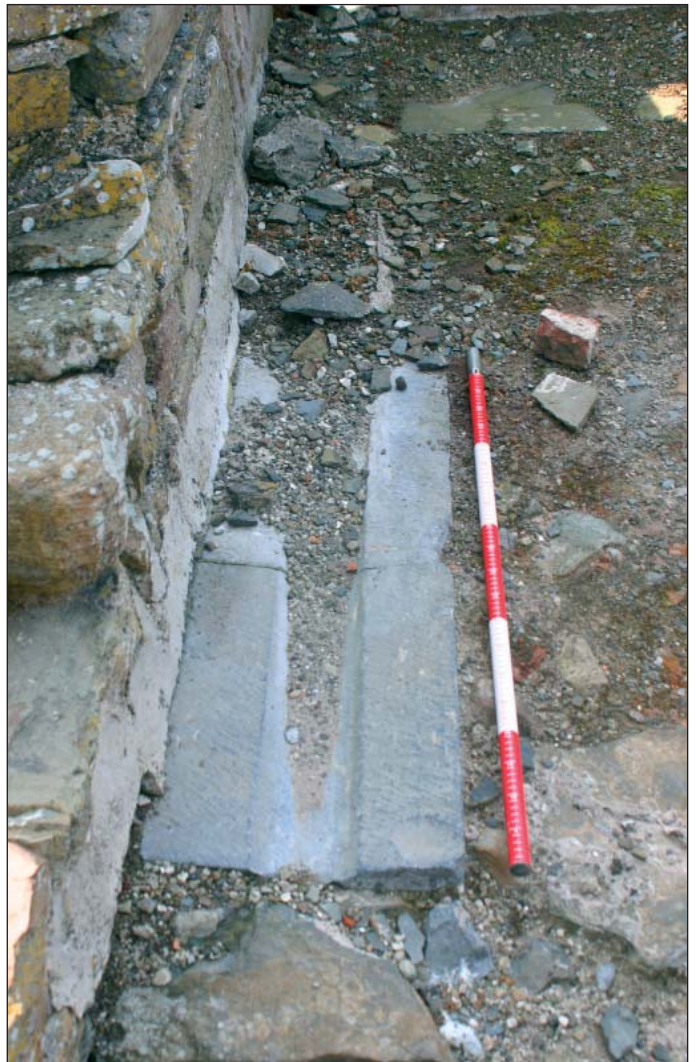
**Plate 12:** Image of sandstone architectural fragment with roll moulding recorded by writer outside Rattoo church in 2007.

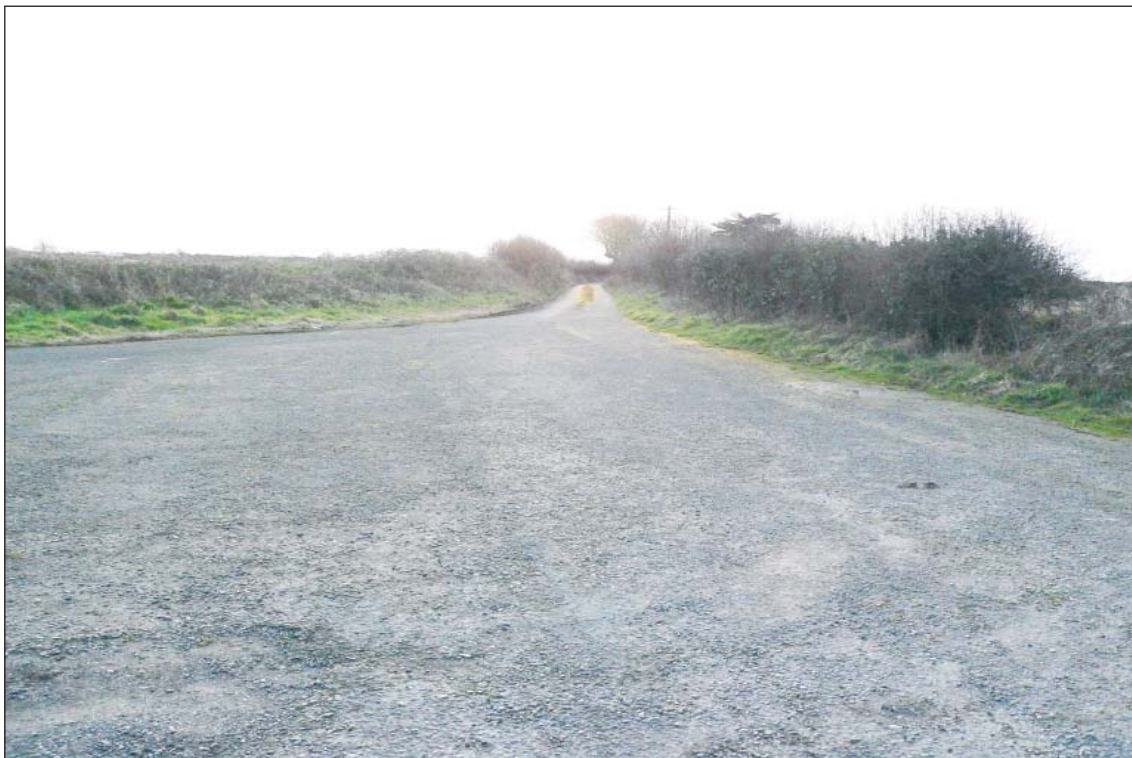
**Plate 13:** View from east of carpark and approach road to Rattoo round tower, church and graveyard.

Rattoo is approached from a third class road exit from the R551. There is a wide ample carpark provided (Plate 13 & Figure 2).

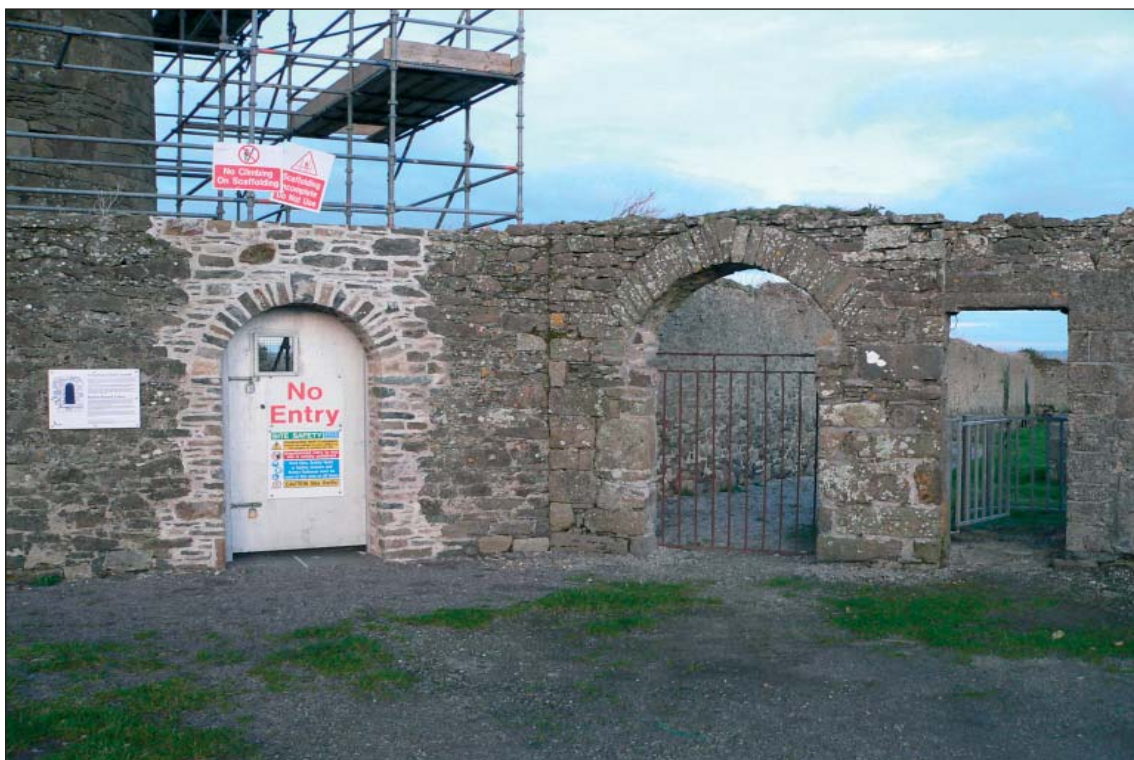
Entrance into graveyard is through an iron gate in poor neglected state. The gate is set beneath a fine stone arch. Beside the gate is a modern galvanised swing-stile in good order. A new entrance to access the Round Tower has also been recently constructed by the OPW (Plate 14).

**Plate 14:** Exterior view of entrance into Rattoo church and graveyard. Note newly constructed entrance into round tower area.

The iron gate should be cleaned conserved and repainted.

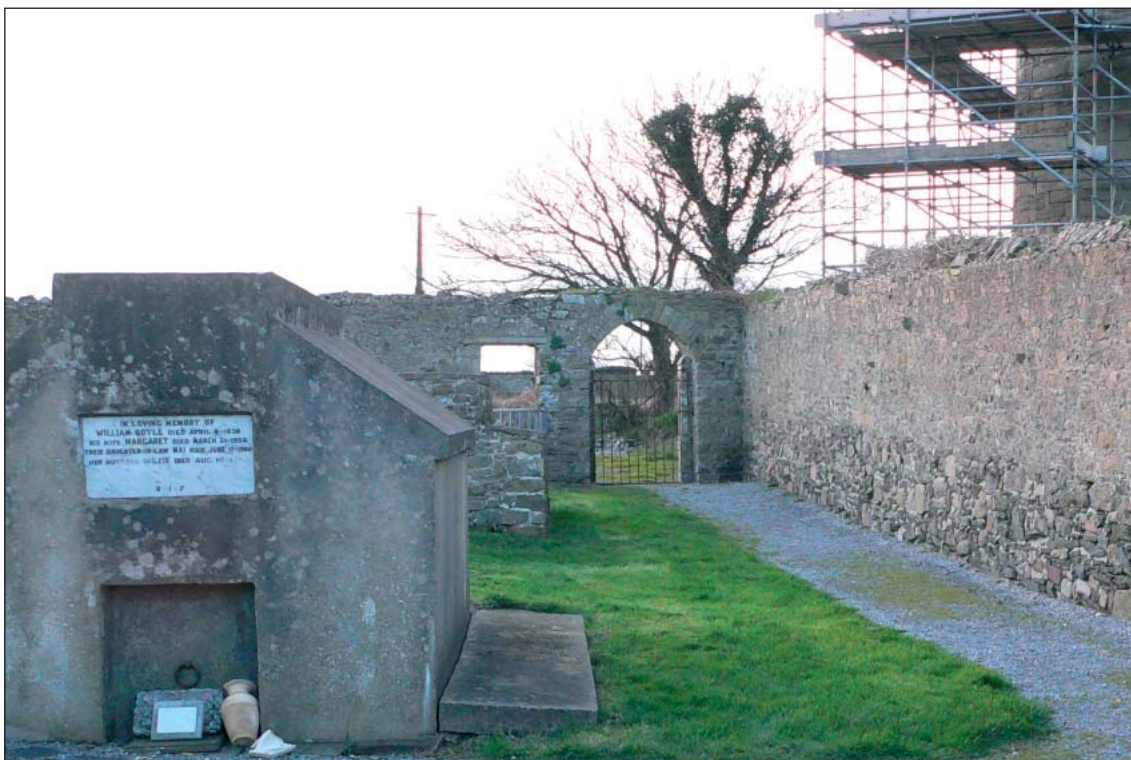
The graveyard and church are enclosed by a high uncoursed rubble stone wall along its W, N and E as well as *circa* 50% of its S boundary where the height of the wall achieves a maximum height of 1.4m. Apart from some ivy on the high section of the S boundary, the walls have, little or no growth or breaches and are in good order, (Plates 15 & 16).

There is a short formal well maintained gravelled path extending E from the entrance along the interior of the N boundary. The path then makes a 90° turn to the S to link with the parish church where it extends around its N, W and part of the S limits of the structure, (Figure 2 & Plates 15).

**Plate 15:** View from east of north west area of graveyard. Note entrance, high boundary wall and gravel path.

The ivy should be kept in check otherwise no further recommendations necessary.

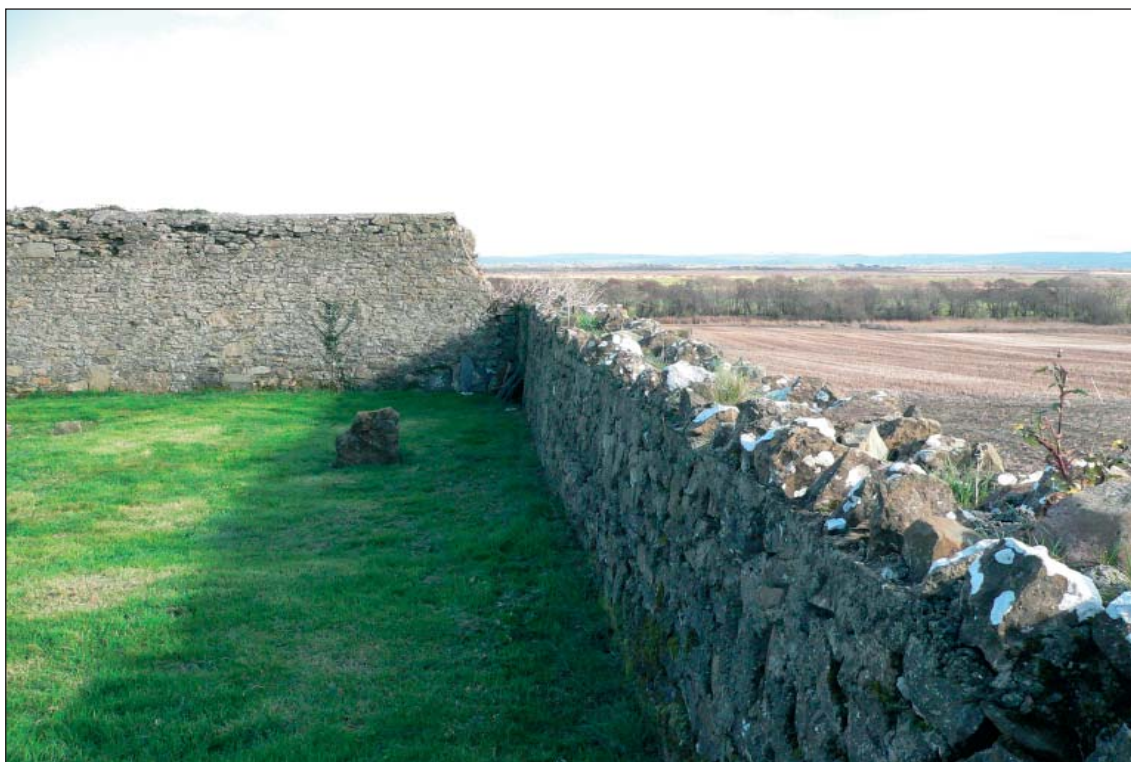
**Plate 16:** View of south east corner of Rattoo graveyard. Note lower boundary wall.

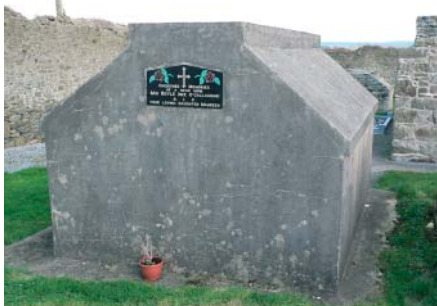
<b>Surname:</b>	Boyle
<b>Tomb No:</b>	13
<b>Photo No:</b>	163-0333 0334 0335

Collapsed ☐ N Open ☐ N Rendered ☒ Y Overgrown ☐ N

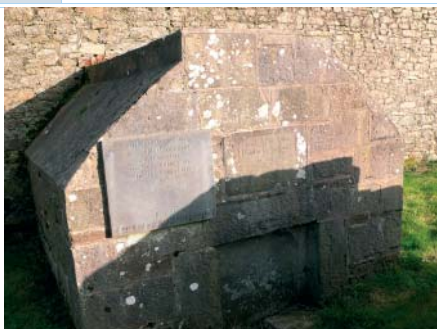
<b>Surname:</b>	Lawlor & Cregan
<b>Tomb No:</b>	28
<b>Photo No:</b>	163-0363 0364

Collapsed ☐ N Open ☐ N Rendered ☒ Y Overgrown ☐ N

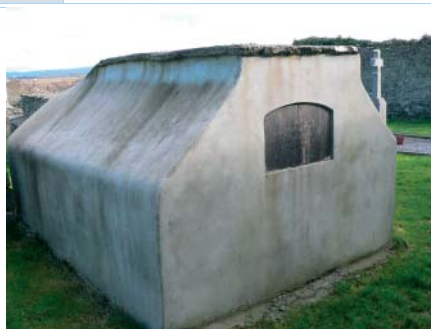
<b>Surname:</b>	Leehy
<b>Tomb No:</b>	7
<b>Photo No:</b>	163-0323 0324

Collapsed ☐ N Open ☐ N Rendered ☒ Y Overgrown ☐ N
