## Archaeological Survey, Srugreana Church and Graveyard, Glebe, Caherciveen, Co. Kerry.

August 2012

The Heritage Office, Kerry County Council, County Buildings, Ratass, Tralee, Co. Kerry.

KE080-016

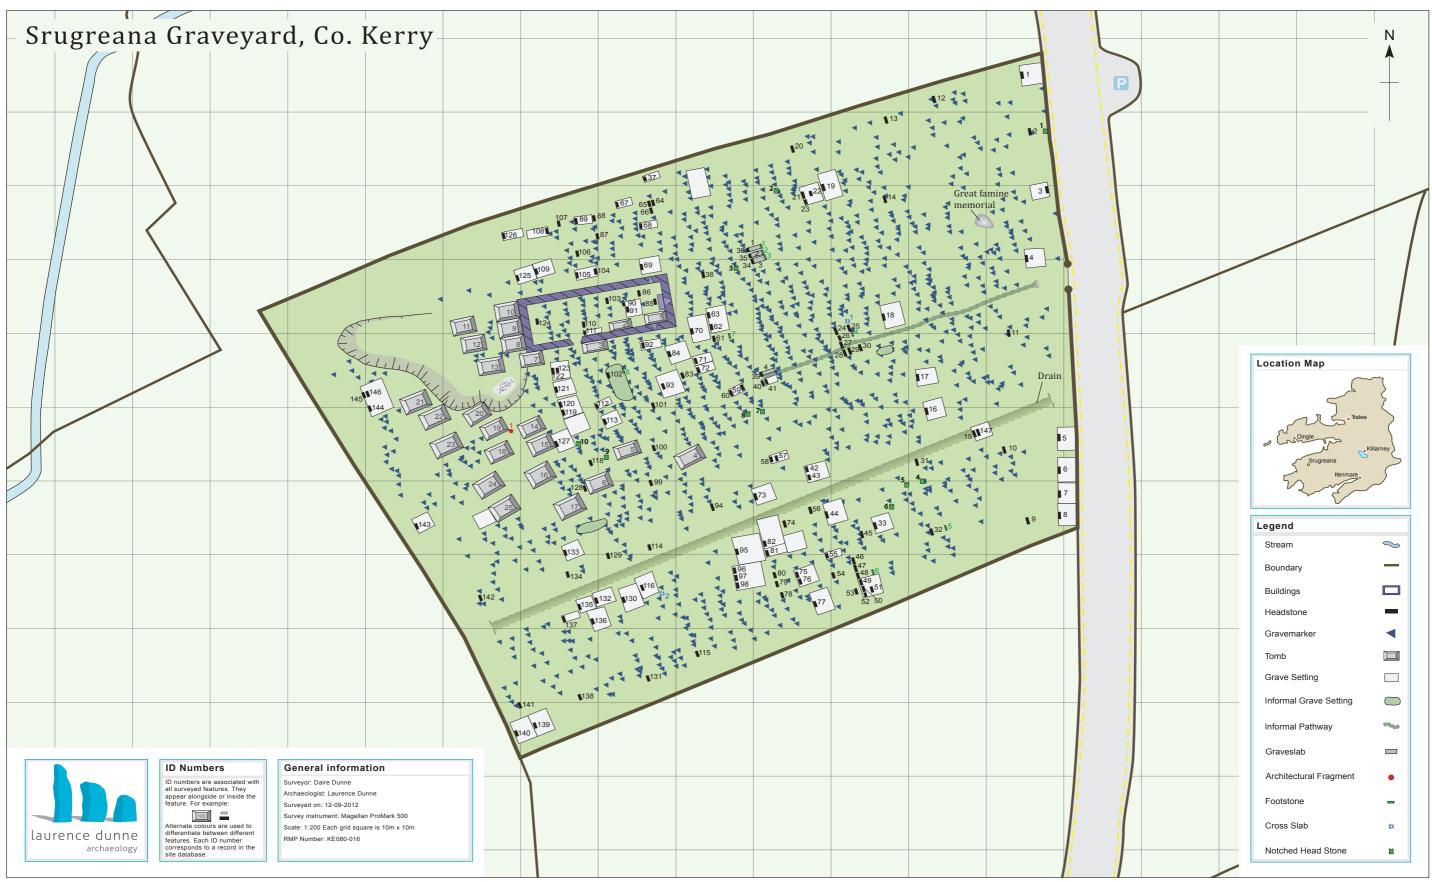
Figure 2: Archaeological survey plan of Srugreana church and graveyard.

Major outcropping of bedrock occurs immediately W of the church against which several tombs have been erected (Figure 2 & Plate 5). Unusually there is a wide open drain that bisects the S limits of the graveyard in an E-W direction and more or less on top of which some modern interments have taken place (Figure 2 & Plate 6). The bumpy undulating interior of Srugreana graveyard appears on first sight as generally open and uncluttered however, the grassy cover masks over 1200 unhewn, uninscribed unknown gravemarkers that are dispersed throughout the site (Figure 2 & Plate 1).

There are twenty five (25) tombs in Srugreana graveyard (Figure 2, Appendix 1 & Plates 2, 4-5 & 10-12). Only three of these tombs have names (16, 17, 25) while the rest are unknown. All the tombs in Srugreana are of the house shaped type and are constructed with local split rubble sandstone. The vast majority have lost their outer render and all bar 3 require differing levels of repair and restoration (Plate 13). Interestingly, none have totally collapsed due in no small measure to the degree of local drystone skills and indeed the use of small split stones. However, there is a large amount of careful work required to maintain these interesting tombs.

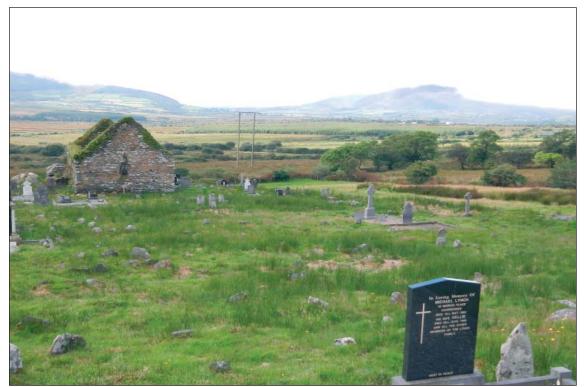
Srugreana graveyard is open, windswept and more or less devoid of trees although the odd holly tree thrives here and there. The ground is uneven with much of the ground now rushy and wet (Plate 1). There are no pathways in Srugreana.

The graveyard in closed along its E boundary by a robust rubble stone wall with 'soldier' capping (Plate 8). It is in general good repair with some grass established in the capping. Otherwise the S & W boundaries comprise regular stone field walls. The N boundary acts as a revetment to the graveyard as it is flush with the graveyard level on the interior which is *circa* 1.6m higher than the exterior ground (Plate 1).

Plate 1: View of Killinane Church and graveyard from E

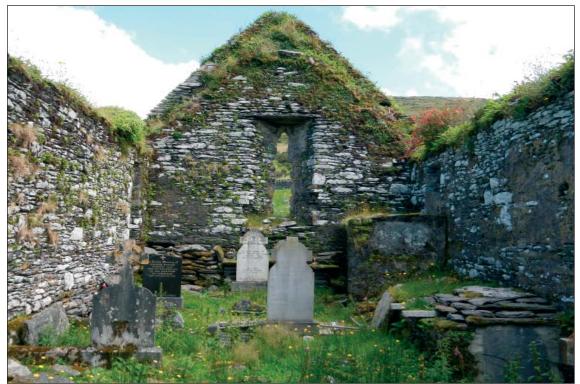
Plate 4: View of E limits of interior of Killinane Church. Note fuchsia establishing itself on the S elevation over Tomb 1

The grass and other vegetation, especially the fuchsia, should be carefully removed or severely cut back from the church. The fuchsia once established can cause serious damage to the structural integrity of the church as it develops very robust root systems.

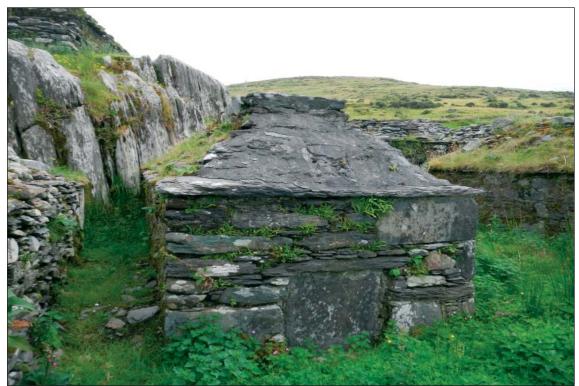
Plate 5: View from W of tomb 22 beside natural bedrock outcrop to W of church

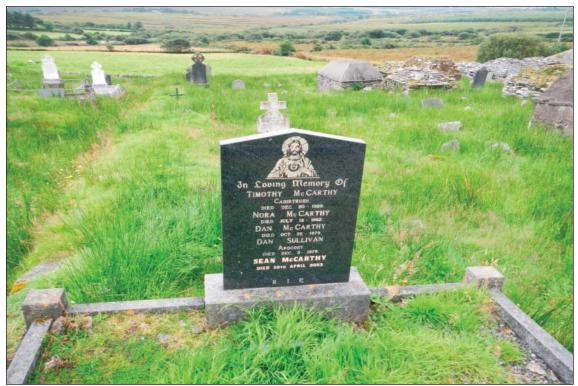
Plate 6: View from E of McCarthy headstone no. 73 & grave-plot immediately beside deep open drain on left

The drain should be made safe and no burials within it.

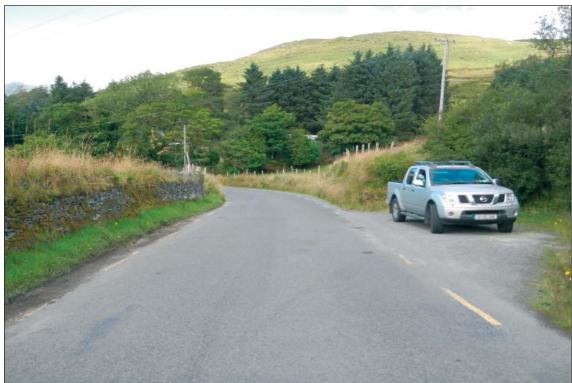
Srugreana is approached along a 3rd class road from an E exit off the N70 a little outside the E limits of Caherciveen (Figure 1). The immediate approach to Srugreana graveyard from the Caherciveen side is uphill around a sweeping bend while limited carparking is accessible on the hard-shoulder. From the opposite direction there is a fast downhill sweeping approach (Figure 2 & Plates 7-8).

Plate 7: View from S of sweeping approach and available parking at Srugreana graveyard

Advance warning signs should be put in place along both approaches to the graveyard.

The carparking should be expanded and improved.

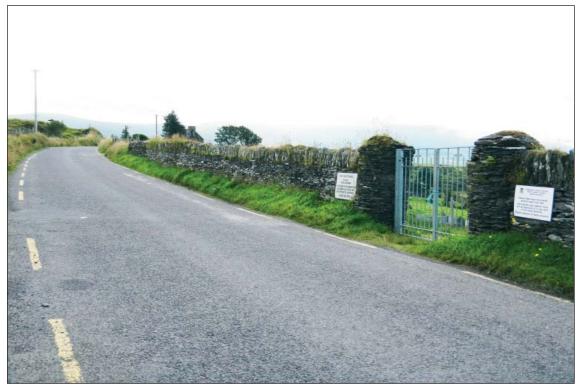
Plate 8: View from N of sweeping downhill approach to Srugreana graveyard

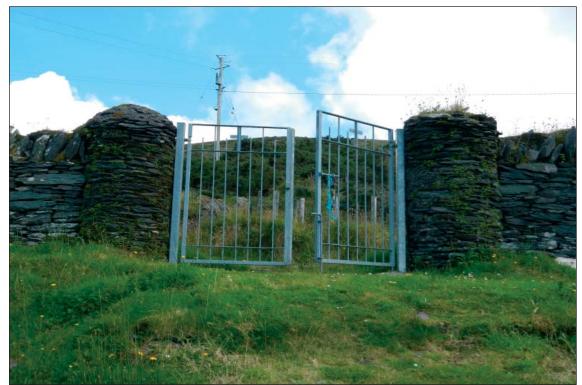
The modern galvanised twin gated entrance is set between two round robust piers of local split rubble sandstone mid way along the E boundary wall (Figure 2 & Plates 8-9). The ground in the immediate interior of the entrance falls away sharply on open bumpy grassy ground. Two irregular and partially concealed steps lead down to an informal grassy path the runs directly W to terminate at the centre of the graveyard (Figure 2). Otherwise there are no other paths, formal or informal.

**Plate 9:** View from W of interior of modern entrance gates to Srugreana graveyard. Note sharp, slippery grassy slope and no pathway

The immediate interior of entrance area should be levelled and expanded and a formal gravelled sloping safe pathway constructed to access the interior. The N boundary should be increased in height for H & S considerations.

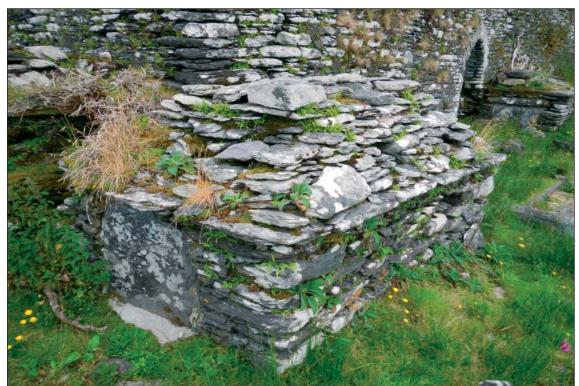
Plate 11: View from SW of Tomb 7 abutting SW corner of Killinane Church

There is an amount of specialist work required to preserve, repair and restore the tombs at Srugreana. Important targeted repairs are required of some to close them off (Tomb 7, Plate 13). As these old tombs are built of local split red sandstone it will be necessary to repair them with similar material and seal open tombs with sandstone or slate flags. Grass and moss covering some of the tombs should only be fully removed as the primary element of an agreed inclusive strategy of repairs and other conservation and restoration works. This work should be undertaken with expert archaeological advice and guidance.

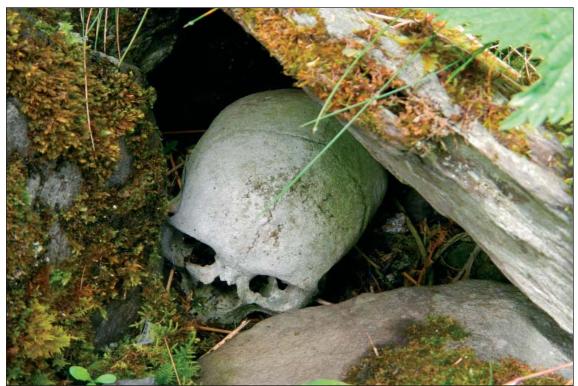
Plate 13: Close up view of exposed human skull in Tomb 7

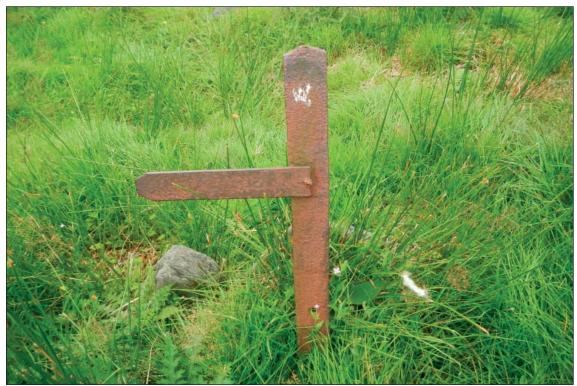
Plate 15: View from E of locally made broken wrought iron cross no. 12

The wrought iron crosses should be professionally conserved, cleaned and painted Local information should be accessed to establish the unknown and illegible names. The grass should be kept low.

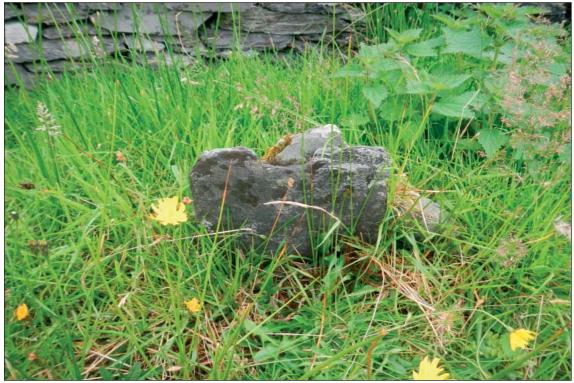
Plate17: View of notched gravemarker no.1

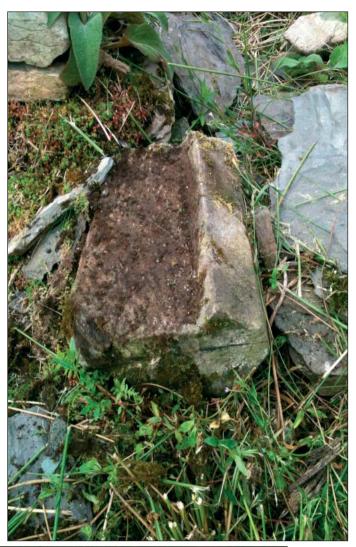
Only one architectural fragment (AF1) was recorded in Srugreana (Figure 2, Appendix 6 & Plate 19). This rebated rectangular block is chamfered along one side.

Plate 19: View of architectural fragment AF1 lying loose on ground

This medieval cut stone fragment should be secured or it will be lost. As no adequate location is available in Srugreana the fragment should be removed to the Kerry County Museum.

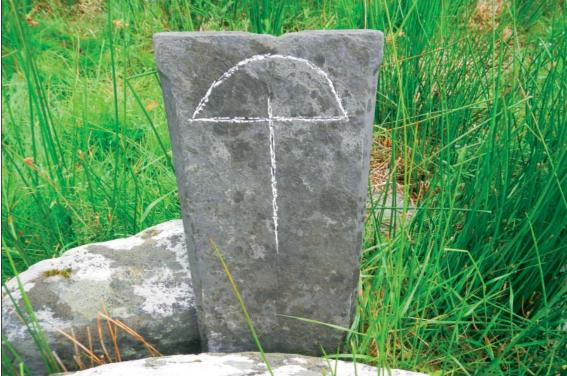
Cross-slab CS1 is a lightly incised Latin cross whose arm tips are connected by a crescential line making the overall motif like a bow-and-arrow. The flat slate stone is also slightly notched at the top centre (Plate 20).

Plate 20: View of cross-slab CS1

The cross-slabs should be archaeologically illustrated and the grass around them kept low.

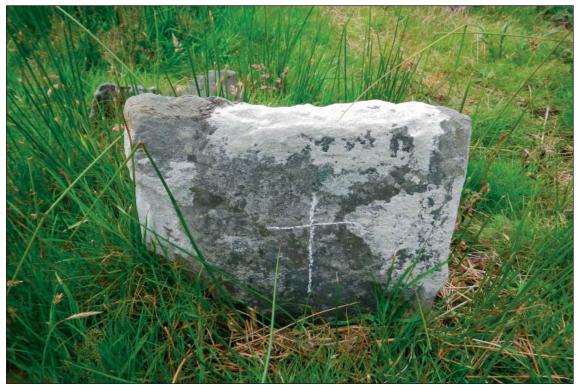
Cross-slab CS2 is a low squarish slab of sandstone with a centrally disposed small lightly incised Latin cross (Plate 21).

Plate 21: View of cross-slab CS2

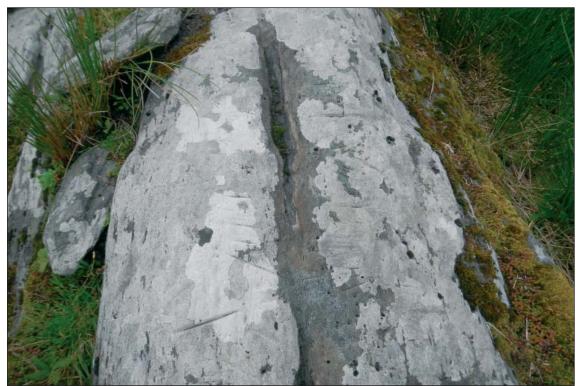
Situated immediately to the SW of the church on exposed bedrock are several blade sharpening marks, grooves and cuts. These marks are possibly consistent with individuals sharpening scythes and sickles to keep the grass low in the past (Figure 2 & Plate 23).

Plate 23: View of sharpening marks on bedrock outcrop to SW of medieval church
