Archaeological Survey,
Stradbally Church and Graveyard,
Ardbeg,
Castlegregory
Co. Kerry.

September 2010

Client: The Heritage Office,
Kerry County Council,
County Buildings,
Ratass,
Tralee,
Co. Kerry.

RMP No.: KE035-018 graveyard

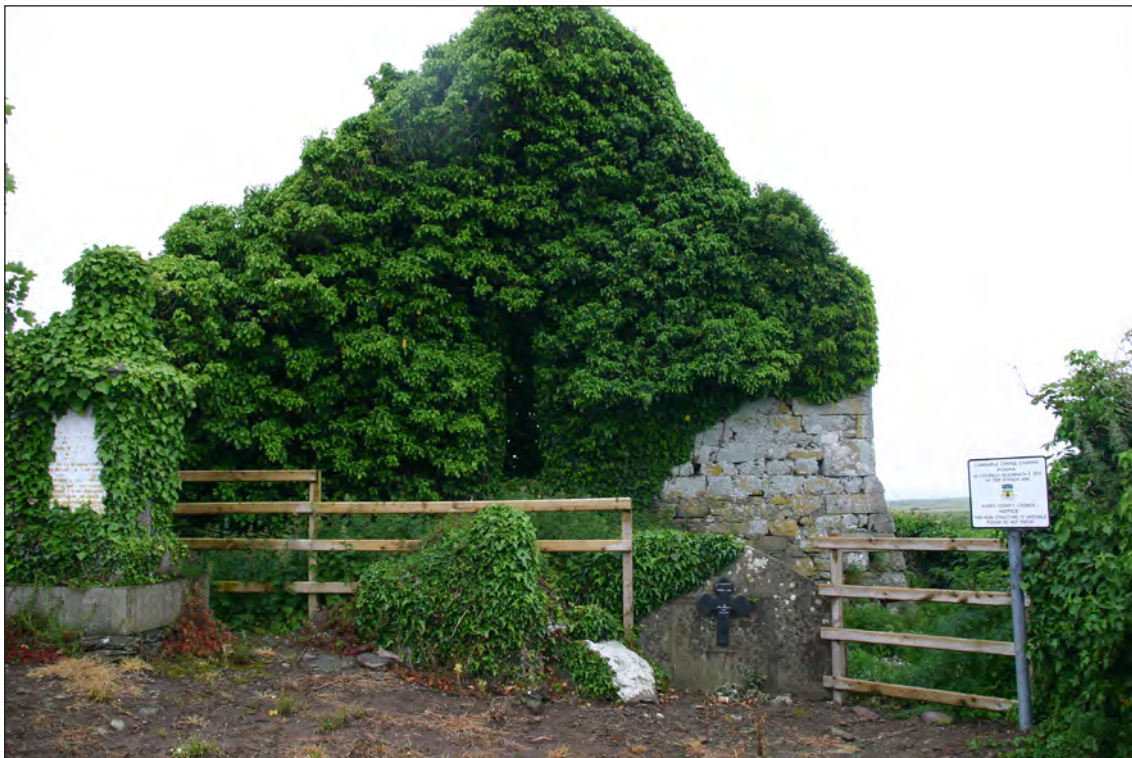
The small graveyard and ruined remains of the church at Stradbally are in a very poor state of repair. Negotiation around the western half of graveyard is achieved with difficulty as there is no formal path. The church ruins are very hazardous underfoot due to collapsed masonry and collapsed and collapsing tombs. For the most part it is largely overgrown while the church is completely hidden under a massive growth of ivy and trees. The church was fully surveyed and published in the Dingle Archaeological Survey... *The present remains, 15.7m x 5.67m internally, are of late 15th/early 16th century date. The walls are built of coursed rubble with ashlar quoins and dressings. The E, N and S walls stand to full height but the W limit of the church is indicated only by protruding bond stones at the SW corner. The lower 1.5m of the external face of the E wall is battered, the batter returning as a weathered buttress at the NE and SE corners. The fragmentary remains of a buttress survive at the SW corner but the NW quoin has fallen. The E gable retains its ashlar coping. It was lit by a two-light cusped ogee-headed window, with splayed ingoings, which now lacks its central mullion...At the E end of the N wall is a single-light, ogee-headed window...Only the chamfered jambs and splayed ingoing of the N door survive...The pointed doorway in the S wall has simple block jambs and a lintelled rear arch...A small stoup projects from the external wall face immediately W of the doorway...At the E end of the south wall is an aumbrey and beside it a piscina...The circular basin is fluted radially and has a central drain* (Cuppage et al 1986, 363-4 & Figure 6). This record of Stradbally church is still particularly relevant today except that much of the church examined then is today totally concealed under dense foliage. The chamfered jambs of the N door have now totally collapsed and lie in a tumble on the ground. Numerous architectural fragments are dispersed around the church including several water spouts, some of which have been re-used in nearby collapsed tombs (see architectural fragments below).

Access into the church is partially cut off from the public by a wooden fence (Plates 5-7).

Plate 5: Close-up view of the east gable of the medieval church of Stradbally. Note immense growth of ivy now spreading to nearby graves and tombs. Further, note temporary wooden fence and warning sign erected by Kerry County Council

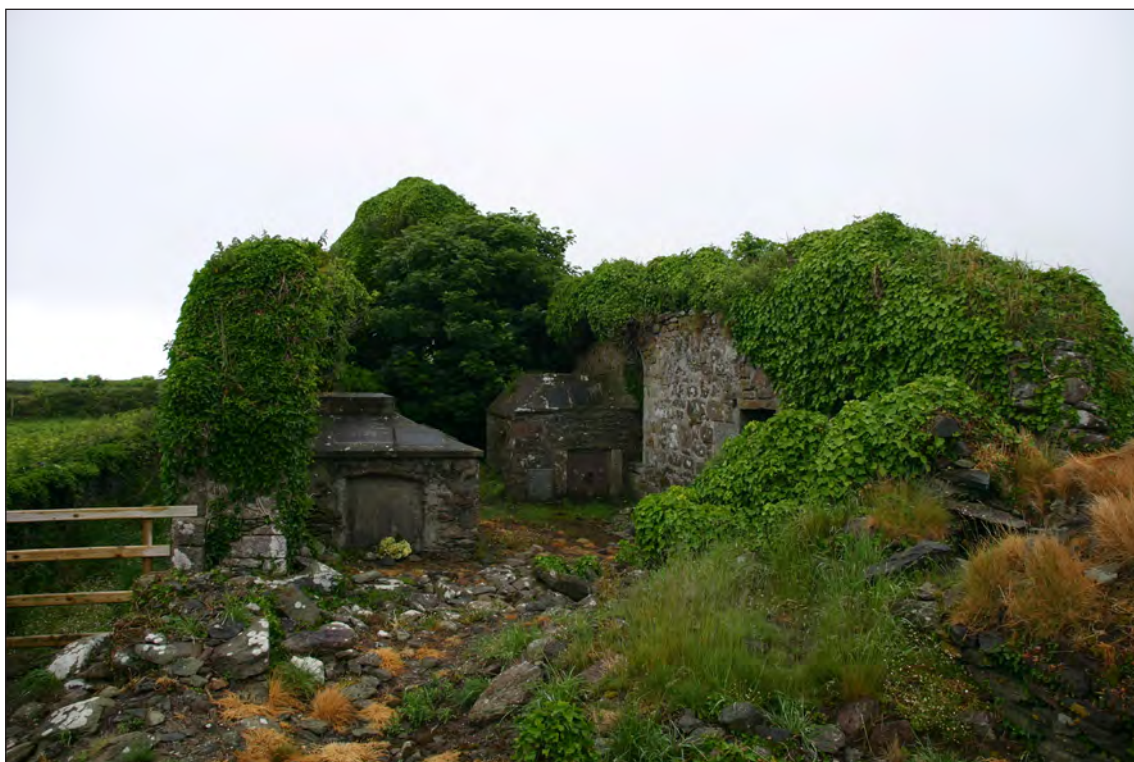
Plate 6: View of interior of collapsed western limits of Stradbally Church. Note tombs at the east end and collapsed toms in foreground

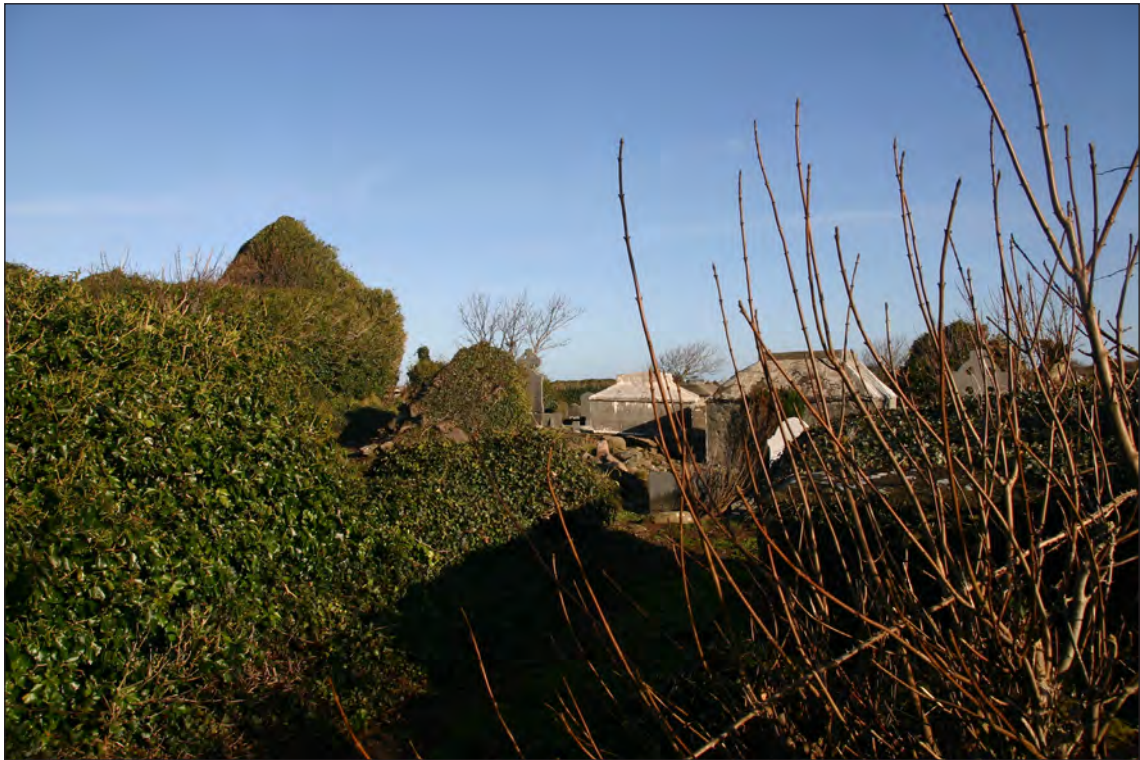
Plate 7: View of overgrown tombs in south-western limits of Stradbally Graveyard

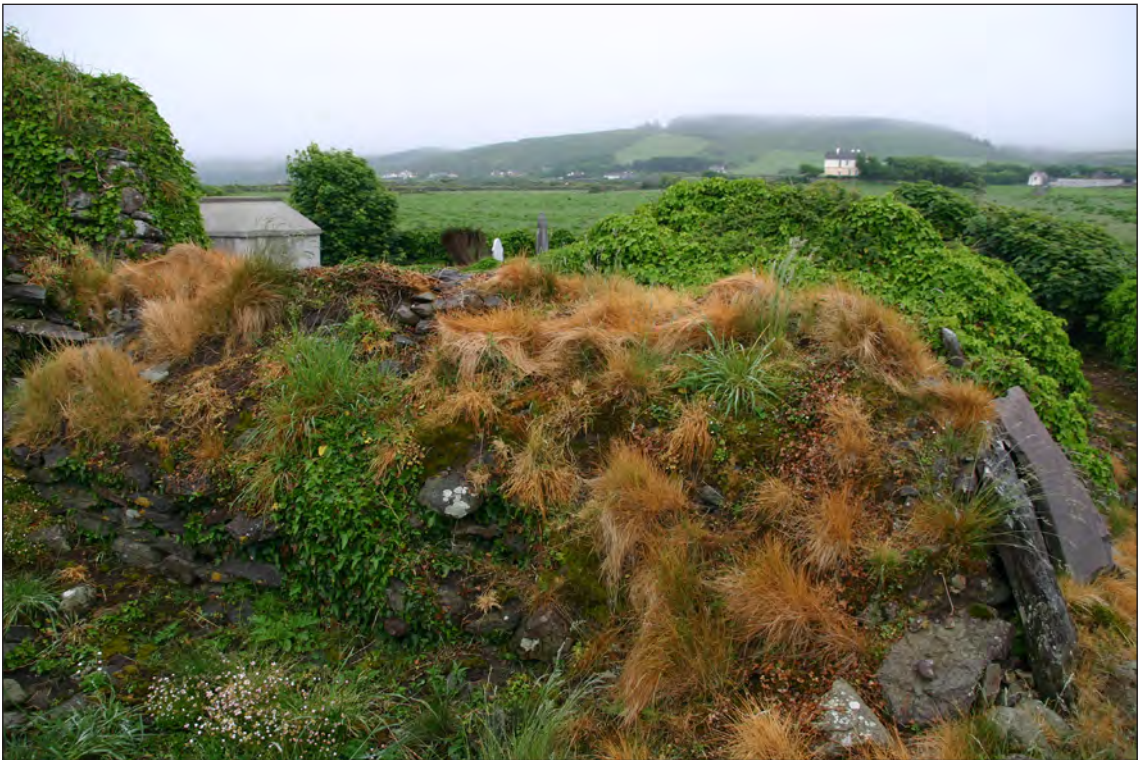
Plate 10: View from north west of completely overgrown unnamed tomb (85) at western end of ruined church. Note dead grass from weed killer use

There is an enormous amount of specialist work required to preserve, repair and restore these unnamed tombs at Stradbally. Some will only require the removal of ivy and possibly re-pointing. However, several will require careful rebuilding and important repairs are required of others to close them off. Indeed there is some question as to some tombs if they are viable at all and that maybe they should or could not be refurbished. As these old tomb are built of local red sandstone it will be necessary to repair them with similar material and seal open tombs with sandstone flags.

Grass and ivy covering some of the tombs should only be fully removed as the primary element of an agreed inclusive strategy of repairs and other conservation and restoration works. Tombs that are fully covered in grass should be cut back for further evaluation to determine the nature and extent of further conservation / restoration works. This work should be undertaken with expert archaeological advice and guidance.

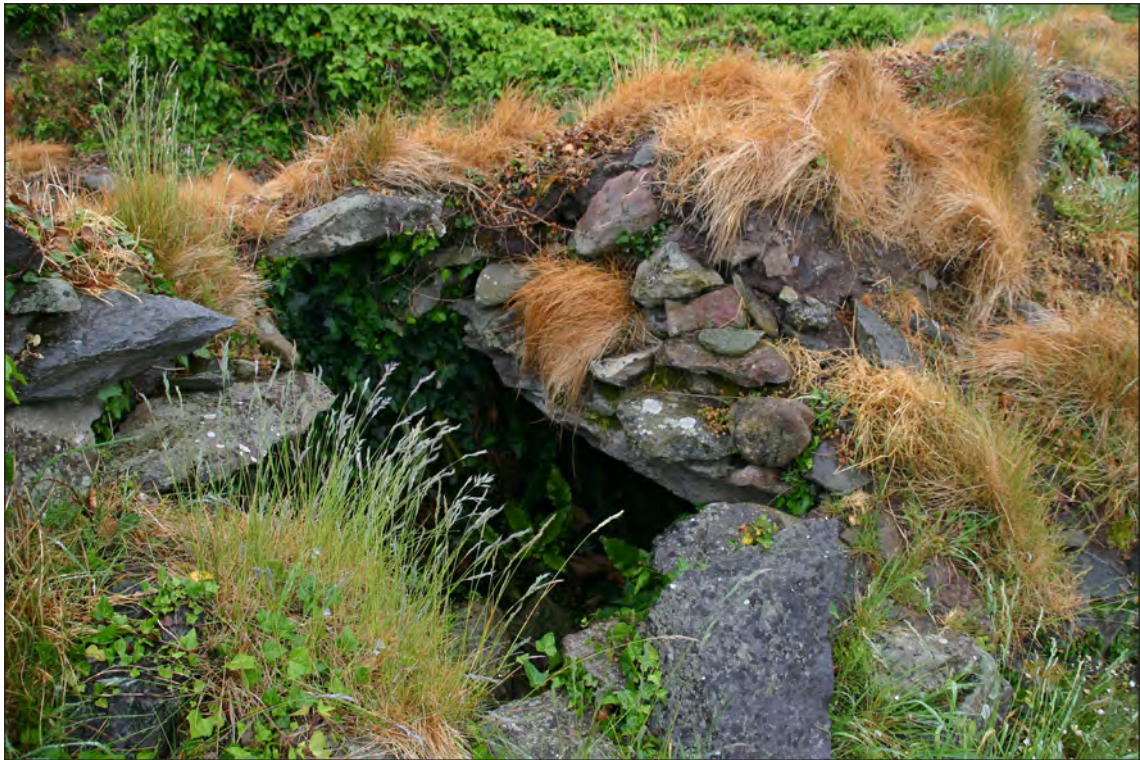
Plate 11: View of collapsed overgrown unnamed tomb (80) at western end of ruined church. Note dead grass from weed killer use

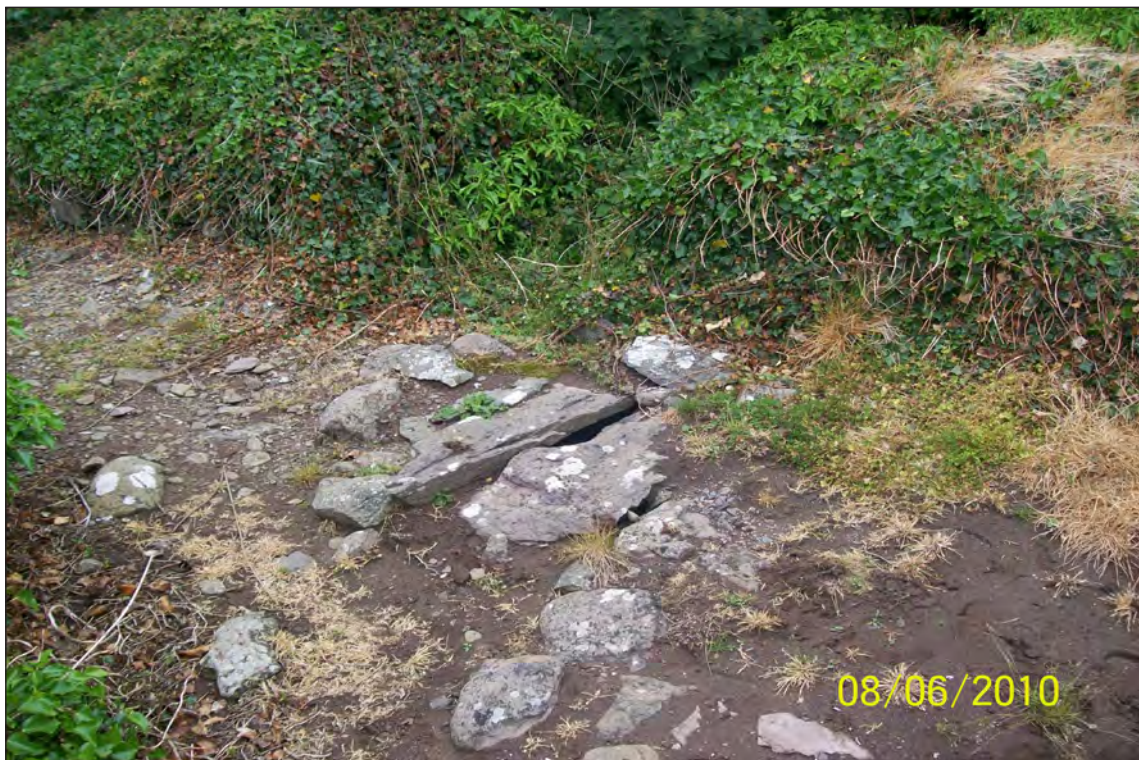
Plate 12: View of exposed lintelled graves to south of church

The exposed lintelled graves should be repaired properly under archaeological expert advice and supervision. The graves should then be covered with earth, re-sodded or re-seeded. The unhewn grave markers should be left *in situ*. This will preserve the graves and make the graveyard easier to negotiate.

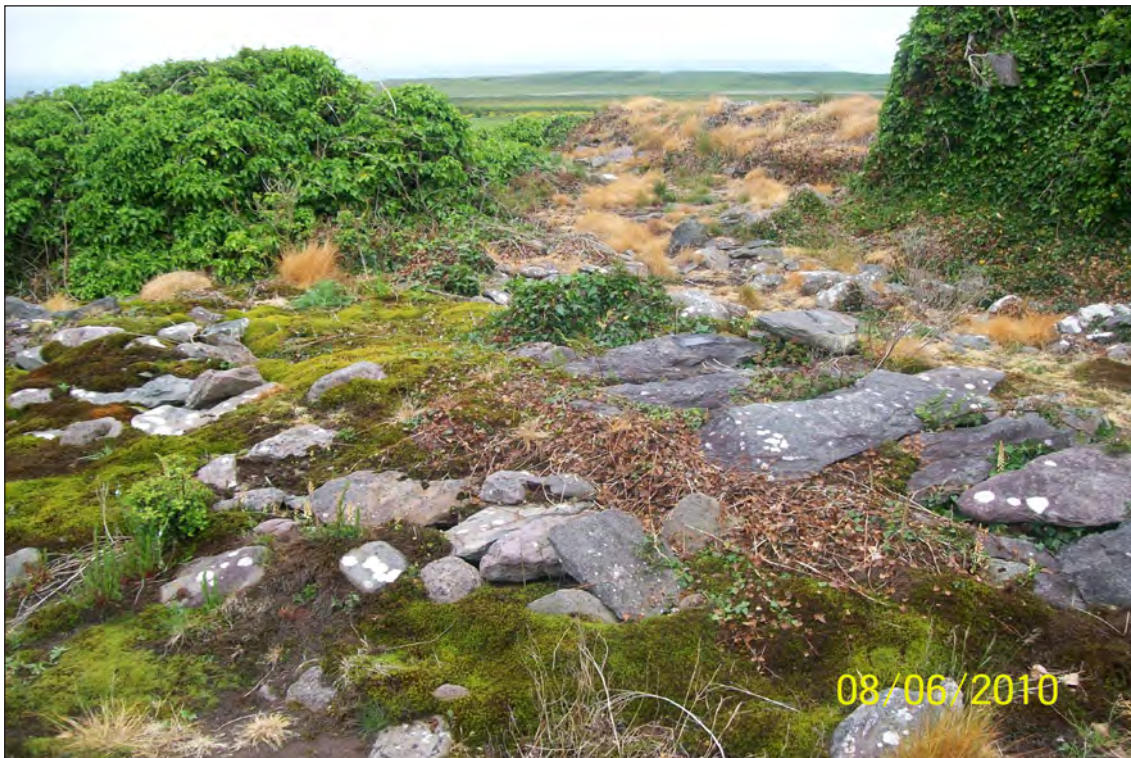
Plate 13: View of exposed lintelled graves and unhewn grave stones to south of church

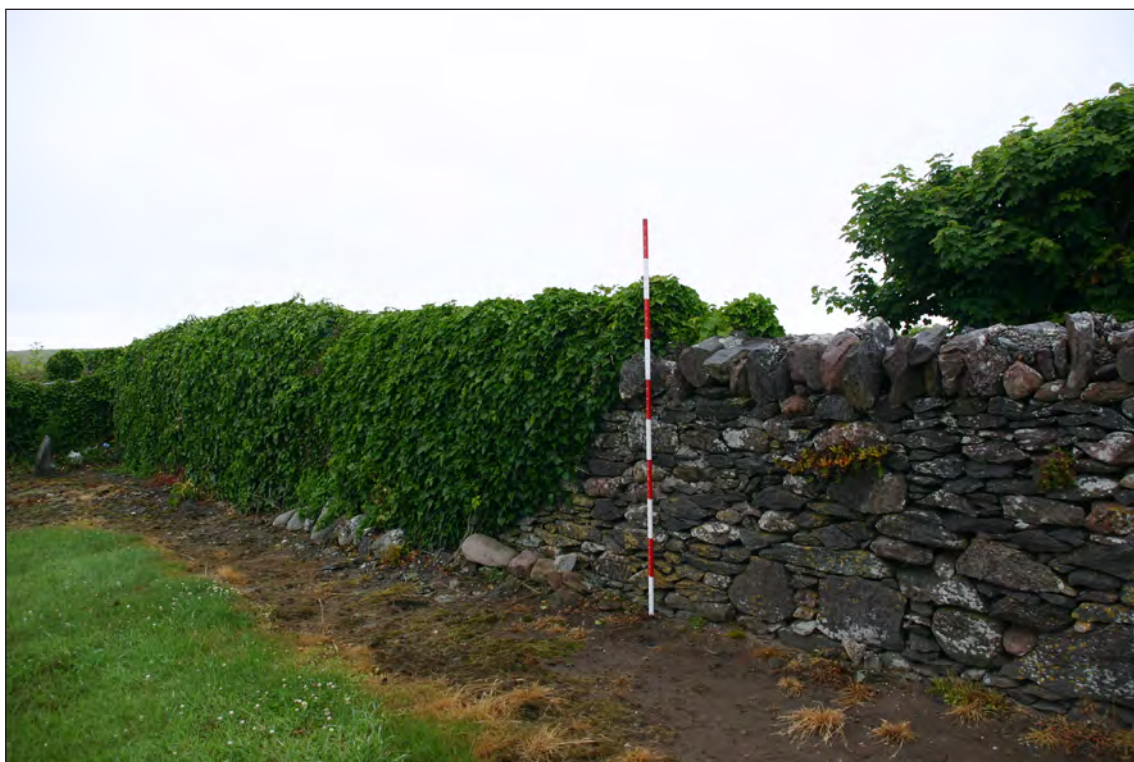
Plate 14: View of interior of east and partially covered boundary wall. Note recent scarping along the wall and subsequent muddy pathway. Further note use of weed killer

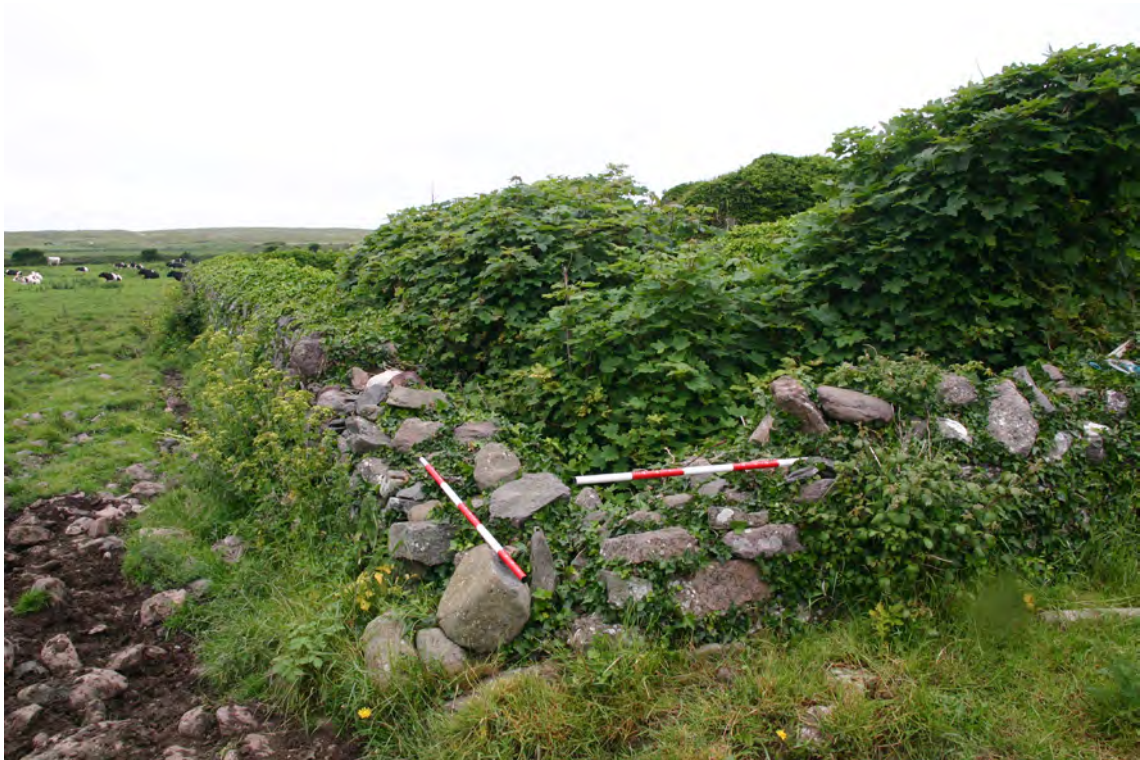
Stradbally Graveyard is partially bounded by a random rubble wall of local sandstone bedded in mortar and capped with 'soldiers'. The eastern boundary wall along the road-side and the northern boundary wall are in good order, albeit with a good growth of ivy and average 1.5m in height (Plates 4 & 14). The boundary walls along the south, west and north west are lower and not as well built and sections of the them are in poor repair, partially breached and covered in ivy and other growth (Plates 15-16 & Figure 5).

Plate 15: View of exterior NW corner of boundary wall. Note extent of vegetation

- Repairs to the boundary walls should be undertaken by people with a proven track record in repairing dry stone walls.
- An information booklet on care and maintenance for tombs should be compiled and supplied to the relevant parish church.

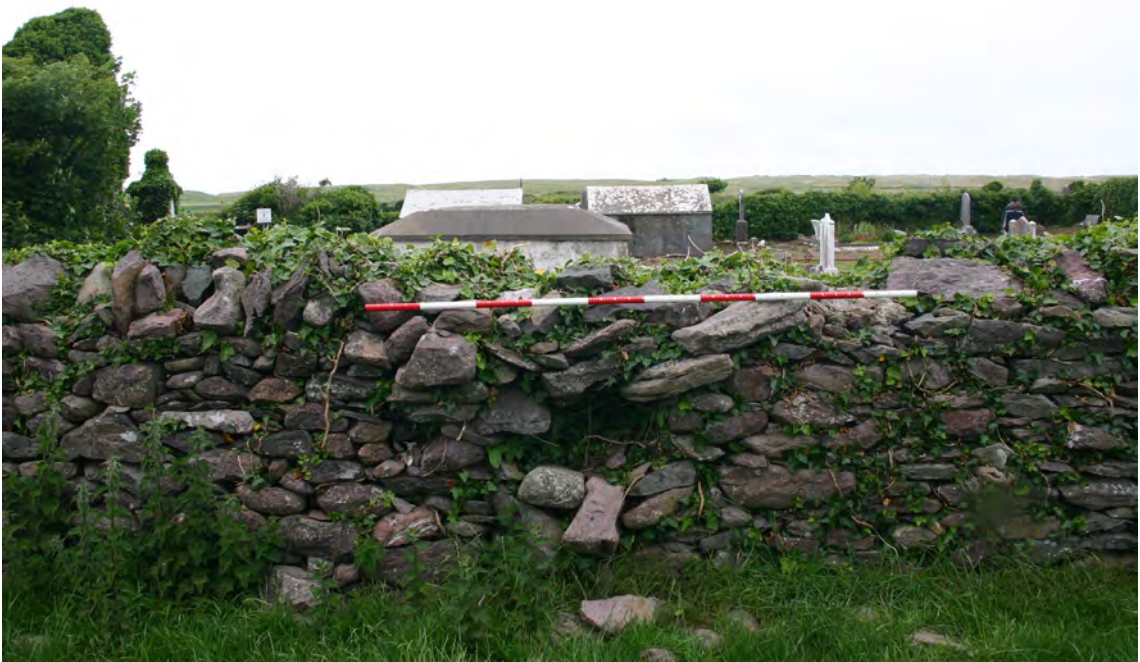
Plate 16: View of exterior collapsing section of south boundary wall

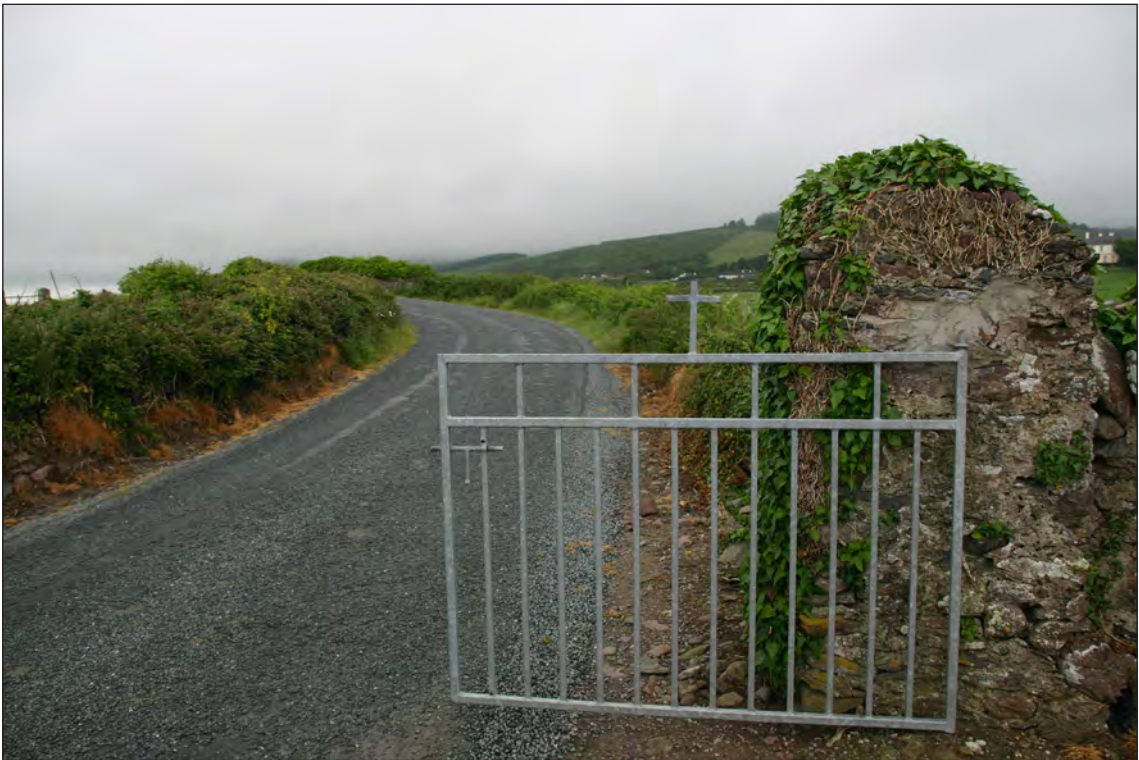
Plate 18: View of dangerous open entrance gate on roadway. Note narrow sharp approach from bridge

If possible carparking should be provided for on the eastern side of the road or on the northern side of the graveyard. An independent swing stile or similar should be provided for pedestrian and elderly access. The gates should be re-aligned and stopped from opening onto the road.

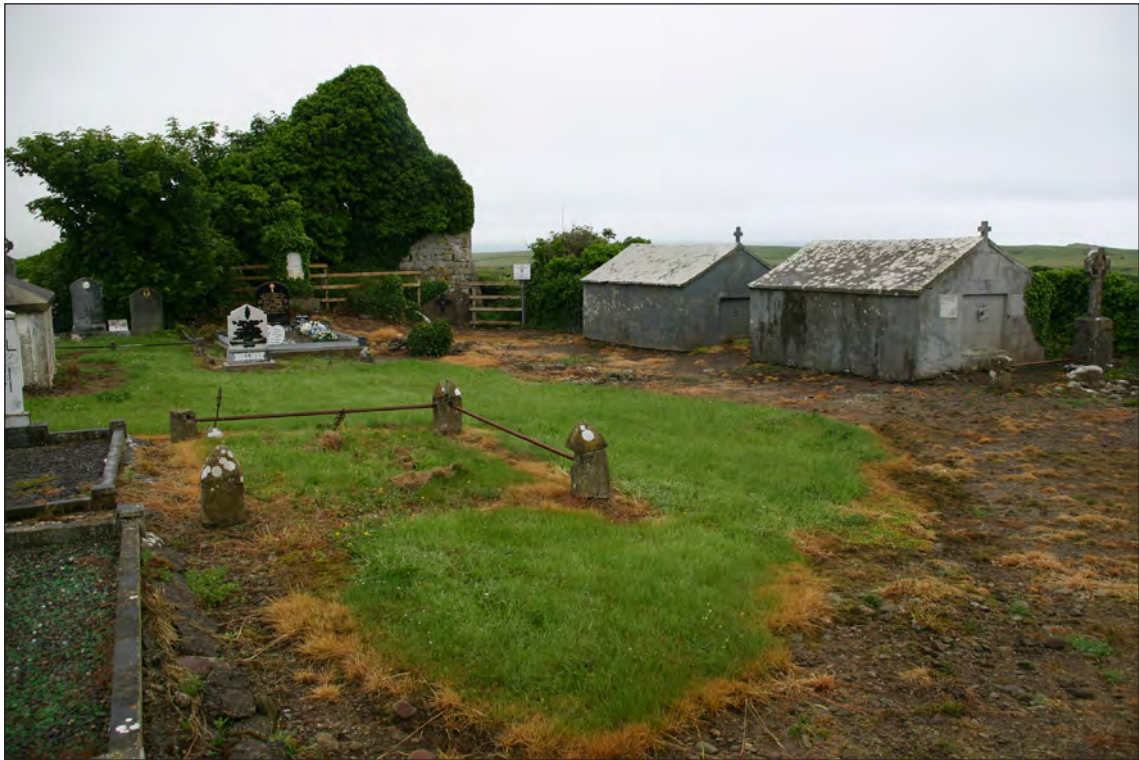
Plate 19: View of eastern area of graveyard, note ad hoc informal paths and use of weed killer

Additional defined gravel paths should and can easily be constructed. The work should be carried out under archaeological supervision and advice as there are several lintelled

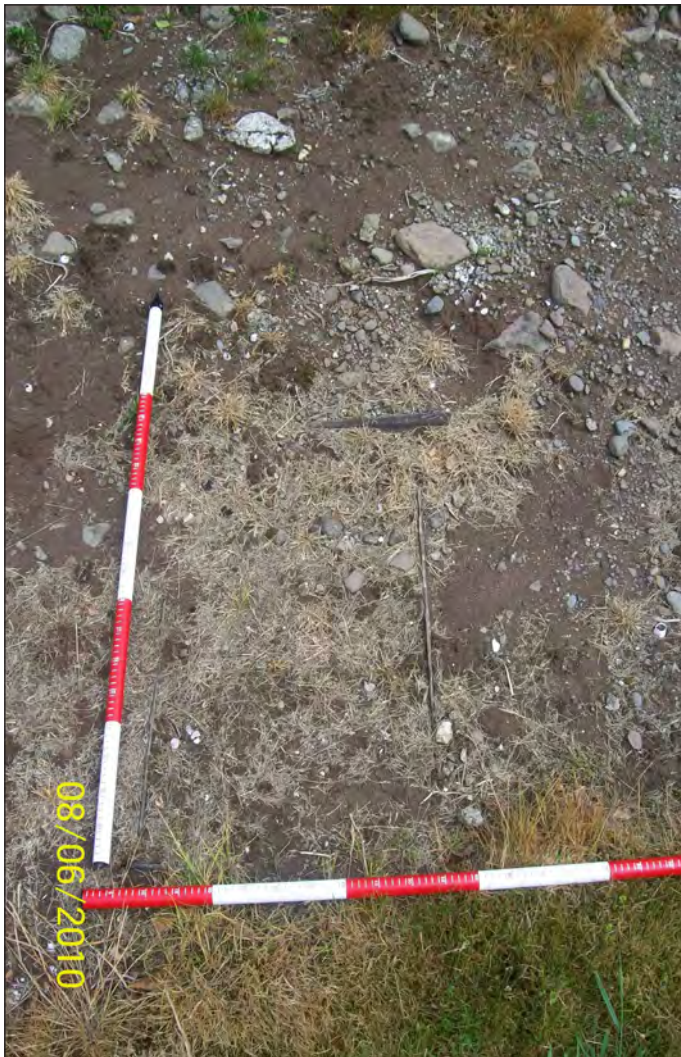
Plate 20: View of recently exposed small rectangular box shaped child's burial at east end of graveyard

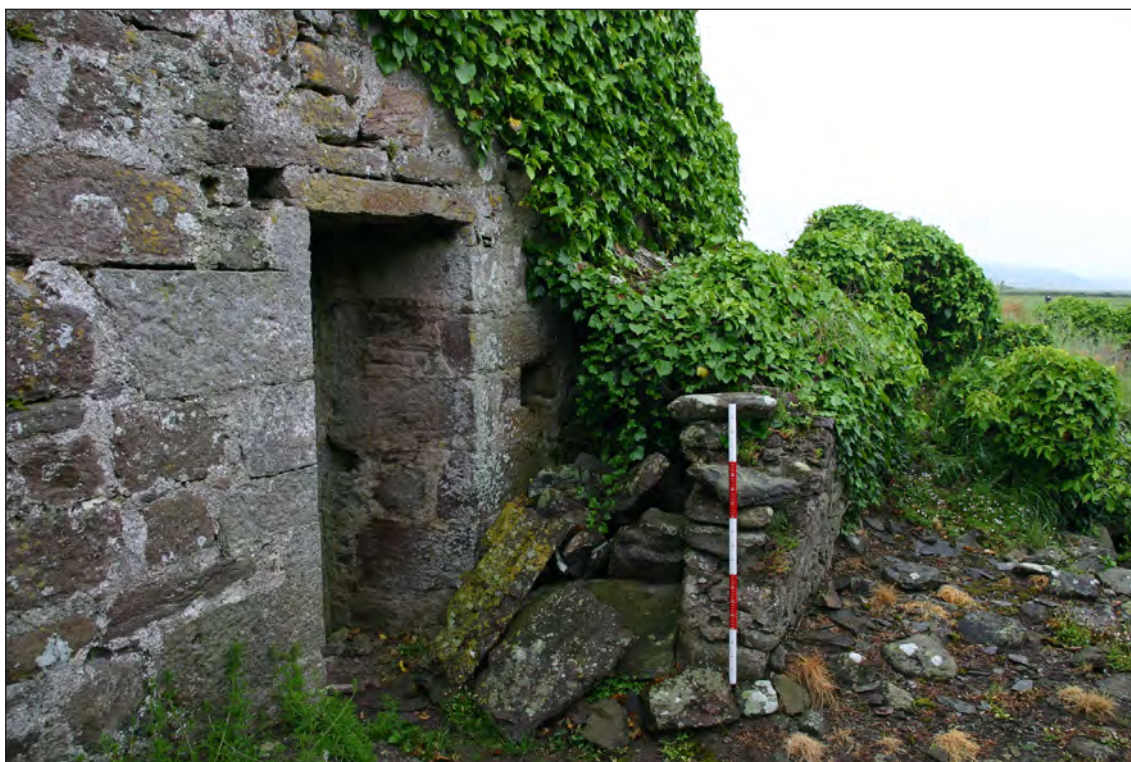
Plate 22: View of narrow lean-to tomb immediately W of south doorway of church

Plate 23: Close-up view of interior of narrow lean-to tomb immediately W of south doorway of church. Note partial collapse of tomb fabric and remains of wooden coffin(s)

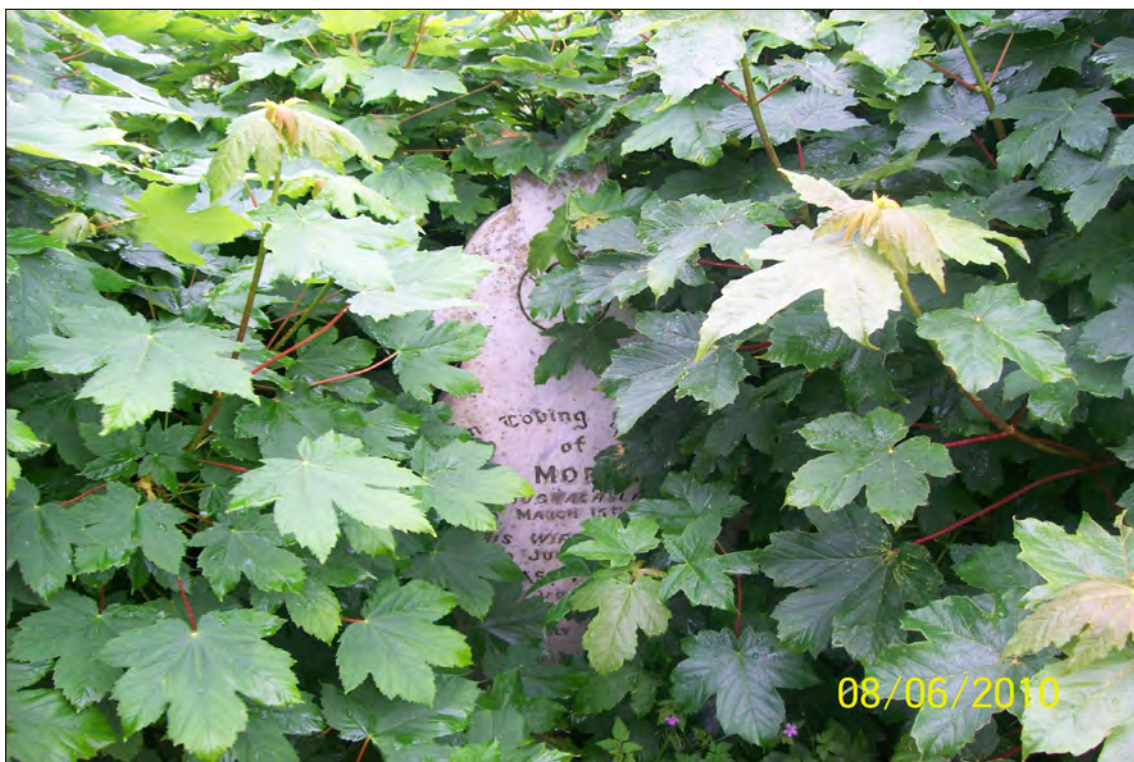
Plate 26: View of overgrown Moriarty headstone (63) at SW corner of graveyard

The painted vandalised Kelliher headstone (27) should be cleaned professionally. The headstones and grave settings under pressure of intense growth should be cleaned back and the vegetation removed. The broken metal grave setting around the unnamed headstones (16 & 17) should be replaced (Plate 27).

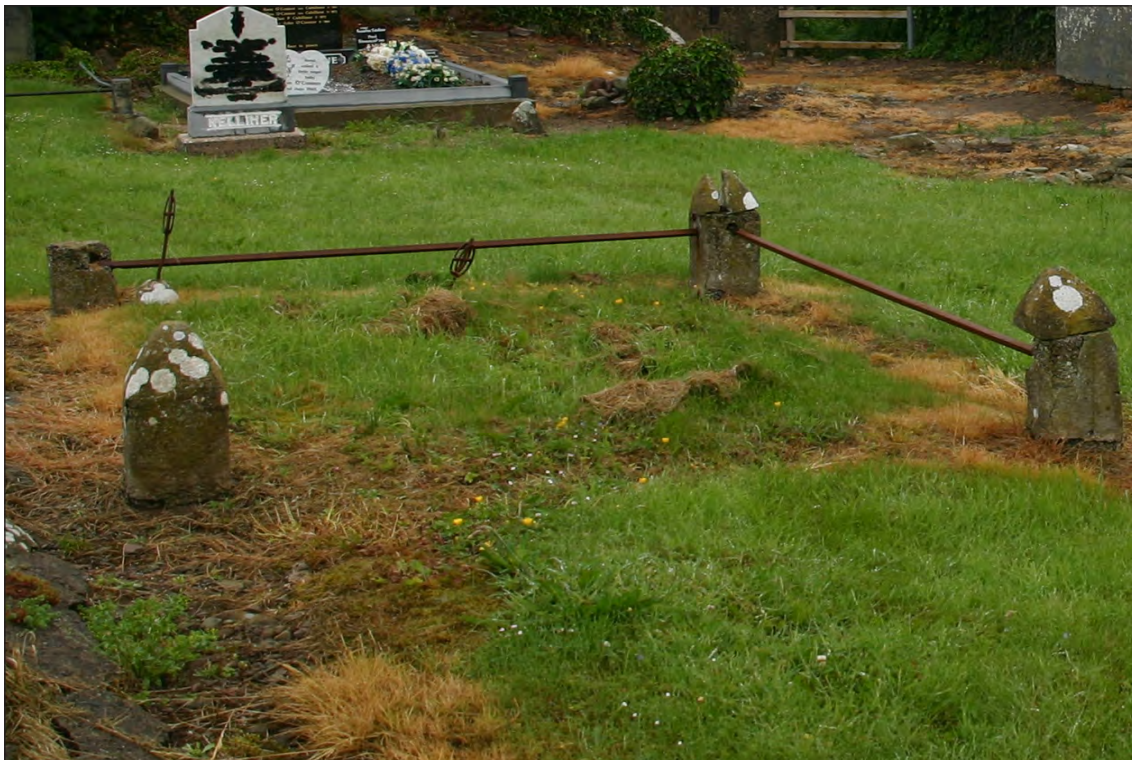
There were thirty-eight named headstones recorded at Stradbally graveyard associated with formal grave settings (Appendix 3, Figure 5 & Plate 1). The majority of the headstones are in good condition although once again some vandalism was recorded of the painting or spraying of black paint in an effort to read inscriptions (Plate 24). A few others are concealed and under pressure by the increasing heavy growth of ivy and bushes and trees (Plates 25-26). A small number of grave settings are constructed with metal bars, some of which are now broken (Plate 27).

Plate 27: View of broken metal grave setting around unnamed graves 16 and 17

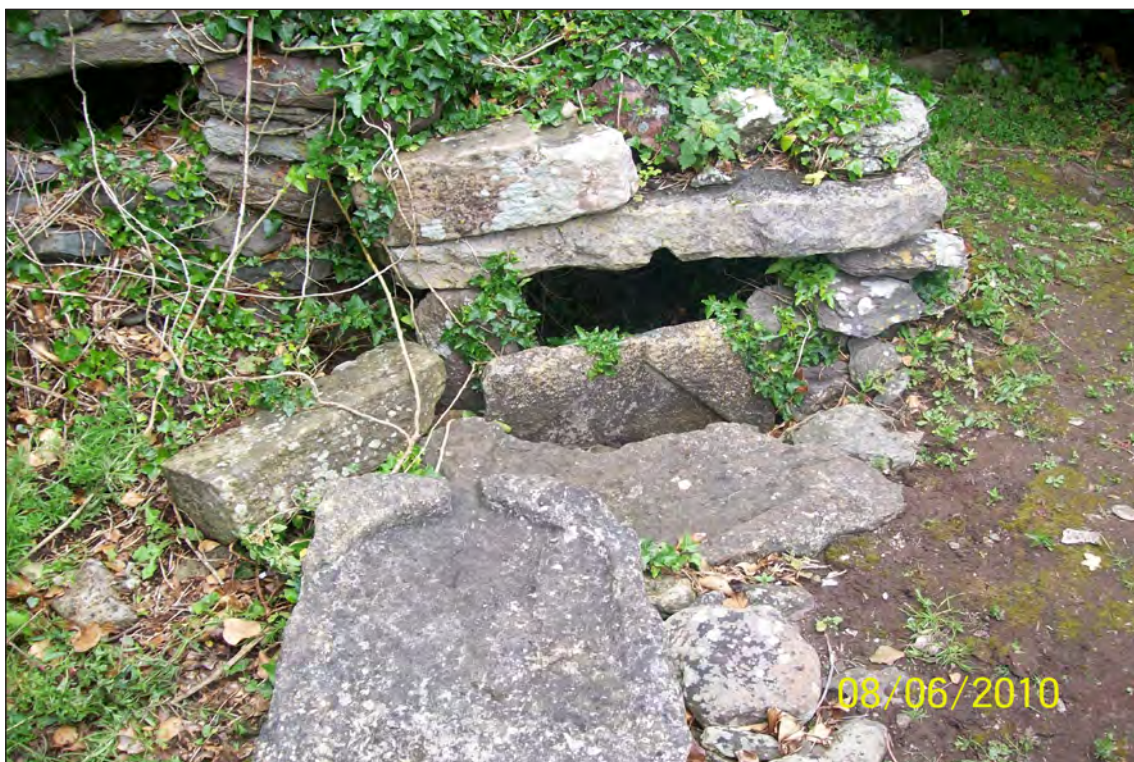
Plate 28: Close up view of architectural fragments comprising collapsed and re-used water spouts and other structural masonry in the interior of the medieval church

The collapsed loose *ex situ* architectural fragments should be collected and removed to the Kerry County Museum for safe keeping storage and individual recording.

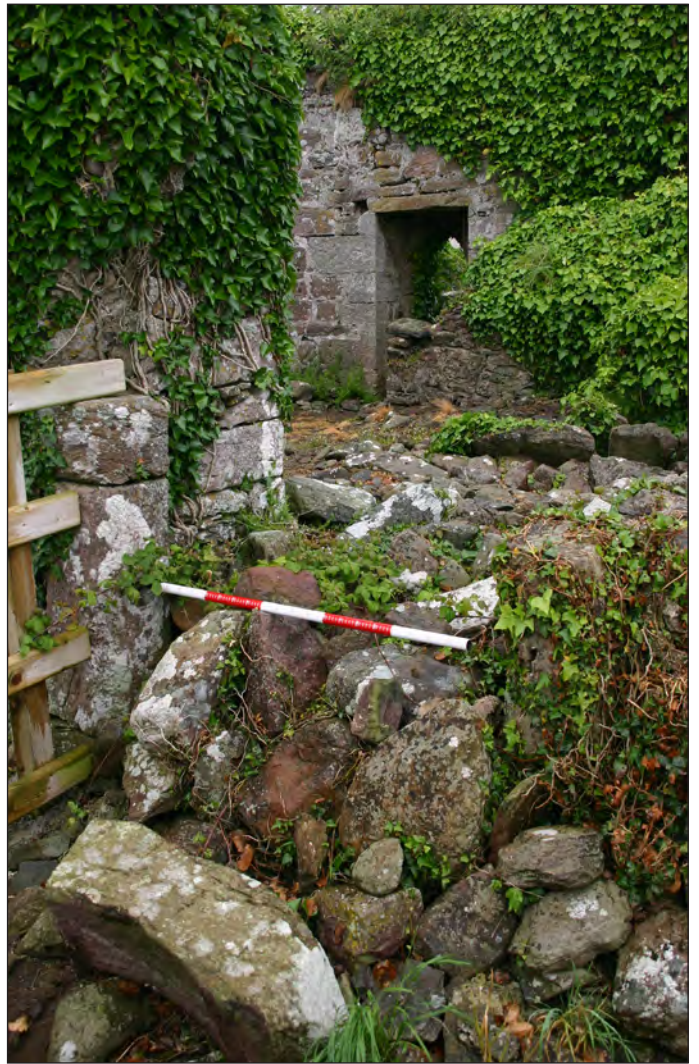
Plate 29: View of collapsed chamfered arched jambs of N doorway from north

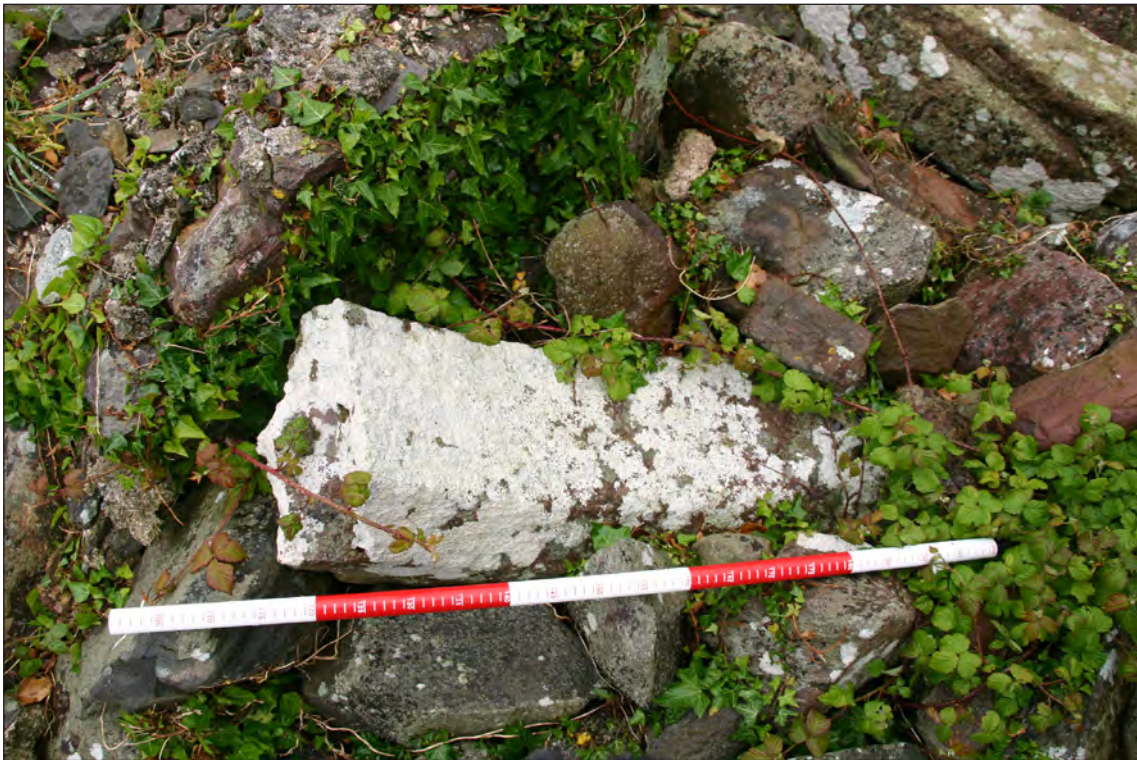
Plate 30: Close up view chamfered curved fragment of N doorway
