Archaeological Survey, Ventry Graveyard, Ventry, Co. Kerry.

September 2010

Client: The Heritage Office,

RMP No.: KE052-119- Church, KE052-119001-Font

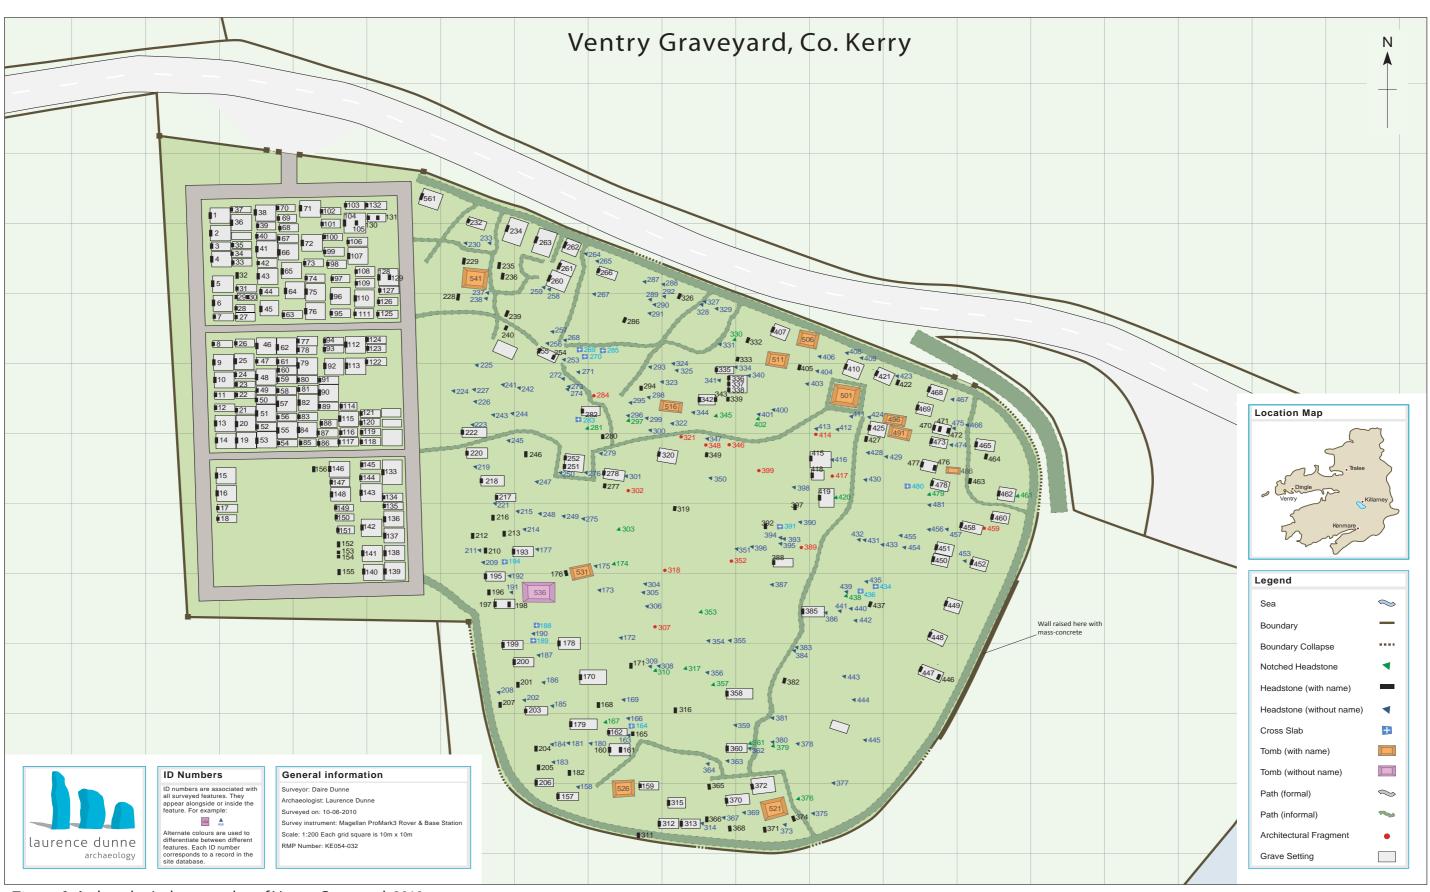
Figure 6: Archaeological survey plan of Ventry Graveyard, 2010.

The old medieval graveyard of Ventry is bounded by a drystone wall of locally derived uncoursed rubble sandstone, capped by coarse gravel cement. Sections of capping are missing from a few areas and one or two walling breaches have been poorly patched up and require proper repair (Plates 4-7 & Figure 6).

A length of boundary wall extending beside the Kavanagh family tomb (506) is very low (0.30m) and dangerous as the interior of the burial ground is much higher than the road-side level, 1.15m externally (Plate 8, Figure 6). Part of the boundary wall at the eastern end of the old graveyard is surmounted by an inappropriate and unsightly section of mass concrete (Plate 9 & Figure 6). The modern or new section of Ventry graveyard is enclosed by a wall built of concrete blocks, laid-flat and coursed between featured square and capped piers. Several of the piers are now missing their cap stones and a few others are cracked. The wall is rendered on the inside by a coarse dash (Plates 10-11).

There is a single gravelled path in general good condition that extends around the entire internal perimeter of the graveyard, old and new (Figure 6 & Plates 4, 6 and 9).

There are no formal paths to access the interior of the old medieval burial ground. Currently there is an inadequate *ad hoc* network of irregular informal grassy paths often kept low by visitors to specific graves (Figure 6). However, grass cutting is too infrequent and the grass is not kept low enough across the difficult bumpy and undulating terrain that is studded with old low profile gravemarkers that are often difficult to see and easy to fall

The interior of the new burial ground is equally subdivided into three areas by formal paths (Figure 6). However, the grave plots were poorly laid out and too closely spaced and congested, consequently it is impossible to access internal graves without walking across or stumbling over other graves (Plate 15).

The capping missing and broken at several locations along the boundary wall of the old Ventry Graveyard should be replaced and repaired with similar material sensitive to the existing good intact *in situ* capping.

Partially or poorly repaired sections of dry stone walling should be properly repaired with local sandstone and recapped by people experienced in such work and with a proven track record.

The low area of boundary walling near the Kavanagh family tomb (506) should be heightened for health and safety considerations to *circa* 1m.

The inappropriate and unsightly mass concrete section surmounting the drystone boundary wall should be removed and the wall recapped.

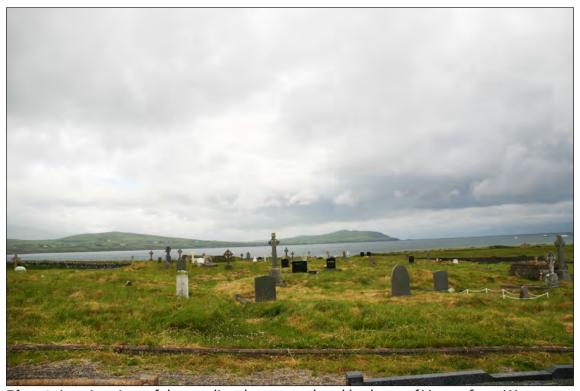
Plate 2: Interior view of the medieval graveyard and harbour of Ventry from W

The original and much larger burial ground is covered in grass and is bumpy, uneven and is difficult to traverse in several places (Plate 2). Much of the dense grass and rough areas

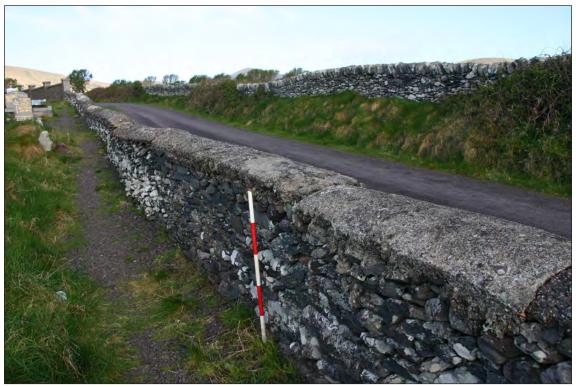
Plate 4: View from E of section of N boundary wall and internal perimeter graveled pathway at Ventry Graveyard

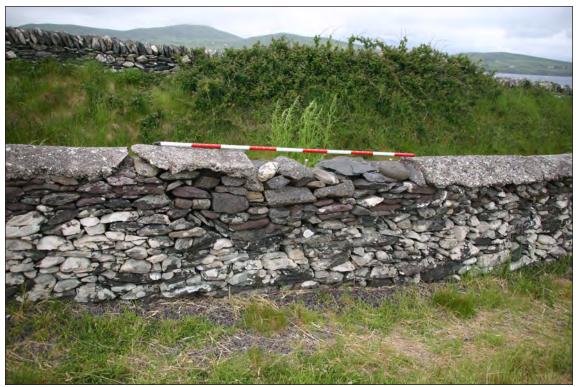
Plate 5: Close-up view of damaged and poorly repaired section of boundary wall at N

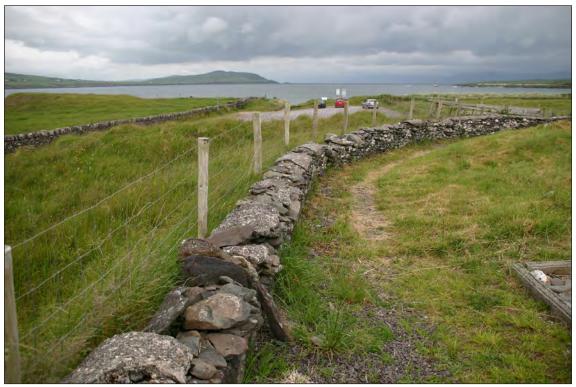
Plate 6: View of curving SE section of boundary wall at the medieval graveyard of Ventry. Note poor reduced condition and destroyed capping

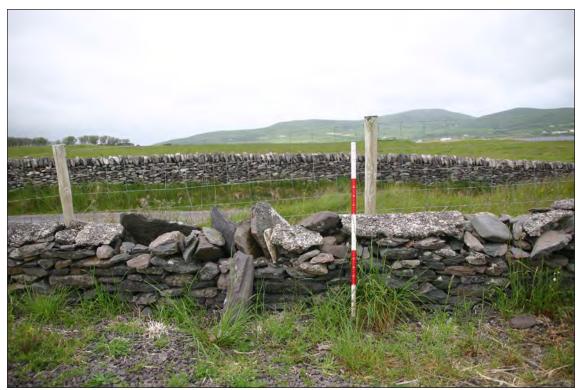
Plate 7: Close-up view of damaged and poorly repaired section of boundary wall at NE. Contrast damaged wall to drystone wall beyond

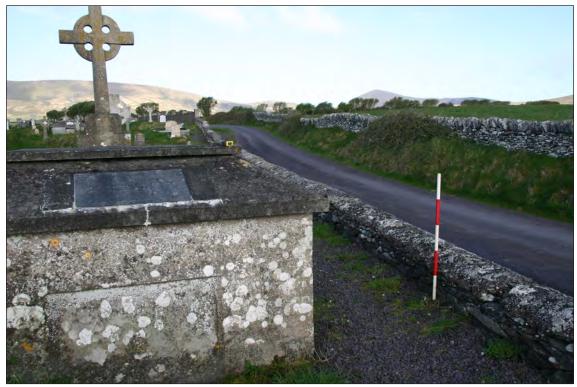
Plate 8: View of very low section (0.30m) of interior of walling near the Kavanagh family tomb (506). Note fall-off on roadside exterior

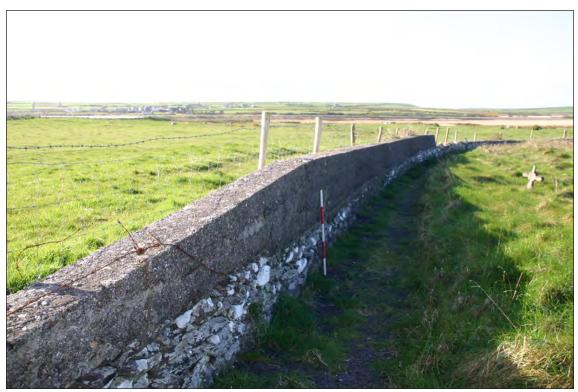
Plate 9: View of section of unsightly inappropriate mass-concrete walling on SSE limits of boundary wall

- Repairs to the dry stone boundary walls and damaged capping should be undertaken by people with a proven track record in repairing dry stone walls.
- The unsightly and inappropriate section of mass-concrete on the E boundary wall should be removed and the wall capped.

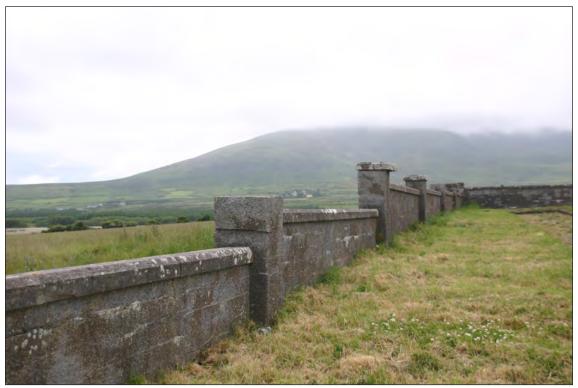
Plate 10: View of S boundary wall of new section of Ventry Graveyard. Note missing capping

The damaged piers of the walling around the new graveyard section should be recapped and repaired.

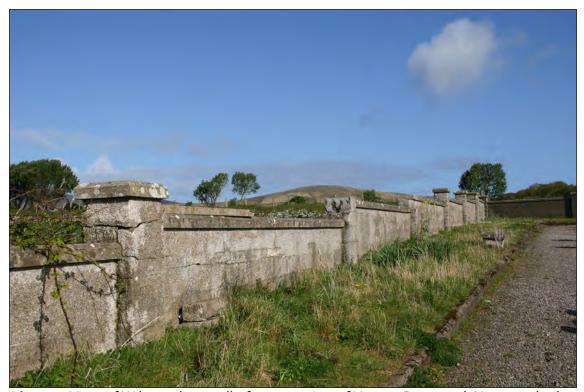
Plate 11: View of W boundary wall of new section of Ventry Graveyard. Note cracked piers and missing capping

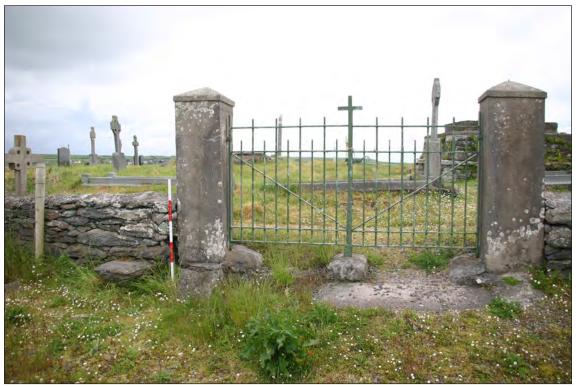
There are two gate entrances to Ventry Graveyard, the first at the new section and the second directly into the old burial ground at the SE. The gates into the old Ventry graveyard comprise modern green painted galvanised gates set between two square capped and rendered piers and are tied with cord. A broken step-stile survives beside the LH pier as one approaches from the road (Plate 13).

Plate 14: View of entrance gates and broken step-stile to old medieval area Ventry Graveyard from N

The step-stile should be repaired or replaced by a squeeze or swing-stile to provide direct pedestrian access into the old Ventry Graveyard.

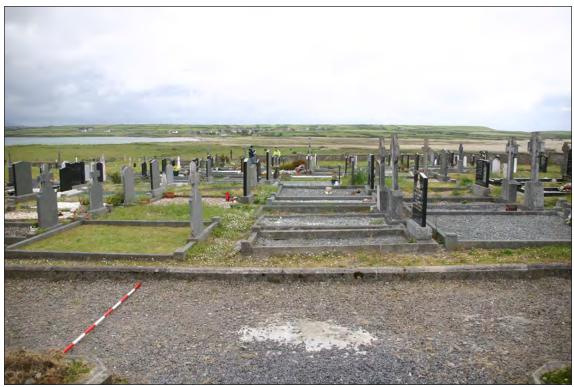
Plate 15: View of interior of new section of Ventry Graveyard from N

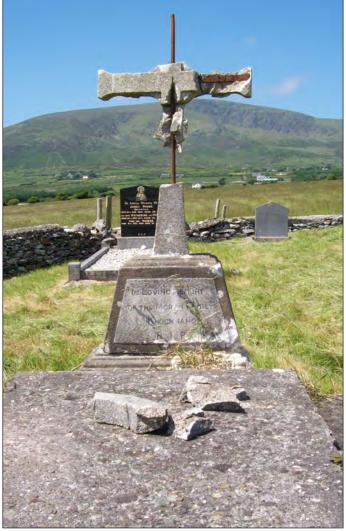
Eleven named tombs were recorded dispersed around the old medieval burial ground generally in good state of preservation, (Plates 8, 16, Appendix 1 & Figure 6). None of the tombs are of ashlar masonry. The majority are built with local rubble sandstone, concrete blocks, rendered and comprise simple rectangular box type mainly and a few 'strong-box' types. As well as normal memorial plaques, an additional feature on the tombs is the attachment of crosses or headstones surmounted on their W end. This feature is similar to Aglish Graveyard. The render on tombs (501 and 526) is coarse and made with a high proportion of beach pebbles (Plates 17-18). The cross surmounting the rendered Moran family tomb (526) is shattered and fallen away from its internal re-enforcing bars.

Plate 17: View of shattered cross surmounting Moran tomb (526) in medieval area of Ventry Graveyard from E. Note Mount Eagle in background

Very little work is required on the named tombs apart from re-rendering work to some of the sides and haunches and the removal of minor vegetation growth.

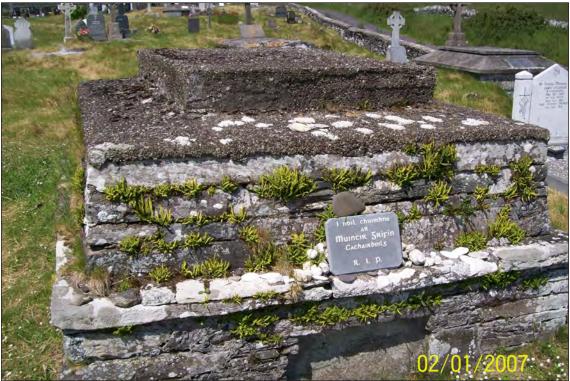
Plate 18: View of the Griffin family tomb (501) from E. Note growth establishing itself on un-rendered sides

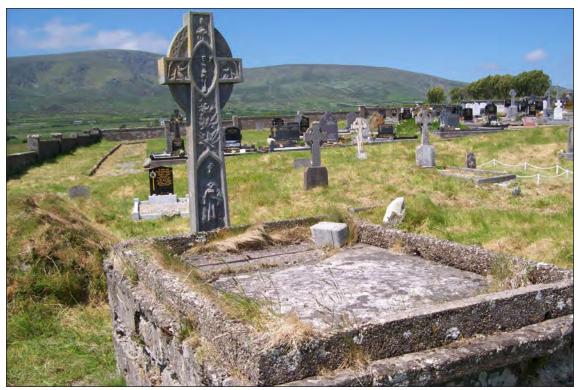
The simple box type tomb (531) is constructed of un-rendered concrete blocks and has a small amount of grass growing on top (Plate 19). None of the tombs are built with ashlar masonry.

Plate 19: View of the O'Connor family tomb (531) from E. Note: un-rendered sides and grass establishing itself around rim of tomb

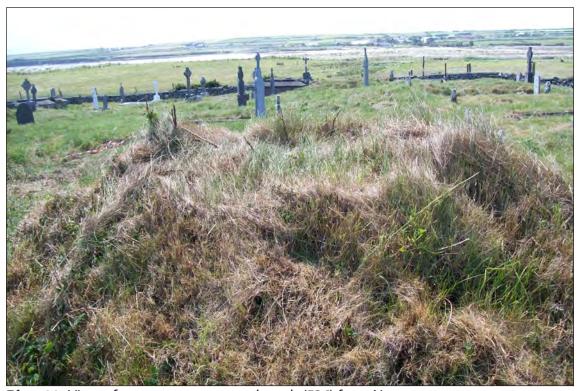
Only one unnamed tomb (Plate 20, Appendix 2 & Figure 6) was recorded. This comprises a grassy overgrown mound (536) in the SW limits of the old graveyard at Ventry.

Plate 20: View of overgrown unnamed tomb (536) from N

The grass covering the tomb should only be fully removed as the primary element of an agreed inclusive strategy of repairs and other conservation and restoration works. The grass should initially be cut back for further evaluation to determine the nature and extent of potential further conservation / restoration works. This work should be undertaken with expert archaeological advice and guidance.

- All vegetation on the unnamed overgrown tomb should be cut back and removed. The tomb should then be repaired re-pointed, re-rendered and restored sensitive to their original construction. This work should be done under the supervision of an archaeologist qualified in this area or a conservation architect experienced in this field and may require Ministerial Consent.

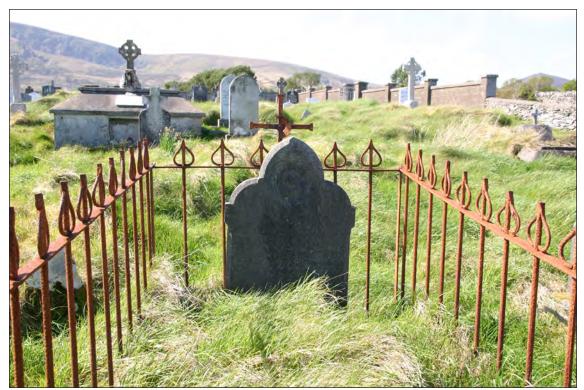
Plate 21: View of wrought iron railing around the grave (260) of John Sullivan who died in 1871

The grave setting around the burial of John Sullivan (260), who died in 1871, is nicely featured in wrought iron (Plate 21).

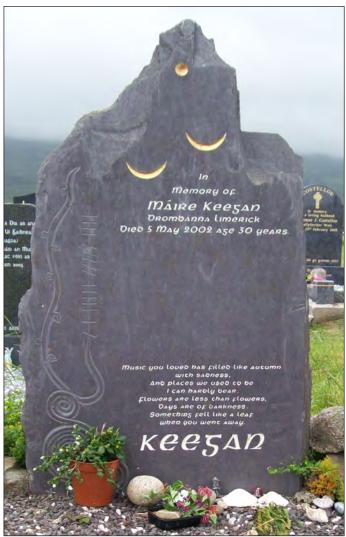
Plate 22: View of modern headstone of Máire Keegan. Note: name of Máire written in ogham letters on left

One very fine modern headstone (136) is made from a large thick irregular slate and is decorated with several motifs, some of which are painted in gold. Of other interest is that the Christian name of the deceased Máire Keegan, who died in 2002 aged 30, is also written in ogham letters (Plate 22).

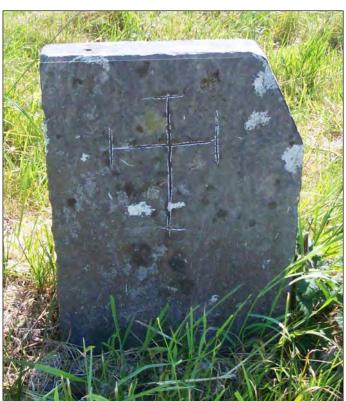
Eleven are incised on local sandstone while the twelfth (391) is slate and lightly incised with a Latin cross with T-bar terminals (Plate 26).

Plate 26: View of cross-slab (391) with Latin cross and T-bar terminals

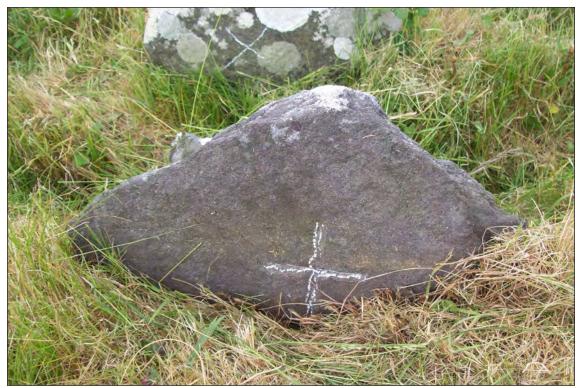
Five cross-slabs (189, 194, 270, 285 and 480) are incised with small equal-armed crosses (Plates 27-31). One of which (285) is incised on a shouldered type cross form (Plate 30) while another (480) in incised on a punch dressed fragment of medieval masonry originally from the church (Plate 31).

Plate 27: View of cross-slab (189) with small equal-armed cross

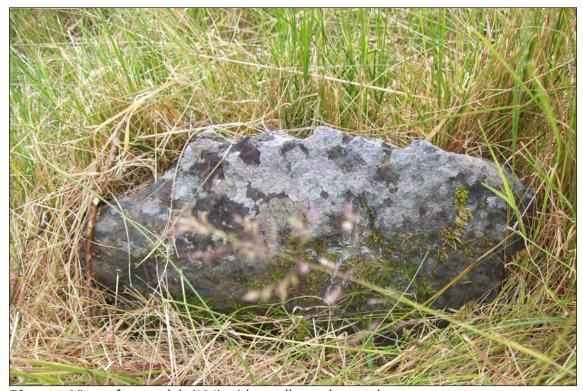
Plate 28: View of cross-slab (194) with small equal-armed cross

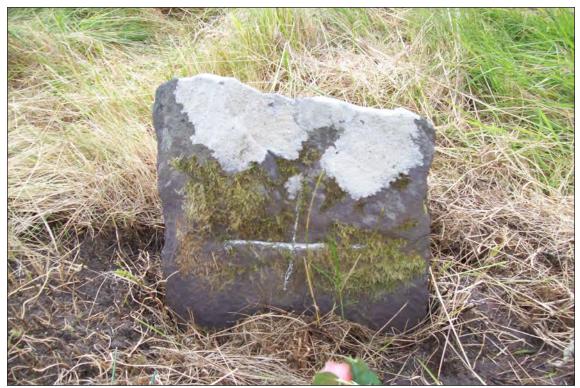
Plate 29: View of cross-slab (270) with small equal-armed cross

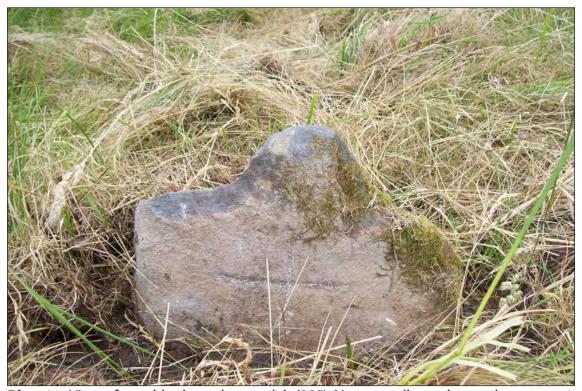
Plate 30: View of roughly shaped cross-slab (285). Note: small equal-armed cross

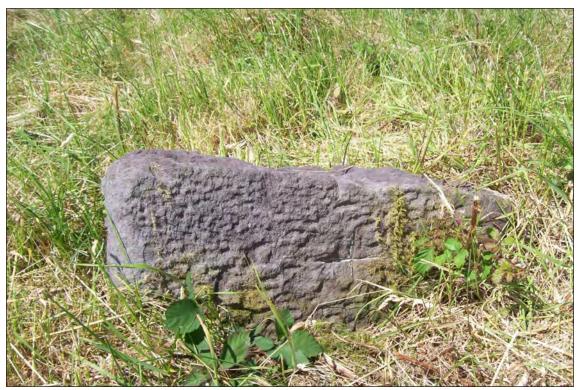
Plate 31: View of small equal-armed cross inscribed on medieval architectural fragment (480)

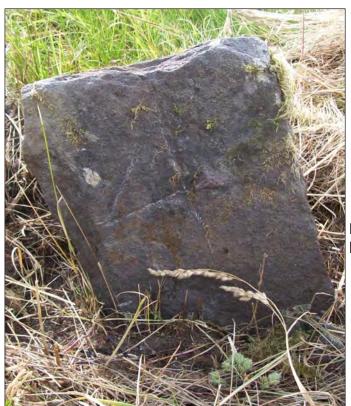
Plate 32: View of cross-slab (269). Note: lightly incised gable-shaped cross

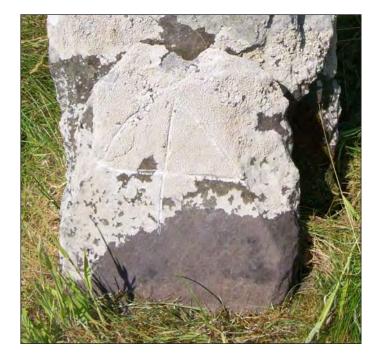
Plate 33: View of cross-slab (434). Note: lightly incised gable-shaped cross

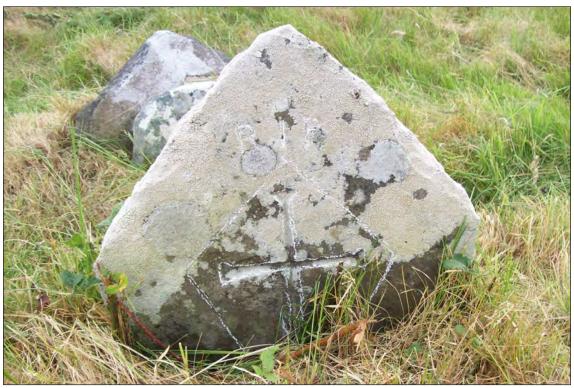
A variant form of the previous two is cross-slab 188 that comprises an equal-armed cross with expanded terminals set within a kite shaped plane on a similar kite shaped slab. Over the motif are the letters R.I.P (Plate 34).

Plate 34: View of cross-slab (188). Note: equal-armed cross with expanded terminals within kite-shaped plane and the letters 'R.I.P' over

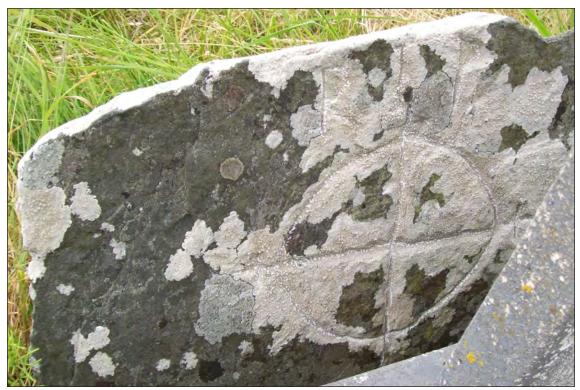
A cross-in-circle is also inscribed on another stone (283). The arms and shafts are further crossed near their ends forming four other small crosses. Over the cross are the letters R.I.P (Plate 35).

Plate 35: View of cross-slab (283) with cross-in-circle incised on it. The arms and shafts are further crossed near their ends forming four other small crosses. Note the letters 'R.I.P' over it

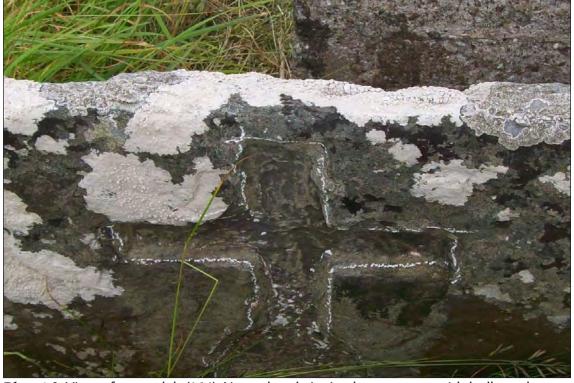
A small rather crudely and deeply incised squat cross with a bulbous base to its shaft (164) is also found on another possible fragment of masonry from the medieval church (Plate 36).

Plate 36: View of cross-slab (164). Note: deeply incised squat cross with bulbous base

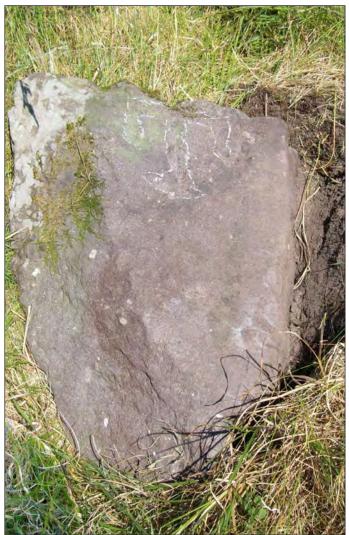
Cross-slab (436) is inscribed with a small Tau cross on its uppermost limits. The cross has down-turns to both arms and a T-bar to the base of the shaft (Plate 37). The cross-slab lies loosely on the surface.

Plate 37: View of cross-slab (436) lying flat on surface. Note: lightly incised Tau-cross with down-turns to both arms and T-bar to the base of the shaft

The grass around them should be kept low as some have a very low above ground register and will rapidly become lost or broken. The loose Tau cross-slab (436) should be re-stood *in situ*. If this is not possible it should be removed to the Kerry County Museum for safety.

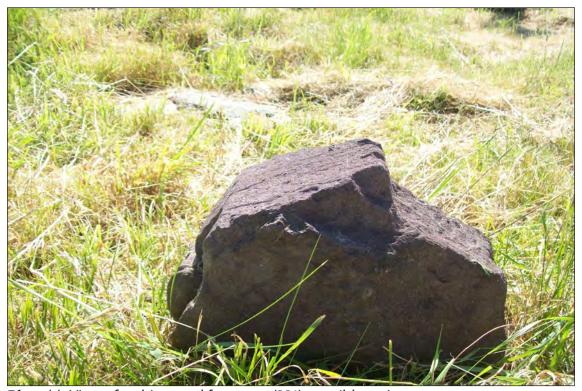
Plate 44: View of architectural fragment (321), possible springer-stone

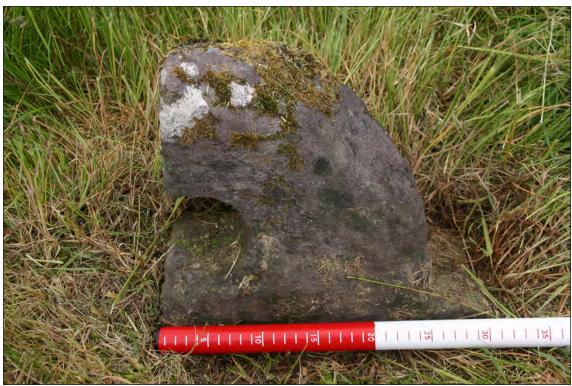
Plate 45: View of door-hinge-stone (307) from medieval parish church of Ventry

Another fragment (307) is a door hinge-stone (Plate 45).
