Archaeological Survey,  
Raheenyhooig Graveyard,  
Burnham Demesne,  
Dingle,  
Co. Kerry.

September 2010

Client: The Heritage Office,  
Kerry County Council,  
County Buildings,  
Ratass,  
Tralee,  
Co. Kerry.

RMP No.: KE053-059-graveyard

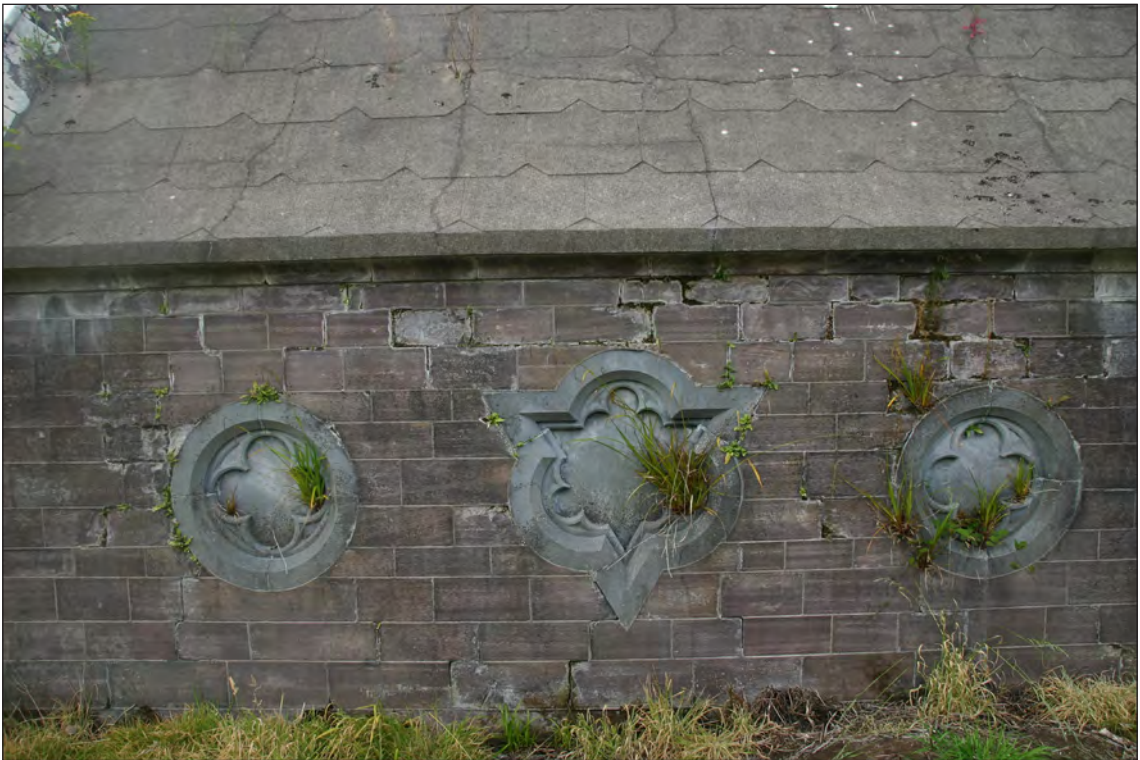
**Plate 4:** View of S elevation of 'Ventry' mausoleum. Note: growth in recessed limestone panels

- The recorded protected structure, Ventry mausoleum, should be repaired as a matter of urgency. This work will need to be carried out under auspices of the NIAH of the DoEHLG and in collaboration with the current Lord Ventry.

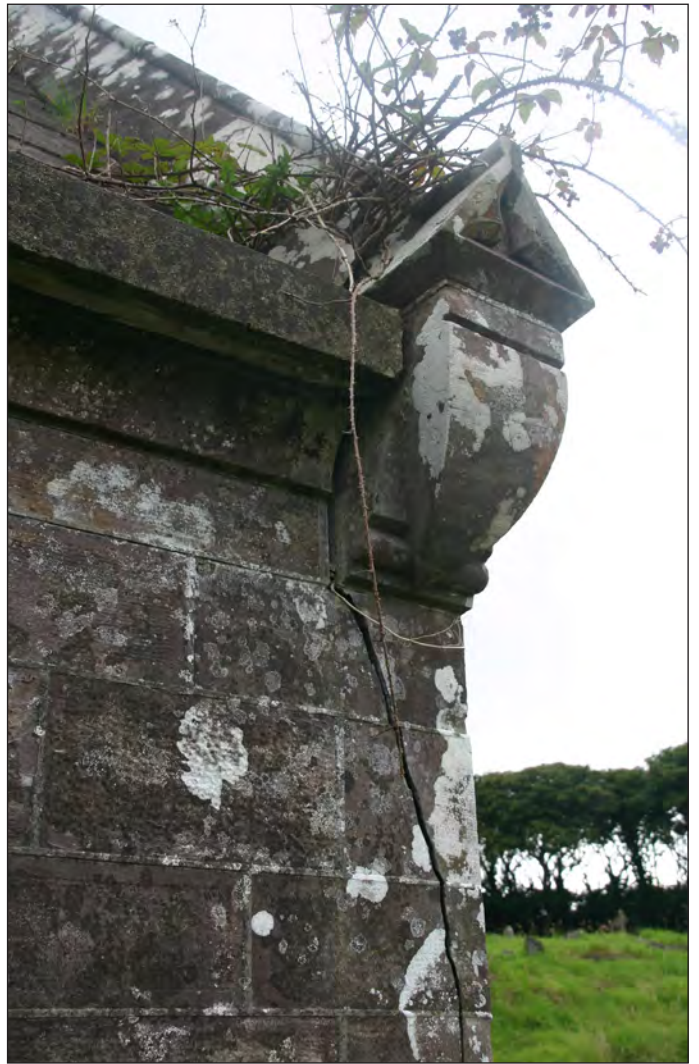
**Plate 5:** View of growth and severe crack on the gable shoulder and weather coping

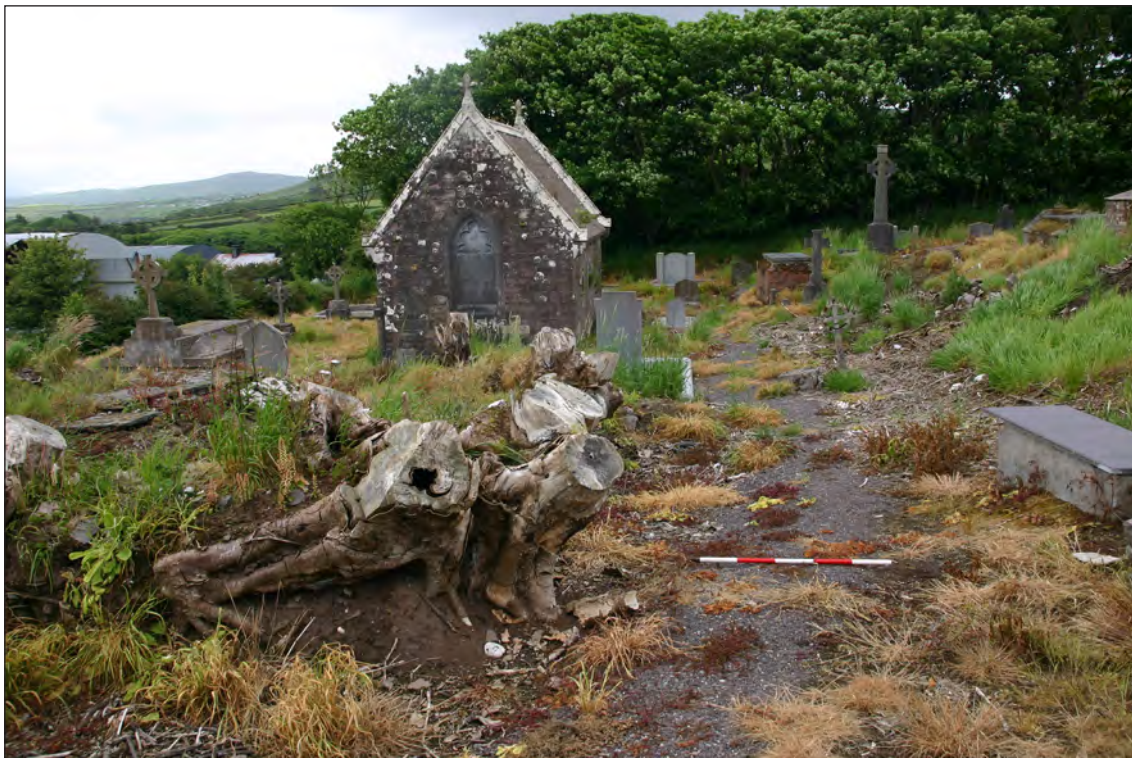
**Plate 13:** View of recently constructed graveled pathway in Raheenyhooig. Note: pathway not maintained and grass and other vegetation encroaching

- Recent, poorly designed and poorly executed and partially collapsing, gravelled paths should be repaired and re-aligned under archaeological supervision and advice.

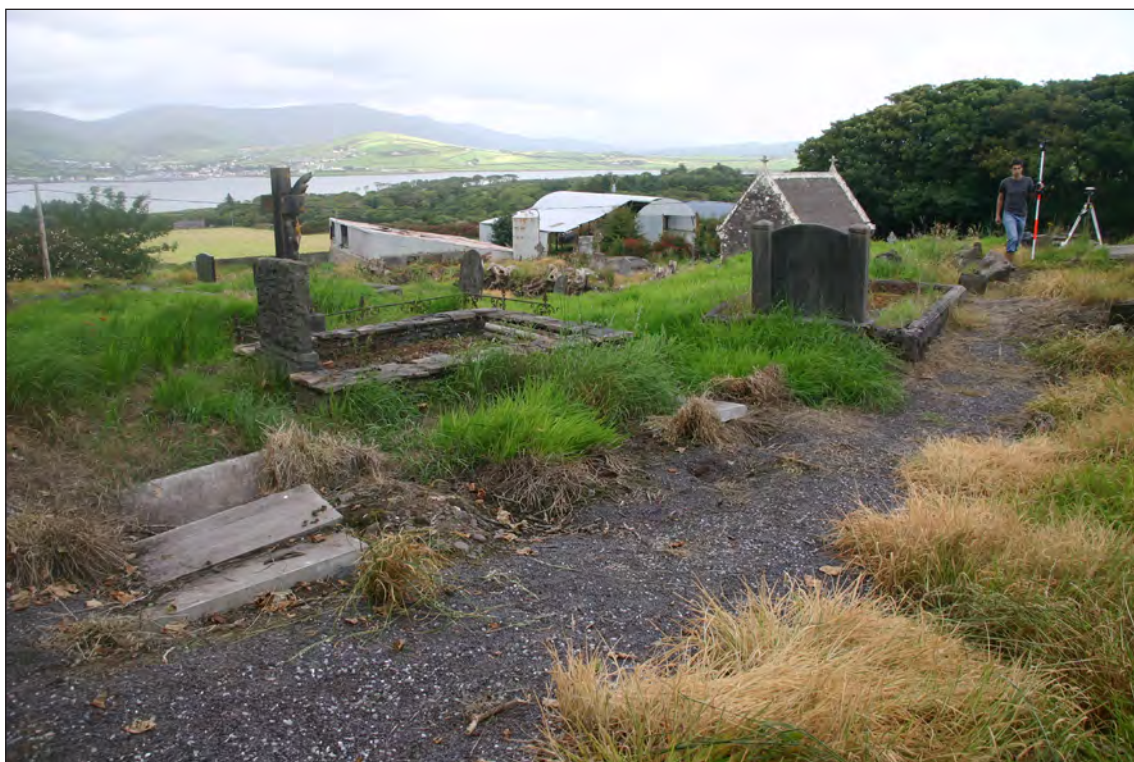
It is also, apparent, that broad spectrum weed killer is liberally used across the site-a feature noted at several graveyards-a practice that is not allowed in historic graveyards and should be discontinued immediately (Plates 1, 8-9 & 14).

**Plate 14:** View of recently constructed graveled pathway in Raheenyhooig. Note: partial collapse of recently installed concrete lintels and further collapse of verge of pathway

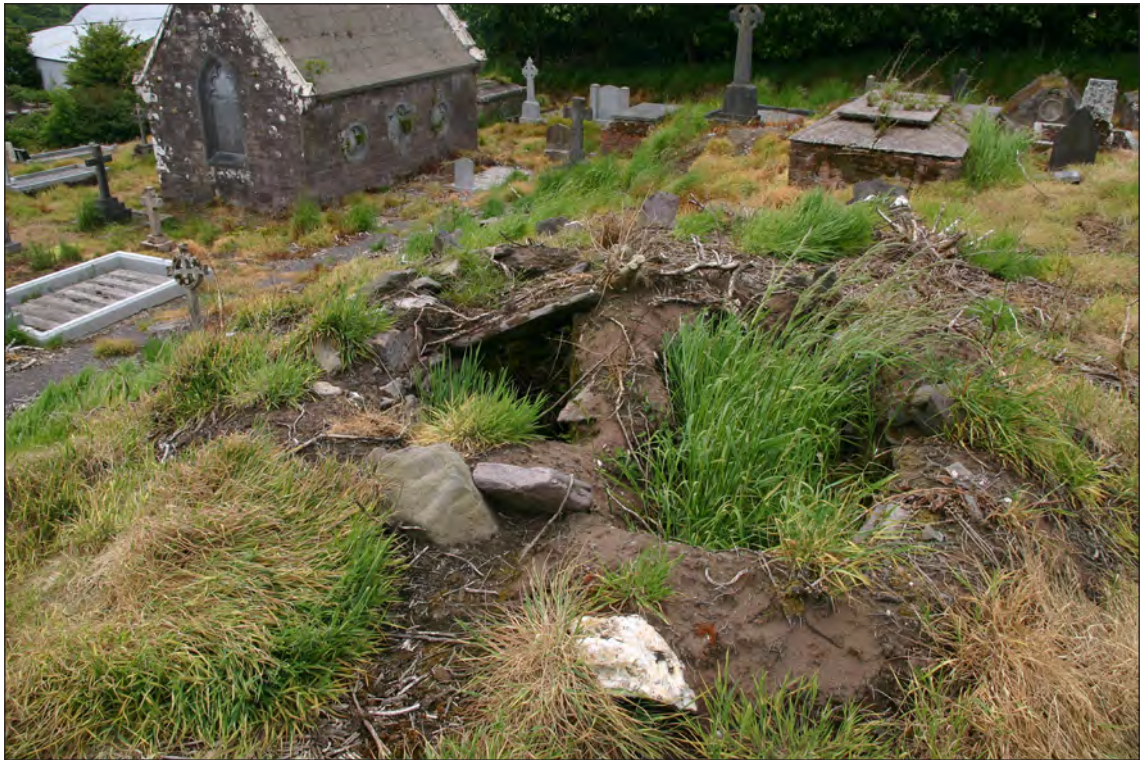
**Plate 15:** View of pair of collapsed lintelled graves from SW

- Exposed, open, collapsed and partially collapsed lintelled graves should be properly repaired and covered under strict archaeological supervision.
- Recent, previous, poorly covered graves should be repaired and re-covered under archaeological advice and supervision.

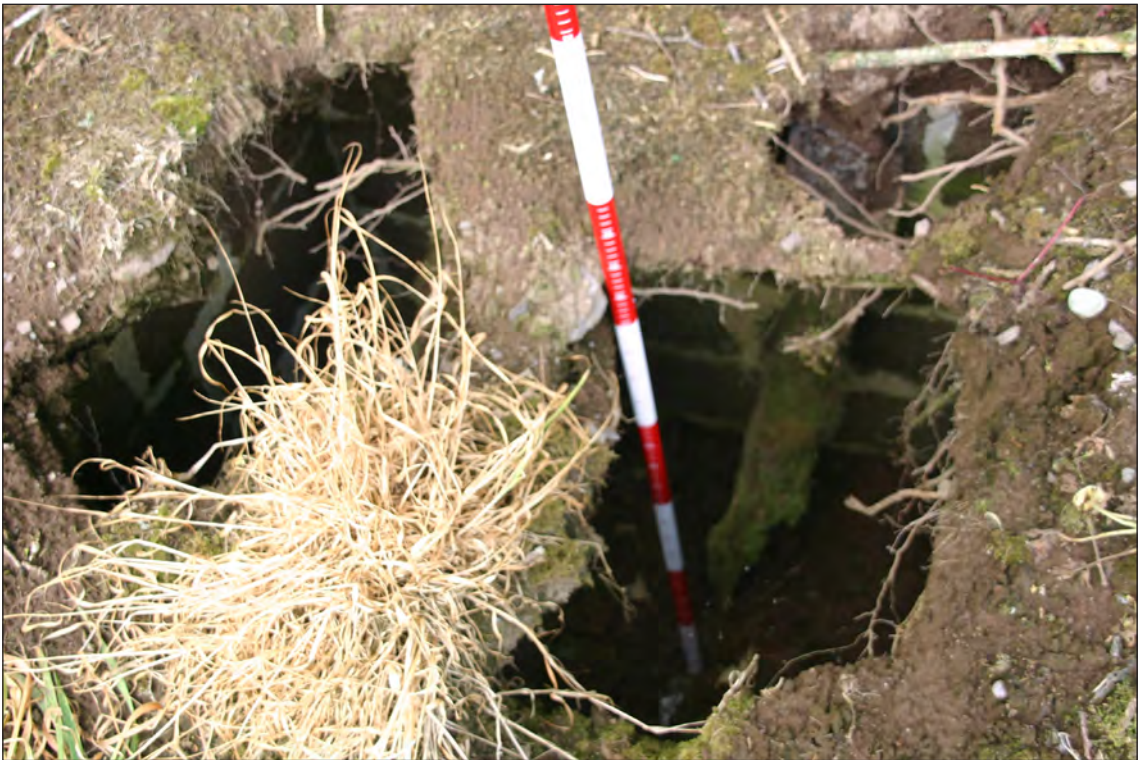
**Plate 16:** Close-up view of collapsed grave (514)

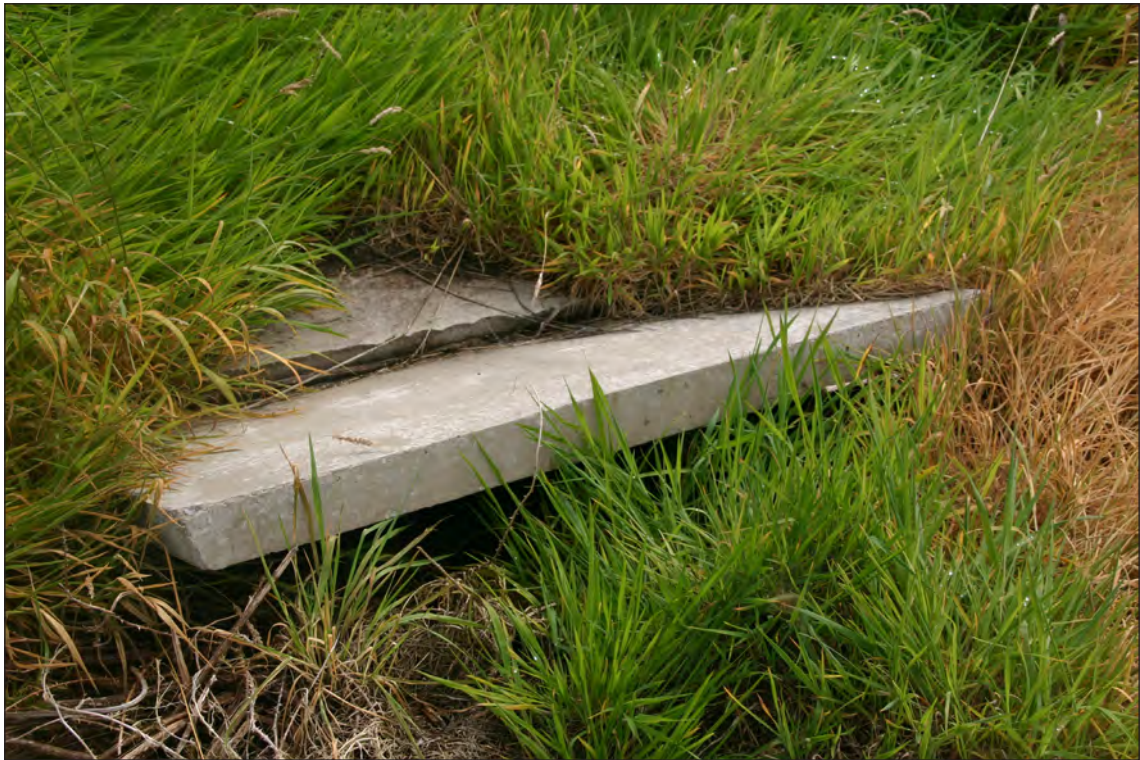
**Plate 17:** View of collapsing recently installed concrete lintels

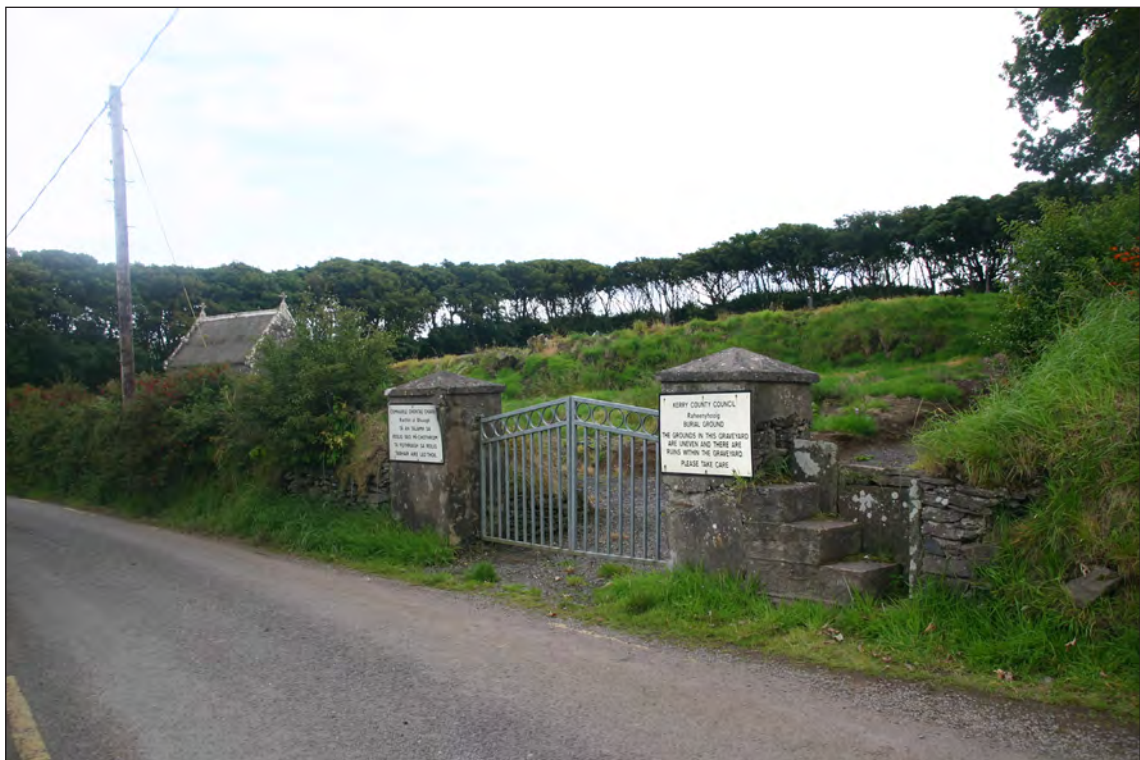
The entrance to Raheenyhooig is through a pair of modern galvanised gates that are set between two square, capped and rendered piers (Plate 22). The right or western pier has impact damage and part of its render has fallen and the pier has partially shifted. Consequently, the gates are out of alignment and difficult to open or close. There is a step-stile into the graveyard on the right or north-west side of the gate that requires work on its interior as it is concealed under ramped earth and irregular and slippery (Plates 21 & 24 ).

**Plate 22:** View of entrance gates to Raheenyhooig Graveyard. Note: step-stile on right

The gate pier should be repaired and the gates re-aligned for ease of access. The gates should only be opened inwards to avoid a potential roadside hazard.

- The entrance gates should be re-aligned and the damaged gate pier repaired.
- The area around the inside of the step-stile should be cleared.

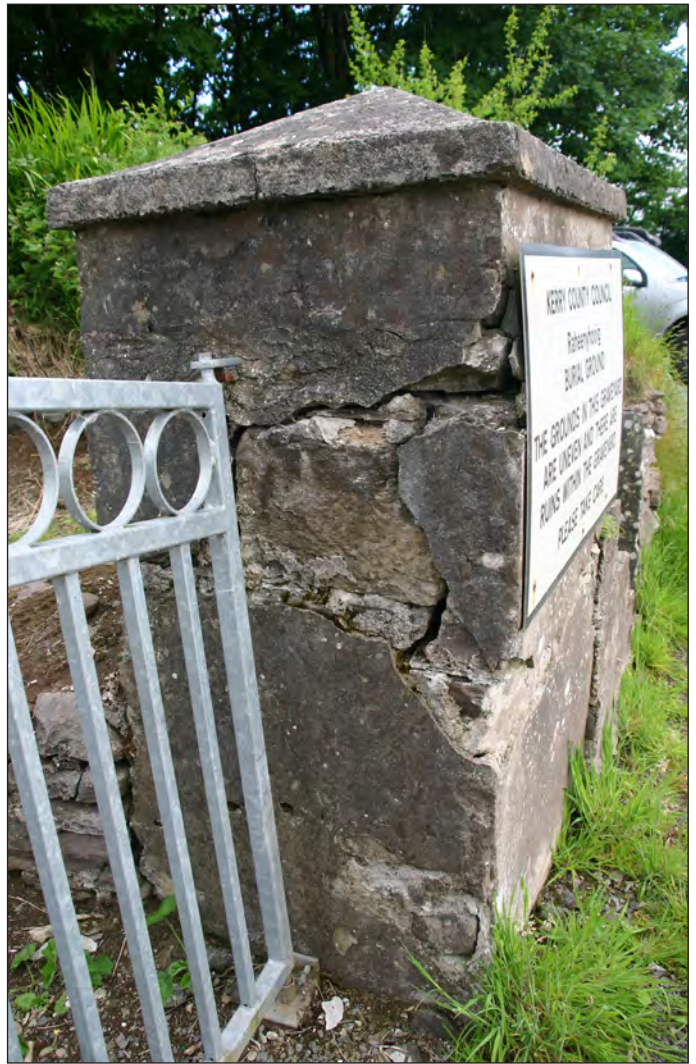
**Plate 23:** View of RH damaged entrance pier of Raheenyhooig Graveyard

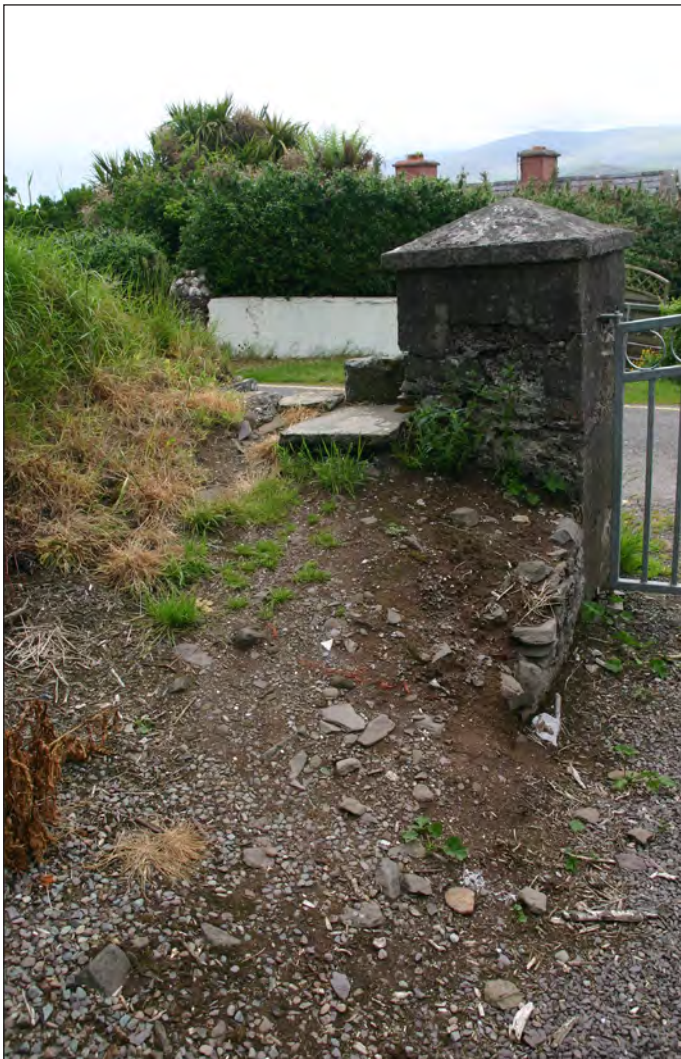
**Plate 24:** View of interior of step-stile. Note: ramped material covering stile

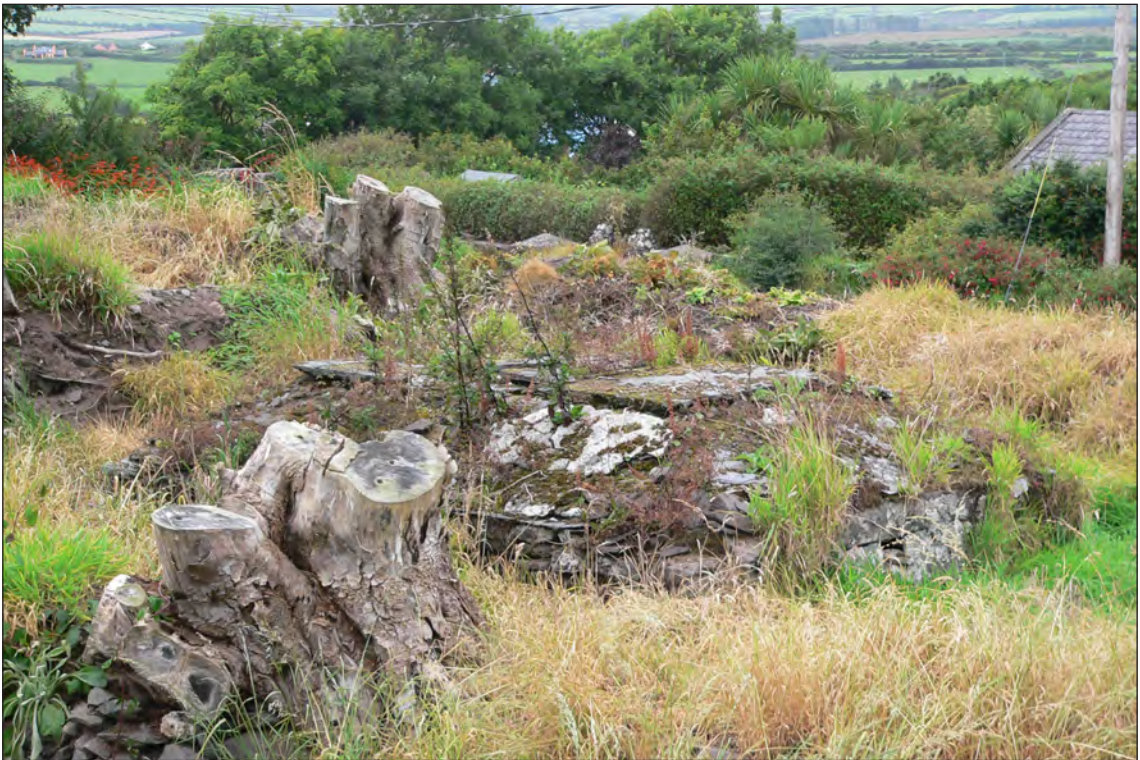
There are sixteen named tombs recorded in Raheenyhooig Graveyard (Appendix 1 & Figure 5). The tombs, for the most part, are in a good state of preservation, although the Ventry tomb (370) is in rag-order while minor repairs are required to the sides and haunches of others where some of the render is gone and a couple of the building stones fallen (Plates 26-28). Ten of them are of the 'strong-box' type and the other six are simple rectangular box or chest type. The majority are built with local rubble sandstone, brick or concrete blocks and rendered. None of the tombs are built with ashlar masonry.

**Plate 26:** View of collapsing 'Ventry' tomb (370) from S.

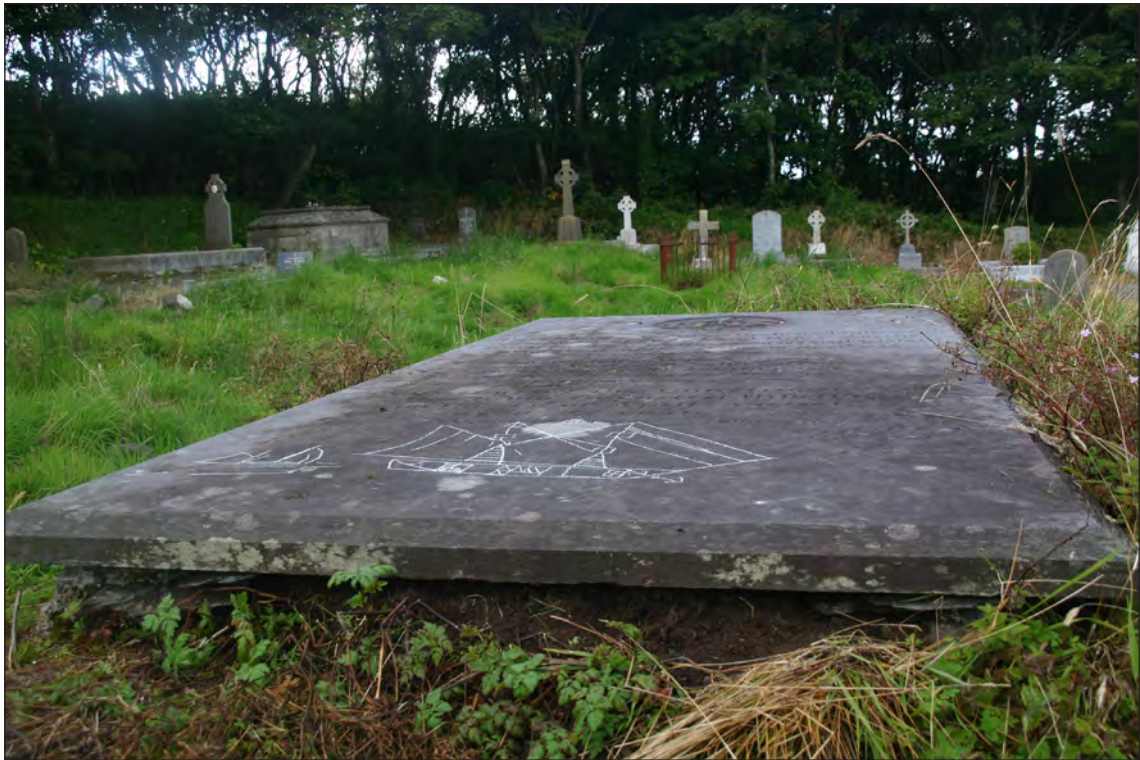
**Plate 29:** View of 1846 'Forhan' tomb (337). Note: ship-graffiti

The cleaning of tomb memorial slabs and plaques should only be carried out by professional people with a proven track record of undertaking such work. Uninformed amateur cleaning can result in the loss or erosion of inscriptions and would entirely destroy ship graffiti and other features. The Forhan tomb (337) is a paradigm of how amateur work could do damage or erase the ship graffiti.

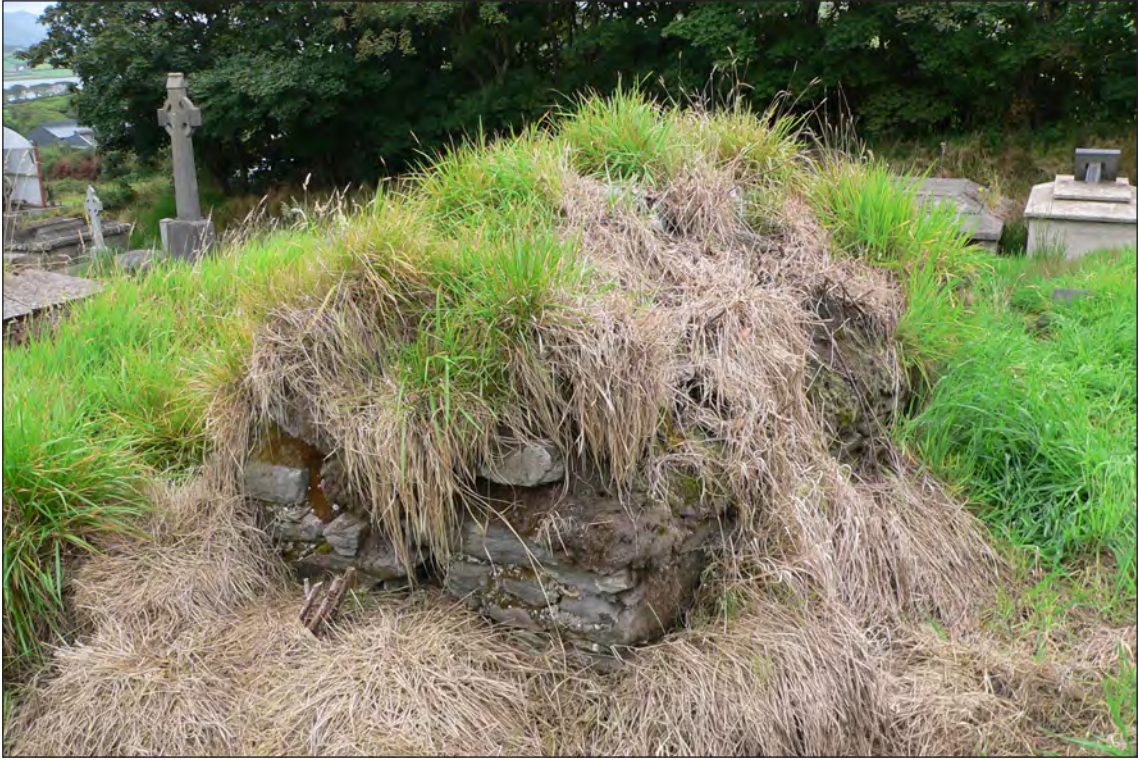
Twenty unnamed tombs were recorded in various states of preservation (Appendix 2). Many are constructed with rubble sandstone, brick and concrete blocks and are generally rendered or capped with rectangular flag stones. Six unnamed tombs are in good order (522, 545, 207, 252, 257 and 272) while tomb (194) requires minor repairs to its upper limits. However, there are thirteen unnamed tombs that are partially covered by grass or indeed survive as grass covered mounds (Appendix 2 & Plates 31-32).

**Plate 31:** View of unnamed overgrown tomb (297)

The grass and other vegetation partially covering some of the tombs should only be fully removed as the primary element of an agreed inclusive strategy of repairs and other conservation and restoration works. Tombs that are fully covered in grass should be cut back for further evaluation to determine the nature and extent of further conservation / restoration works. This work should be undertaken with expert archaeological advice and supervision.

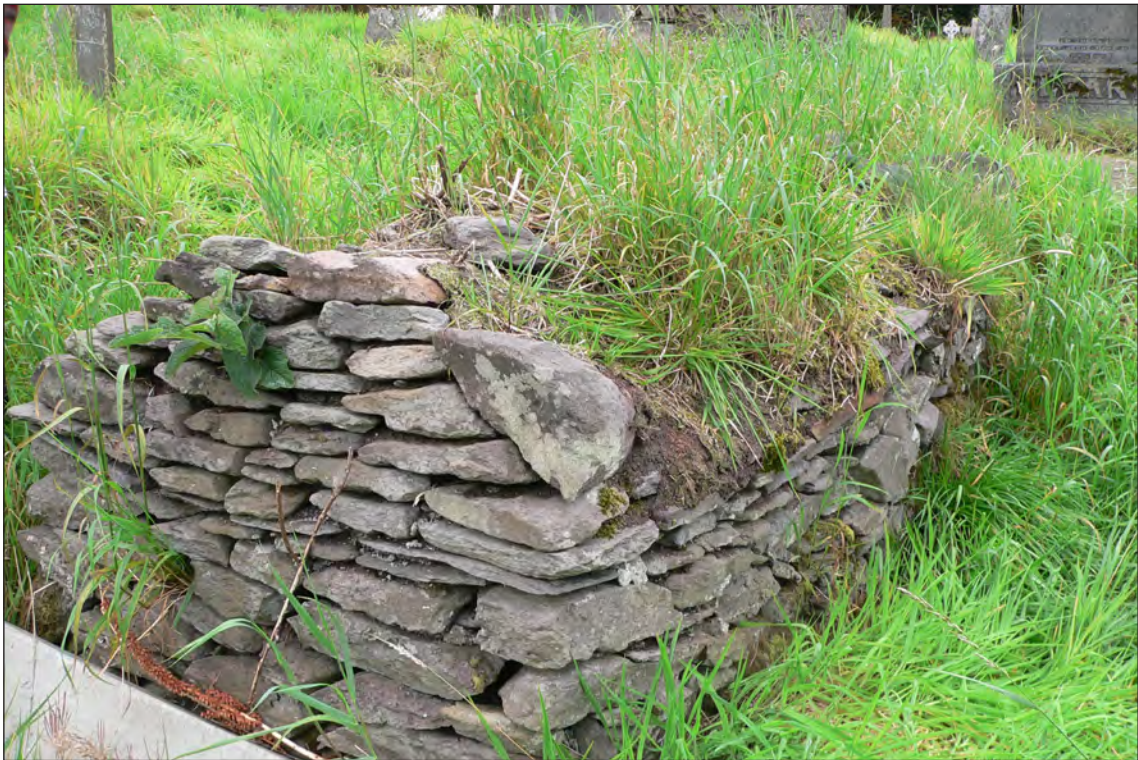
**Plate 32:** View of unnamed overgrown tomb (302)

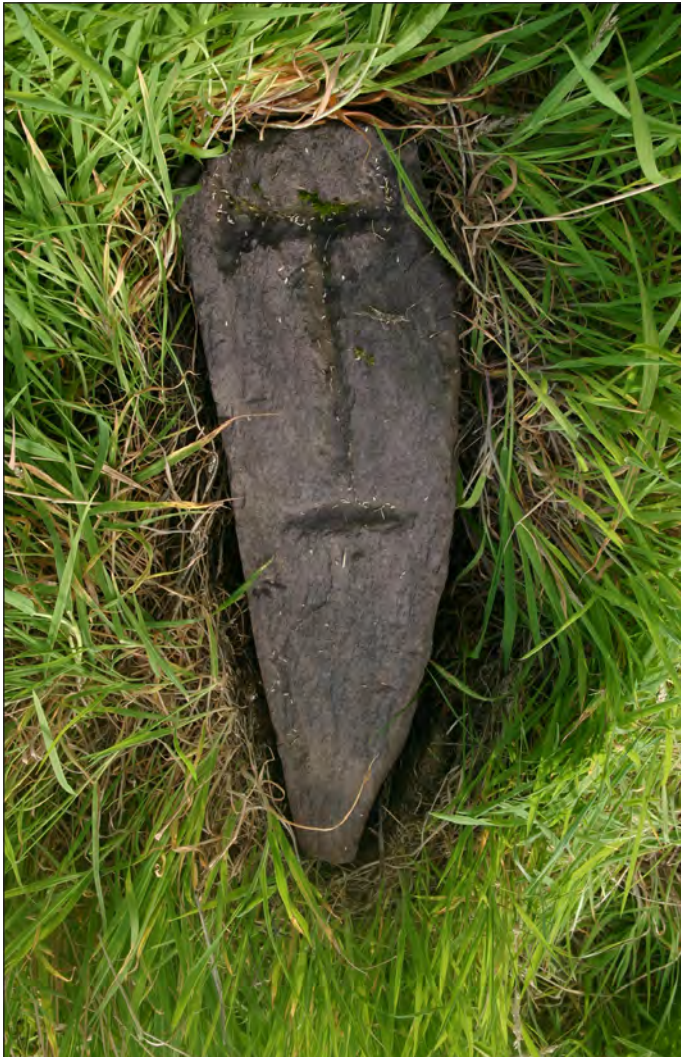
Two of the cross-slabs (74, 564, Plates 36-37) are loose while a third (57) lies flat on the surface (Plate 38 & Figure 5).

**Plate 38:** View of Tau-incised cross-slab (57) lying loose on the ground

- All the cross-slabs and holed stone should be archaeologically illustrated and researched.
- The loose cross-slabs should be secured in situ or removed to the Kerry County Museum for safe keeping.

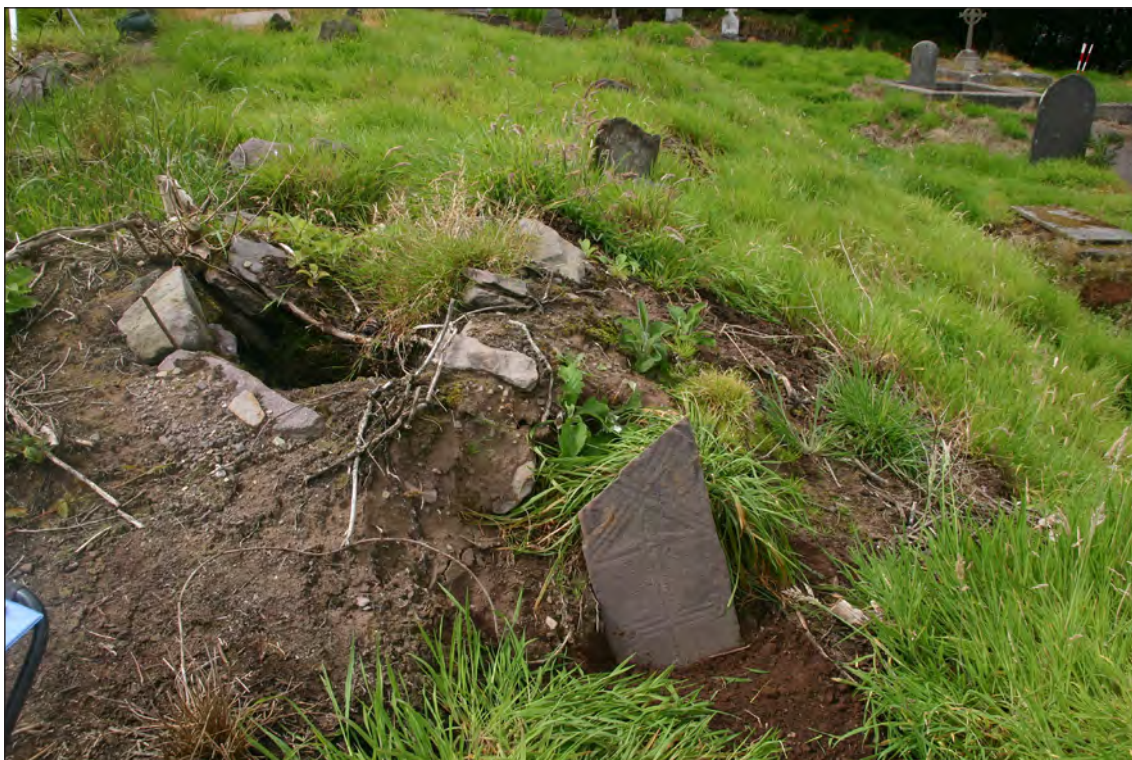
Cross-slab (564) is a thin rectangular slab with upper LH corner broken (Plate 37). The stone features a lightly incised motif comprises interlaced triangular panels set within a square, pendant to which is a vertical shaft of three lines and two arms with 'C' scroll returns. This particular interlaced motif is not paralleled in the corpus of cross-slabs on the Dingle or Iveragh Peninsulas although the 'C' scrolls feature on a number of early slabs. The cross-slab lies somewhat loosely and precariously against a collapsed lintelled grave (Plate 41 & Figure 5).

**Plate 41:** View of cross-slab (564) lying precariously against collapsing lintelled grave from E

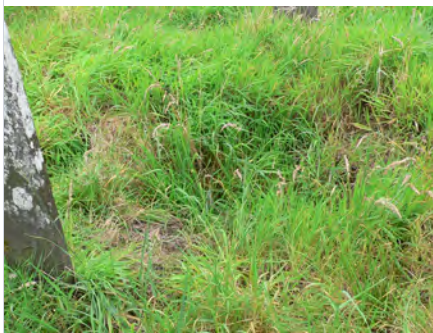
<b>Tomb No:</b>	312
<b>Photo No:</b>	152_0800
<b>Photo:</b>

<b>Notes:</b>	
Collapsed	Y
Open	Y
Rendered	N
Overgrown	Y
