Project code: KCCG11
Client: Kerry County Council
Date: September 2011

Archaeological Survey of Kinard Burial Ground, Lispole, Dingle, County Kerry

Surveyors: Ann Frykler & Robert Hanbidge
Report Author: Robert Hanbidge

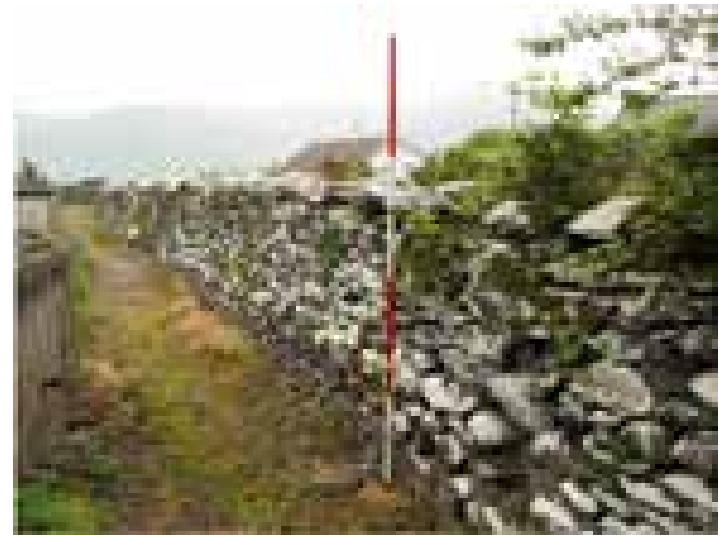
The boundary walls surrounding the historic section of the graveyard consist of both roughly dressed mortared rubble stone with rubble stone coping and drystone walling (Plates 1-7). Rendered rubblestone walls with rendered square-profile piers enclose the graveyard extension. The drystone walling survives in mixed condition in the different boundaries with occasional areas of collapse to the walls and the coping. The area of most concern is in the western boundary where a substantial portion of the wall has partially collapsed (Plates 6 and 7).

Plate 2-Internal view of eastern boundary

Repair collapsed sections of the walls.

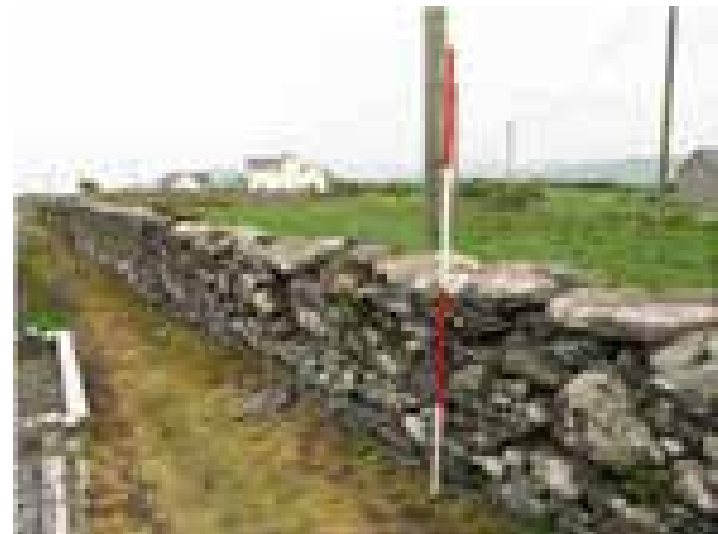
Plate 4-Internal view of northern boundary

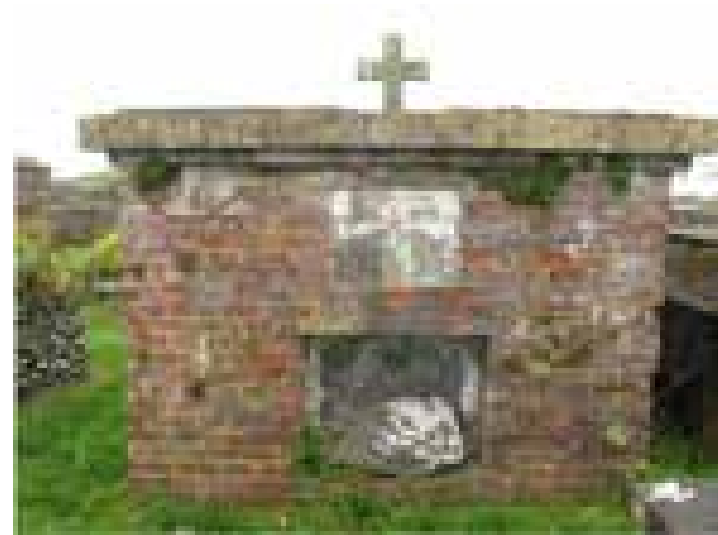
Plate 14-View of tomb (Grave No. 80), from east

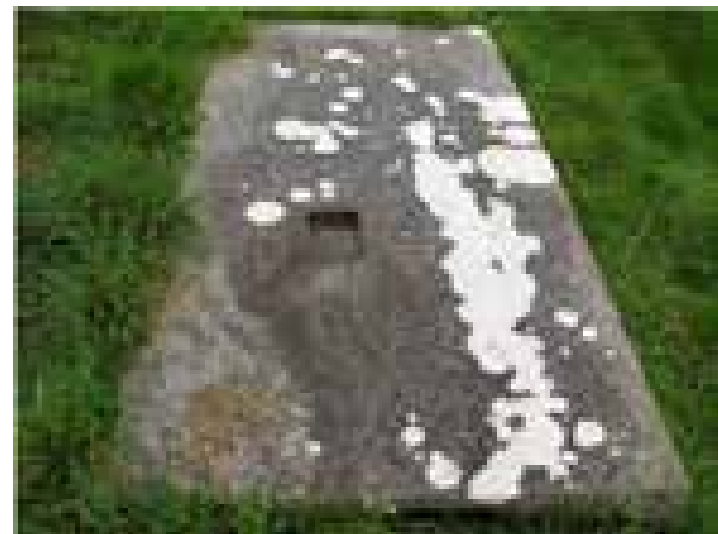
Most of the tombs are in good condition e.g. Grave No. 230 (Plate 15). However some of the capstones of the tombs are becoming increasingly weathered and are almost illegible e.g. Grave No. 71 (Plate 16).

Plate 16-View of capstone to tomb (Grave No. 71), from east

General maintenance of the tombs including the repointing and repairing of areas of damaged rendering

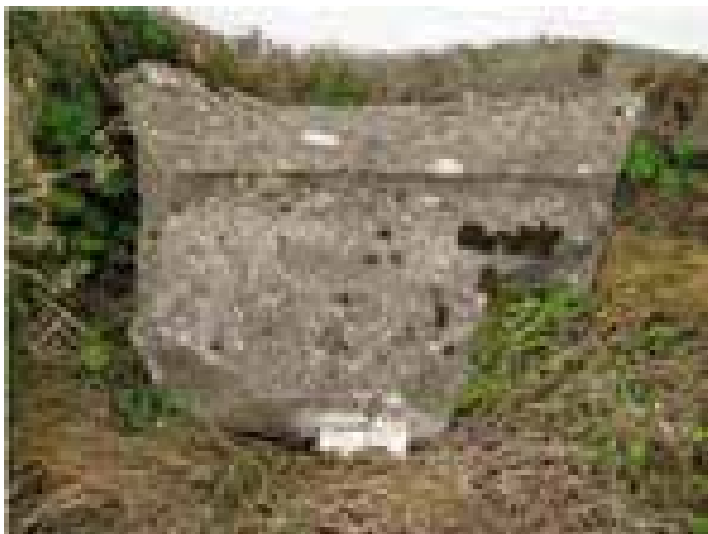
Plate 23-View of broken headstone to Grave No. 8, from east

Collapsed headstones should be re-erected. Any broken or damaged headstones should be replaced.

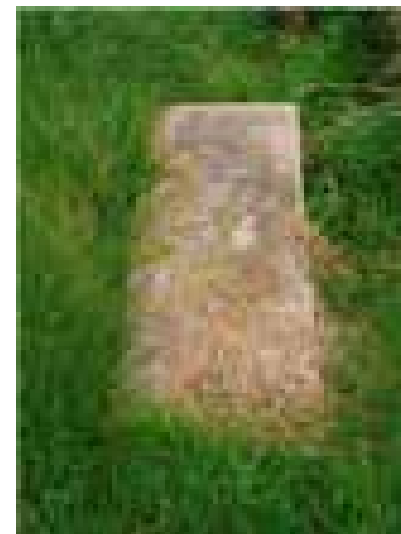
There are 6 unnamed headstones and plots within Kinard Graveyard. The majority of these are in reasonable condition. However several of these burials are in poor condition, e.g. Grave No. 379 appears to be a plot or burial which has been in-filled with rubble to form a level surface as this plot is truncated by the exterior path (Plate 22). There are some examples of broken headstones e.g. Grave No. 8 (Plate 23). Some plots in common with other grave types within Kinard Graveyard, show signs of collapse with temporary fixes such as concrete slabs and lintels being placed over the voids e.g. Grave No. 25 (Plate 24).

Plate 24-View of Grave No. 25, from west

The use of concrete lintels to cover the voids caused by collapse, do represent a quick remedy in addressing these safety concerns. However these should be in turn covered with earth and a grass surface established which would integrate these repairs works within the historic character of the graveyard and reduce any visual impact that these would have.

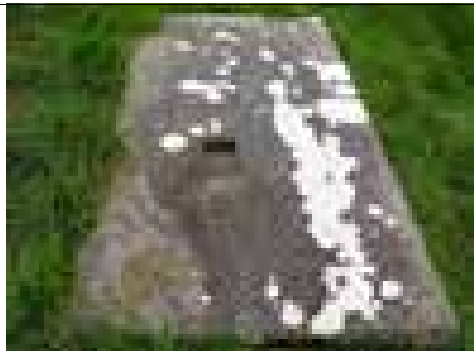
Grave_No	Family Name	Photo_Name
71		IMG_0126
Notes		
Heavily eroded illegible
