Archaeological Survey,  
Shronahiree Graveyard,  
Glencar,  
Co. Kerry.

October 2008

Client: The Heritage Office,  
Kerry County Council,  
County Buildings,  
Ratass,  
Tralee,  
Co. Kerry.

RMP No.: KE082-001

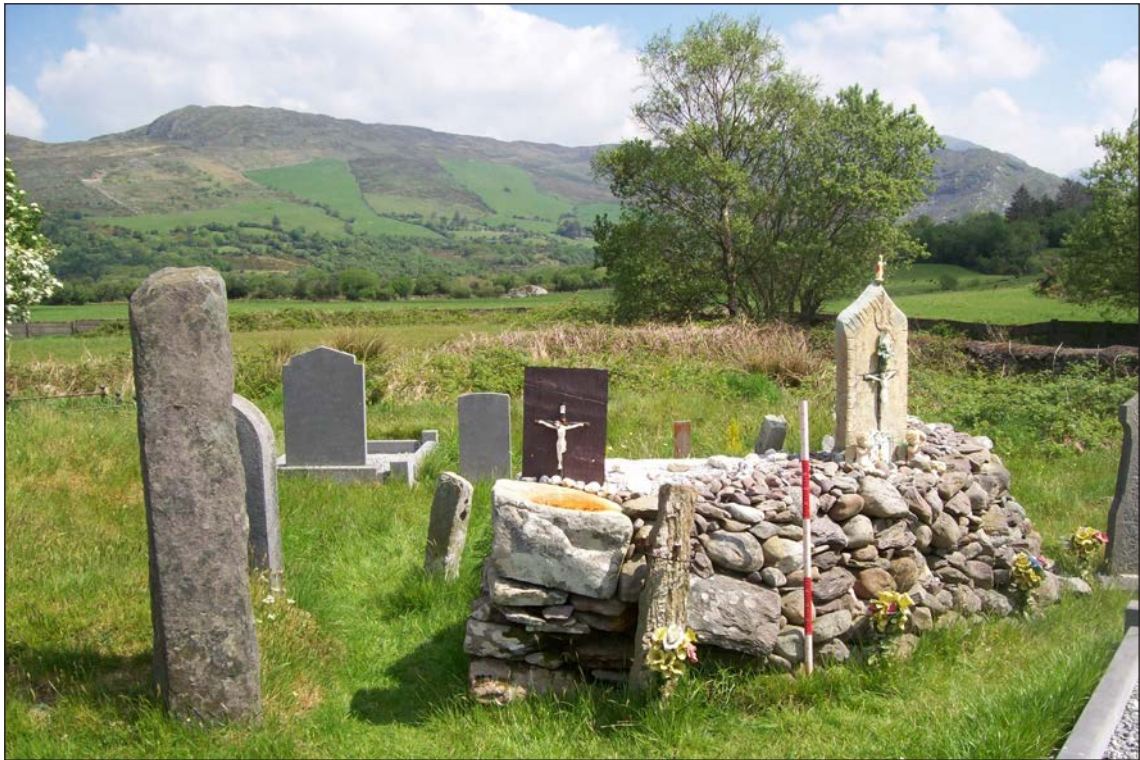
The church ruins are situated on a small platform towards the eastern side of the old graveyard (Plate 3).

Plate 3: View of church ruins from southwest

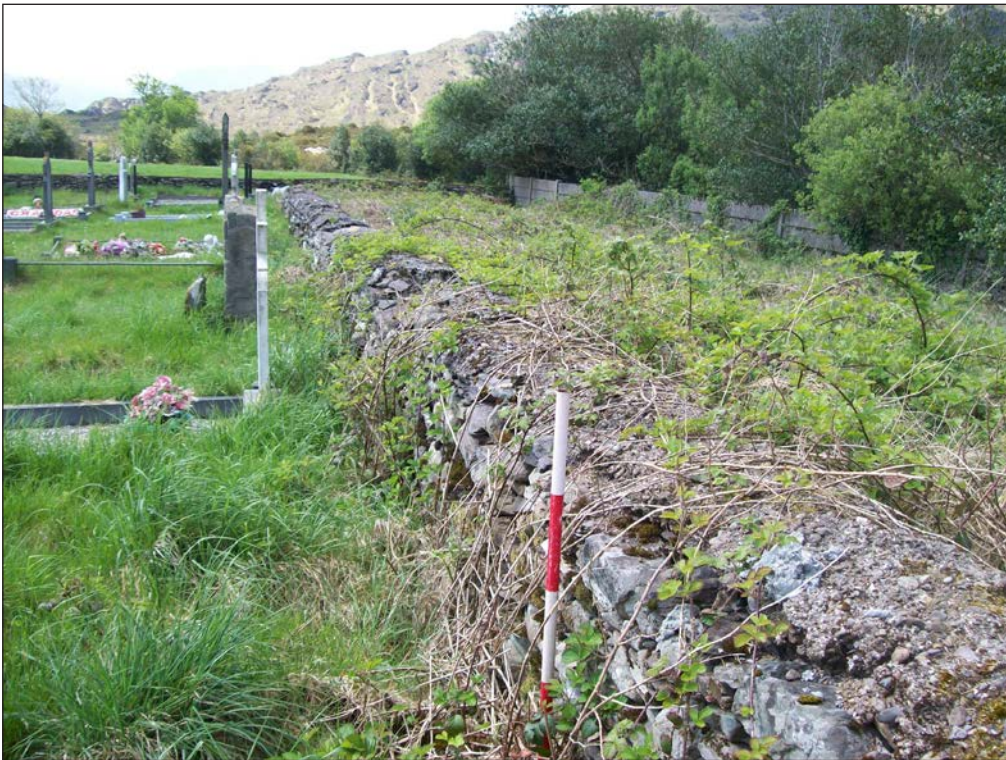
Plate 4: View of overgrown area in the north and northwestern area of the graveyard, from northeast

A large area in the north and northwestern area of the graveyard is extremely overgrown with brambles and is inaccessible (Plate 4).

There are two western boundaries (Plate 4). The original western wall is the same construction as that in the east and south, and while the newer boundary is located approximately 10m west of the original and is constructed of the same concrete panels as in the north. The area in between these two boundaries is extremely overgrown and inaccessible (Plate 9).

The large area of overgrowth between the two western boundaries should be cut back and then maintained on a regular basis.

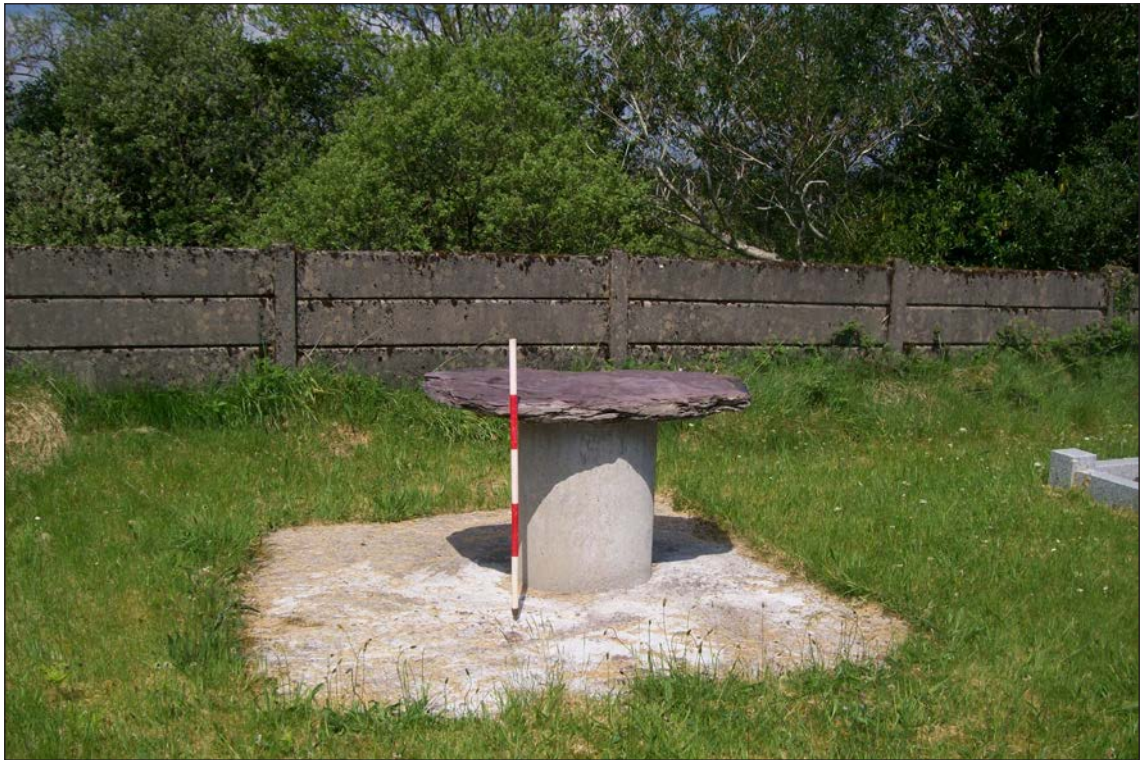
A permanent altar of concrete and sandstone is located on the western side of the extension (Plate 5).

Plate 5: View of altar in modern extension from east

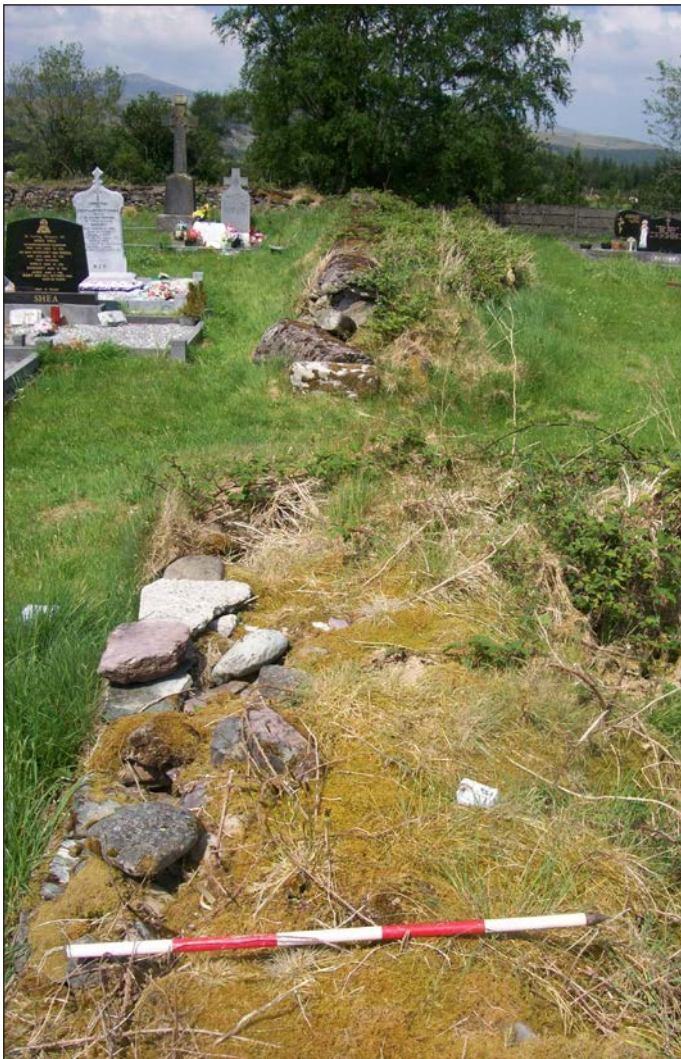
There are two northern boundaries evident. The original boundary wall is of the same fabric as in the south and east (Plate 6), while the new northern boundary for the extension is constructed from concrete panels and is heavily overgrown in places and measures *c.* 1.2m in height (Plate 7). There is a large opening in the old northern boundary which allows access/

Plate 6: View of original boundary wall now forming division between the old and new areas of the graveyard, from southeast

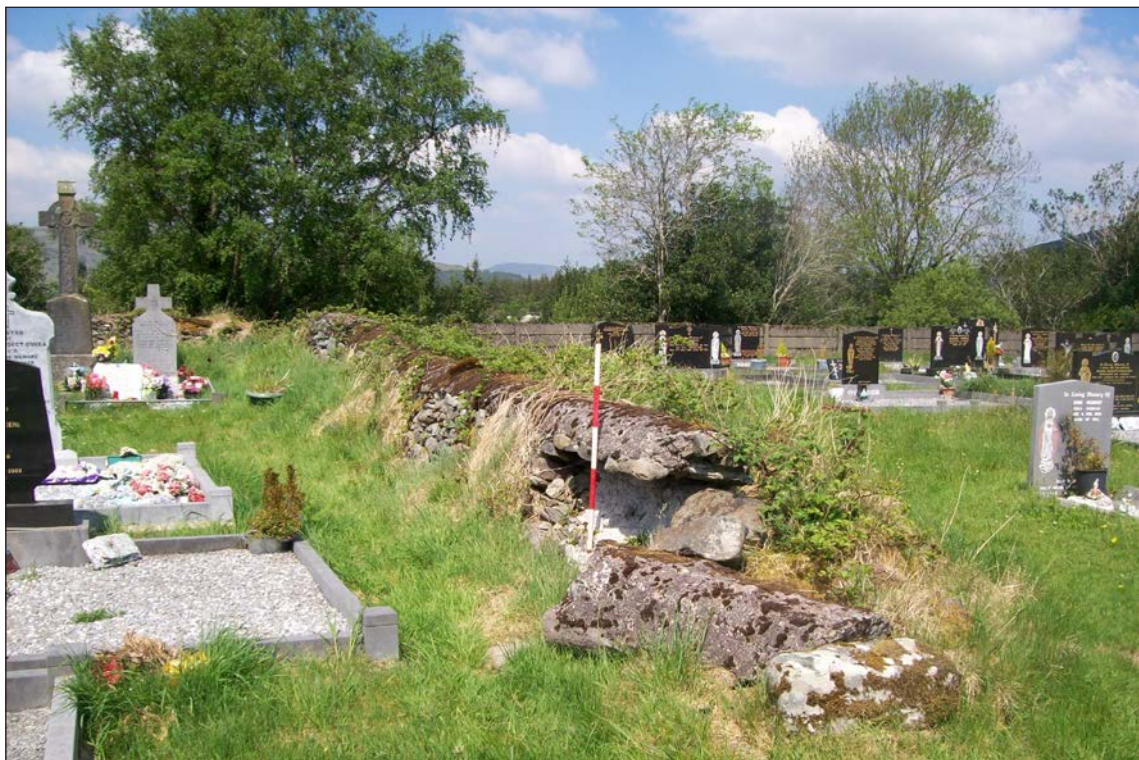
**Plate 8: View of breach in original boundary wall allowing access between the old and new areas of the graveyard from southeast**

egress between the two areas of the graveyard and a small area of collapse is evident (Plate 8). This wall is overgrown with brambles on both sides.

The small area of collapse of the original northern boundary wall, which now forms the inner dividing wall between the old and new areas, should be repaired and made good.

The overgrowth of brambles etc along the interior and exterior of the original northern walls, and along the new northern and eastern boundaries should be cut back and removed.

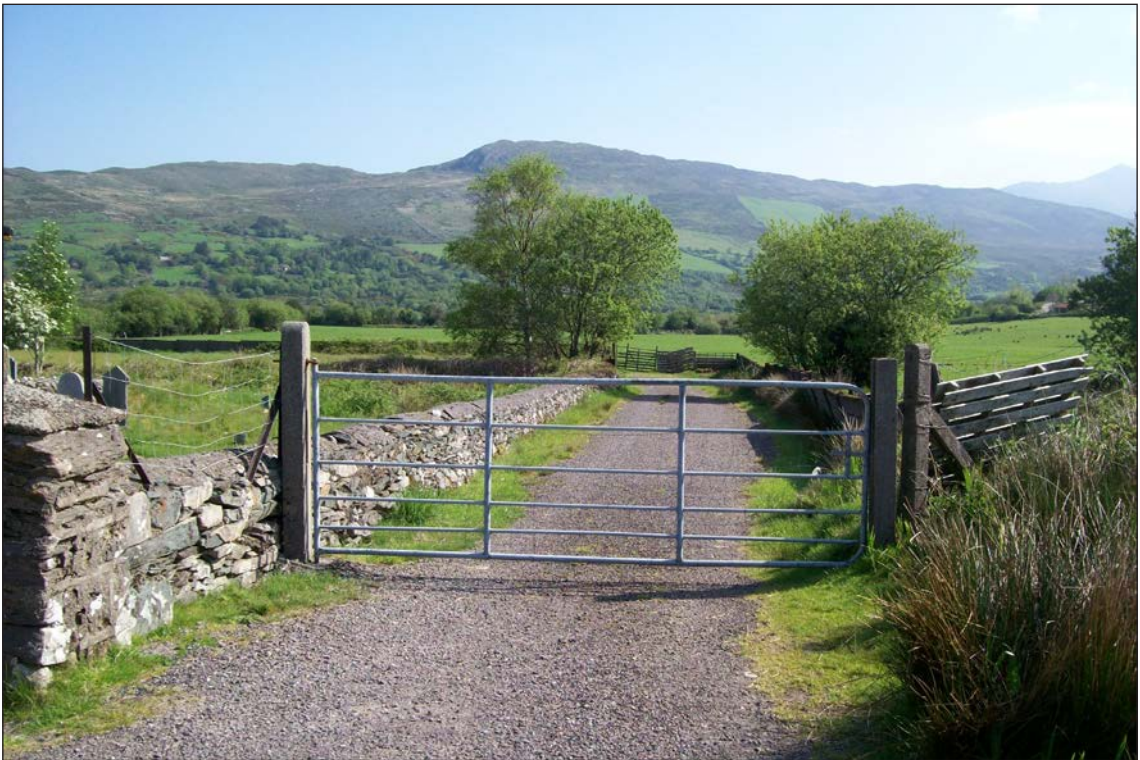
Located to the south of this entrance, and set back from it by approximately 2m, is a modern metal farm gate which allows access/egress to another entrance for the extension (Plate 10).

Plate 10: View of entrance allowing vehicular access to the modern extension, from south

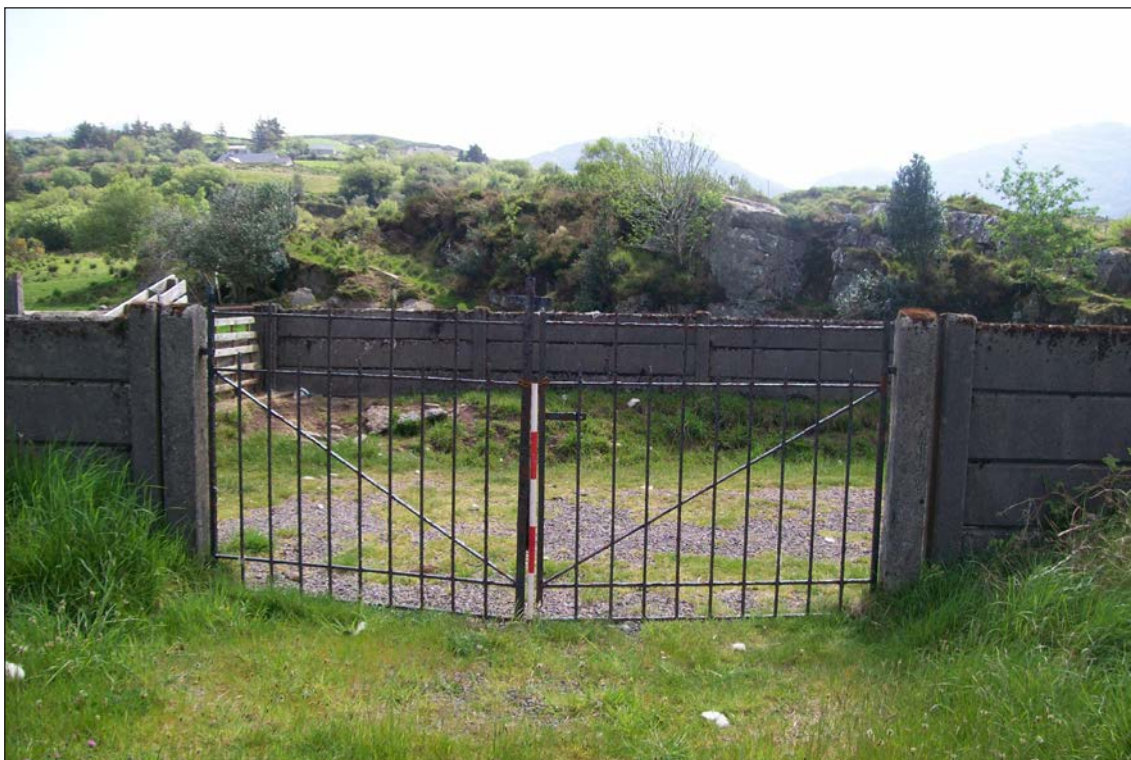
The entrance to the modern extension comprises double metal gates with a small metal cross at centre (Plate 11).

Plate 11: View of entrance gates to the modern extension from northwest

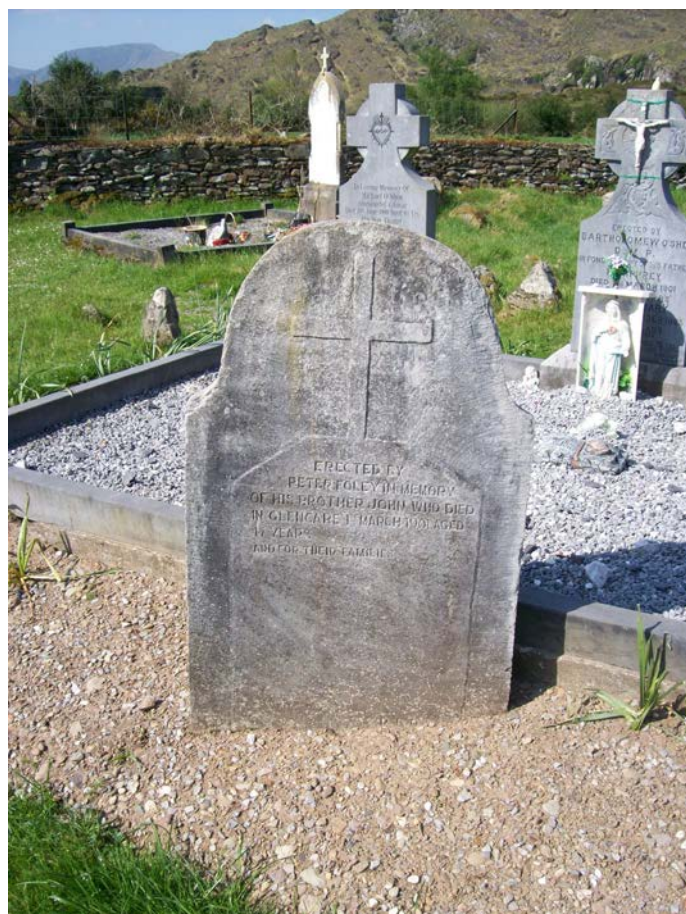
Plate 12: View of earliest inscribed headstone dated to 1901 (ref. no.10)

The earliest dated to 1901 (ref. no.10) and commemorated the death of John Foley of Glencar (Plate 12).

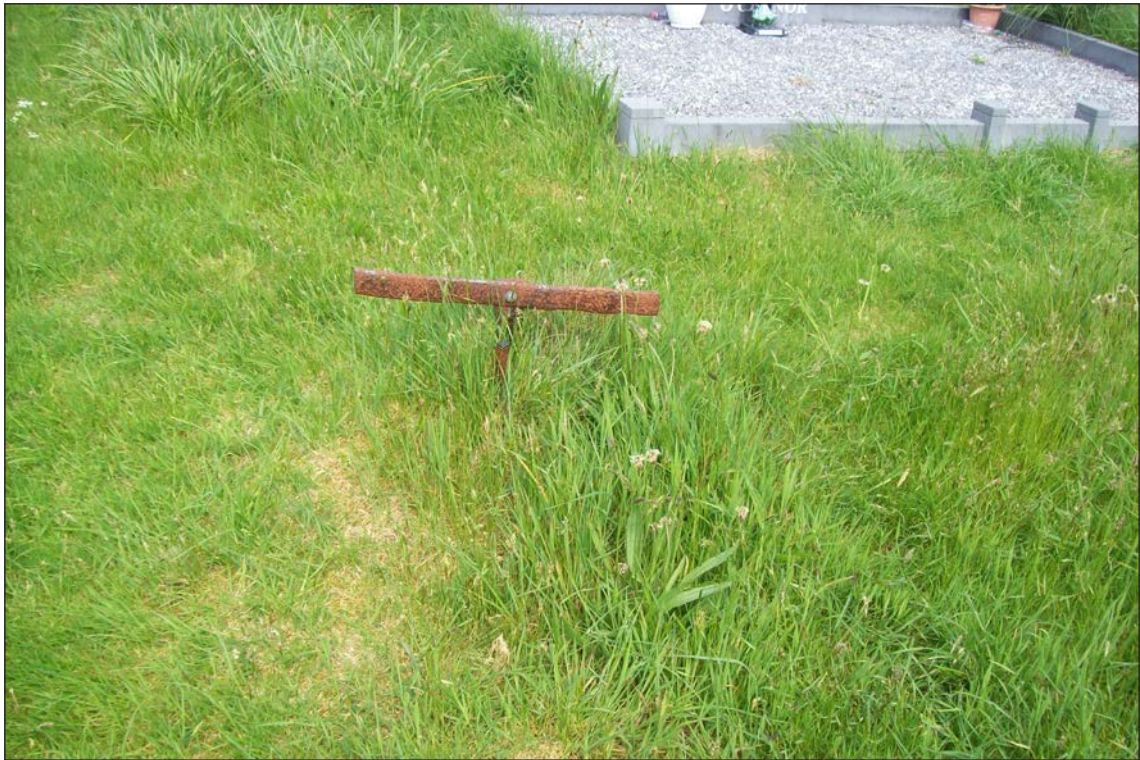
**Plate 13: View of broken metal cross denoting an unnamed grave in the modern extension, from east**

Two unnamed headstone (ref. no. 174) were recorded within the graveyard (Plate 13).

Located in the new extension the temporary metal cross is broken and no name is evident.

Temporary name plaques should be established for the two unnamed graves, until a permanent headstone is erected.

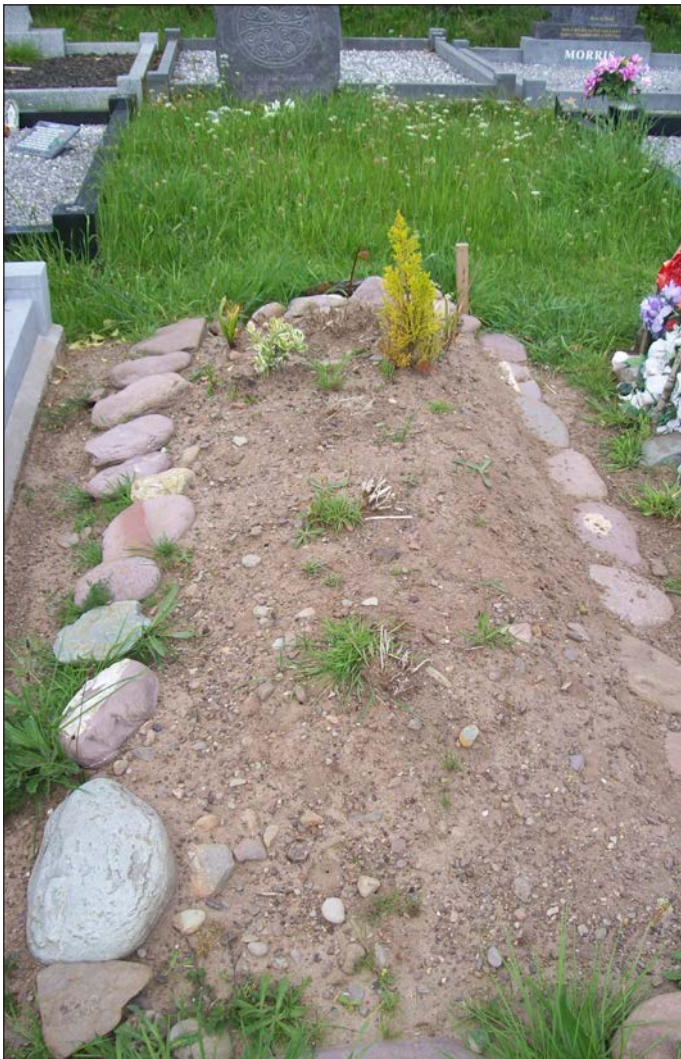
**Plate 14: View of unnamed grave-plot in modern extension, from east**

An unnamed grave-plot (ref. no. 193), without either a headstone or temporary name plaque, was also recorded in the extension (Plate 14).

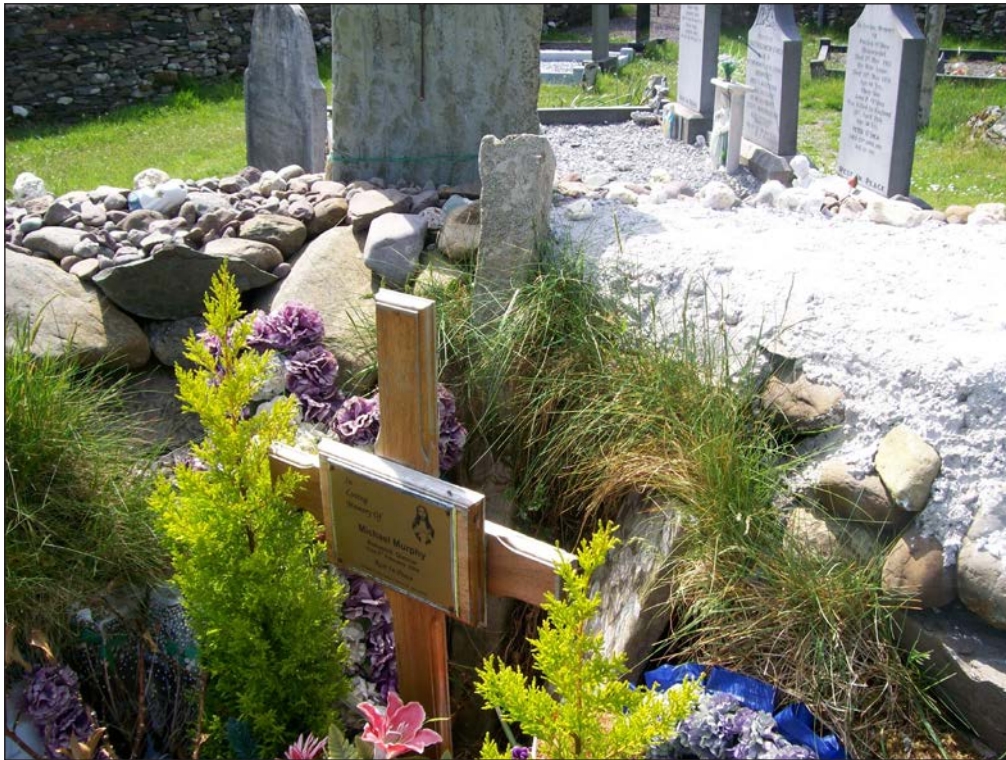
Plate 15: View of Cross Slabs (ref. 24 & 25) from north

The survey undertaken in 2008 found that slabs no. 1 (ref. no. 24) and no. 2 (ref. no. 25) described above have been moved from their previously recorded location (Plate 15). They are now located within the interior of the church, and are almost completely hidden from view by a modern grave. Indeed, they are almost assimilated into the grave setting itself of the grave (ref. no. 27). It was very difficult to gain an advantage to photograph Cross slab no. 2, given its location (Plate 16).

While the published survey made no reference to the presence of graves within the church interior, it is clear that the graves were present at the time as the headstones date from 1906 to 2006 (Plate 19). The most recent grave (ref. no. 27) should not have been permitted as there was and is ample room for burials in the extended area, and this grave caused disruption to two of the recorded cross slabs. A cement render has also been established on the interior western wall of the church, immediately behind the grave (Plate 15).

Cross slabs 1 and 2 should be removed from their current location within the modern grave setting, under archaeological supervision, and securely fixed in a suitable location in the vicinity of the ruins of the church or back in the locations recorded by the Iveragh Peninsula Survey (ibid).

The two displaced cross slabs should be returned to their location as recorded in the Iveragh Peninsula Survey, or to a location deemed suitable by a qualified archaeologist.

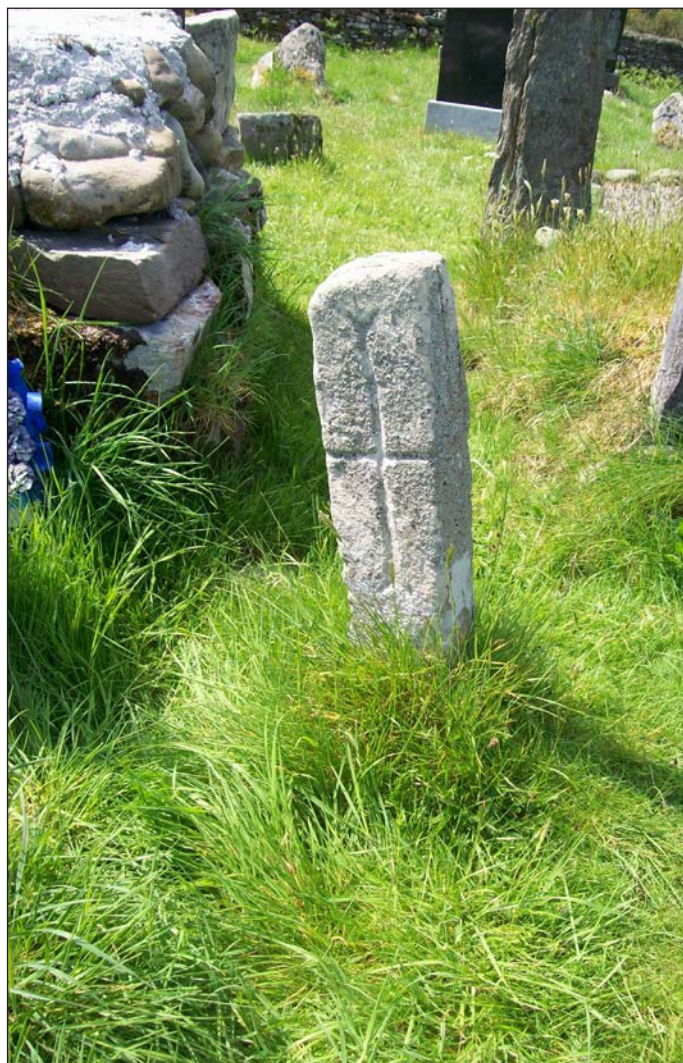
**Plate 17: View of Cross Slab (ref. no. 26)  
from north**

Cross slab no. 3 (ref. no. 26) is still in the location recorded by the Iveragh survey (Plate 17).

No further burials should be permitted within the church interior as this could damage the Cross slab no. 3 which stands immediately inside the entrance.

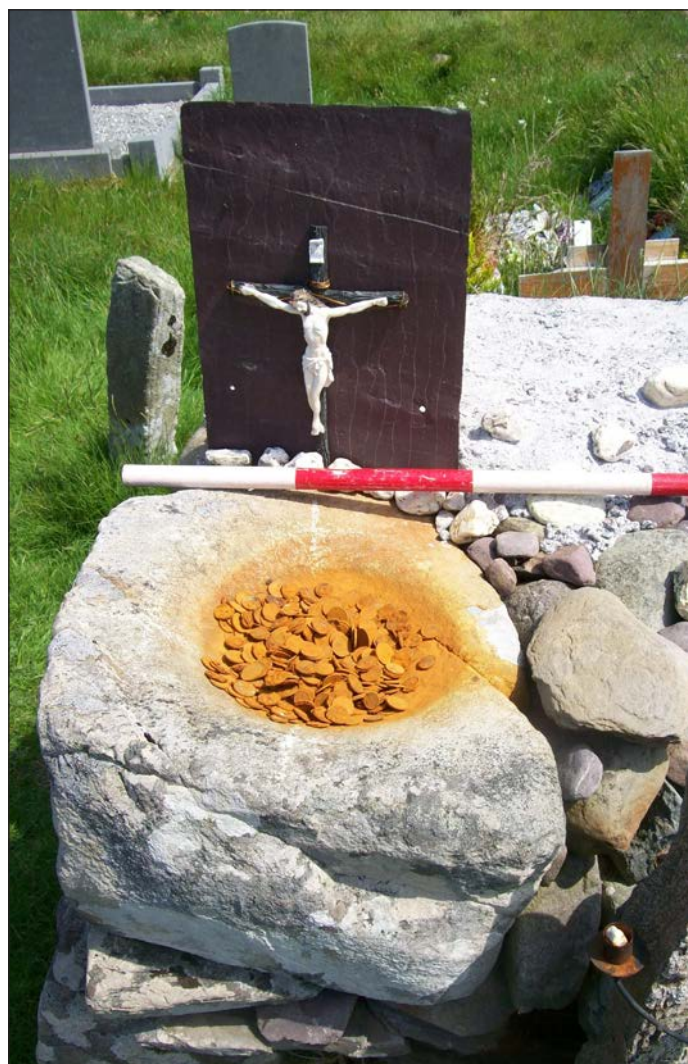
**Plate 18: View of Bullaun Stone (ref. no.  
208) from south**

The current survey found that the bullaun stone (ref. no. 208) has remained in the same location as described above (Plate 18). However, a practice has emerged of dropping coins into the depression which has heavily stained the stone.

The practice of using the bullaun stone for the deposition of coins should be halted and a suitable container fixed to the graveyard boundary wall by the pedestrian entrance should people feel the need to make a votive offering.

Votive offerings should be removed from the bullaun stone.

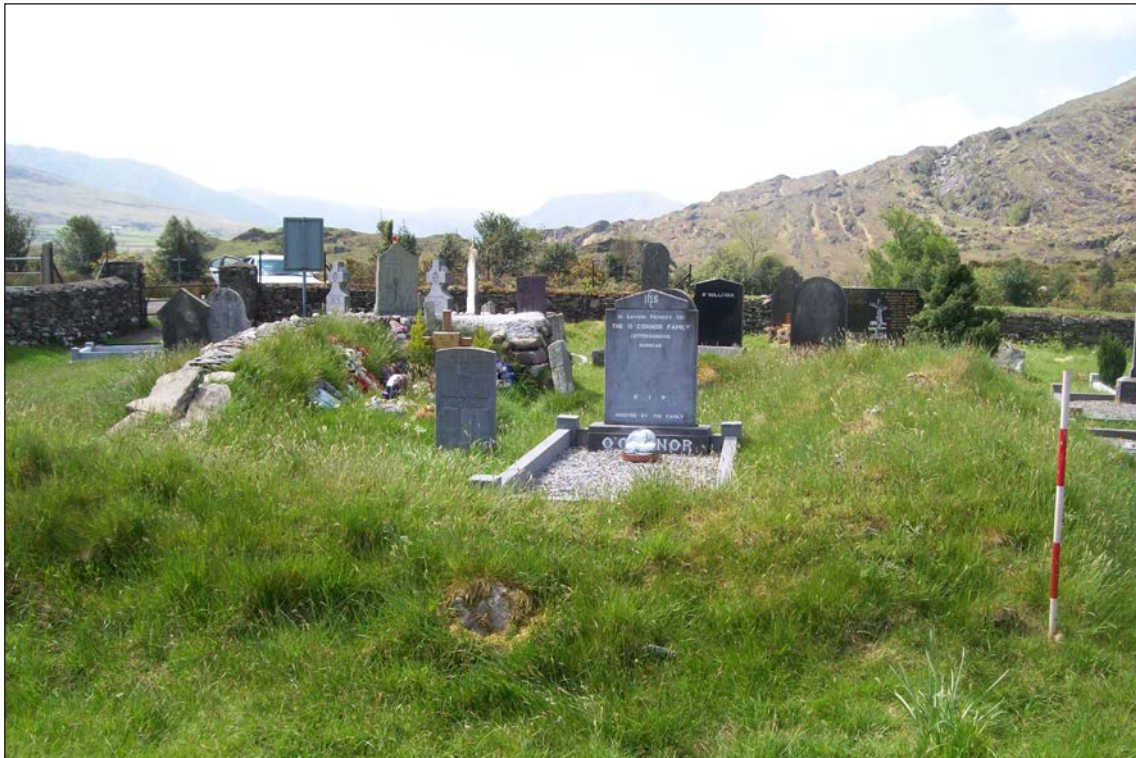
Plate 19: View of headstones within church interior, from northeast

The western and northern walls of the church are completely covered with sod and as a result, have been protected from the damage which has been inflicted upon the exposed fabric of the church (Plate 19).

No further burials should be allowed within the church interior.

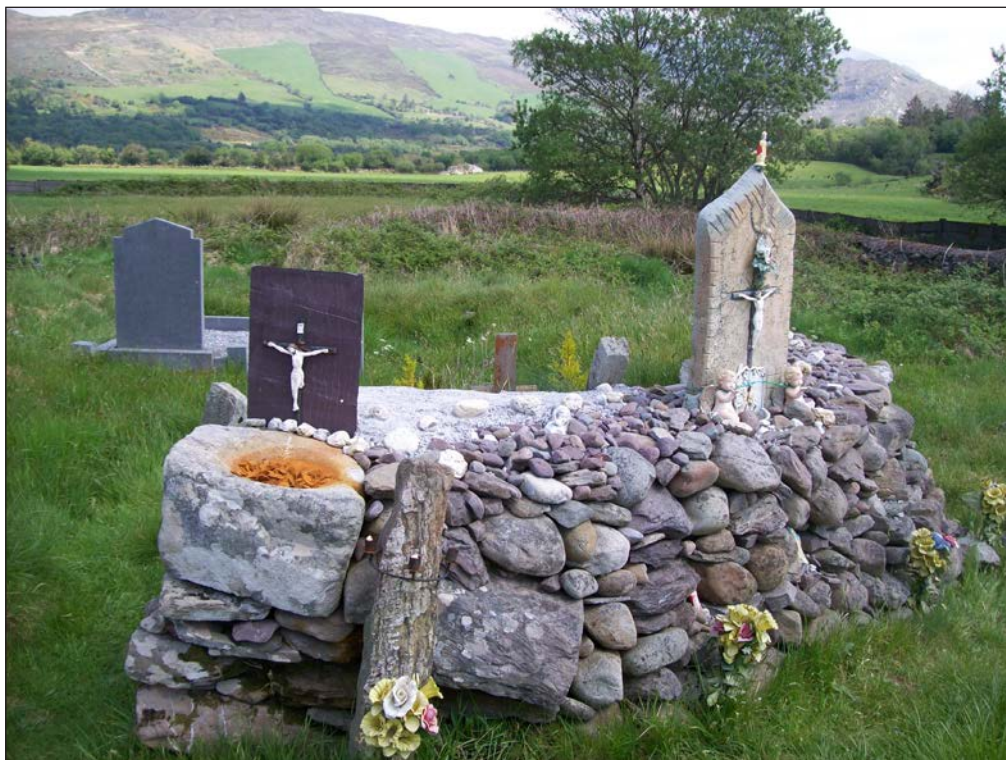
Plate 20: View of southern and eastern walls of the church

The upper surface of the southern and eastern walls has been covered with loose small sandstone pebbles which have been added for some unknown purpose to the original construct of the building (Plate 20). As stated previously, a small area of the upper surface and interior of the southern wall has been covered in a crude cement render and is possibly associated with the recent grave in 2006 of a member of the Murphy family.

Two modern 'shrines' have also been established on the upper surface of the southern wall of the church and are cemented *in situ* (Plate 20).

Any cavities or small recesses, such as those caused by a collapsed stone, in the southern and eastern walls have been 'filled' with small statues to the Child of Prague Virgin Mary and Jesus. Plastic flowers have been established at intervals along the base of length of the southern and eastern walls (Plate 20).

A stone, measuring approximately 0.5m in height, is located to the immediate east of the entrance to the church on its exterior. The stone has been fitted with candle holders, and almost abuts the exterior southern wall of the church (Plate 20).

The loose rubble sandstone pebbles should be removed from the upper surfaces of the southern and eastern walls under archaeological supervision.

The two fixed shrines should be removed from the upper surface of the southern wall under archaeological supervision.

The small statues which are scattered throughout the fabric of the southern and eastern walls should be removed.

The plastic flowers along the base of the southern walls should be removed.

The stone which seems to function as a candle holder, immediately outside the entrance to the church should be removed.

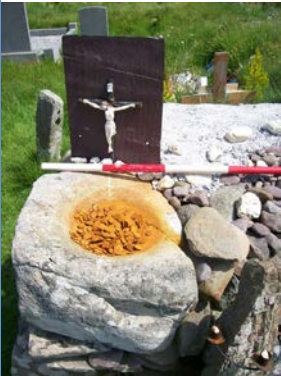
ID No.	208
Photo No.	100-5196
Photo

Notes	Bullaun Stone
