Archaeological Survey,
Churchill Graveyard,
Tralee,
Co. Kerry.

laurence dunne
archaeology

October 2010

Client: The Heritage Office,
                     Kerry County Council,
                     County Buildings,
                     Ratass,
                     Tralee,
                     Co. Kerry.

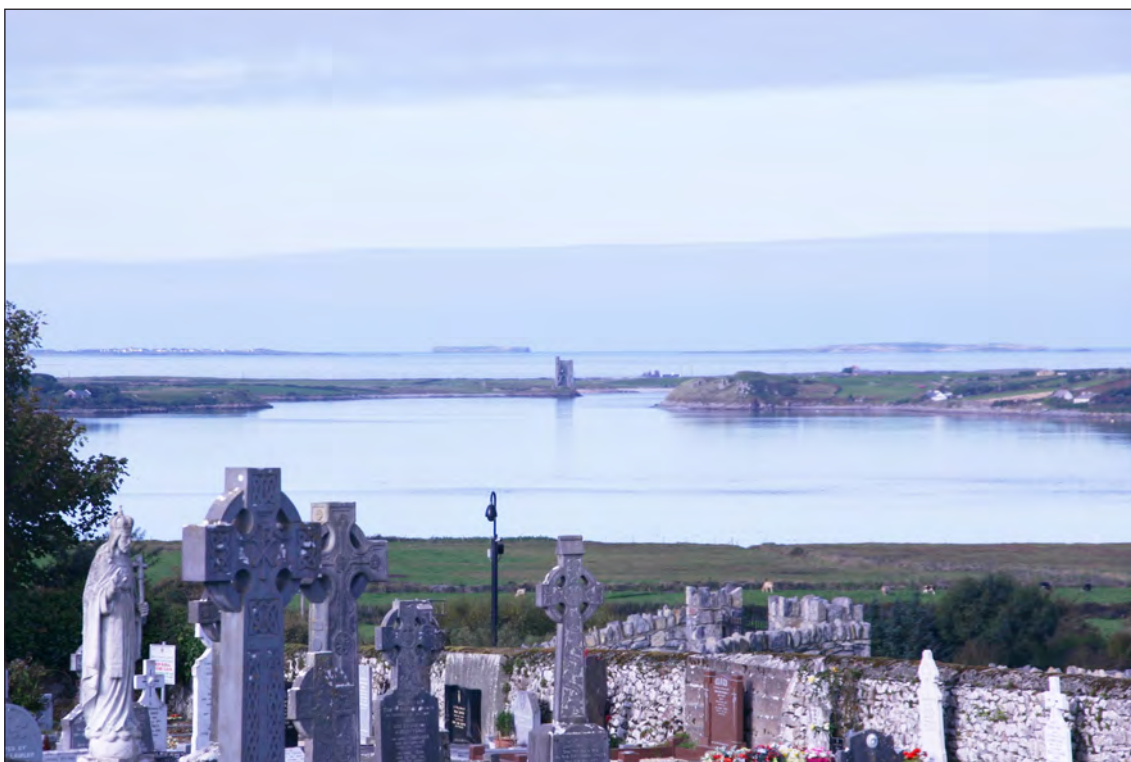
Immediately inside the main vehicular gateway there is a wide gravel trackway that more or less bisects the graveyard in two separating the older burial ground from the newer area. This trackway essentially extends to the old ruined church and is recorded on the 2nd Edition OS map of 1896 (Plate 15 & Figure 5). However, there are no other paths in the old medieval burial ground which is completely overgrown and unmanaged (Plates 8-9).

Plate 9: View of medieval burial ground area of Churchill Graveyard from south-west. Note wild unmanaged neglected state

The old medieval burial ground area should have its dense grass cut very low. The ground should then be resurveyed and informal paths created and maintained by regular cutting.
