Date: October 2009

Project code: TGSK09

Archaeological Survey, Aglish Graveyard, Aglish, Co. Kerry.

RMP No.: KE058 024

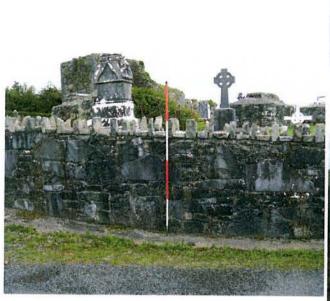
Plate 01 - Recent enclosing wall from west.jpg

The boundary walls surrounding the earlier graveyard are of mortared rubble stone with rendered capping. There is also a section of recent, presumably double layered, dressed rubble limestone wall to the west (plate 1), having recent cement render capping and decorative rubble stone crenellations. A well executed stile is located to the northeast corner in the earlier wall.
