Archaeological Survey, Aghavallen Graveyard, Rusheen, Ballylongford, Co. Kerry.

September 2010

Client: The Heritage Office,

RMP No.: KE002-058 Church

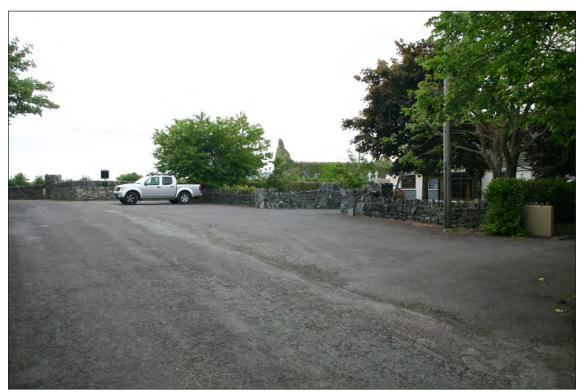
Plate 1: Approach view of Aghavallen Church, Graveyard and carpark from south

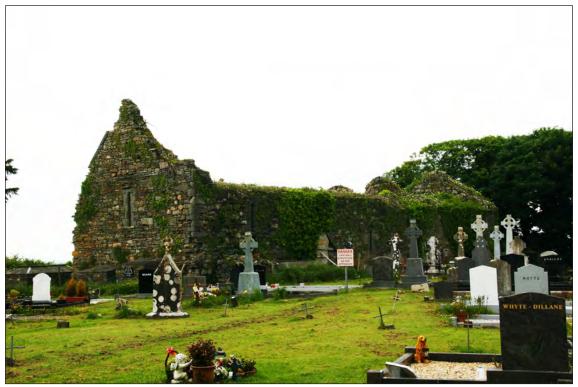
Sixty six unnamed graves were recorded within the graveyard (Appendix 4), the majority comprising simple unhewn stone gravemarkers as well as some simple iron or wooden crosses (Plate 2). Un-hewn un-inscribed headstones and the grass grave they mark form

Plate 2: Entrance approach view of Kilnaughtin church and graveyard from southwest. Note simple metal crosses and further note DANGER sign

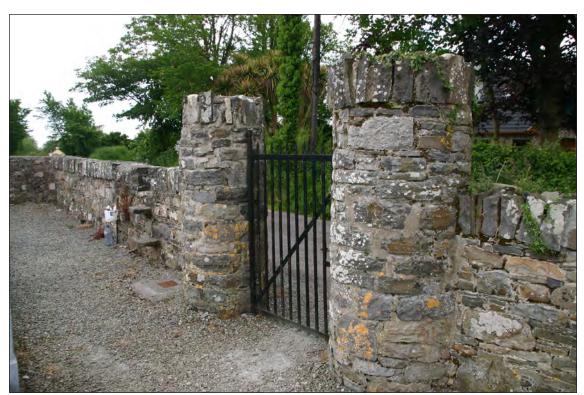
Plate 7: Interior view of the entrance gateway and graveled pathway, from north. Note tap and water bottles beside stepped stile on left

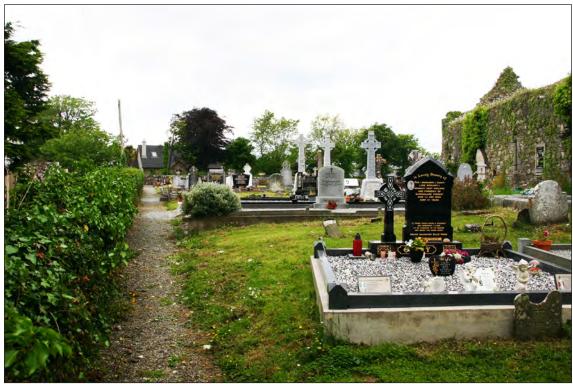
Plate 8: View of the southern limits of Aghavallen Graveyard, from east. Note the close proximity of church to boundary and perimeter pathway. Further note unhewn headstones in grassy area

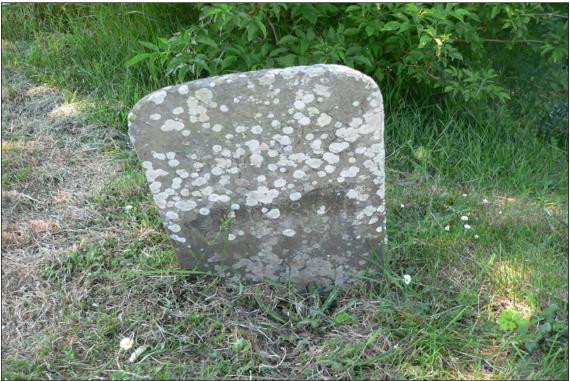
Plate 20: View of early 19th century illegible headstone (199), possibly 1812, similar to others from Lisselton graveyard

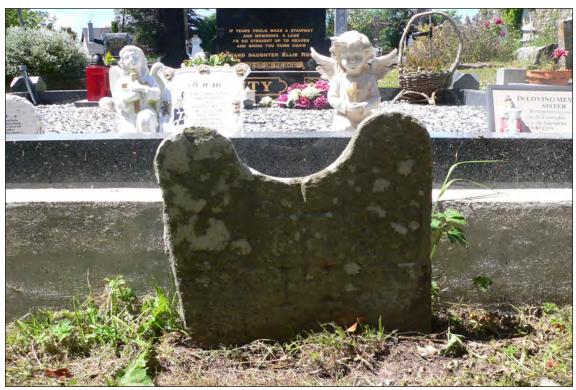
Plate 23: View of the second late 18th century illegible headstone (172) similar to (85). See also Plate 22

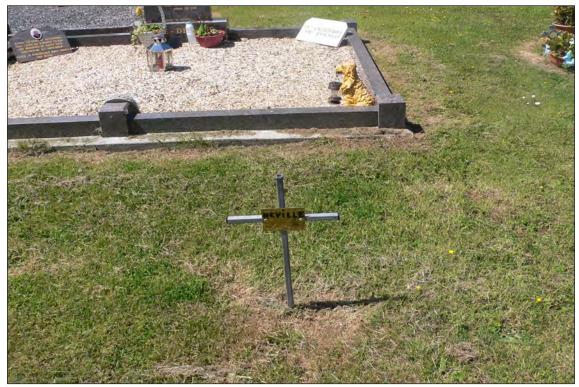
Five rectangular 19th century grave-slabs (78, 181, 229, 234 and 269) were also recorded of which one was totally illegible (see below). A number of inscribed grave markers include modern small temporary metal crosses that have put in place in advance of a more expensive and formal grave setting and headstone (Plate 24).

Plate 24: Close up view of modern and possibly temporary metal cross denoting the grave of Neville (99)

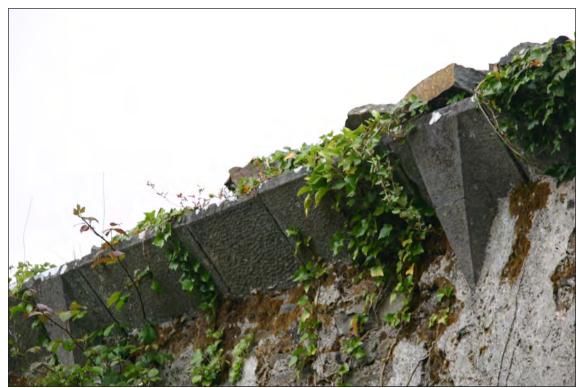
The relict remains stand to full height and are constructed of local rubble sandstone as well as some shale flag type stone. However, dressed limestone was used for all openings and quoins, many of which are now robbed out (Plates 26). Internally the side elevations also feature a very finely dressed chamfered limestone corbel course that contiguously project along the uppermost level at the east end of the south and north elevations. The corbel course carried the wall plate onto which the roof timbers were fixed. This feature is similar to Kilnaughtin, Carrigafoyle and Killeen Cowpark Church in Limerick (Dunne 2010; Leask 1985, 86-7 and Plate 27).

Plate 27: View of the dressed limestone, corbel course including featured larger pointed corbels on interior of Aghavallen Church. This very fine architectural feature is identical to Carrigafoyle and Kilnaughtin churches

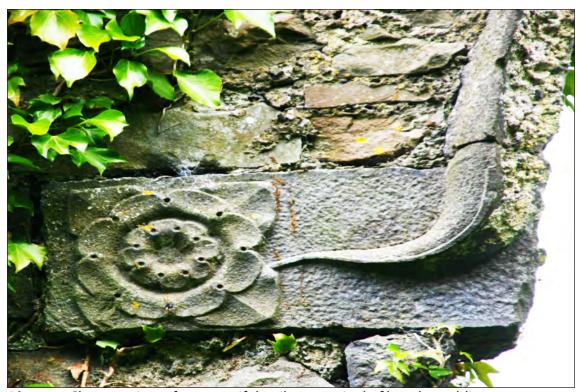
The east gable, virtually completely overgrown with ivy, is pierced by a central tall window (Plate 28). Most of its dressed masonry has been robbed out and it may have had twin lights as is found in a similar sized window ope at Kilnaughtin. The east window does retain a hood moulding on the exterior that finishes in a wonderful flourish depicting a rose motif terminal on its south or left side (Plate 29).

Plate 29: Close up view of rose motif detail on terminal of hood moulding over exterior of east window
