Archaeological Survey,
Church Island Graveyard,
Lough Currane,
Waterville,
Co. Kerry.

September 2012

Client: The Heritage Office,
Kerry County Council,
County Buildings,
Ratass,
Tralee,
Co. Kerry.

RMP No.: KE098-039

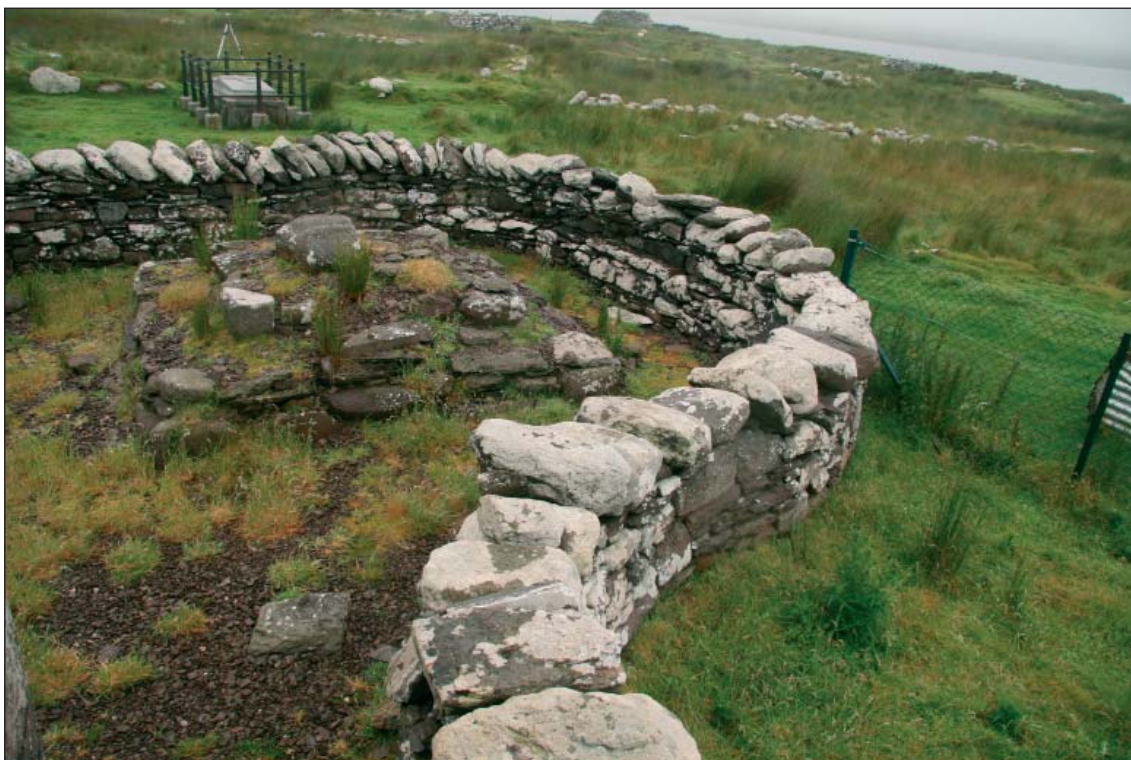
Plate 5: View of curving section of graveyard enclosing wall at the N-W limits of site. The crook-like meander is disposed around the leacht of St. Finan

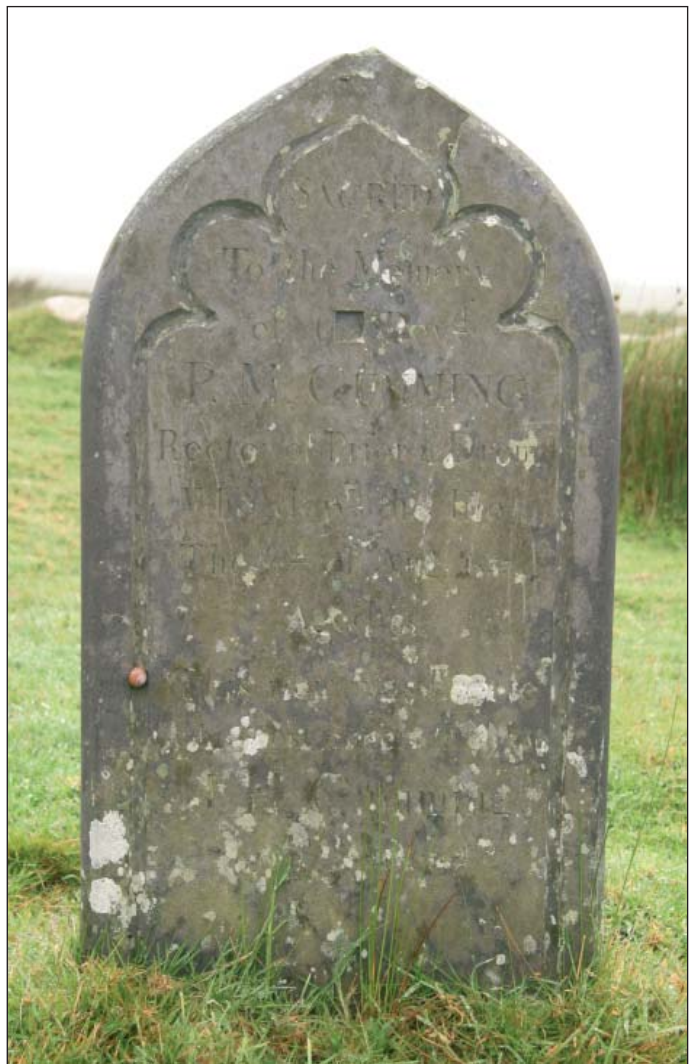
There is only one recorded modern named headstone on Church Island. The headstone, which is without a formal grave setting, is situated outside the west limits of the enclosure and records the death of Rev P.M. Cumming, rector of Prior and Dromod who died in 1855, (Figure 2 & Plate 13).

Plate 13: View of the Re. P.M. Cumming slate headstone. The headstone is the only modern upright headstone at the site

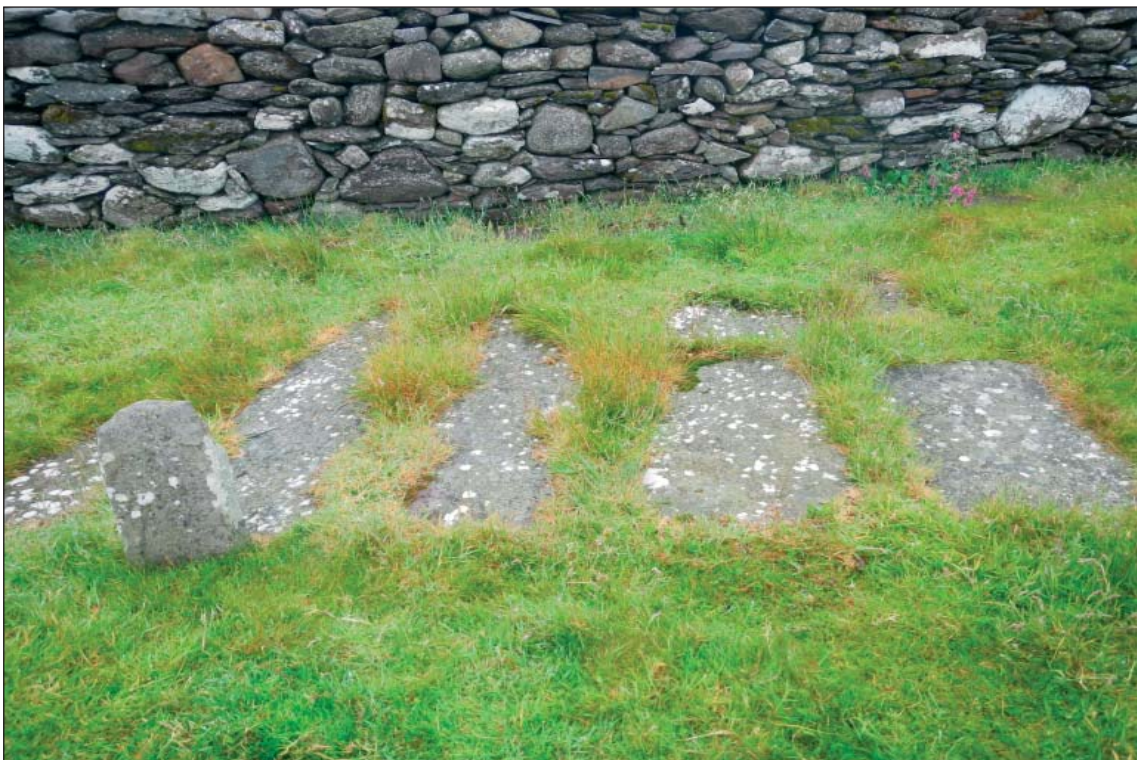
Plate 14: View from W of the row of graveslabs and two cross-slabs at the N-E area of the burial ground

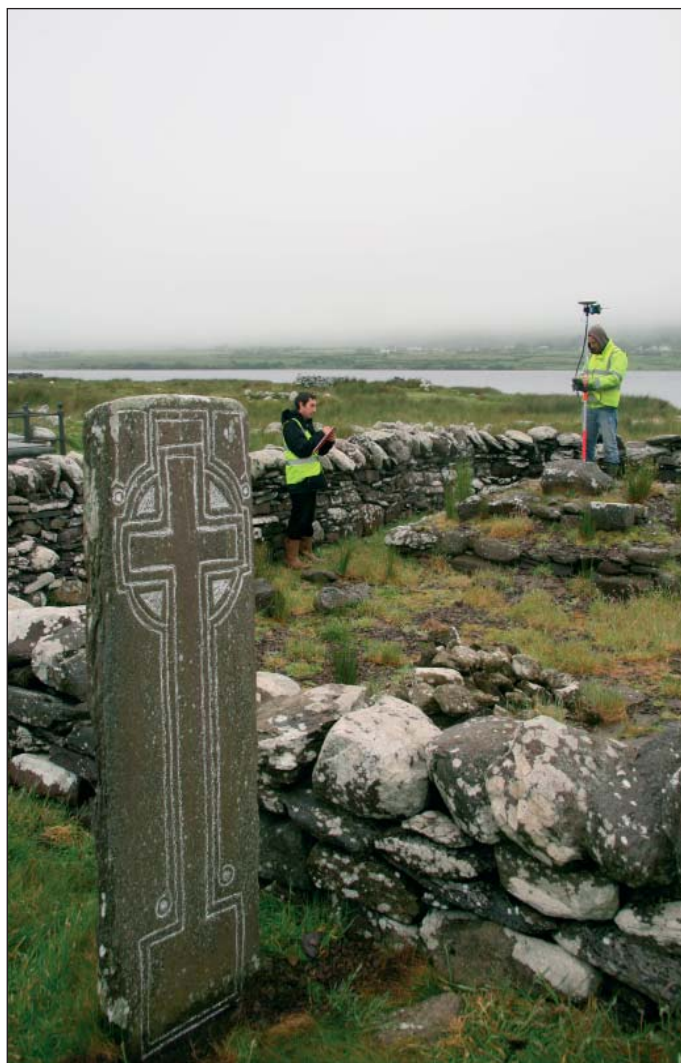
CS 1 known as the Anmchad slab is situated within *leacht* 3 outside the north elevation of the chancel (Figure 2 & Plate 18).

Plate 18: View of Anmchad cross-slab, CS1, from W

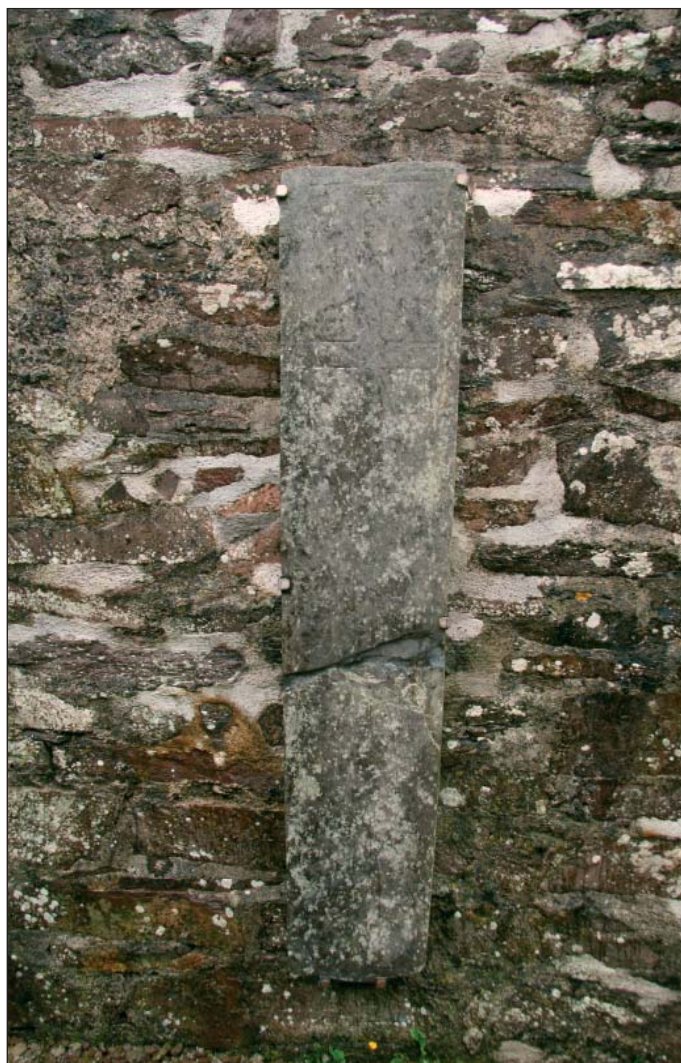
CS4 is attached to the inside north elevation of the nave (Figure 2 & Plates 8 & 22). It is also recorded as cross-slab no. 5 in the SKAS. This cross-slab is reputed to have marked the grave of St. Finan and when recorded by the SKAS it formed the lid of the O'Connell tomb that until recently was situated abutting the exterior south elevation of the nave (*ibid*, & Figure 2).

Plate 22: View of cross-slab, CS4 on interior N elevation of nave

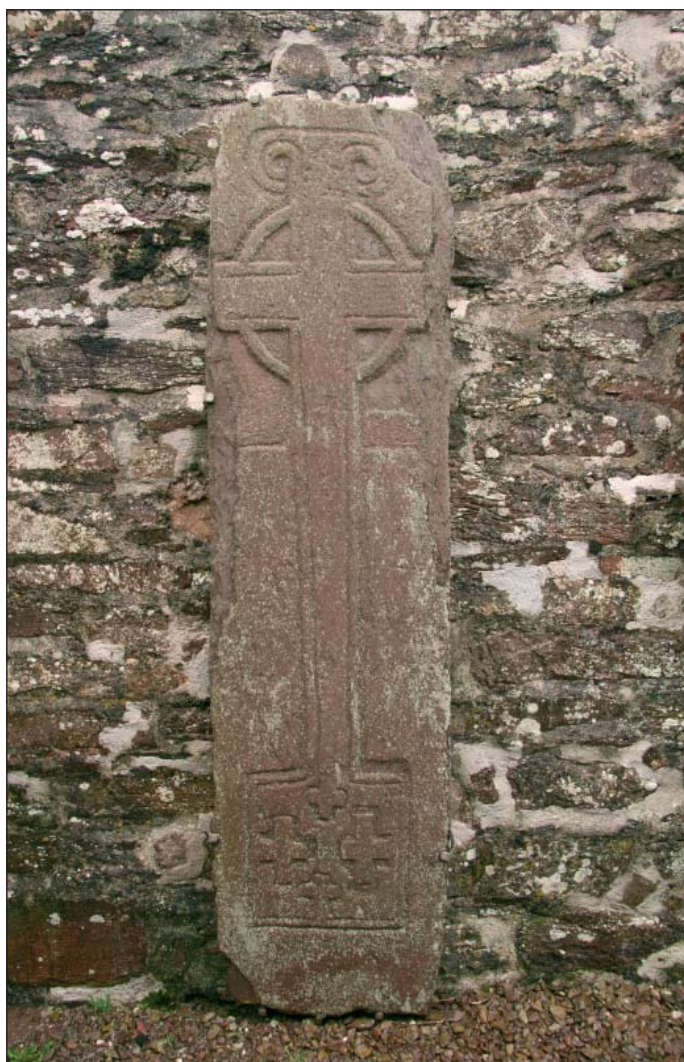
It is possible that GRVS 6 is a modern replacement for the fractured cross-slab CS 5 now attached to the interior of the nave (Figure 2 & Plate 8). It seems likely that the moved cross-slab, CS5, was then substituted with the current GRVS 6, (*ibid*, 317).

CS5 is attached to the inside north elevation of the nave (Figure 2 & Plates 8 & 23). It is recorded as cross-slab no. 6 in the SKAS. This stone was previously recorded as lying in a row of five other graveslabs to the N-E of the church (*ibid*).

Plate 23: View of cross-slab, CS5, on interior N elevation of nave

Enquiry should be made to the OPW regarding the possible substitution of the fractured cross-slab (CS5) and replacement with another slab GRVS 6.

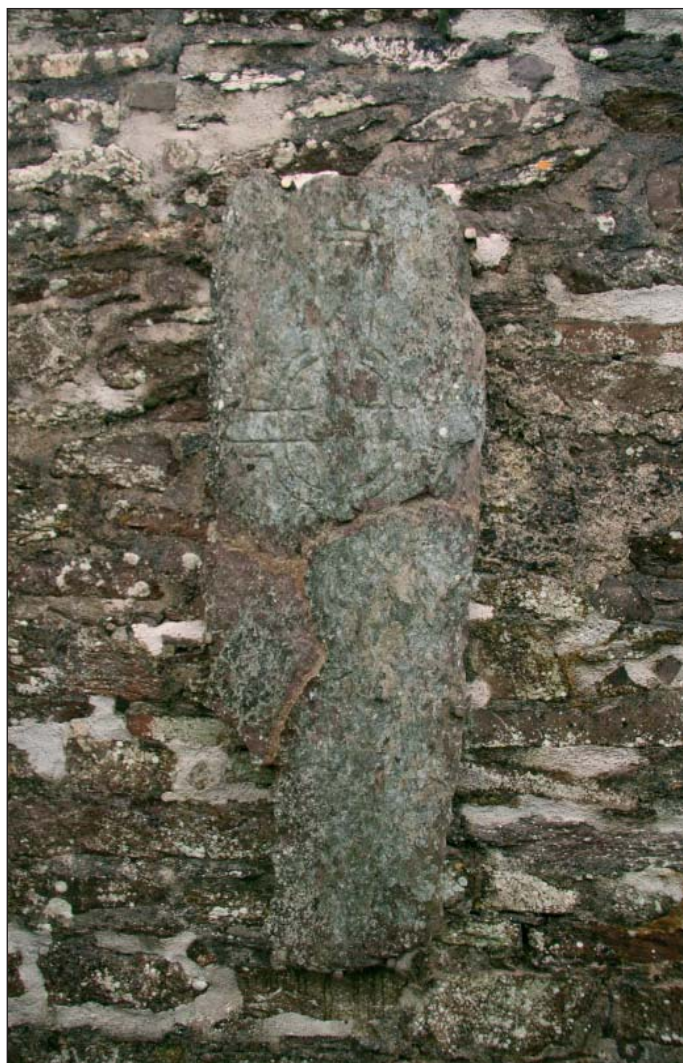
CS6 is attached to the inside north elevation of the nave (Figure 2 & Plates 8 & 24). It is recorded as cross-slab no. 3 in the SKAS. This stone was previously recorded as lying 4m W of the church doorway and 2m N of CS3 (*ibid*, 320).

Plate 24: View of cross-slab, CS6, on interior N elevation of nave

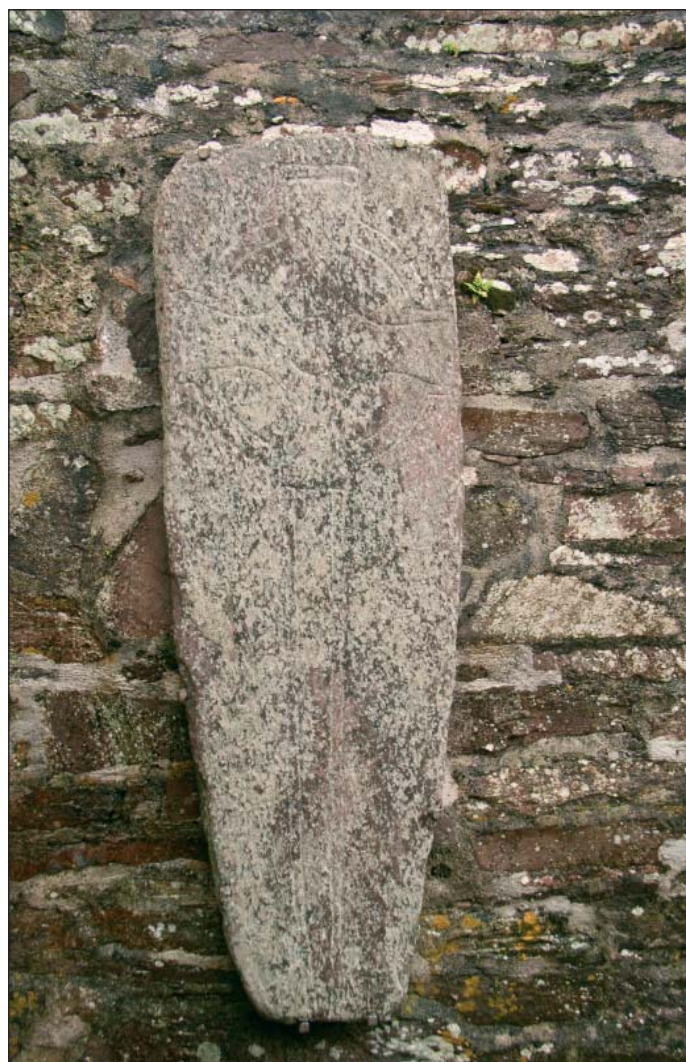
CS8 is a small outline cross *in situ* on the inside north elevation of the nave (Figure 2 & Plate 25).It was recorded as cross-slab 11 by the SKAS (*ibid*, 321).

Plate 25: View of in situ cross-slab, CS8, on interior N elevation of nave

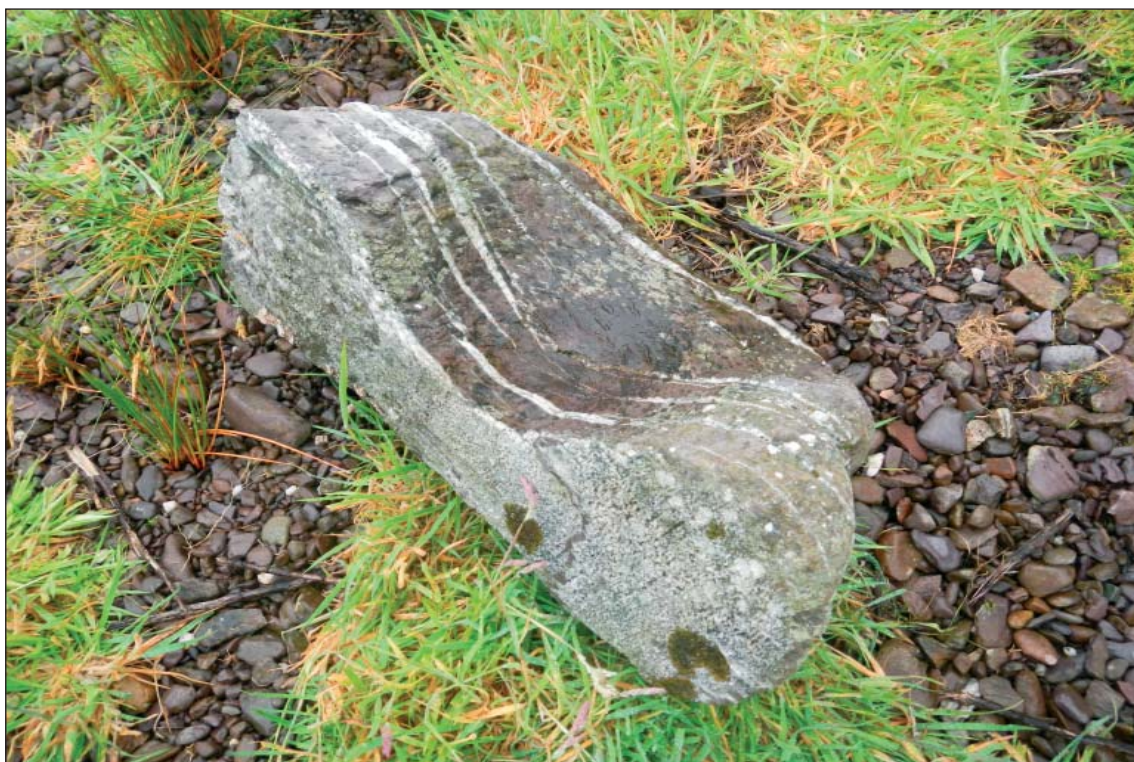
Plate 32: View of split fragment of possible bullaun stone lying loose immediately W of the church

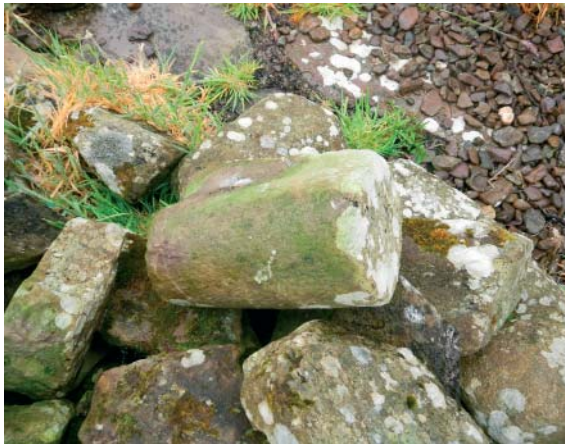
AF No: 2

Three loose architectural fragments (AFs) were recorded, two are situated immediately outside the doorway of the church within a loose pile of stones while the third stone stands against the interior S-W corner of the church (Figure 2 & Appendix 5). AF 1 comprises a small triangular fragment of sandstone masonry lying loosely on a small pile of stones. AF 2 is a small section of Romanesque roll-moulding possibly from one of the orders forming the S side of the doorway (Plate 29 & Appendix 5).

Plate 29: View of roll-moulding fragment, (AF2), lying loose on a pile of stones outside the doorway on the W gable of the church

These three small loose mobiliary architectural fragments should be secured *in situ* if possible otherwise they should be removed to a safe repository for their preservation.

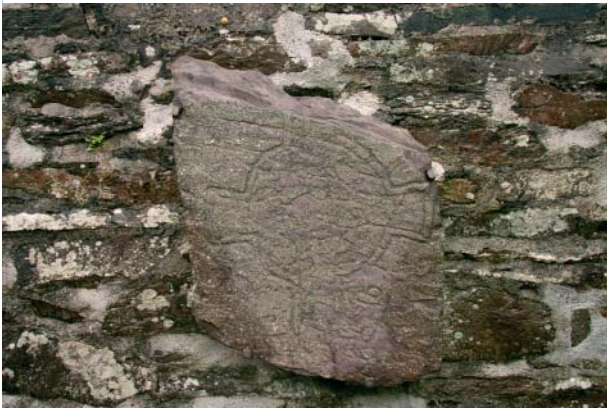
| CS No: | 7 |

Plate 15: Close-up view of cross-slab CS7 on the nave of the church. Note the fresh spalling at the top and the surviving patch outer lamination of its face
