Archaeological Survey, Dunurlin Church and Graveyard, Ballyferriter, Co. Kerry.

October 2010

RMP No.: KE042-041 church and graveyard

Written by: Laurence Dunne

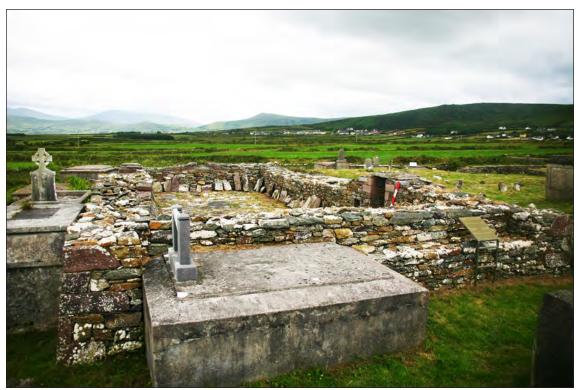
Plate 9: The ruined medieval church of Dunurlin from W. Note distinct basal batter of church on left

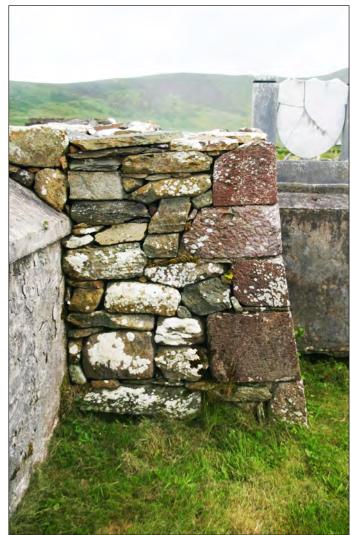
**Plate 15:** View NW corner of Dunurlin Church. Note sharp basal batter and well dressed, matched quoins

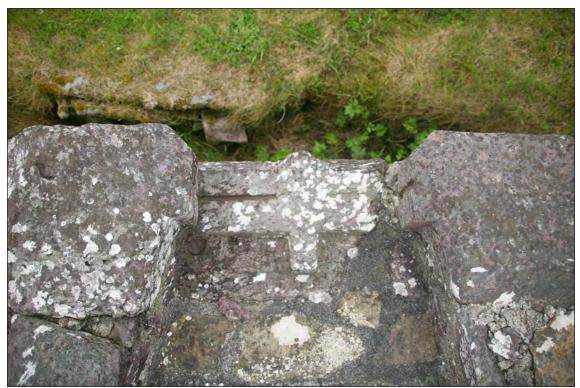
Plate 17: Overview of basal limits of chamfered, splayed embrasure of E window. Note projecting 'V' base for centre mullion to accommodate twin lights. Further note glazing slots to base and side stones. Note also pivot stone for window shutter

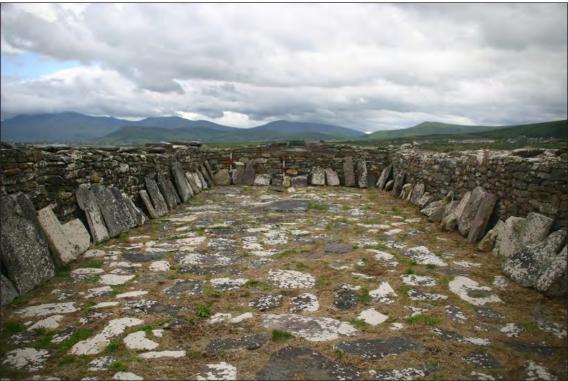
No previously unrecorded architectural fragments were recorded in Dunurlin Graveyard. According to Ó Coileáin 110 architectural fragments were found during the 1991 excavations of which 101 were noted in the course of this survey and discussed above (Plate 20). However, it is possible that other were removed to the Ballyferriter Museum. One fragment identified by Ó Coileáin as a cusped ogee head of a window was not found.

Plate 20: Interior view from W of Dunurlin Church. Note over 100 medieval architectural fragments lining the entire walls

The entire architectural fragments should be fully recorded and illustrated and catalogued. The records from the excavation should be compared to the fragments that are currently in the church. Some of these fragments are mobile and should be removed to the Ballyferriter Museum for safe keeping. Of particular relevance in this regard are the loose cross-slab (535, Plate 24) and the holed stone that lies on top of the NW corner of the church walls.

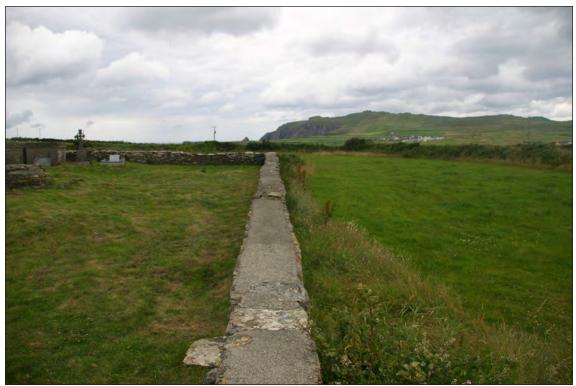
Another gate entrance provides access from the new graveyard into old (Plate 28 & Figure 5). This original entrance comprises of a pair of rusted gates set between two square low piers built of rubble stone and set in mortar. Immediately beside the gate to the W or left is a two step stile while a second stile is built into the W limits of the wall (Plates 29-30). A third disused step stile is located on the N boundary wall (Plate 25).

Plate 25: View of NW boundary wall of Dunurlin Graveyard. Note disused step-stile

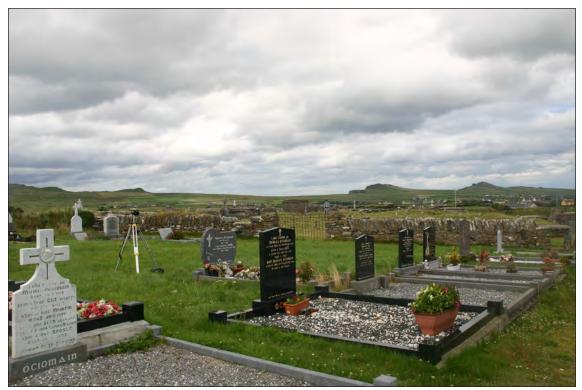
Plate 29: View NW of interior of new section of Dunurlin Graveyard. Note late 19th century boundary wall between the old and new burial grounds

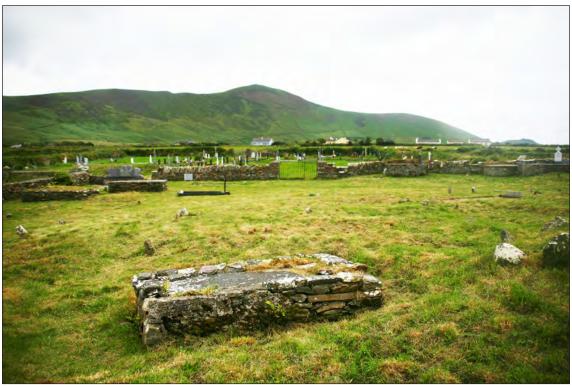
**Plate 34:** View of raised central area of medieval section of Dunurlin Graveyard from N. Note the numerous unnamed and unhewn headstones dispersed around the interior and the low un-rendered tombs

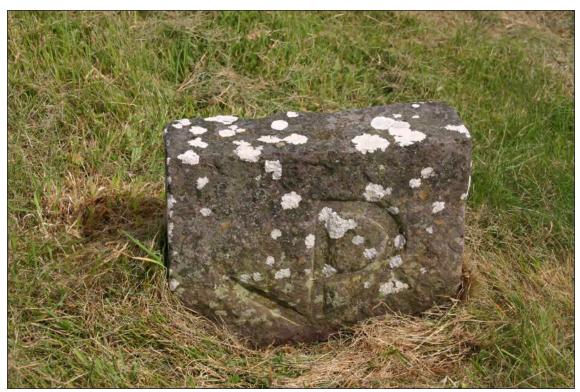
There were six small cross slabs recorded in Dunurlin in the course of this survey, (Appendix 5 & Figure 5). One of the cross-slabs is modern (546), located beside the bench/patio area has a Chi-Rho inscribed on it (Plate 35 & Figure 5).

Plate 35: View of modern cross-slab (546) with Chi-Rho motif situated at SE corner of old burial ground beside modern bench seating area

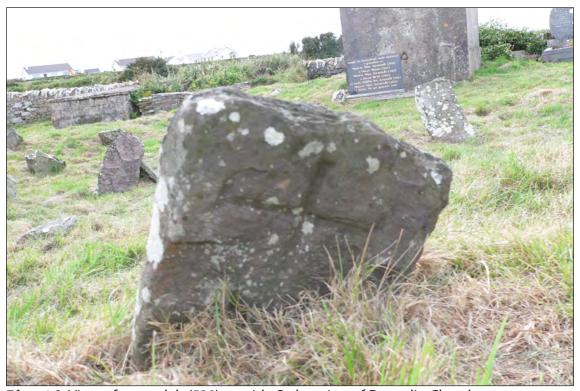
Four other cross slabs, (530, 531, 532 and 533), are clustered together outside the south-eastern limits of the church (Figure 5). Cross-slab (530) has a deeply incised Latin cross with 'T' bar terminals to both arms (Plate 36). Immediately beside to the N is a rough partially exposed stone with a deeply cut possibly Latin cross. The stone is inclined on its face which makes it difficult to determine the full extent of the cross form (Plate 37). The third cross-slab of this group, (532), lies immediately W of 531 (Plate 38 & Figure 5). This sandstone lies on its side and partially displays a rough Latin cross (?) on one face and a small equal armed cross on the other face. The fourth cross-slab (533) is also barely visible above the ground and has deeply incised cross partially visible (Plate 39).

Plate 36: View of cross-slab (530) outside S elevation of Dunurlin Church

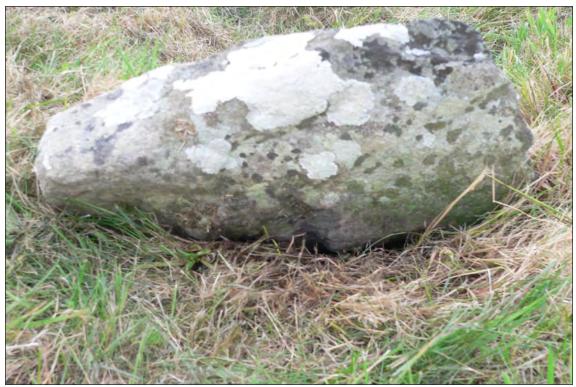
Plate 39: View of cross-slab (533) outside S elevation of Dunurlin Church
