Project code: KCCG11
Client: Kerry County Council
Date: June 2011

Archaeological Survey of Dysert Burial Ground, Lixnaw, Co. Kerry.

Surveyors: Ann Frykler & Robert Hanbidge
Report Author: Robert Hanbidge

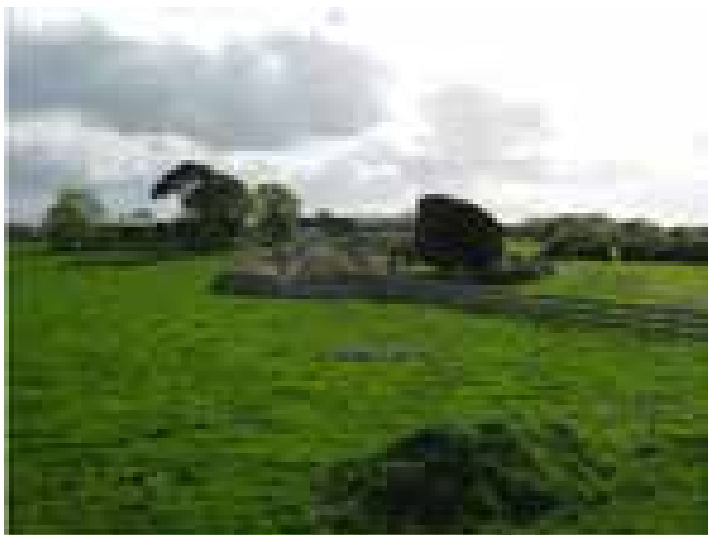
The surrounding level topography exposes the graveyard to the elements in all directions, although surrounding hedgerows and trees to the south-west do offer some shelter (Plate 1). Large earthen embankments/levies, which line the course of the lower stretches of the River Feale, do offer substantial protection from flood waters and extreme high tides, as well as serving as a buffer from north-eastern winds (Plate 2). Within the graveyard immediately to the north of the centre are the ruinous remains of a church, of which only the south, west and northern walls survive (Plates 3-5). The church ruin is illustrated as a rectangle on the OS First Edition 6" Map Sheet 10 (1839) (Figure 2), while on the OS 25" Map Sheet 10-13 (1910) (Figure 3) only the south, west and north walls are illustrated. The church is recorded in the Record of Monuments and Places (RMP) as KE010-062. The graveyard itself is listed under KE010-062001, while a third RMP, an ecclesiastical enclosure KE010-062002, encompasses the site of the graveyard. A hilltop enclosure KE010-081 is located c. 700 m to the southwest within the neighbouring townland of Curraghcroneen.

Plate 1-General view of Dysert Graveyard from east

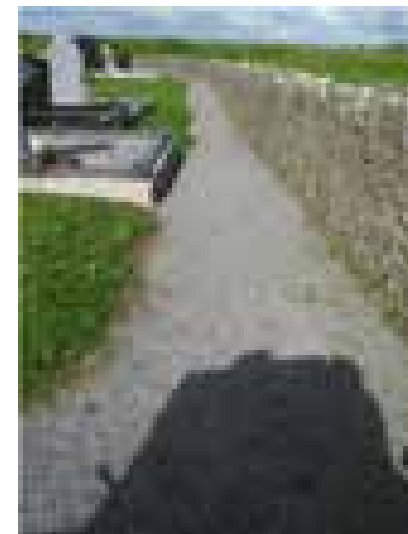
There is one primary pathway located around the perimeter of the graveyard immediately inside the boundary walls (Plate 12). Constructed from gravel, the path has a maximum width of 2 m and provides easy access to the majority of the graves.

Plate 12-Gravel path from southwest

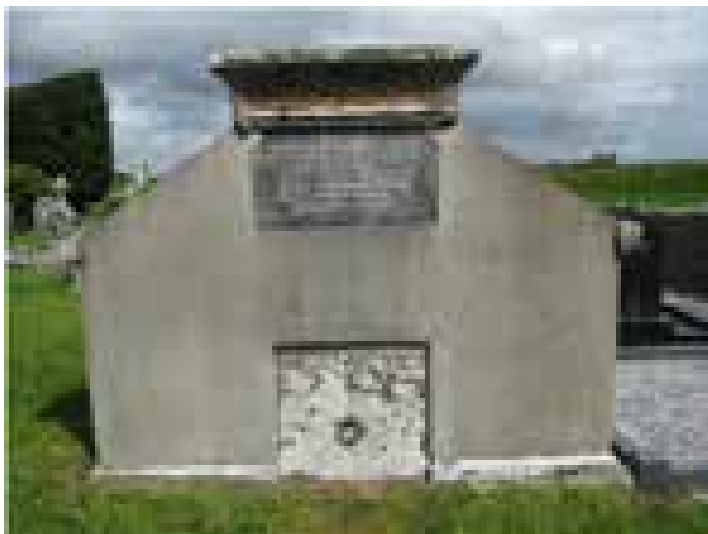
Also located close to the entrance, the Byrne Family Tomb (Grave No. 14) is in good condition and has been recently restored with new external rendering (Plate 15). The form of the tomb correlates to the general architecture of tombs that are found with County Kerry and features a pleasant inscribed limestone plaque mounted over the entrance.

Plate 15-View of Grave No. 14, from south-west

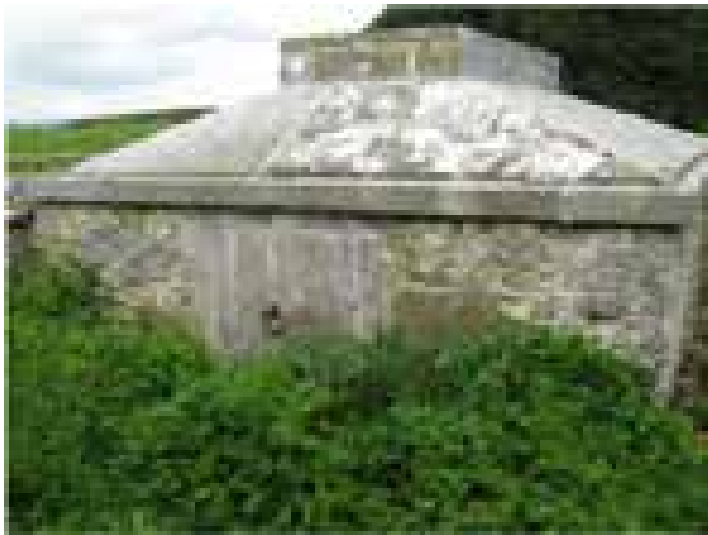
Grave No. 41 is located within the internal area of the church and is positioned abutting the northern church wall. This tomb is quite substantial in size and is in very good condition and has been partially restored. Constructed with exposed rubblestone walls, the tombs features contrasting tooled limestone eaves course and a hipped limestone slab roof with tooled limestone blocks to the central platform (Plate 17).

Plate 17-View of Grave No. 41 from southwest

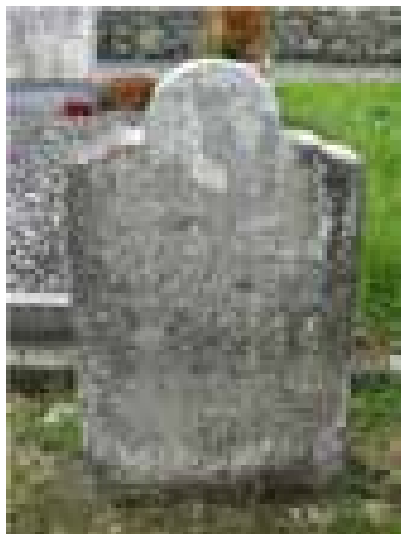
There are 39 named headstones and plots at Dysert Burial Ground. The majority of the graves date to the 20th century. Nineteenth century graves are present although these are in a minority with the earliest inscribed headstone being Grave No. 10 which dates to 1837 (Plate 19). More recent graves from the 21st century are also present e.g. Grave No. 15 from 2008 and Grave No. 22 from 2005.

Plate 19-Headstone to Grave
No. 10 from east

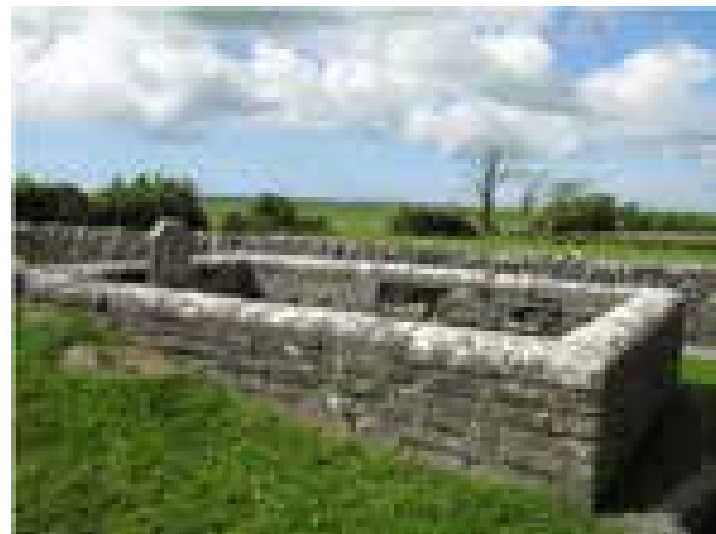
The largest plot present is Grave No. 40 which is located to the north of the northern church wall. The plot is rather unusual as it is defined by an unusually high ashlar dressed limestone block enclosing walls, which feature tooled concave limestone coping (Plate 20). The wall survives in reasonable condition with a few areas of collapse to the interior. A broken headstone is centrally located to the interior, of which the lowermost inscription is visible and mentions 'Major J. M. Home, Late 36 Regt' who died in Scotland 1868 and is buried by Polwarth Church Berwickshire in the Scottish Borders, suggesting that it is a member of his family who is interred here. A later headstone to the west end of the plot confirms that one of Major J. M. Home's sons is buried here.

Plate-20 View of Grave No. 40 from southeast

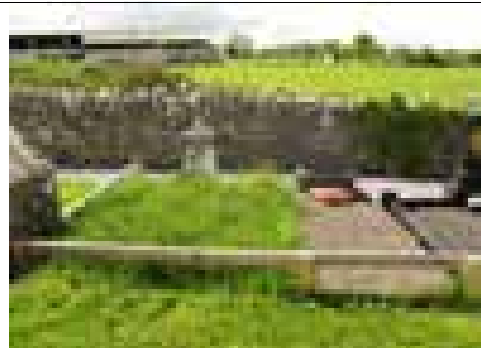
Grave_No	Family Name	Photo_Name
38	Hewson	IMG_0082
Notes		
Poor condition, four yew trees in each corner, cast iron railings are broken and missing

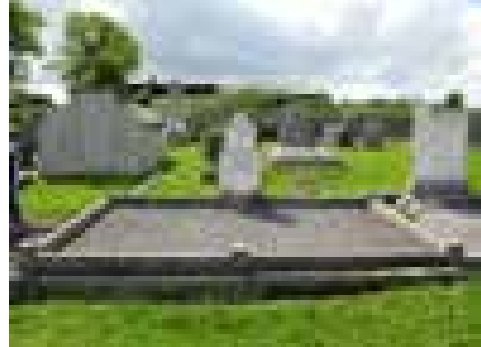
Grave_No	Family Name	Photo_Name
28	Naughten	IMG_0060
Notes		
Plot in moderate condition, Wrought iron railing is gone in many places

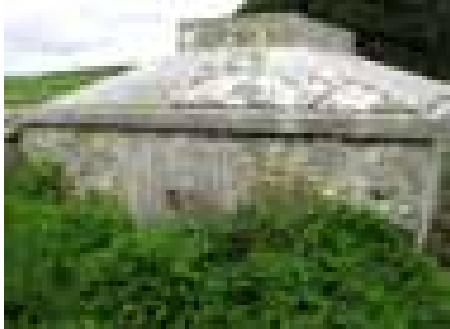
Grave_No		Photo_Name
41		IMG_0089
Notes		
Tomb in good condition

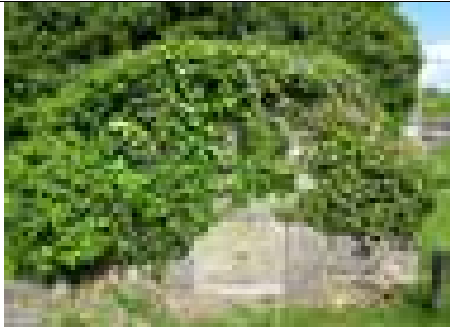
Grave_No		Photo_Name
46		IMG_0099
Notes		
Tomb overgrown by ivy in moderate condition
