Date: September 2009 Client: The Heritage Office, Kerry County Council Project code: TGSK09

## Archaeological Survey, Killaha Graveyard, Killaha, Co. Kerry.

RMP No.: KE067 057

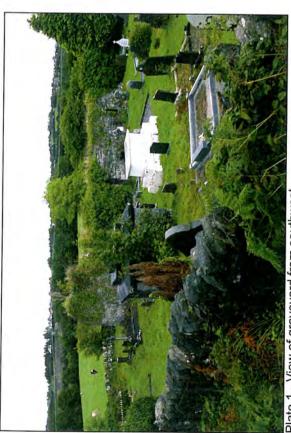
The older part of the now expanded graveyard is surrounded by a rubble stone boundary wall and is almost sub-rectangular in plan, having a curving section of wall to the southeast (Figure 4, Plate 1). There are pedestrian and double-leaf gates on the west side and a substantial opening on the east side, however this may have not have been intended for access or egress and may have been enlarged in more recent times. A more recent rectangular extension, enclosed by a rendered boundary wall, has been added to the southeast with a formal layout of graves to its southeastern end and a small number of plots to the northwest located just outside the older graveyard wall. The extension is accessed via double-leaf gates to the northwest that lead to a gravel track running from the carpark along the north side of the older boundary wall. To the north and south there are fields used for grazing at the time of the survey. The interior of the older graveyard comprises an uneven ground surface sloping downwards from the southwest corner and eventually levelling out in the northern half. The ruinous remains of a church are situated in the centre of the northern half. The grass was uncut at the time of the survey facilitating the identification of a number of distinct desire lines. A variety of small shrubs grow within the grounds and ivy has taken root in several spots along the boundary wall and church. The graves do not conform to any formal plan within the, however the majority of the headstones face east.

Plate 1 - View of graveyard from southwest.

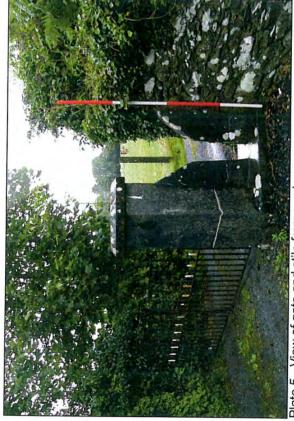
The extension is accessed through a gate comprising capped and rendered square profile gate piers holding a double-leaf metal gate. Connected to the southern gate pier is another stile comprised of concrete (Plate 5). A third stile is located in the centre of the eastern wall of the extension; this comprises capped and rendered square profile piers flanking a V-shaped concrete stile (Plate 6).

Plate 5 - View of gate and stile from west.

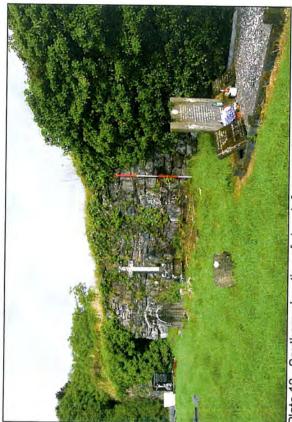
In the northern half of the graveyard stand the ruinous remains of a single-cell single-storey church, built c.1500. The building is of a coursed, roughly dressed rubble stone construction with substantial walls (approx 0.65 metres thick). Lime render can be seen in patches throughout the church with concentrations to the interior and the base of the northern exterior wall (Plate 14). There is vegetation growing in heavy volumes throughout the building with a substantial amount found on the eastern elevation (Plate 15) and large amounts found along parts of the southern and northern walls (Plate 12). It is mainly concentrated in amongst the looser masonry to the upper courses of the walls. The southwest exterior corner has recently deteriorated (Plate 16). Areas of rubble from the church were also surveyed next to the eastern exterior side of the door opening and a substantial pile lies along the interior of the southern wall.

Plate 12 - Southern elevation of church from southeast.

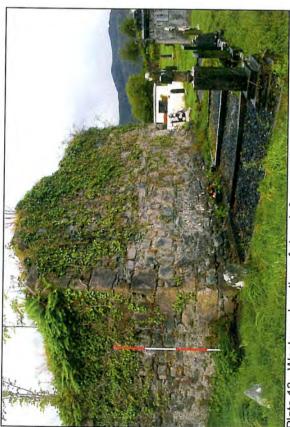
Plate 13 - Western elevation of church from northwest.

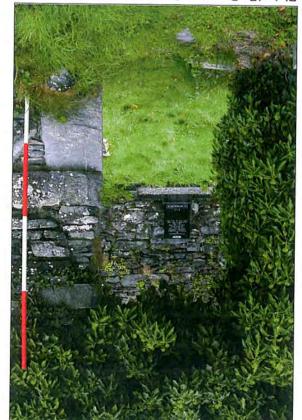
Plate 17 - Door opening to church from south elevation.
