Project code: KCCG11
Client: Kerry County Council
Date: July 2011

Archaeological Survey of Dysert Burial Ground, Farran, Castleisland, County Kerry

Surveyors: Ann Frykler & Robert Hanbidge
Report Author: Robert Hanbidge

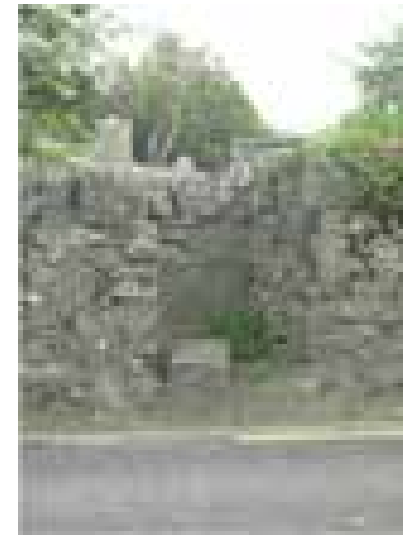
Plate 6-View of recess accommodating Grave No.8, from west

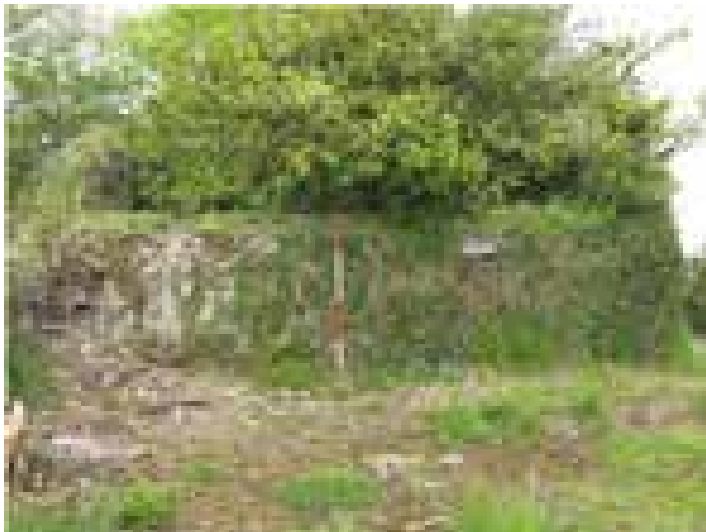
Miscellaneous No. 02: Located in the south-eastern portion of the graveyard and orientated on a north/south axis is a three-bay single-storey former house. This house, now in a much ruinous condition forms an integral part of the graveyard, as the external elevations to the east and north form part of the graveyard's boundary walls (Plates 31, 32 and 33). The house walls consist of mortared roughly dressed rubblestone and it originally had a pitched roof, (the gables survive). The ruin is in reasonable condition with the only collapse occurring at the northern gable where the site of a possible window has been enlarged or a breach has been created to allow access (over a mound of rubble) to the interior. Internally, the building is overgrown with trees. Square-headed window openings flank a central square-headed door opening on the west elevation. Examination of the OS First Edition 6 Inch Map Sheet 039 (1846) depicts the entrance to this building in the west (now overgrown and completely inaccessible) while to the east was the site of another smaller structure, possibly an outbuilding, the site of which now forms part of the graveyard. Examination of the OS Second Edition map Sheet 039-12 (1893), indicates that this smaller possible outbuilding was no longer extant at this time and the graveyard had been extended to occupy its site.

Plate 7-View of east elevation of ancillary building
(Miscellaneous No. 02)

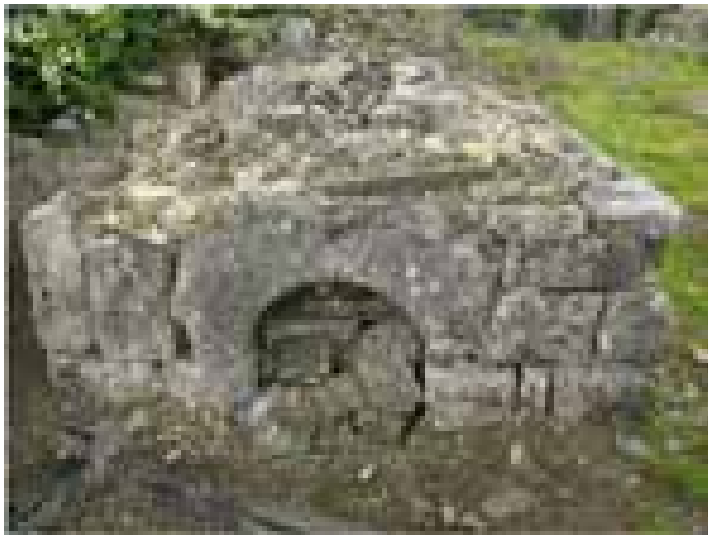
Plate 17-View of tomb, Grave No. 10, from west

Of particular interest is Grave No. 10, which is distinguished by its unusual round-headed entrance at the west elevation (Plate 17). This elaborate entrance features a finely crafted arch carved from a single limestone block. Further uncomplicated ornamentation of chamfering both to the arch and surrounds adds further refinement to this tomb. Such an entrance is unusual and the exact origin of this elaborate masonry is interesting, considering the possibility that the masonry may have originated from the church within the graveyard; thus this tomb may be of further architectural importance. The roof of this tomb has collapsed and is represented by a low mound of rubble.

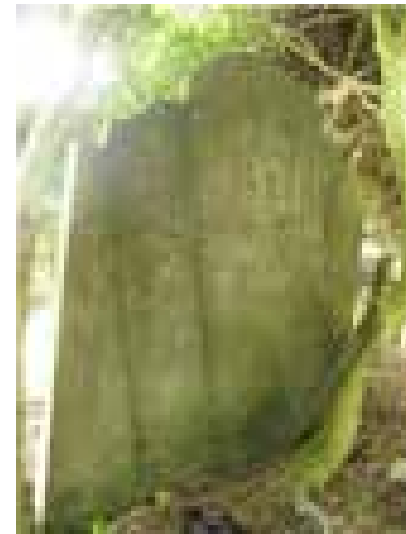
Plate 20-View of Grave No. 42, from east

There are 39 named headstones and plots within Dysert Graveyard. The majority of these are in good condition and mostly date to the nineteenth and twentieth centuries. The oldest inscribed headstone carries a date of 1788 and belongs to Grave No. 42 (Plate 20), commemorating Laurence Hickey. Unfortunately this grave is situated beneath excessive tree growth and is partially inaccessible.

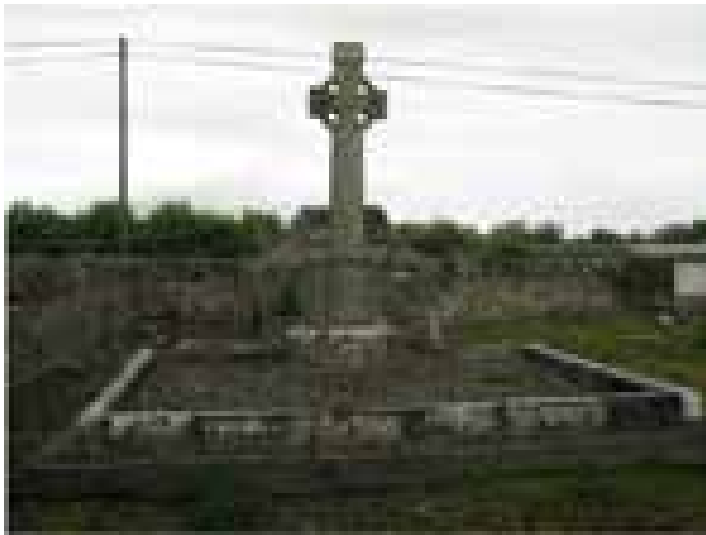
Plate 21-View of Grave No. 15, from east

There is great variety in the design of headstones and plots within Dysert Graveyard with many consisting of simple inscribed limestone plaques while others are more elaborate examples such as High Crosses with tooled limestone block plinths e.g. Grave No. 15 (Plate 21). More elaborate detailing such as wrought-iron railing and decorative cast-iron railings surrounding other plots e.g. Grave No. 59 (Plate 22) also make a significant contribution to the historic appeal of the graveyard.

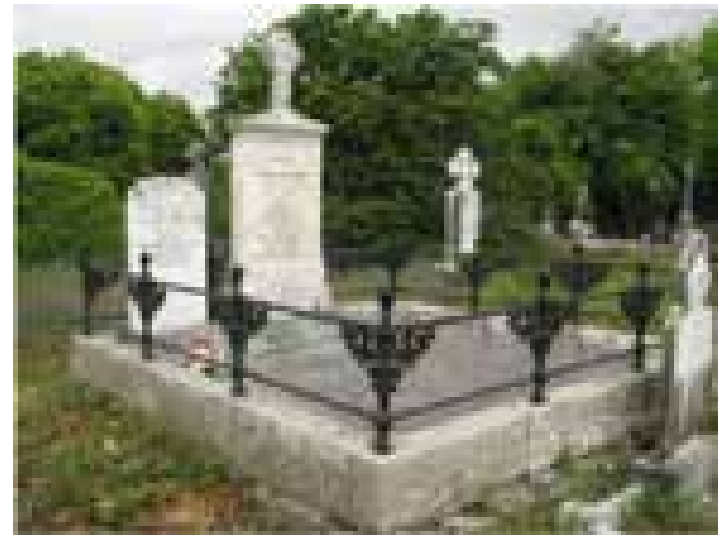
Plate 22-View of decorative cast-iron railing to Grave No. 59, from southeast

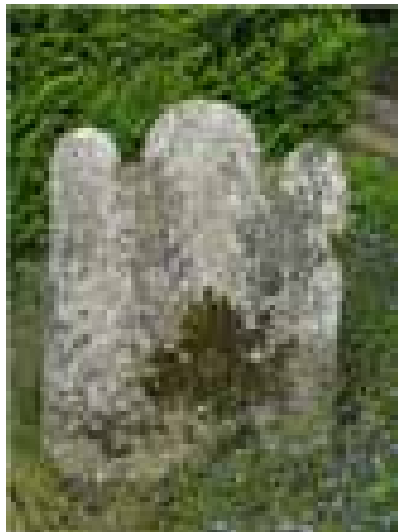
In contrast there only 3 unnamed or illegible headstones and plots (Grave No's; 3, 7 and 41) were present during the survey of Dysert Graveyard. Grave No. 3 was located in the north-western corner of the graveyard and was partially hidden by the presence of a large tree. It is likely that all three of these graves were originally inscribed, however due to weathering or collapse they are now illegible. This is supported by Grave No. 41 which bears a date of 1799, though the rest of the inscription is illegible (Plate 23). The collapsed headstone of Grave No. 7 may be inscribed on its downward facing side.

Plate 23-View of unnamed headstone to Grave No. 41

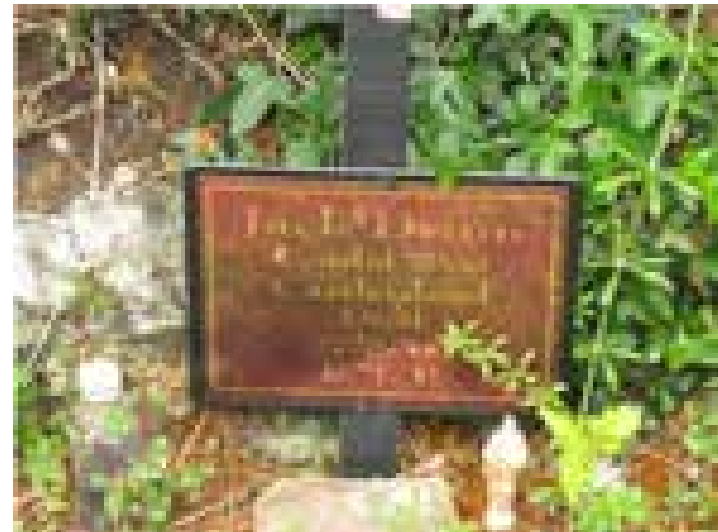
Plate 24-View of named gravemarker to Grave No.4, from east

The first named gravemarker, Grave No. 4, is located on the eastern side of an unnamed tomb (Grave No. 6) and consists of a simple plaque nailed to a wooden peg (Plate 24).

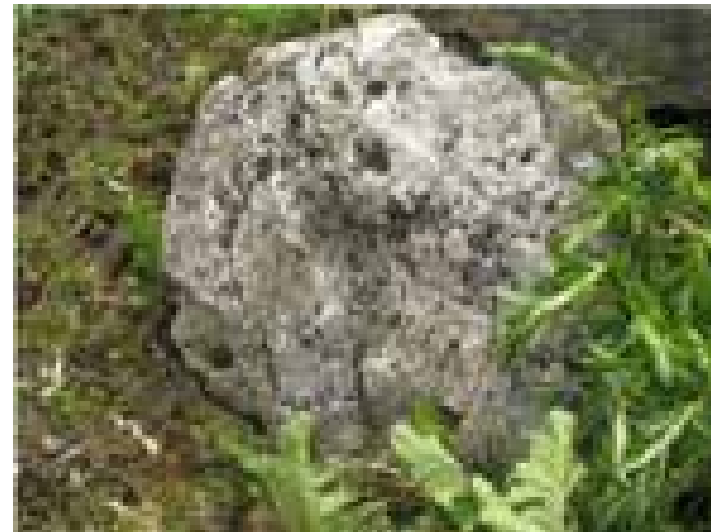
Plate 27-View of Grave No 65, from east

In total 21 unnamed gravemarkers were recorded in this survey of Dysert Graveyard. The majority tended to be concentrated in the eastern area of the graveyard and usually consisted of simple locally sourced stone which was placed in an upright position, e.g. Grave No. 65 (Plate 27). During the duration of this survey, much of the eastern area of the graveyard was overgrown with weeds and there is a possibility that more unnamed gravemarkers do exist which were not visible during this survey. It also must be noted that in the very south-eastern corner of the graveyard there are some areas of what appears to be bedrock breaking through the ground surface.

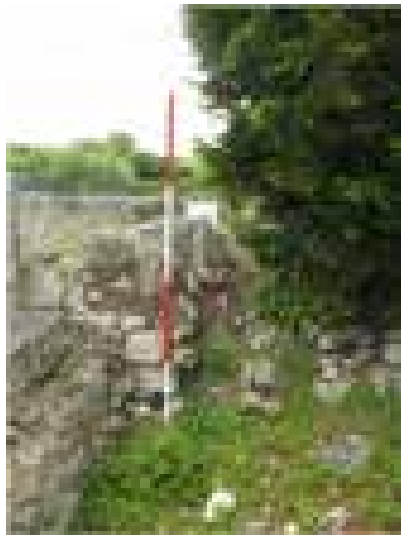
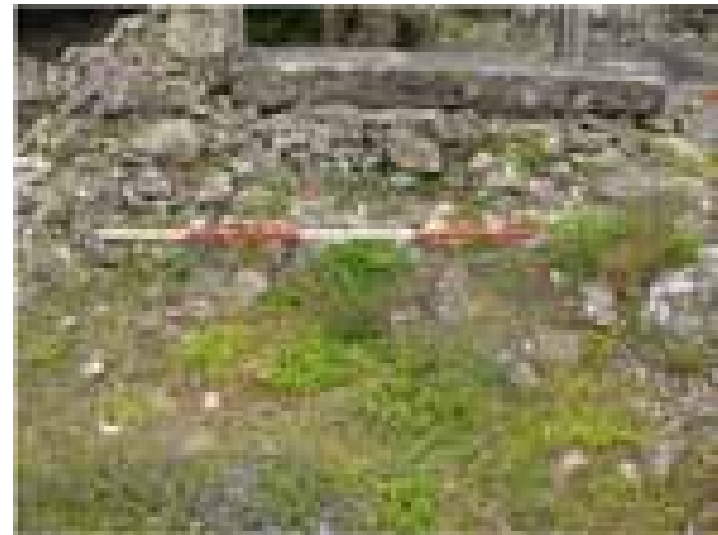
Located to the northwest of the central area of the graveyard are two low surviving portions of the walls of a church, the east and south elevations (Plate 28, 29 and 30). The church ruin is listed in the RMP as KE039-086 and is depicted on the OS First Edition 6 Inch Map Sheet 039 (1846) and on the OS Second Edition map Sheet 039-12 (1893) as a rectangular building described as 'in ruins'. The surviving portions of the walls survive to a maximum height of 1 m and are very weathered. They consist of roughly dressed rubble limestone walls with a lime and aggregate mortar. The largest section of surviving wall is the eastern elevation. Only a low portion (10 cm high) of the southern elevation is partially visible and this is heavily impacted on as a result of the presence of tombs (Grave Nos. 5 and 49). It is most likely that the majority of the stone work within the church walls has been robbed out to aid in the construction of the surrounding tombs and graves.

Plate 28-Interior view of east elevation of church ruin

Plate 29-Exterior view of south elevation of church ruin

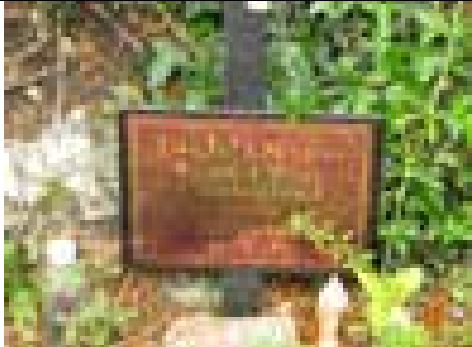
Grave No. 33 was a similar named plaque, however the provenance for this grave marker is unknown as the plaque is unsecured and loose. The plaque commemorates Mary Lenihan and may have originated from elsewhere within the graveyard (Plate 25). Its current location is on top of a collapsed tomb (Grave No. 35) and it seems unlikely that this tomb is the burial place of this person, although this is mere speculation. No other Lenihan graves were recorded within the graveyard.

Grave_No	Family Name	Photo_Name
33	Lenihan	IMG_0072
Notes		
Single grave plaque which is unsecured, original location is unknown

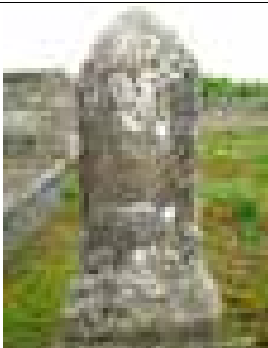
Grave_No	Family Name	Photo_Name
42	Hickey	IMG_0082
Notes		
Large headstone in good condition, protected by excessive overgrowth, 1788

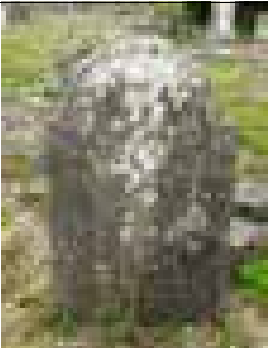
Grave_No	Family Name	Photo_Name
45	Prindivill-Taylor	IMG_0088
Notes		
Single headstone 1835

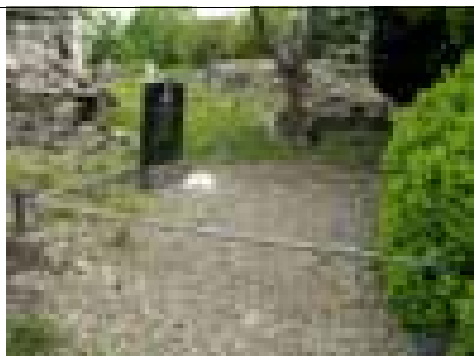
Grave_No	Family Name	Photo_Name
31	Brosnan	IMG_0069
Notes		
Plot in moderate condition, iron railing is broken to the east

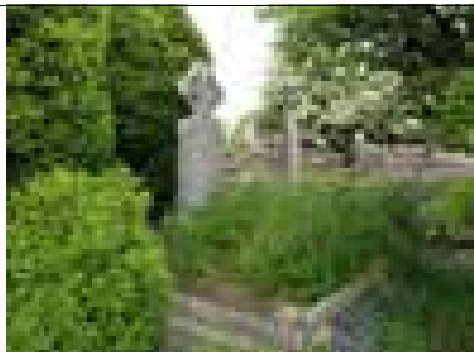
Grave_No	Family Name	Photo_Name
43	Brosnan	IMG_0084
Notes		
Plot in moderate condition

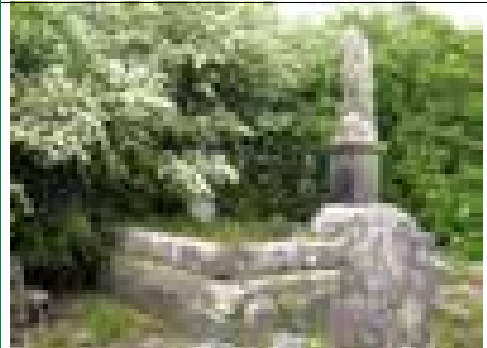
Grave_No	Family Name	Photo_Name
46	Buckley	IMG_0089
Notes		
Plot in moderate condition

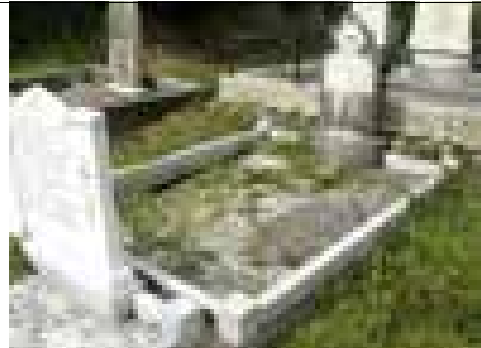
Grave_No	Family Name	Photo_Name
61	Coffey	IMG_0115
Notes		
Plot in moderate condition, subsiding

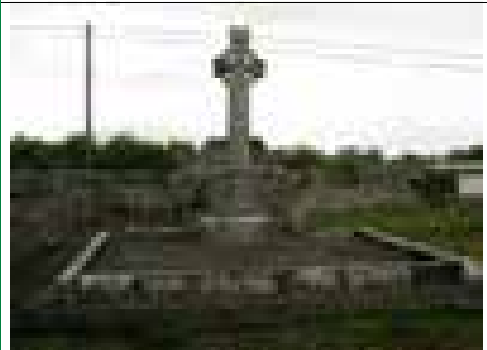
Grave_No	Family Name	Photo_Name
15	Casey	IMG_0031
Notes		
Plot in good condition

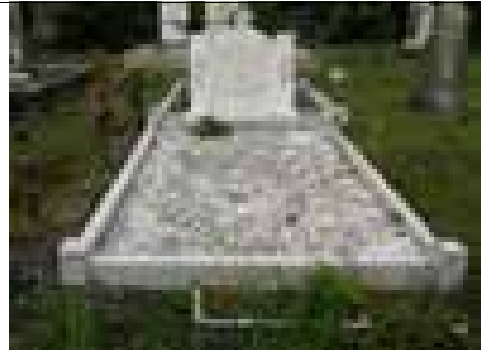
Grave_No	Family Name	Photo_Name
77	Coffey	IMG_0141
Notes		
Plot in good condition

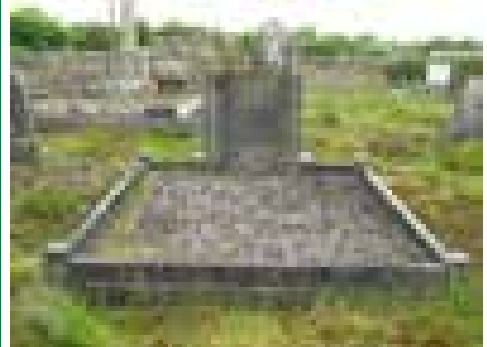
Grave_No	Family Name	Photo_Name
19	Casey	IMG_0038
Notes		
Plot in good condition

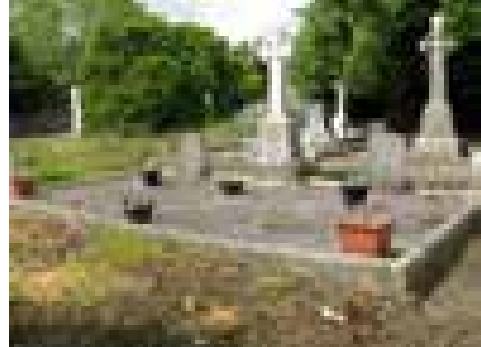
Grave_No	Family Name	Photo_Name
67	Curtin	IMG_0122
Notes		
Plot in good condition

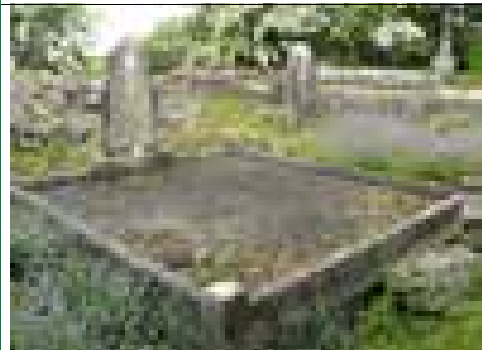
Grave_No	Family Name	Photo_Name
44	Dennehy	IMG_0086
Notes		
Plot in good condition

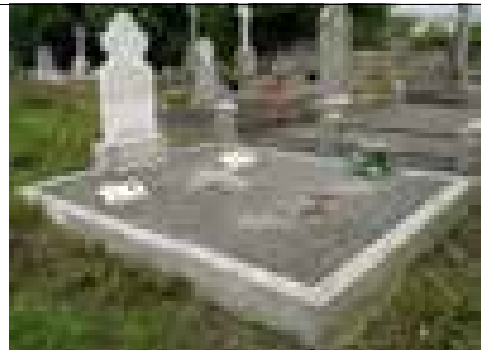
Grave_No	Family Name	Photo_Name
74	Flynn	IMG_0136
Notes		
Plot in good condition

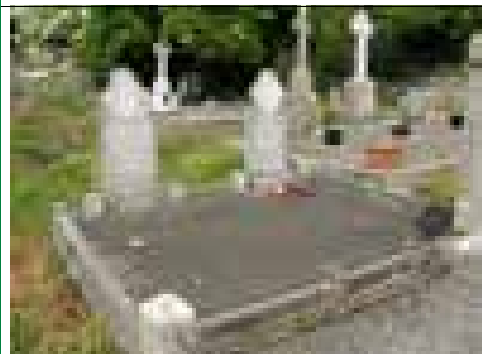
Grave_No	Family Name	Photo_Name
68	Doody	IMG_0126
Notes		
Plot in good condition

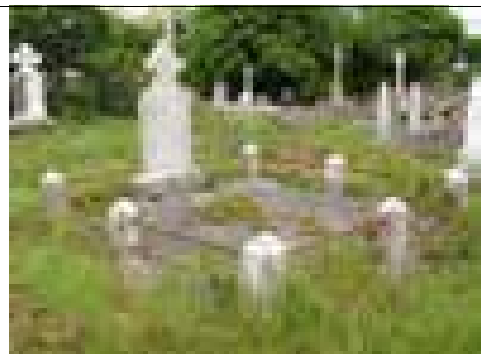
Grave_No	Family Name	Photo_Name
75	Greaney	IMG_0138
Notes		
Plot in moderate condition, subsiding, weeds

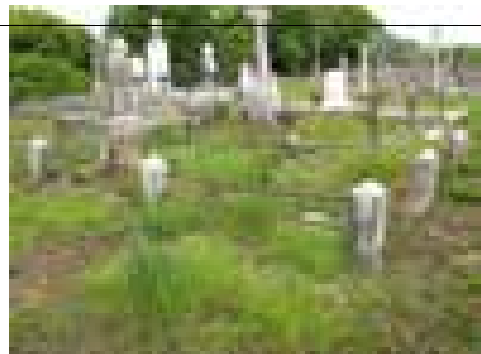
Grave_No	Family Name	Photo_Name
79	Hanafin	IMG_0145
Notes		
Plot in poor condition, plot markers and railings fallen down and headstone fallen over and broken

- Any damaged graves, collapsed or broken headstones, collapsed or damaged tombs should be repaired and re-erected if they have fallen over.
- Efforts should be made to locate the burial place associated with the disturbed grave plaque that represents the burial place of Mary Lenihan (Grave No. 33).

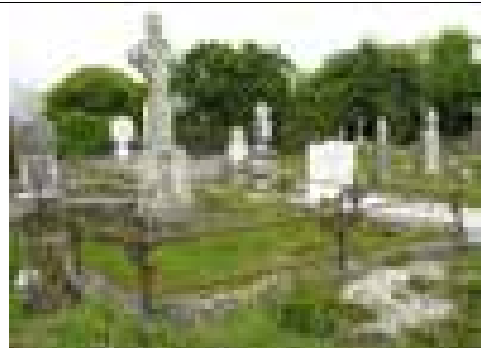
Grave_No	Family Name	Photo_Name
78	Hickey	IMG_0143
Notes		
Plot in moderate condition, wrought and cast iron railings are in parts broken, subsiding

- A rust treatment and possibly a fresh coat of paint should be applied to the entrance gate along with the various iron crosses and plot railings to prevent further degradation.

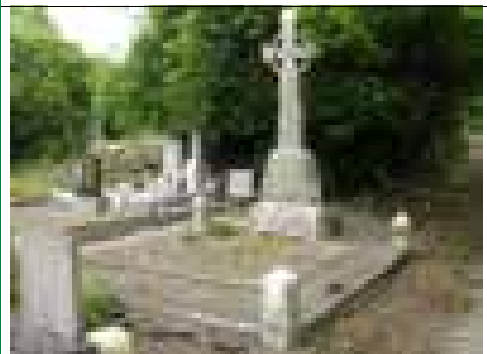
Grave_No	Family Name	Photo_Name
56	Hickey	IMG_0104
Notes		
Plot in good condition

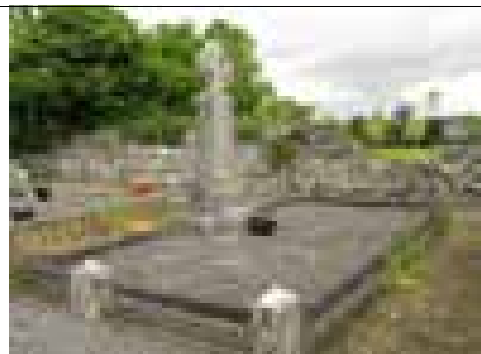
Grave_No	Family Name	Photo_Name
72	Horan	IMG_0132
Notes		
Plot in good condition

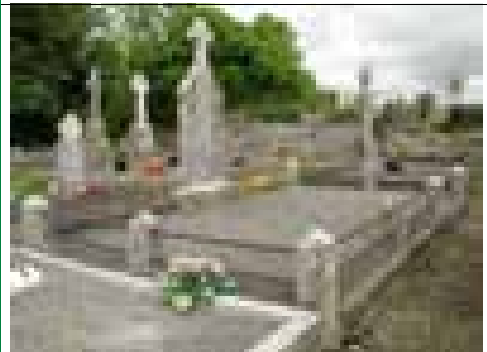
Grave_No	Family Name	Photo_Name
73	Hickey	IMG_0134
Notes		
Plot in good condition,

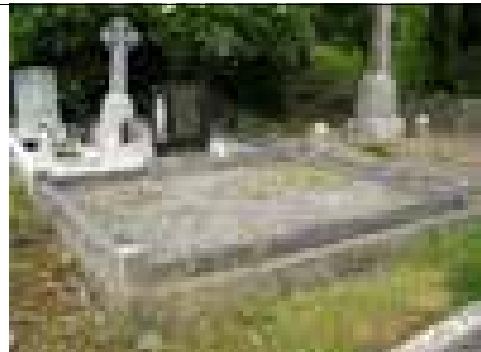
Grave_No	Family Name	Photo_Name
57	McCarthy/Roche/Kea	IMG_0107
Notes		
Plot in good condition

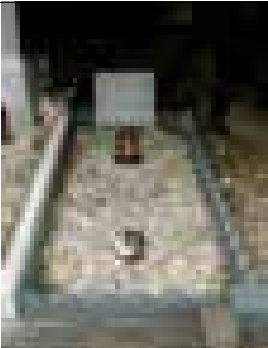
Grave_No	Family Name	Photo_Name
54	Moriarty	IMG_0099
Notes		
Plot in good condition

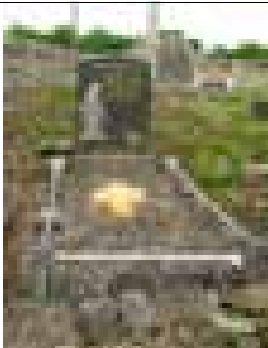
Grave_No	Family Name	Photo_Name
34	O'Connor	IMG_0073
Notes		
Plot in moderate condition

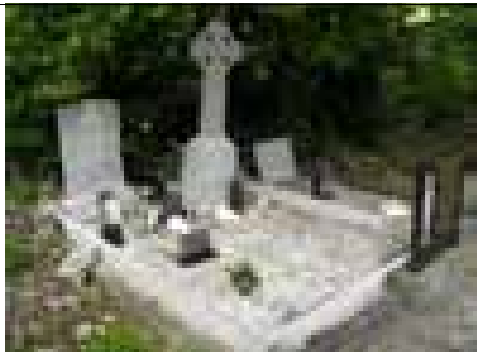
Grave_No	Family Name	Photo_Name
55	Moriarty/Keane	IMG_0101
Notes		
Plot in good condition

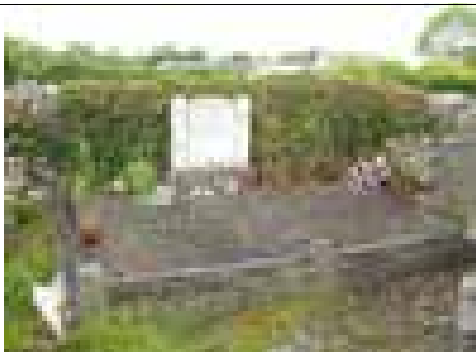
Grave_No	Family Name	Photo_Name
11	Riordan	IMG_0022
Notes		
Plot in good condition

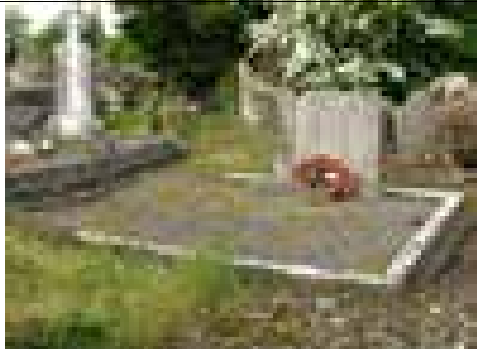
Grave_No	Family Name	Photo_Name
22	O'Connor	IMG_0049
Notes		
Plot in good condition, subsiding

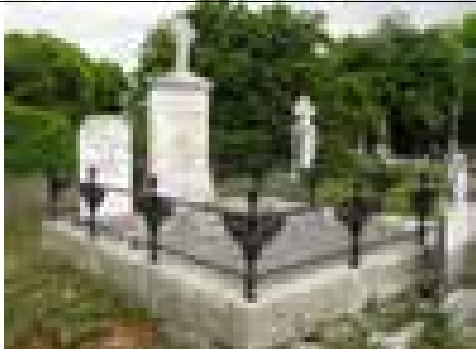
Grave_No	Family Name	Photo_Name
59	Walsh	IMG_0110
Notes		
Plot in good condition

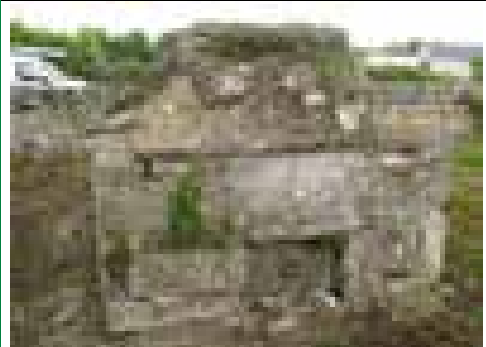
Grave_No	Family Name	Photo_Name
13	Carroll	IMG_0025
Notes		
Tomb in moderate condition, 1823

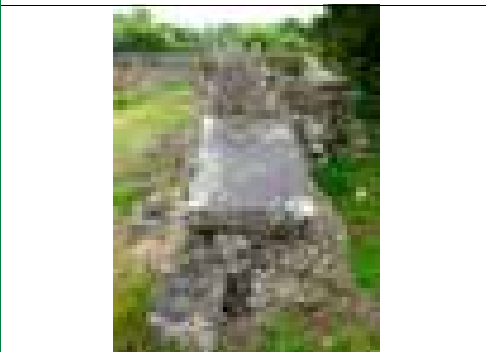
Grave_No	Family Name	Photo_Name
5	Coghlan	IMG_0005
Notes		
Tomb in moderate condition with headstone

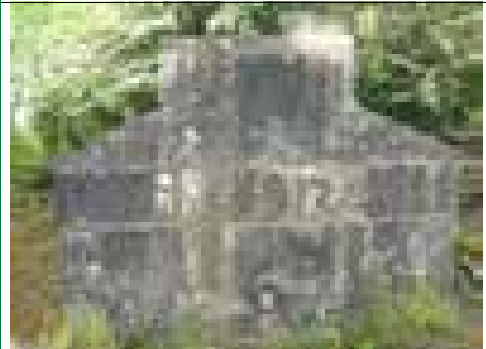
Grave_No	Family Name	Photo_Name
23	O'Connor	IMG_0051
Notes		
Tomb in good condition, 1852

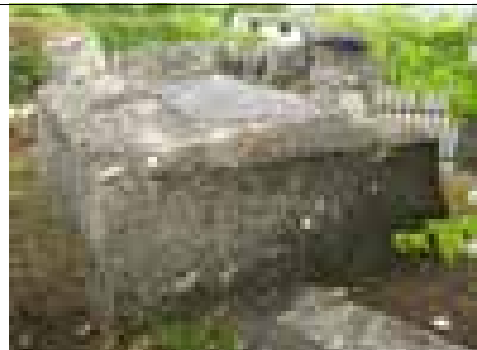
Grave_No	Family Name	Photo_Name
8	O'Rourke	IMG_0010
Notes		
Tomb in good condition, concrete sarcophagus, west elevation part of west graveyard wall

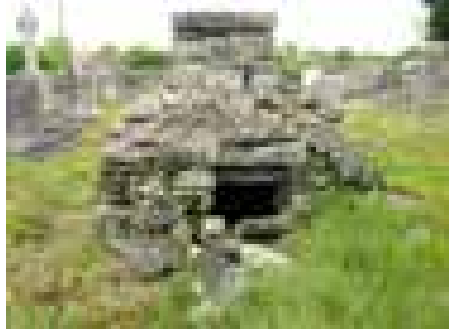
Grave_No		Photo_Name
20		IMG_0040
Notes		
Tomb in moderate condition. Entrance has collapsed and human remains are clearly visible inside tomb, a skull fragment is also located just outside the tomb,

- Restoration works to the collapsed tombs will require further investigation. It is highly unlikely that it will be possible to clear out the rubble from these in filled tombs which would require archaeological work as disturbed/crushed human remains will be uncovered. The laying of a protective geotextile and the construction of a low rectangular structure to cap the tomb would be a suitable remedy if a stable foundation can be laid.

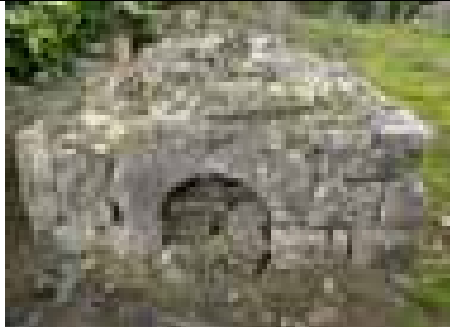
Grave_No		Photo_Name
10		IMG_0017
Notes		
An abundance of architectural fragments, probably from the old church, primarily the entrance to the tomb has round-headed opening

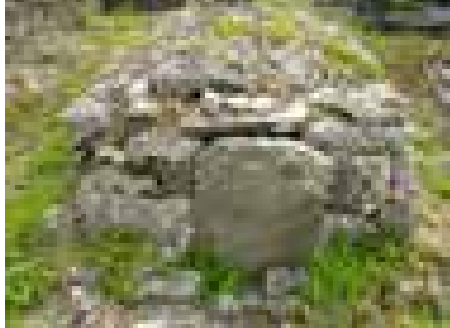
Grave_No		Photo_Name
26		IMG_0060
Notes		
Tomb in moderate condition, roof is crumbling

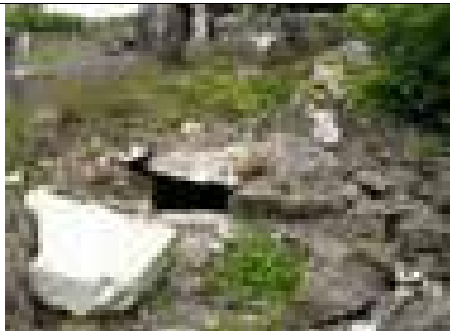
Grave_No		Photo_Name
49		IMG_0094
Notes		
Tomb in poor condition, collapsed

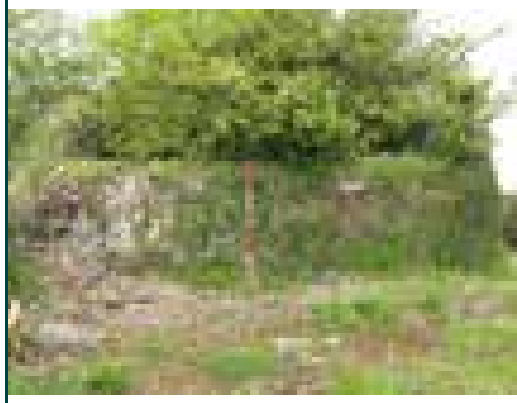
Misc Item No	Photo Name
2	IMG_0175
Notes	
Remains of building partly inside graveyard

Conservation works should be carried out to secure the masonry work as the building is of importance considering its age and the function it plays within the boundaries of the graveyard. Such work would involve the re-pointing of the walls using correct (lime) mortars with flush or recessed pointing. Ribbon pointing must be avoided as its use would damage the structure's historic character. The structural stability of the building needs to be frequently monitored due to the nature of the site, which is in close proximity to a wooded area. Efforts should be made to discourage people from climbing through the breach in the north elevation of the associated building to the southeast.

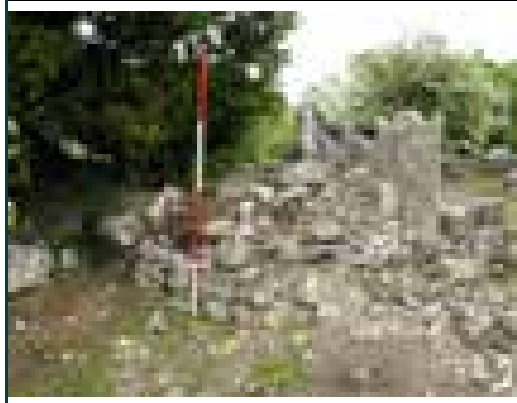
The low form of much of the surviving portions of the walls of the church ruin also causes a significant trip hazard. Any conservation works should address this concern and use appropriate action to ensure that the wall is made stable. Suitable signs should inform the public of this hazard which should also aid in reducing the risks involved.

Misc Item No	Photo Name
1	IMG_0170
Notes	
Remains of church wall

Measures should be taken to secure the existing church ruin from further collapse or disturbance; this could primarily be achieved through the control and management of the attached vegetation. The church ruin is in need of immediate conservation work. Such work would involve the re-pointing of the walls using correct (lime) mortars with flush or recessed pointing. Ribbon pointing must be avoided as its use would damage the structure's historic character.

- Measures should be taken to secure the church ruin from further collapse through the control and monitoring of all attached vegetation and the re-pointing of the structure using appropriate (lime) mortars with flush or recessed pointing. Ribbon pointing must be avoided as its use would damage the structures historic character.
