Project code: KCCG11
Client: Kerry County Council
Date: June 2011

Archaeological Survey of Galey Graveyard, Listowel, Co. Kerry.

Surveyors: Ann Frykler & Robert Hanbidge
Report Author: Robert Hanbidge

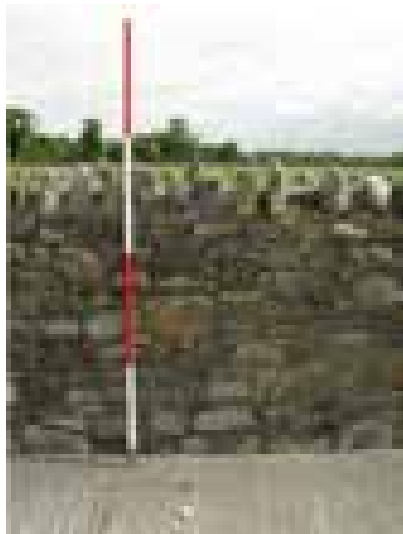
Miscellaneous No. 06: Included within the fabric of the northeastern boundary to the graveyard is a possible font/bullaun stone (Plates 7 & 8). Carved in a locally sourced sedimentary stone, the feature has a circular plan and concave profile which though relatively shallow is similar to other shallow fonts and bullaun stones with smooth sides and a fine concave profile. The basin is deeper in profile in comparison to miscellaneous item No. 01, a cruder example of a basin carved into a narrow slate gravemarker.

Plate 7-View of possible font/bullaun stone
(Miscellaneous item No.06) within wall fabric, from
south-west

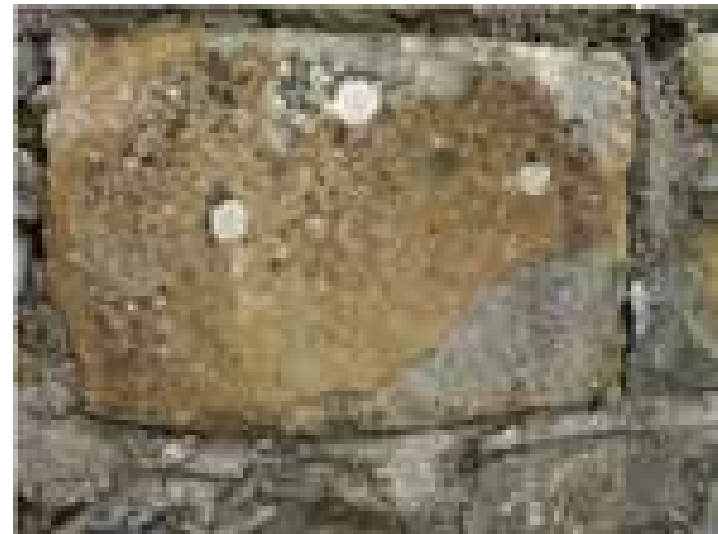
Plate 8-Detail to possible font/bullaun stone from south-
west

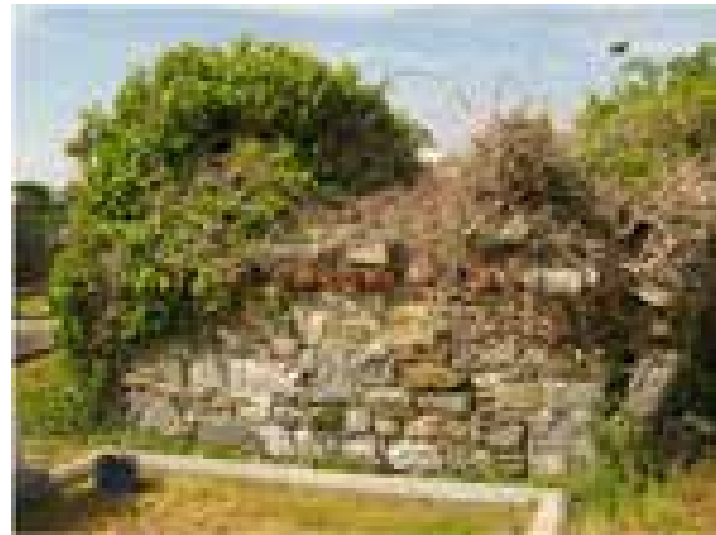
Plate 22-View of tomb (Grave No. 166), from south

Grave No. 166 appears to be the worst affected of the tombs (Plate 22). The walls of the tomb remain upright; however, the roof of the tomb has collapsed and is severely overgrown by ivy and brambles.

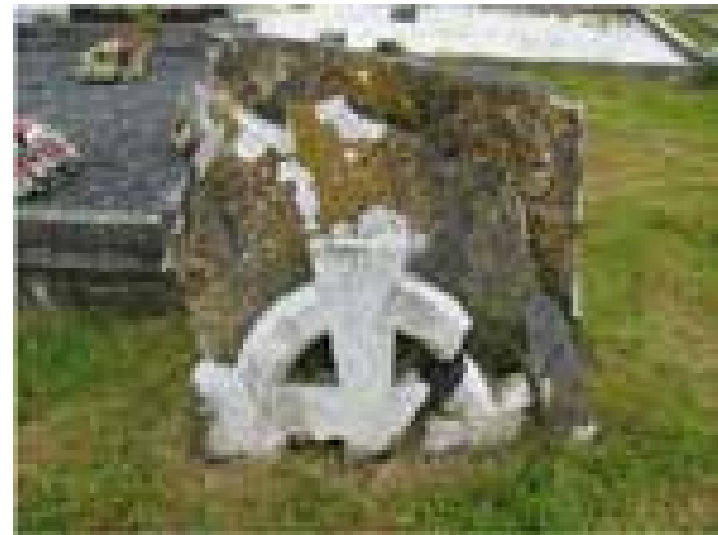
The majority of the headstones are in good condition. There is a small number of headstones which are cracked or broken e.g. Grave No. 13 (Plate 25).

Plate 25-Detail to broken headstone to Grave No. 13, from east

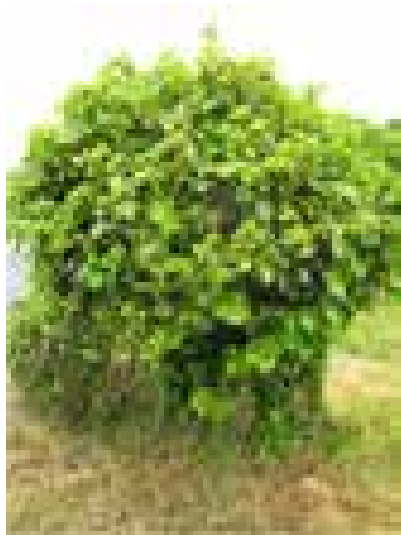
Plate 28-View of Grave No. 288, from east

There are only 18 unnamed or illegible headstones and plots within historic Galey graveyard. Two of which are illegible headstones (Grave Nos. 157 & 288). The headstone at Grave No. 288 (Plate 28) was quite overgrown with ivy and it may be legible upon removal of the ivy.

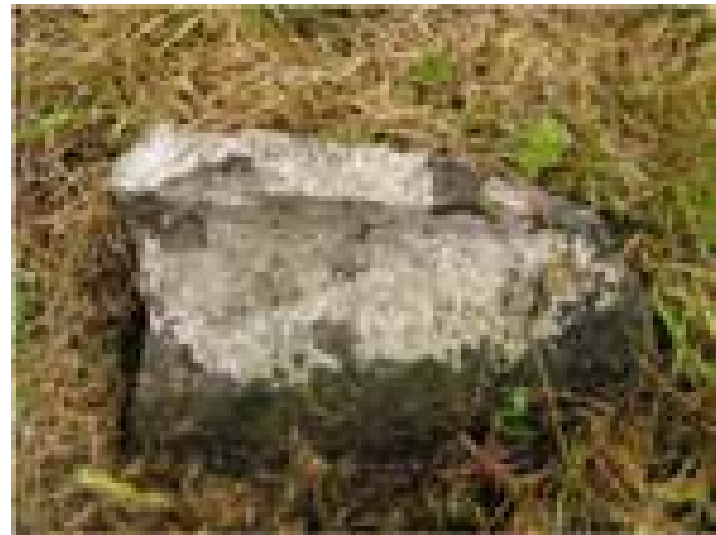
Miscellaneous No. 04: Located just east of the central area of the graveyard is an unnamed gravemarker (Grave No. 321). The stone used for the gravemarker is an architectural fragment that consists of a piece of tooled moulded limestone (an ogee curve which joins up with a lip) (Plate 33). The stone

Plate 33-Architectural Fragment (Miscellaneous No. 04, Grave No. 321)

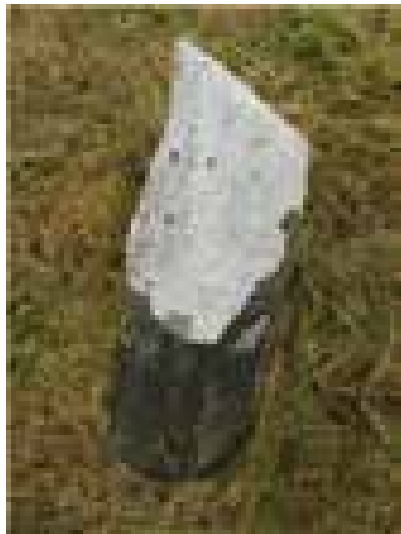
Miscellaneous No. 05: Positioned approximately 2 m to the northwest of the architectural fragment described above (Miscellaneous No. 04) was a second architectural fragment (Miscellaneous No. 05) which acts as the unnamed gravemarker for Grave No. 322 (Plate 34). This stone is also a carved piece of limestone which has a slightly irregular square profile with a notable tooled/cut bevel to one corner, suggesting that the stone once formed part of a jamb to an opening, possibly a door or window of the church.

Plate 34-Architectural Fragment
(Miscellaneous No .05, Grave No. 322)

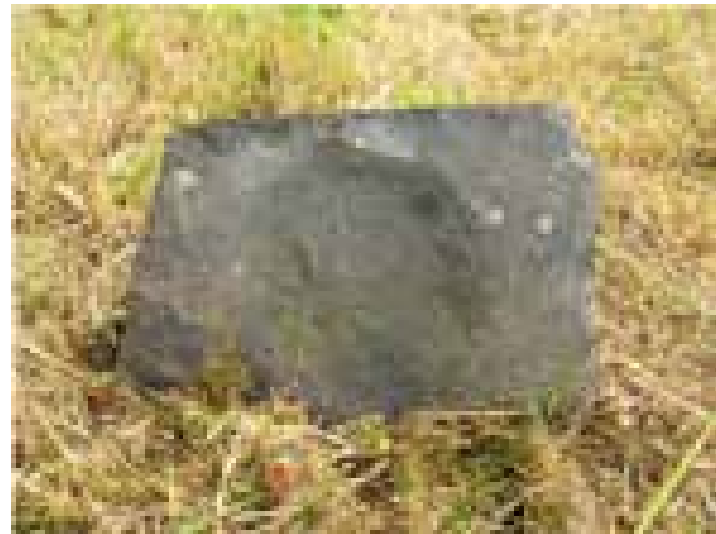
Plate 35-Miscellaneous Item No. 01 (Grave No. 320)

Miscellaneous No. 01: Located in the eastern half of the site, 3 m to the northwest of a tomb (Grave No. 121) is an unnamed gravemarker (Grave No. 320). This gravemarker comprises a roughly circular, shallow (c. 1 cm deep) concave feature carved into the upper surface of a slate stone (Plate 35). The circular feature is roughly carved and therefore does not share many similarities with fonts or bullaun stones, which are often more finely carved and are more 'basin like' in profile with greater depths. There are several smaller depressions around the base of this feature which are unusual and may indicate that the feature may have served as some sort of receptacle, possibly associated with a grave or otherwise, although this cannot be confirmed.

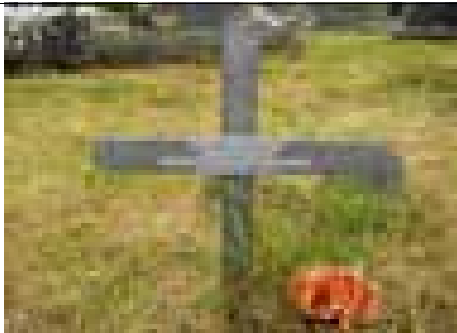
Grave_No	Family Name	Photo_Name
118	Lyons	IMG_0192
Notes		
Iron cross

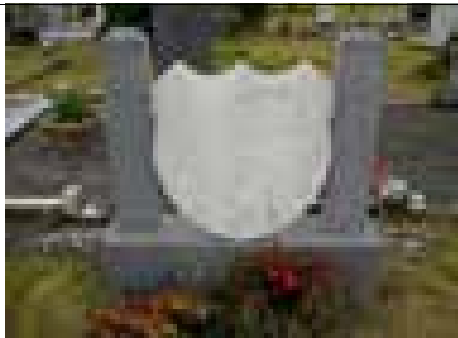
Grave_No	Family Name	Photo_Name
159	Kelly	IMG_0395
Notes		
Single headstone

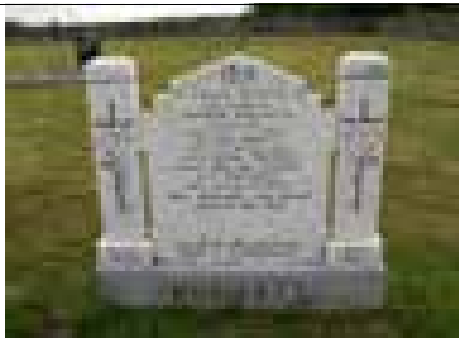
Grave_No	Family Name	Photo_Name
228	Moriarty	IMG_0416
Notes		
Single headstone

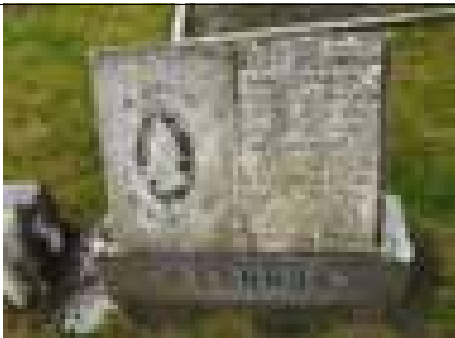
Grave_No	Family Name	Photo_Name
57	O'Connor	IMG_0093
Notes		
Single headstone

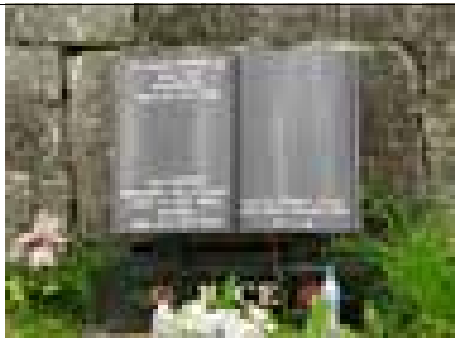
Grave_No	Family Name	Photo_Name
273	Rice	IMG_0483
Notes		
Single headstone

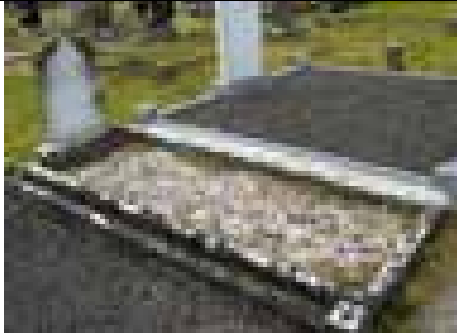
Grave_No	Family Name	Photo_Name
190	Ahern	IMG_0340
Notes		
Plot in good condition, grass

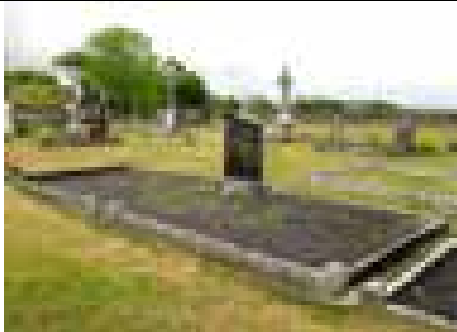
Grave_No	Family Name	Photo_Name
294	Ahern	IMG_0531
Notes		
Plot in good condition

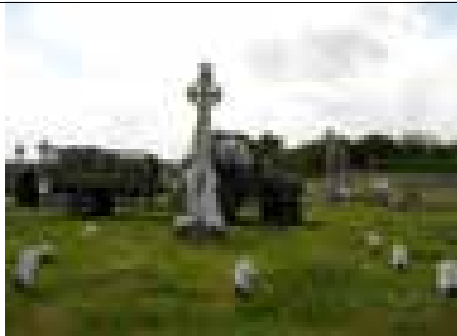
Grave_No	Family Name	Photo_Name
146	Byrne	IMG_0246
Notes		
Partly removed plot in moderate condition

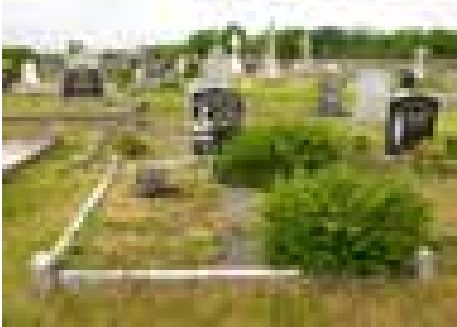
Grave_No	Family Name	Photo_Name
41	Dowling	IMG_0075
Notes		
Plot in good condition, bushes needs trimming

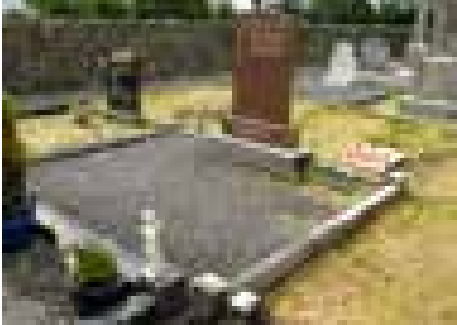
Grave_No	Family Name	Photo_Name
81	Dowling	IMG_0135
Notes		
Plot in moderate condition, subsiding

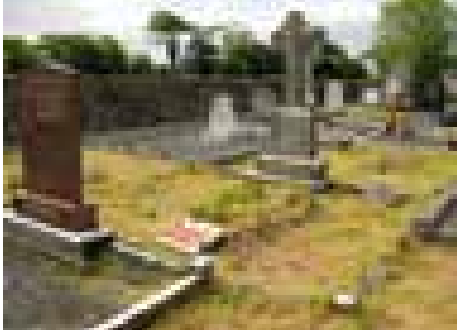
Grave_No	Family Name	Photo_Name
82	Dowling	IMG_0137
Notes		
Grass cover plot in good condition, subsiding

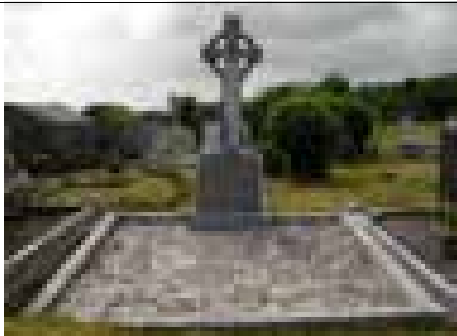
Grave_No	Family Name	Photo_Name
153	Enright	IMG_0259
Notes		
Plot in good condition

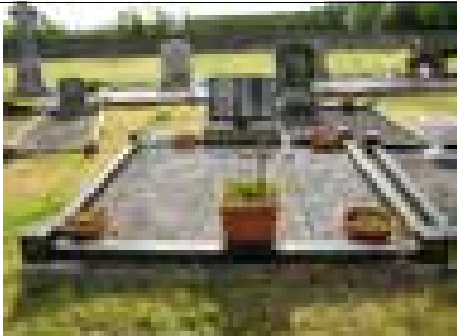
Grave_No	Family Name	Photo_Name
198	Dowling	IMG_0357
Notes		
Plot in good condition

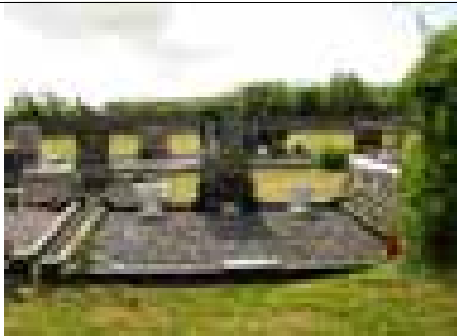
Grave_No	Family Name	Photo_Name
199	Enright	IMG_0359
Notes		
Plot in good condition

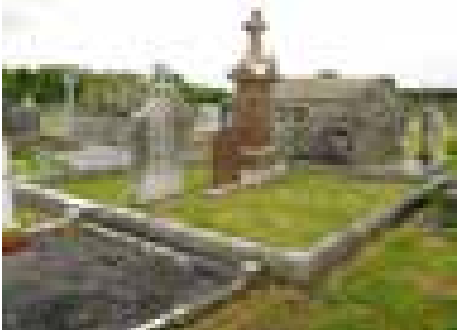
Grave_No	Family Name	Photo_Name
274	Enright/Moloney	IMG_0484
Notes		
Large grass covered plot in good condition

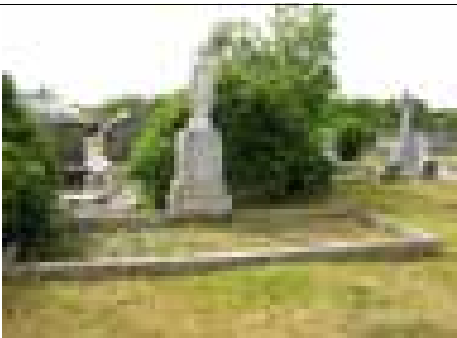
Grave_No	Family Name	Photo_Name
158	Ferris	IMG_0267
Notes		
Plot in good condition, grass

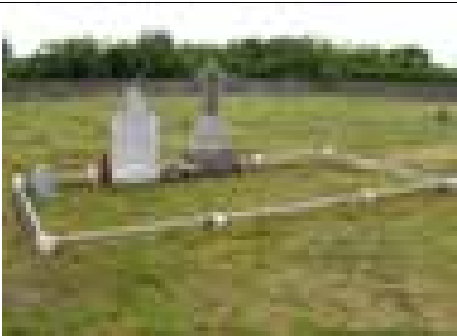
Grave_No	Family Name	Photo_Name
242	Finucane/Collins	IMG_0434
Notes		
Grass covered plot in good condition

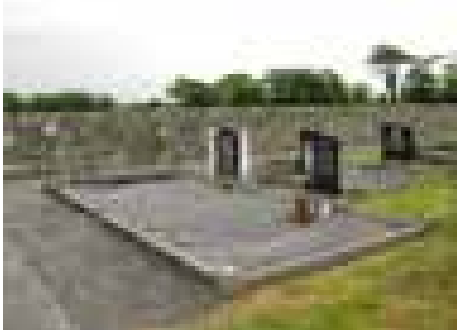
Grave_No	Family Name	Photo_Name
25	Fitzgerald/O'Shea	IMG_0045
Notes		
Plot in moderate condition, subsiding

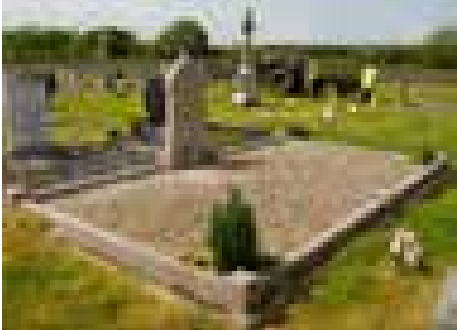
Grave_No	Family Name	Photo_Name
144	Foley	IMG_0243
Notes		
Plot in good condition

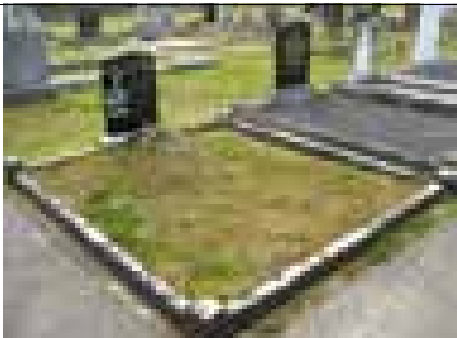
Grave_No	Family Name	Photo_Name
188	Flavin	IMG_0336
Notes		
Plot in moderate condition

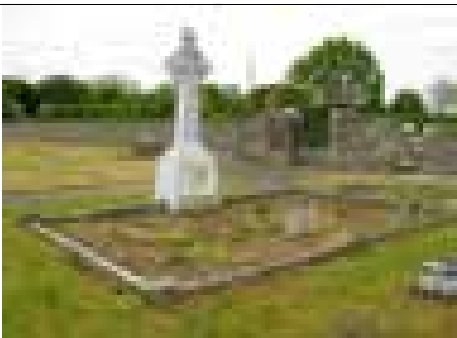
Grave_No	Family Name	Photo_Name
302	Foley	IMG_0543
Notes		
Plot in good condition

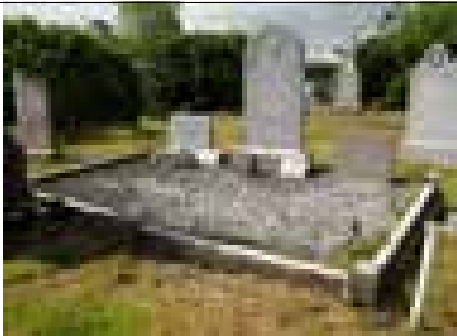
Grave_No	Family Name	Photo_Name
87	Foley	IMG_0148
Notes		
Plot in good condition

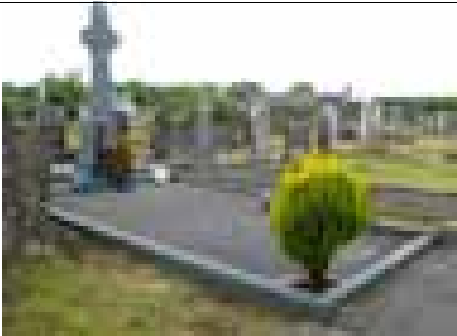
Grave_No	Family Name	Photo_Name
23	Foran	IMG_0036
Notes		
Large irregular shaped plot in good condition

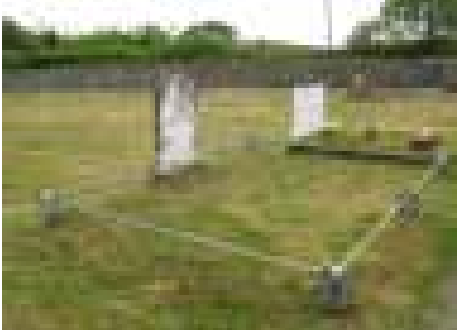
Grave_No	Family Name	Photo_Name
229	Galvin	IMG_0417
Notes		
Grass covered plot in good condition

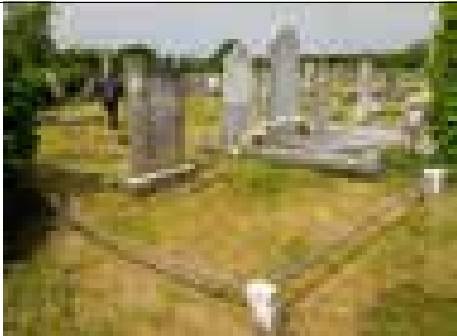
Grave_No	Family Name	Photo_Name
85	Galvin	IMG_0145
Notes		
Grass covered plot in good condition

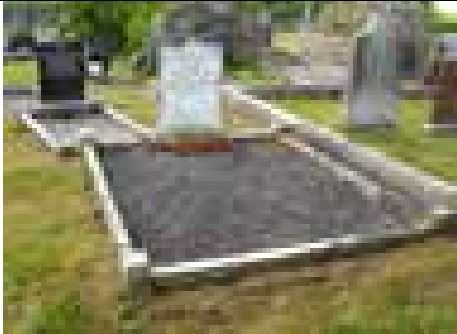
Grave_No	Family Name	Photo_Name
181	Galvin	IMG_0321
Notes		
Plot in good condition

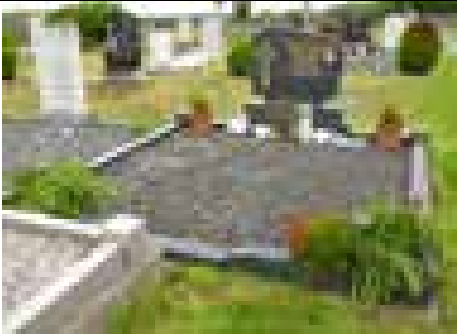
Grave_No	Family Name	Photo_Name
163	Gould	IMG_0402
Notes		
Plot in good condition

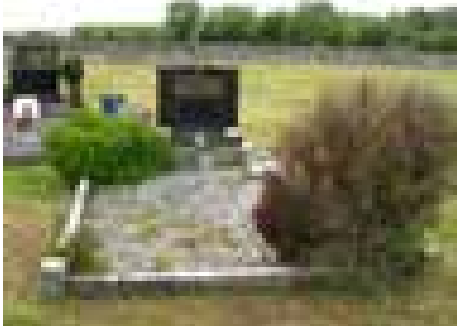
Grave_No	Family Name	Photo_Name
243	Harnett	IMG_0437
Notes		
Plot in good condition, moss and weeds, heather could use a trim

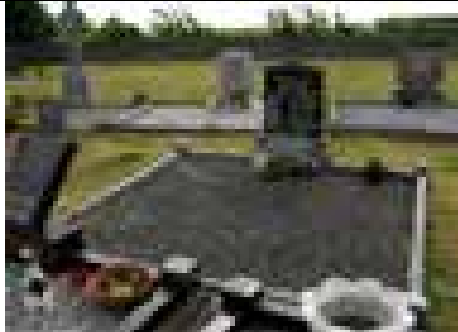
Grave_No	Family Name	Photo_Name
200	Keane/Riordan	IMG_0361
Notes		
Plot in good condition

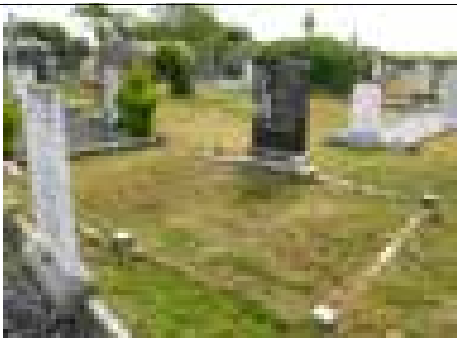
Grave_No	Family Name	Photo_Name
149	Harty	IMG_0252
Notes		
Plot in moderate condition

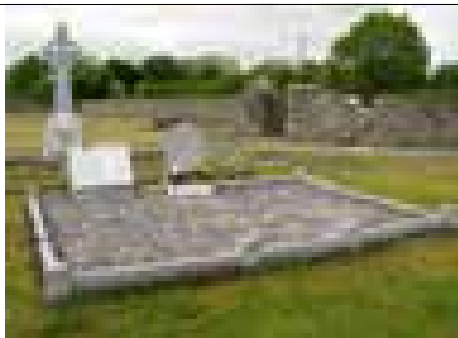
Grave_No	Family Name	Photo_Name
316	Keane/Riordan	IMG_0567
Notes		
Plot in good condition

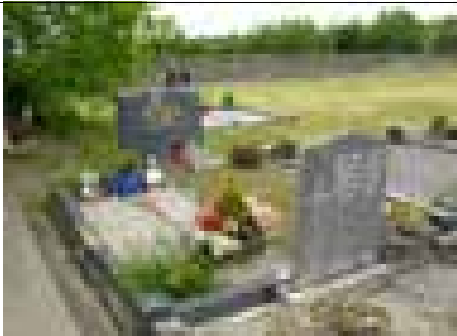
Grave_No	Family Name	Photo_Name
215	Hughes	IMG_0390
Notes		
Plot in good condition, moss

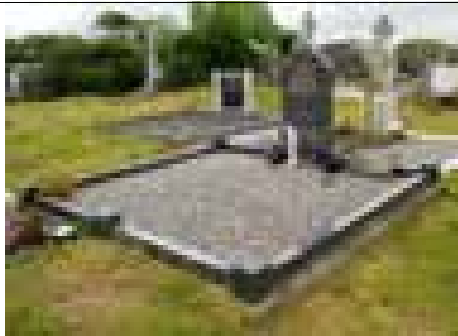
Grave_No	Family Name	Photo_Name
113	Kelly	IMG_0185
Notes		
Plot in good condition

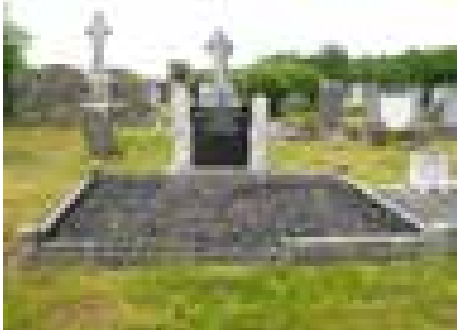
Grave_No	Family Name	Photo_Name
140	Kelly	IMG_0235
Notes		
Plot in good condition

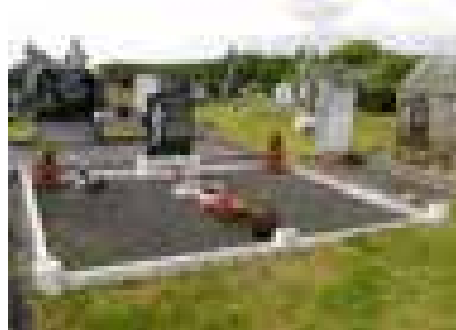
Grave_No	Family Name	Photo_Name
128	Kennelly	IMG_0211
Notes		
Plot in good condition

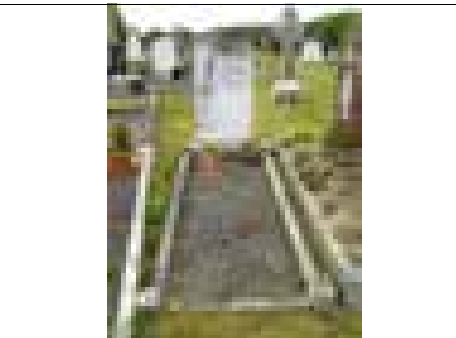
Grave_No	Family Name	Photo_Name
129	Kennelly	IMG_0213
Notes		
Plot in good condition

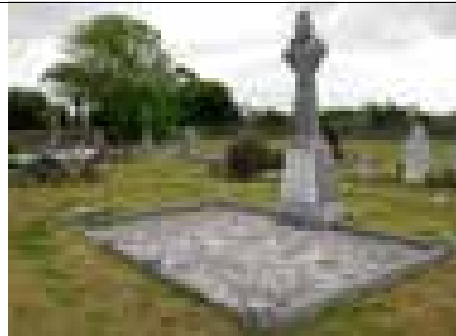
Grave_No	Family Name	Photo_Name
250	Kennelly	IMG_0449
Notes		
Plot in good condition

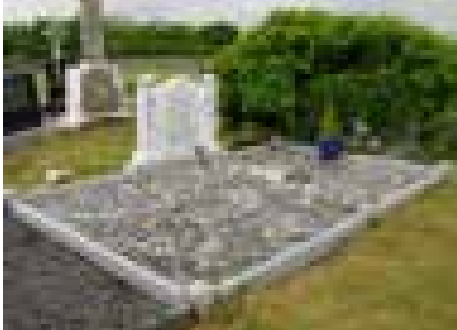
Grave_No	Family Name	Photo_Name
282	Kennelly	IMG_0510
Notes		
Plot in good condition

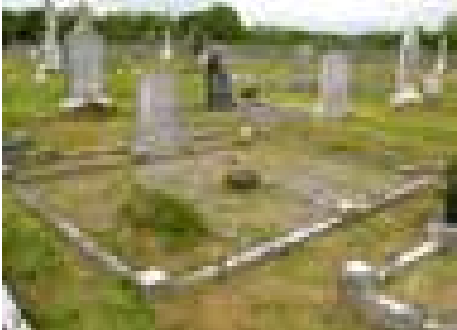
Grave_No	Family Name	Photo_Name
60	Kissane	IMG_0097
Notes		
Plot in good condition, weeds

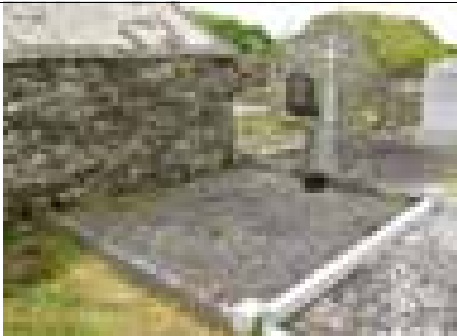
Grave_No	Family Name	Photo_Name
283	Kennelly	IMG_0512
Notes		
Plot in good condition

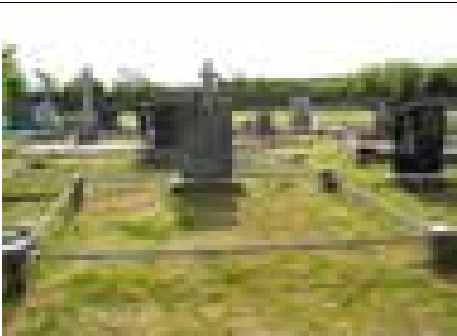
Grave_No	Family Name	Photo_Name
192	Langan	IMG_0344
Notes		
Grass covered plot in good condition

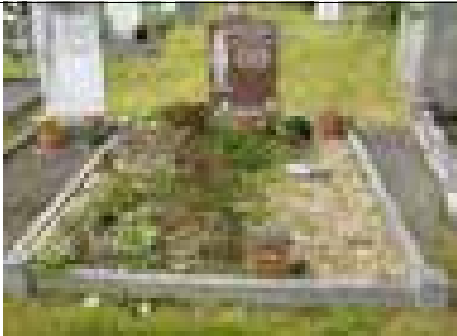
Grave_No	Family Name	Photo_Name
130	Kennely	IMG_0215
Notes		
Plot in good condition

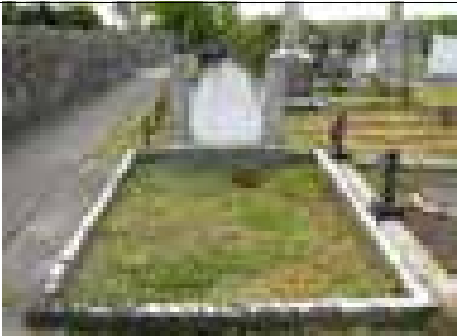
Grave_No	Family Name	Photo_Name
175	Leane	IMG_0312
Notes		
Grass covered plot in good condition

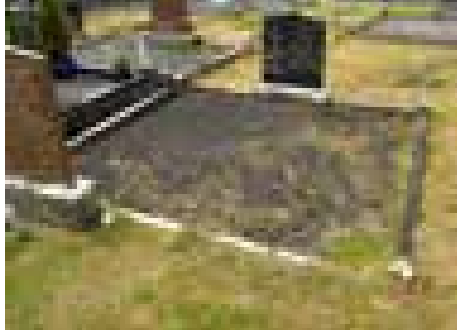
Grave_No	Family Name	Photo_Name
78	Lynch	IMG_0129
Notes		
Plot in good condition

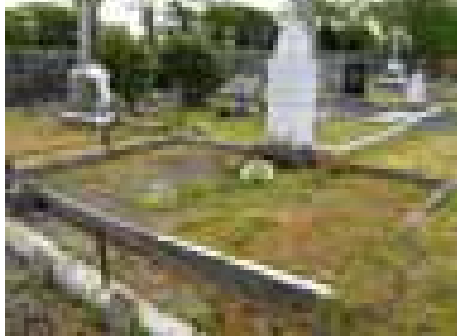
Grave_No	Family Name	Photo_Name
178	Lynch	IMG_0317
Notes		
Plot in good condition, slightly subsiding and moss

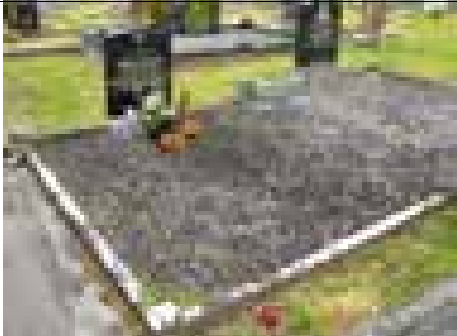
Grave_No	Family Name	Photo_Name
26	Long	IMG_0048
Notes		
Plot in good condition

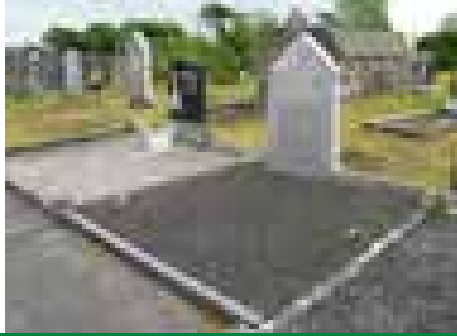
Grave_No	Family Name	Photo_Name
16	Lyon	IMG_0021
Notes		
Plot in good condition, 1867

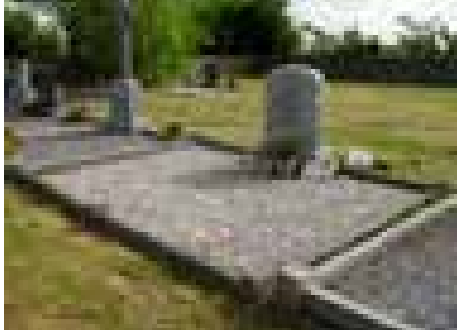
Grave_No	Family Name	Photo_Name
210	McMahon	IMG_0380
Notes		
Plot in good condition

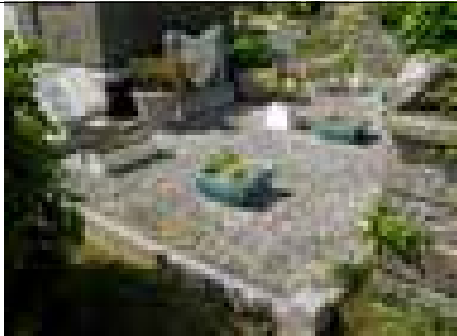
Grave_No	Family Name	Photo_Name
165	Molyneux	IMG_0275
Notes		
Plot in good condition

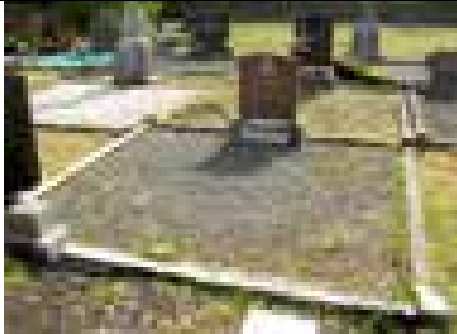
Grave_No	Family Name	Photo_Name
197	Moran	IMG_0355
Notes		
Plot in good condition, moss and grass

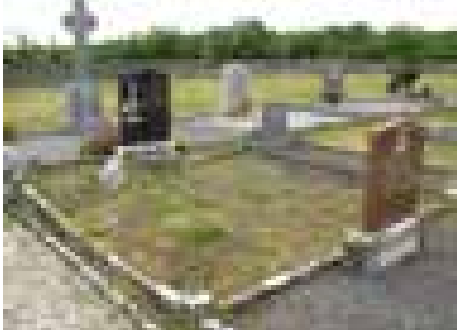
Grave_No	Family Name	Photo_Name
202	Moran	IMG_0365
Notes		
Plot in good condition, grass and weeds

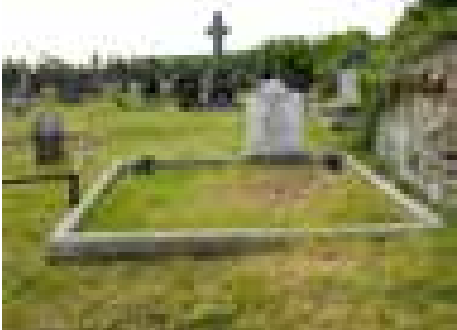
Grave_No	Family Name	Photo_Name
172	Mulvihill	IMG_0297
Notes		
Grass covered plot in good condition

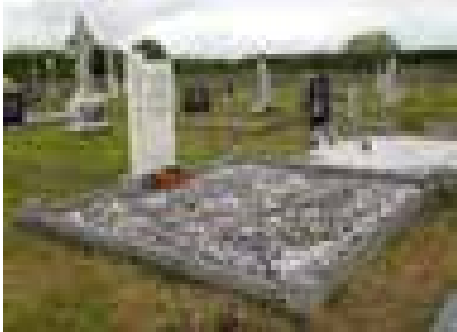
Grave_No	Family Name	Photo_Name
62	Moriarty	IMG_0101
Notes		
Plot in good condition

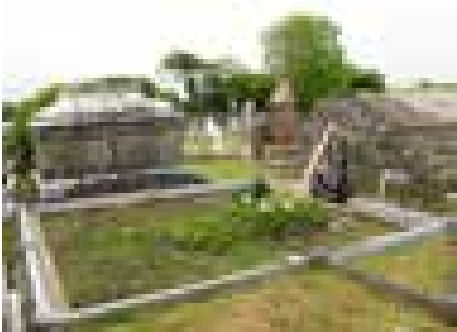
Grave_No	Family Name	Photo_Name
276	Mulvihill	IMG_0495
Notes		
Newly erected plot and headstone

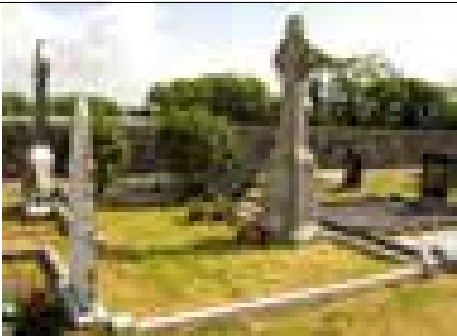
Grave_No	Family Name	Photo_Name
186	Mulvihill/Griffin	IMG_0331
Notes		
Grass covered plot in good condition, also two holy bushes on the south part of plot

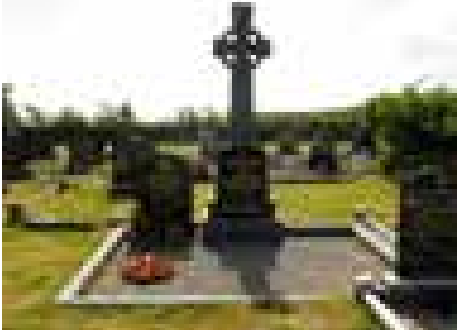
Grave_No	Family Name	Photo_Name
185	Neligan/O'Connor	IMG_0328
Notes		
Plot in good condition

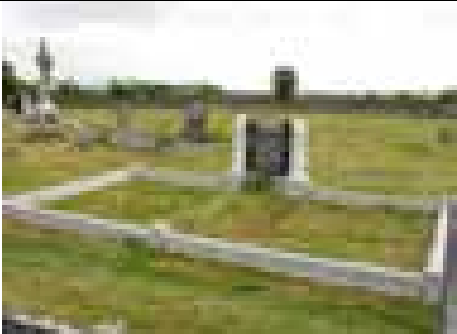
Grave_No	Family Name	Photo_Name
233	O'Carroll	IMG_0422
Notes		
Grass covered plot in good condition

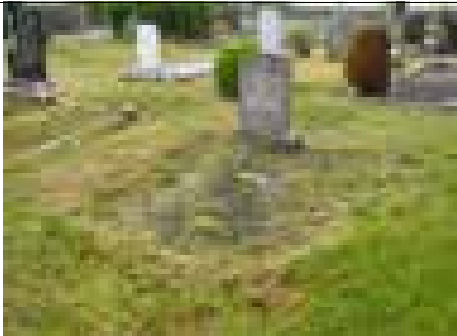
Grave_No	Family Name	Photo_Name
148	Murphy/Mulvihill	IMG_0249
Notes		
Plot in moderate condition

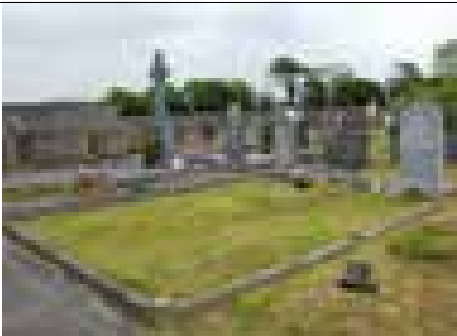
Grave_No	Family Name	Photo_Name
20	O'Connor	IMG_0027
Notes		
Grass covered plot in good condition

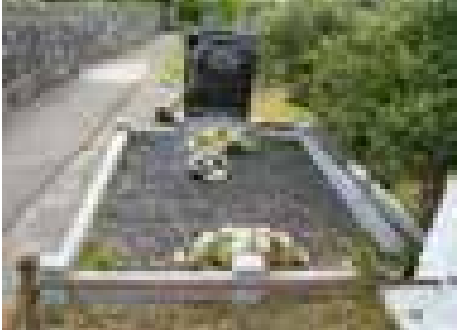
Grave_No	Family Name	Photo_Name
187	O'Connor	IMG_0334
Notes		
Plot in good condition

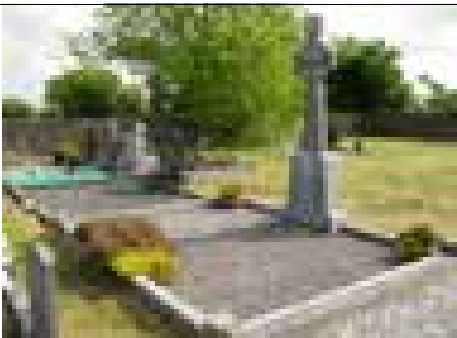
Grave_No	Family Name	Photo_Name
209	O'Connor	IMG_0378
Notes		
Plot in good condition

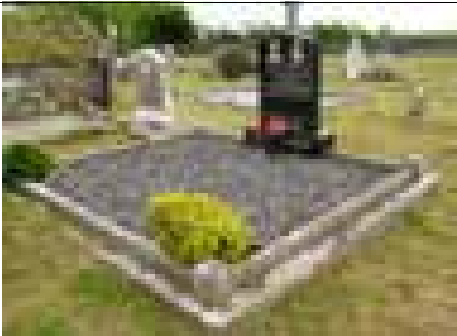
Grave_No	Family Name	Photo_Name
266	O'Connor	IMG_0466
Notes		
Plot in good condition

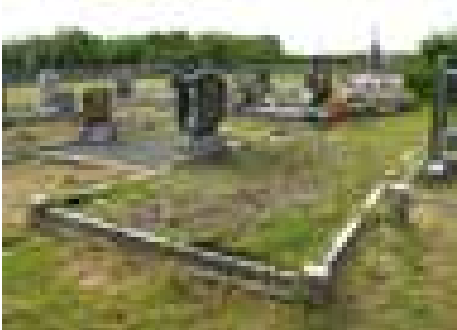
Grave_No	Family Name	Photo_Name
194	O'Dowd	IMG_0348
Notes		
Plot in good condition, weeds

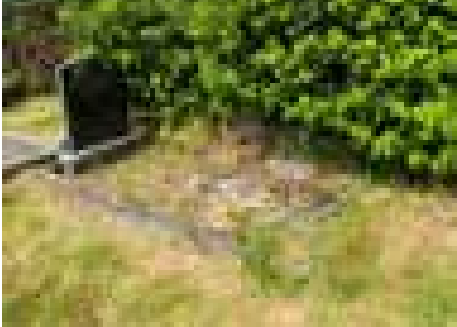
Grave_No	Family Name	Photo_Name
122	Pierse Walshe	IMG_0201
Notes		
Plot in good condition, weeds and grass

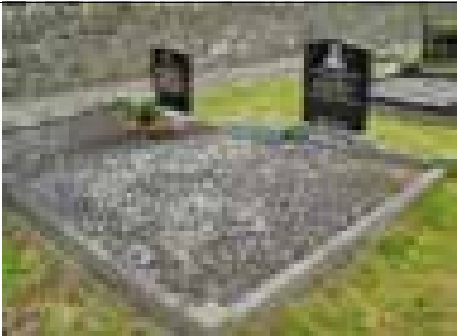
Grave_No	Family Name	Photo_Name
27	Quinlan	IMG_0050
Notes		
Plot in good condition

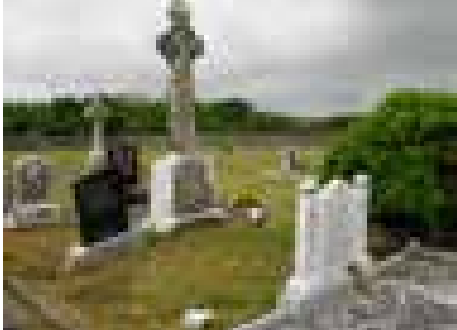
Grave_No	Family Name	Photo_Name
280	Walshe/Walsh	IMG_0506
Notes		
Plot in moderate condition, wrought iron railings heavily corroded and missing

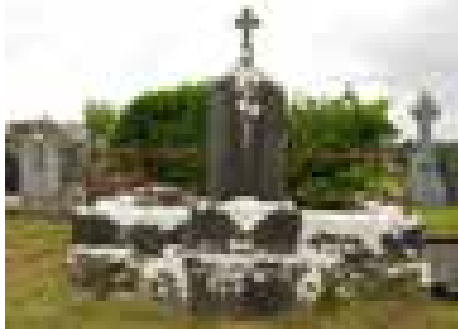
Grave_No	Family Name	Photo_Name
66	Carrol	IMG_0106
Notes		
Old headstone 1777, still in use new handle on entrance stone

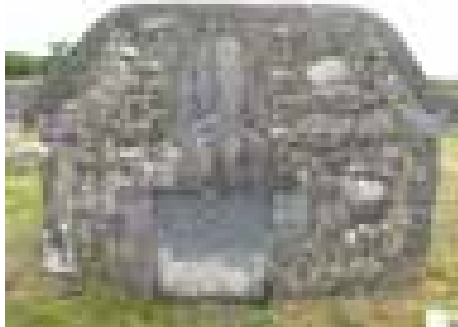
Grave_No	Family Name	Photo_Name
277	Enright	IMG_0497
Notes		
Tomb in good condition, visible roof slates underneath thin coating of render, headstone 1797

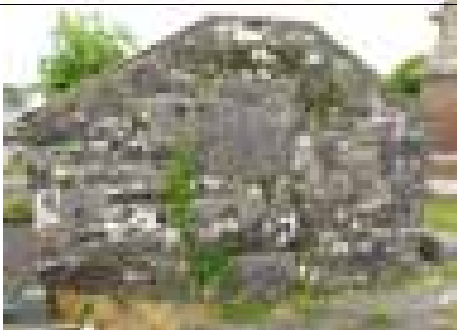
Grave_No	Family Name	Photo_Name
270	Marshall	IMG_0472
Notes		
Tomb in good condition, roof is crumbling, headstone 1783

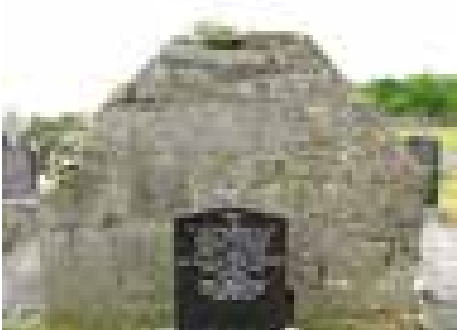
Grave_No	Family Name	Photo_Name
275	Gun	IMG_0490
Notes		
Tomb in good condition, 1835

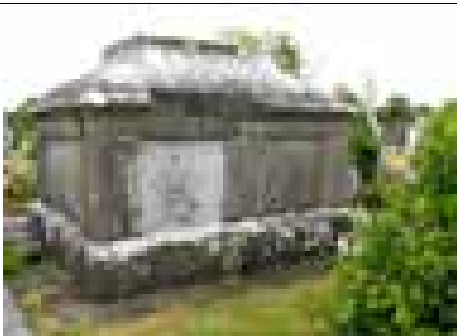
Grave_No	Family Name	Photo_Name
24	Whelan/Bunyan	IMG_0039
Notes		
Tomb in good condition, 1864

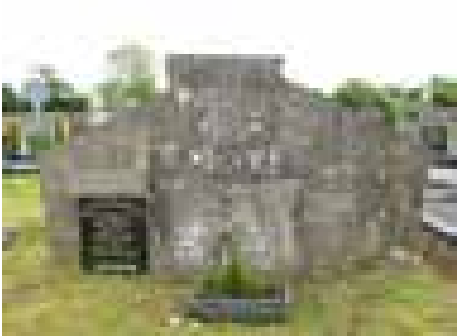
Grave_No	Family Name	Photo_Name
131	Keane	IMG_0217
Notes		
Tomb in good condition, with court to the east

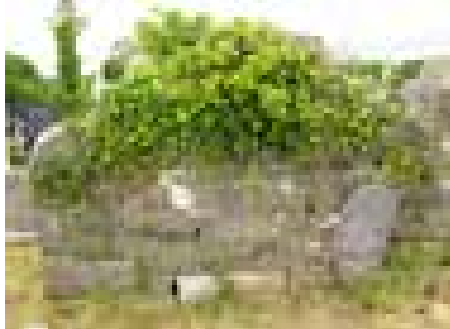
Grave_No		Photo_Name
72		IMG_0116
Notes		
Tomb in moderate condition, walls intact however roof is partly collapsed

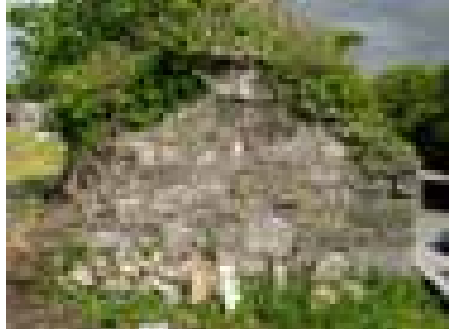
Grave_No		Photo_Name
164		IMG_0271
Notes		
Heavily overgrown tomb in moderate condition

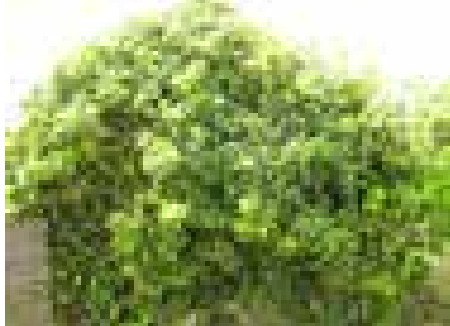
Grave_No		Photo_Name
121		IMG_0197
Notes		
Heavily overgrown tomb

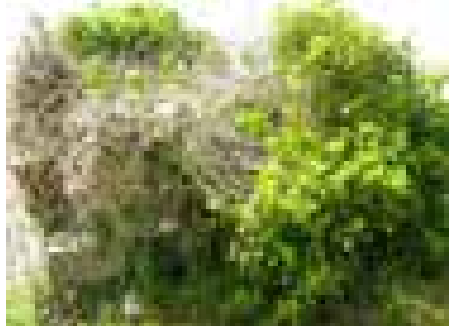
Grave_No		Photo_Name
166		IMG_0280
Notes		
Tomb in poor condition, walls still standing however east wall is pushed out and roof collapsed

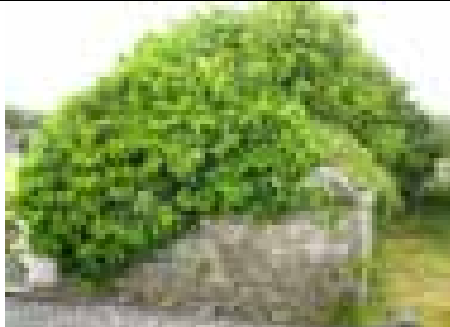
Grave_No		Photo_Name
133		IMG_0227
Notes		
Heavily overgrown tomb in moderate condition

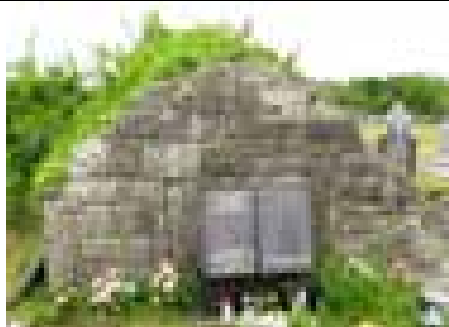
Grave_No		Photo_Name
272		IMG_0479
Notes		
Tomb in good condition, roof slightly overgrown

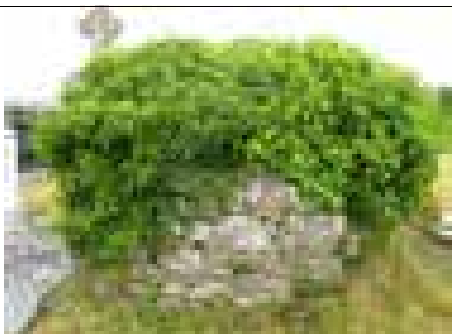
Grave_No		Photo_Name
292		IMG_0525
Notes		
Overgrown tomb in moderate condition

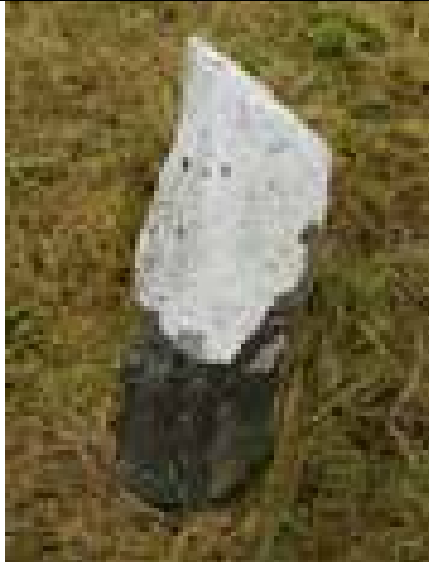
Misc Item No	Photo Name
5	IMG_0518
Notes Doorway or window jam, now also a gravemarker to Grave No. 322

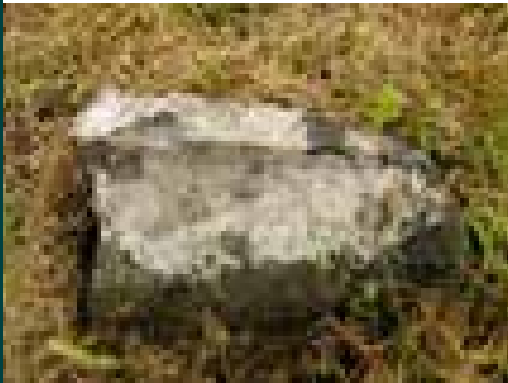
Misc Item No	Photo Name
4	IMG_0517
Notes Architectural fragment, also gravemarker to Grave No. 321

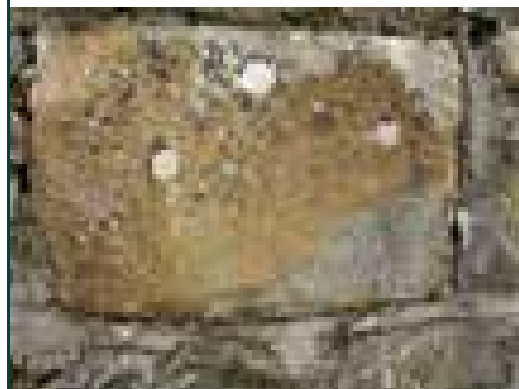
Misc Item No	Photo Name
6	IMG_0613

Possible base of shallow font, incorporated in east graveyard wall

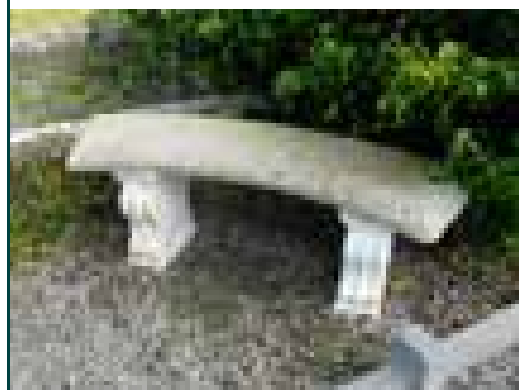
Misc Item No	Photo Name
2	IMG_0279

Seat by grave 165

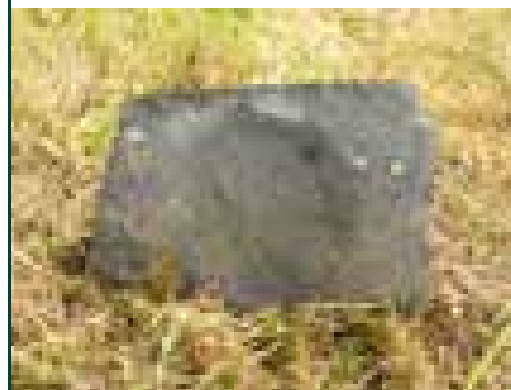
Misc Item No	Photo Name
1	IMG_0196

Stone with cup forming headstone to Grave No. 320

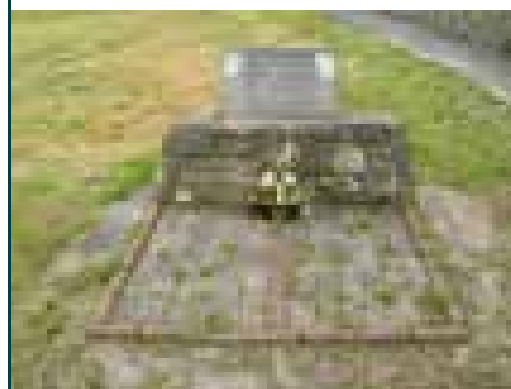
Misc Item No	Photo Name
3	IMG_0414

Memorial to the famine victims buried in this graveyard
