Project code: KCCG11
Client: Kerry County Council
Date: July 2011

Archaeological Survey of Kilmurry Burial Ground, Cordal, Co. Kerry.

Surveyors: Ann Frykler & Robert Hanbidge
Report Author: Robert Hanbidge

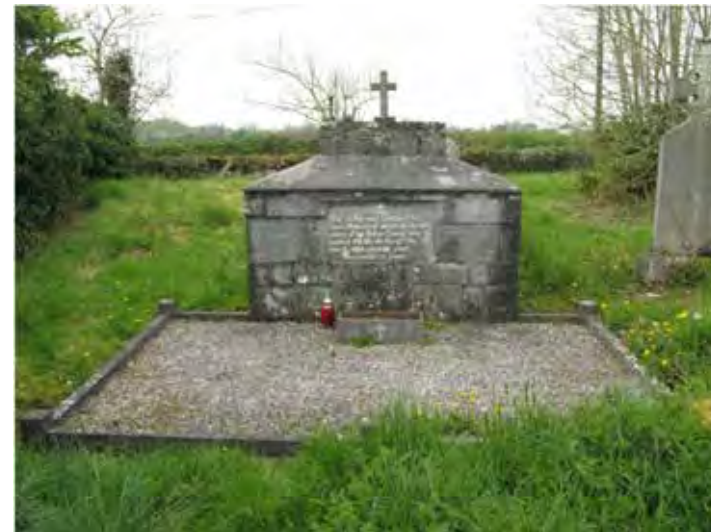
The oldest tomb was Grave No. 89 which belongs to the Horan family and dates to 1826. This tomb is located in the south-western corner of the graveyard and is in excellent condition. It follows a common design in Kerry graveyard tomb architecture, with a hipped stone block roof surmounted by a dressed stone platform (Plate 16). The tomb is enhanced through the use of finely tooled limestone and is also distinguished by the presence of a gravel-covered court area to the east.

Plate 16-View of tomb to Grave No. 89, from east

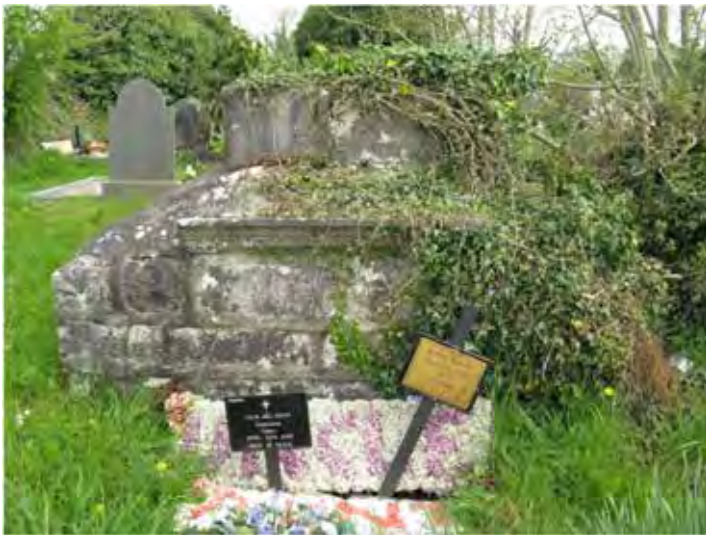
The Reidy Family tomb (Grave No. 97) follows a similar design to Grave No. 89, though it is not as elaborate. It consists of tooled and dressed limestone forming the fabric of the tomb while later rendering is used to form the hipped roof (Plate 17). However this tomb does possess some unusual traits with the inclusion of finely tooled limestone moulding above the eaves at the front (west) elevation and the presence of a sunken pathway at the entrance which is situated below ground level. This tomb remains in use and is in good condition. Overgrowth (mostly ivy) is beginning to establish itself on the southern side.

Plate 17-View of tomb (Grave No. 97), from west

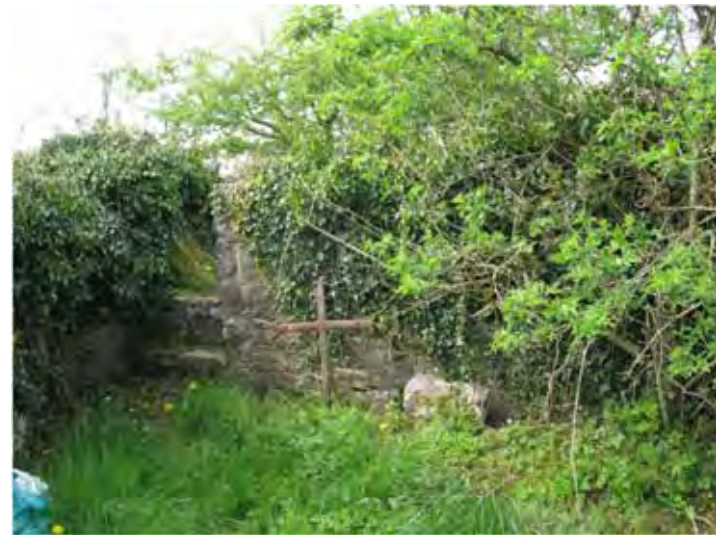
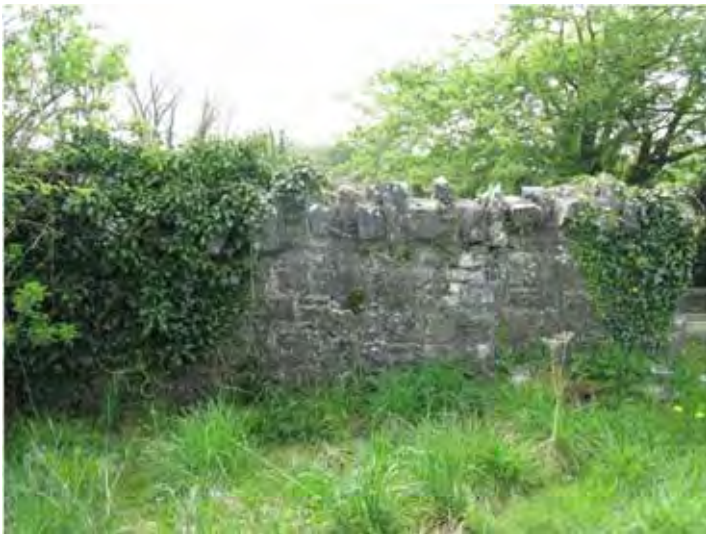
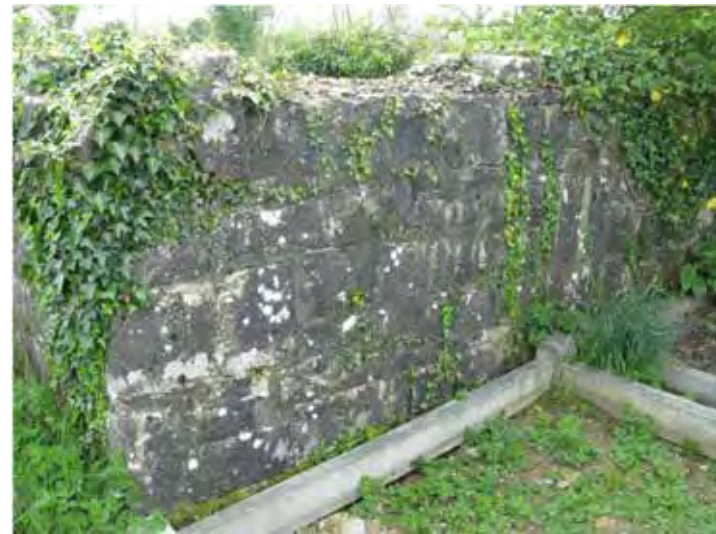
The tomb of Grave No. 56 is more akin to that of a small mausoleum due to its unusual design and scale (Plates 18-20). The structure consists of a rectangular sealed vault which is located adjoining the southern boundary. Dressed stone steps in the eastern elevation provide access to the top of the tomb which is enclosed by rusticated limestone block parapet walls with crenulated dressed rubblestone coping. A very unusual commemorative limestone plaque is incorporated into the eastern side of the western parapet wall and displays a large ornately inscribed central disk (Plates 21 and 22). Two later headstones flank this central plaque on the top of the tomb (plates 23 and 24). This tomb is in good condition, however overgrowth is beginning to establish itself over the structure with some unrestricted tree growth also partially hindering access and views of the tomb.

Plate 18-East elevation of tomb (Grave No. 56)

Plate 19-North elevation of tomb (Grave No. 56)

Plate 20-West elevation of tomb (Grave No. 56)

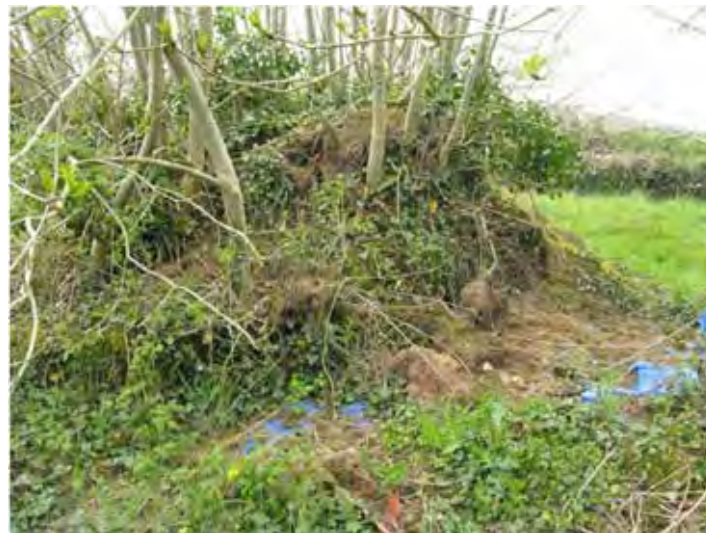
The first unnamed tomb (Grave No. 91) is in very poor condition and is overgrown with ivy and trees (Plate 26). The tomb structure is in a ruined state due to collapse and tree root activity.

Plate 26-View of northern elevation of tomb (Grave No.91)

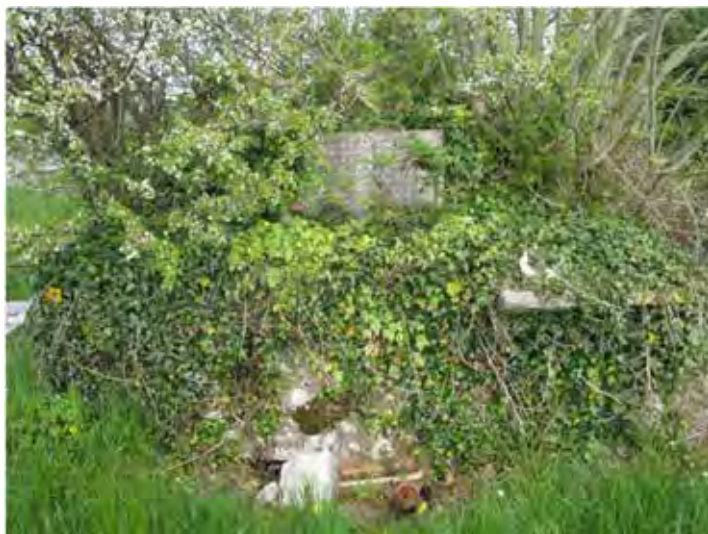
The second unnamed tomb (Grave No. 113) is located in the east of the western terminus of the northern elevation of the church. The tomb is in fair condition and is upstanding; however it is severely overgrown with ivy. A number of trees are also growing out of the tomb and have dislodged some of the masonry (Plate 27). This tomb is inscribed; the plaque is in Irish and appears to be a poetic verse rather than a commemorative plaque to an individual- a date of 1798/1804 indicates the tomb's age (Plate 28). Access to this plaque is partially restricted by tree growth.

Plate 27-View of western elevation of tomb (Grave No. 113)

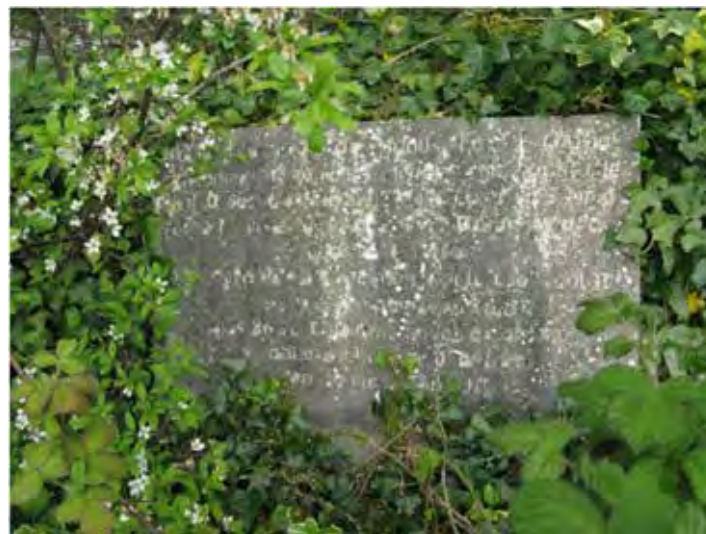
Plate 28-Detail to inscribed plaque to tomb (Grave No. 113).

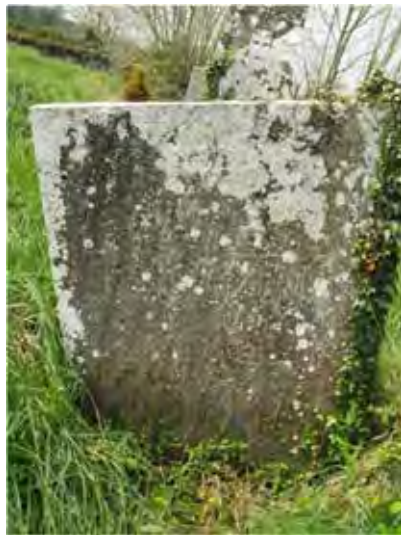
There are 111 named headstones and plots at Kilmurry Graveyard. The majority of these are in good condition and mostly date to the mid-late nineteenth and early twentieth centuries. There is a noted lack of any early nineteenth century or older named graves within this burial ground. The oldest inscribed headstone with a date of 1814 belongs to Grave No. 76 (Plate 29) and commemorates a

Plate 29-View of headstone to
Grave No. 76, from east

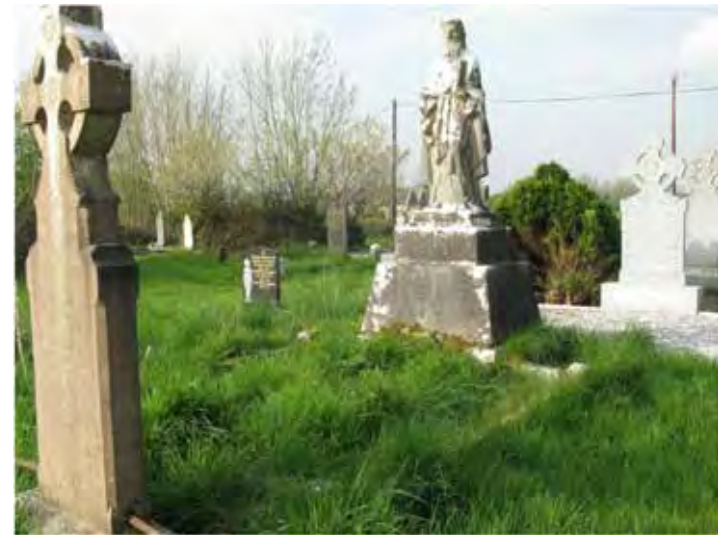
There is great variety in the design of headstones and plots within Kilmurry Graveyard. The majority of the headstones consist of simple inscribed limestone plaques while the more elaborate examples are often associated with plots and consist of High Crosses and statues of biblical features, e.g. Grave No. 10 (Plate 30). More elaborate detailing such as polished or tooled stone plinths, wrought-iron and decorative cast-iron railings and modern galvanised iron railings add further definition to these graves.

Plate 30-View of Grave No. 10 from east

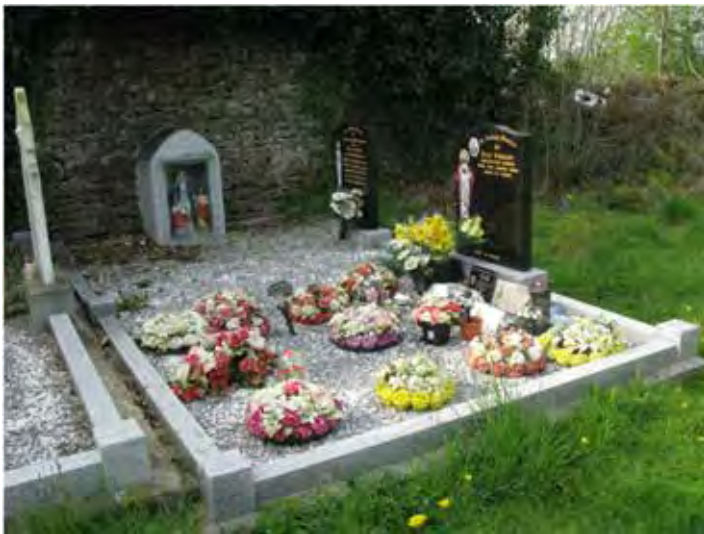
The modern plot of Grave No. 35 which is located abutting the external elevation of the northern church wall has an unusual small grotto built beside the church wall (Plate 31).

Plate 31-View of Grotto to Grave No. 35 from northeast

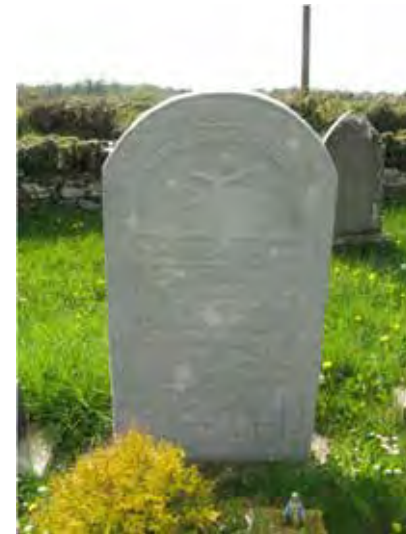
The unusual headstone of Grave No. 106 appears to be an exact replica of an older headstone which presumably was placed here but was replaced when it became illegible (Plate 32).

Plate 32-View of replica headstone to
Grave No. 106, from east

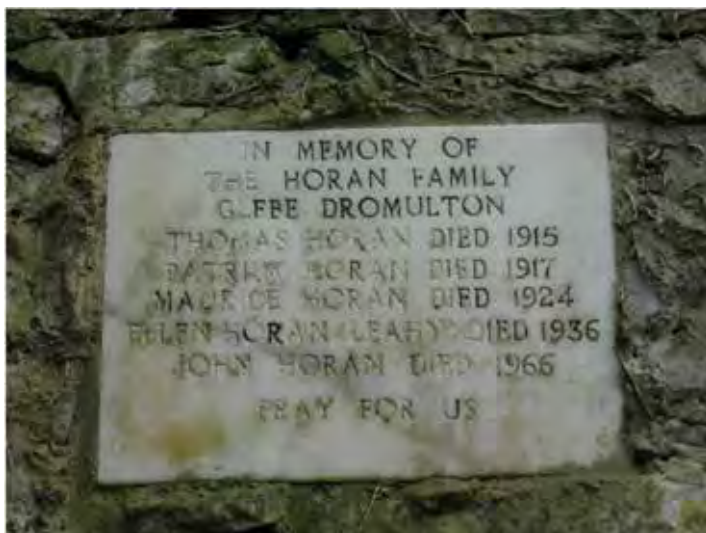
Other forms of headstones consist of wall mounted plaques, e.g. Grave No. 127 (Plate 33) which was mounted to the interior of the southern church wall.

Plate 33-View of wall mounted plaque to Grave No. 127, from north

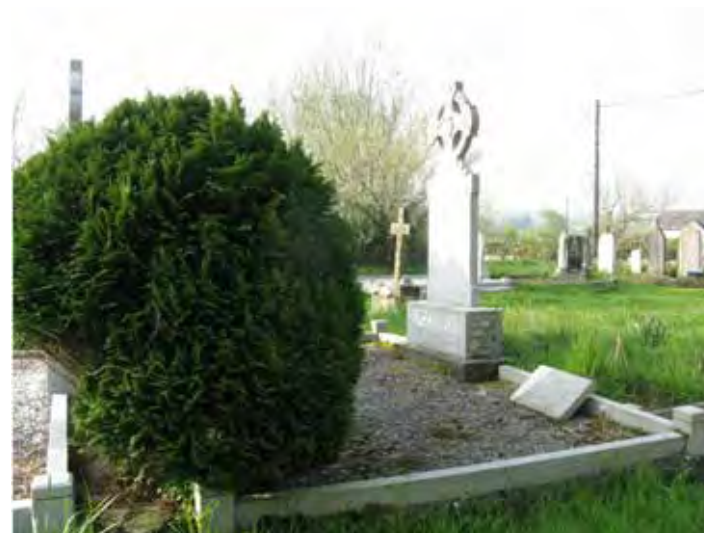
Some plots have trees growing within them which appear to be unmanaged, e.g. Grave No. 6 has two leylandii trees which if left unattended will outgrow the plot and cause disturbance to the headstone and surrounding graves (Plate 34).

Plate 34-View of trees to Grave No. 4, from northeast

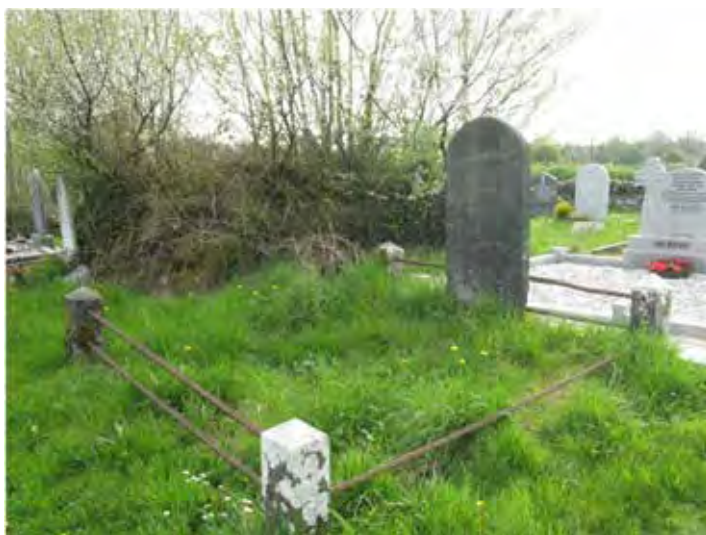
Some of the overgrown plots are missing sections of the wrought-iron plinths, e.g. Grave No. 112 (Plate 35).

Plate 35-View of Grave No, 112 from northeast

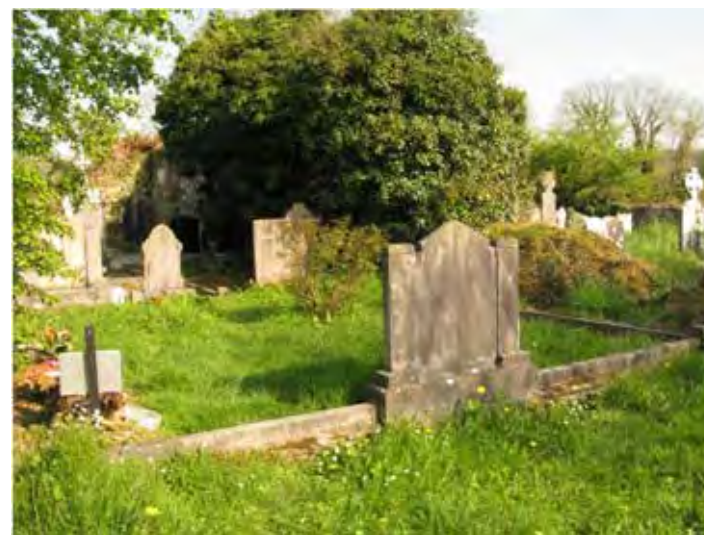
Some other plots are impacted on by the presence of desire lines which cross the grave e.g. Grave No. 117 (Plate 36).

Plate 36-View of desire line crossing Grave No. 117, from northwest

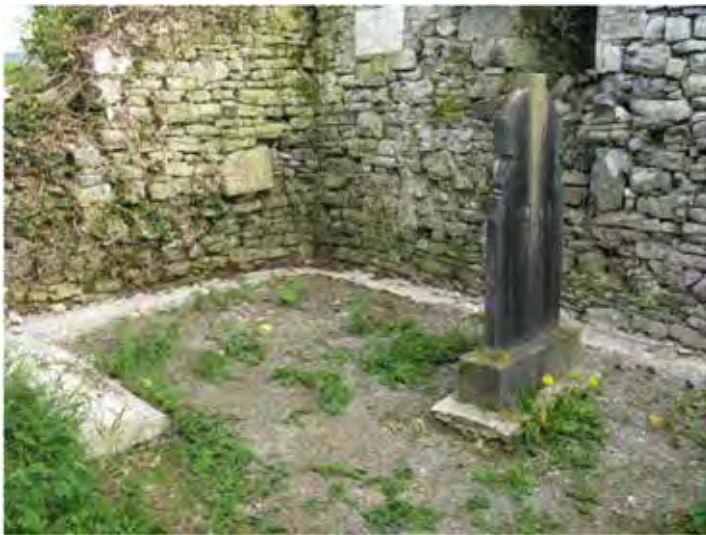
Within the church ruin, some of the burials are disturbed, especially the plot of Grave No. 126 belonging to the Horan Family, which is located in the south-eastern corner of the church ruin (Plate 37). Here the overgrowth has been removed from the church ruin leaving exposed masonry in need of conservation. It also appears that the plot is being prepared for the insertion of a plinth to enclose it, as a concrete foundation has been partially laid. In doing these preparatory works, the ground over this grave has been cleared of excess vegetation and topsoil, and the resulting spoil has been thrown on top of the overgrowth by the eastern wall. Unfortunately it is evident that human remains were uncovered during this work as a number of bones (femurs and smaller long bones) have been deposited along with the spoil on top of the church ruin. Further human remains are visible within the central area of this plot as the craniums of three separate skulls are protruding from the subsoil (Plate 38). The presence of green algae and moss on the bones indicates that they have been exposed for a prolonged period.

Plate 37-View of plot to Grave No. 126, from northwest

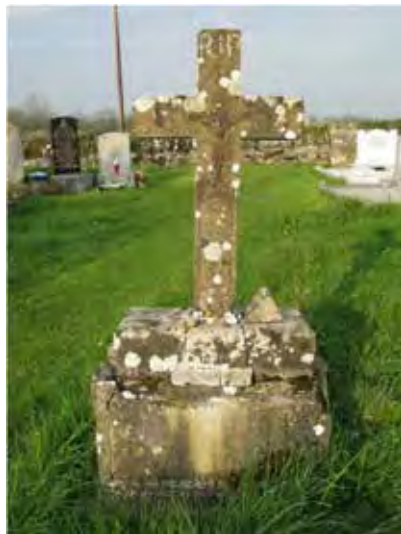
The first, the unnamed headstone of Grave No. 4 consists of a render cross surmounting a rendered pedestal. The headstone was originally inscribed but due to weathering is illegible (Plate 39).

Plate 39-View of headstone to Grave No. 4, from east

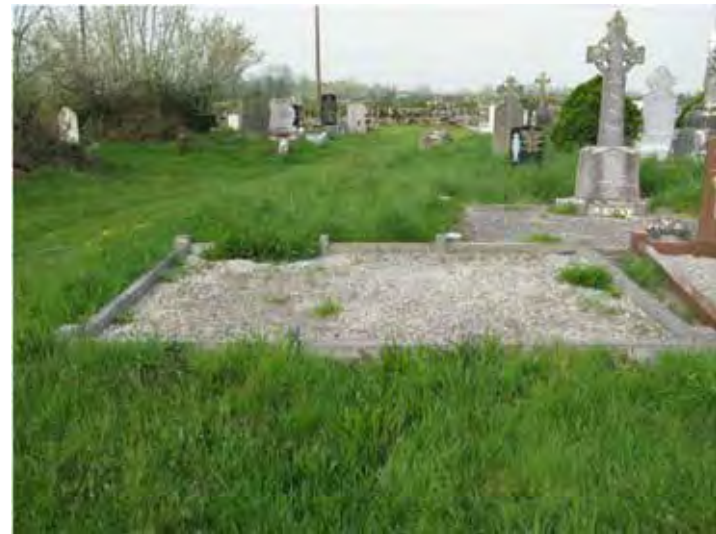
The second, the plot of Grave No. 18 is a modern creation with a cut limestone plinth enclosing a gravel paved area. The plot appears in good condition with the only exception being occasional weed growth which is beginning to encroach on the plot (Plate 40).

Plate 40-View of plot to Grave No. 18, from east

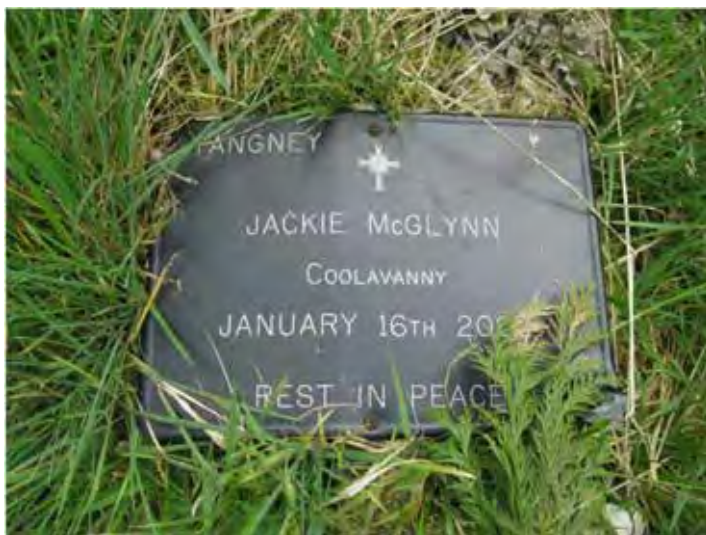
Grave No. 37 commemorates the McGlynn family and consists of a simple modern metal plaque (Plate 41). The gravemarker is in good condition although the wooden stake on which the plaque is mounted is broken and now lies on the ground.

Plate 41-View of gravemarker (Grave No. 37)

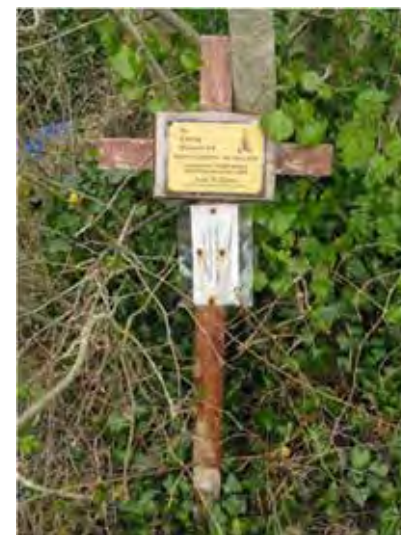
The second gravemarker, Grave No. 92 consists of a wooden cross with a central plaque commemorating Mary Flaherty-McCauliffe. The cross is currently located resting in the overgrowth of a tomb (Grave No. 91). However there is a recent notice nailed to the shaft of the cross stating that 'Mary Flaherty McCauliffe is not buried in this grave. Contact 0667141050' (Plate 42).

Plate 42-View of plaque to Grave No. 92, from west

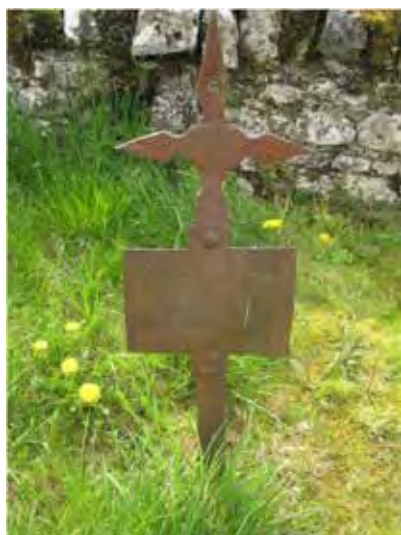
The third gravemarker, Grave No. 99 is one of the more unusual examples of a wrought-iron cross (Plate 43). This unusual design is complemented by the riveting of the inscribed name plaque to the shaft (Plate 43).

Plate 43-View of wrought-iron cross to Grave No. 99, from east

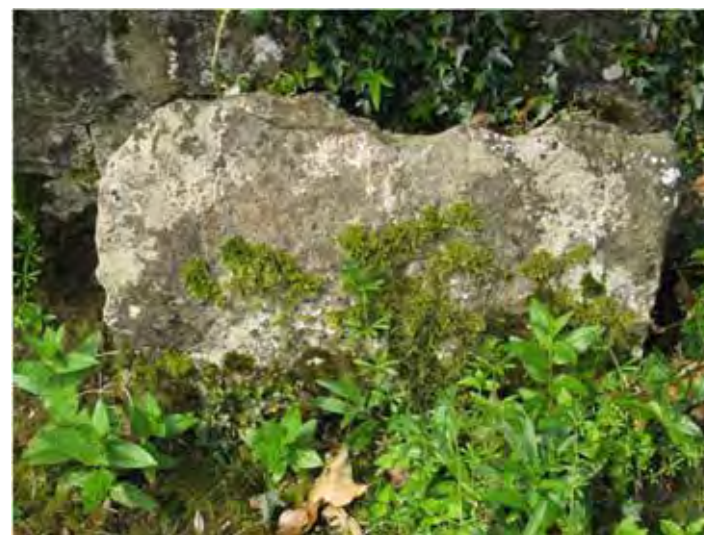
The selection of items used for gravemarkers is also interesting. A third of the gravemarkers consist of simple stone markers (Grave Nos. 54 and 116, Plate 44), half are wrought-iron crosses with simple ornamentation (Grave Nos. 34, 55 and 95, Plate 45) while the remainder consist of an illegible grave plaque (Grave No. 40, Plate 46).

Plate 44-View of Grave No. 54

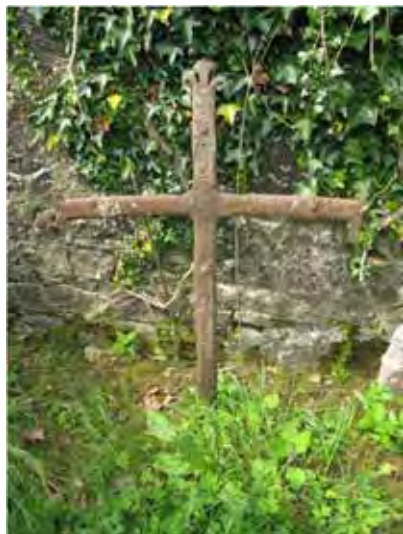
Plate 45-View of wrought-iron cross to Grave No. 95

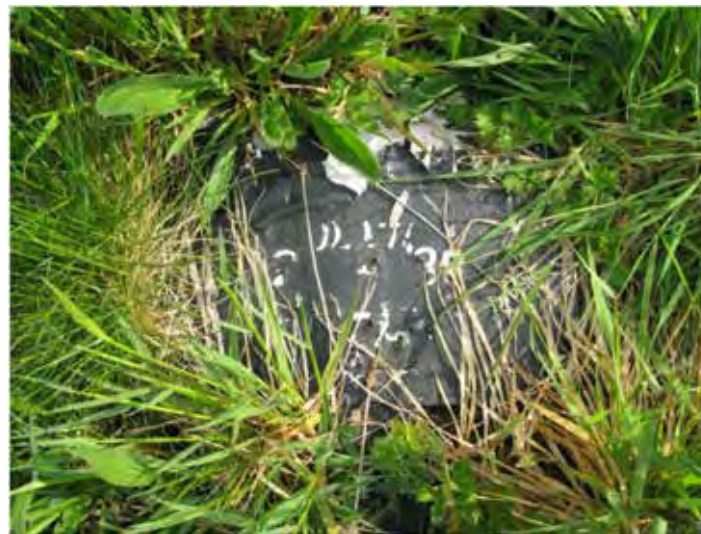
Plate 46-Detail to Grave No. 40, from east

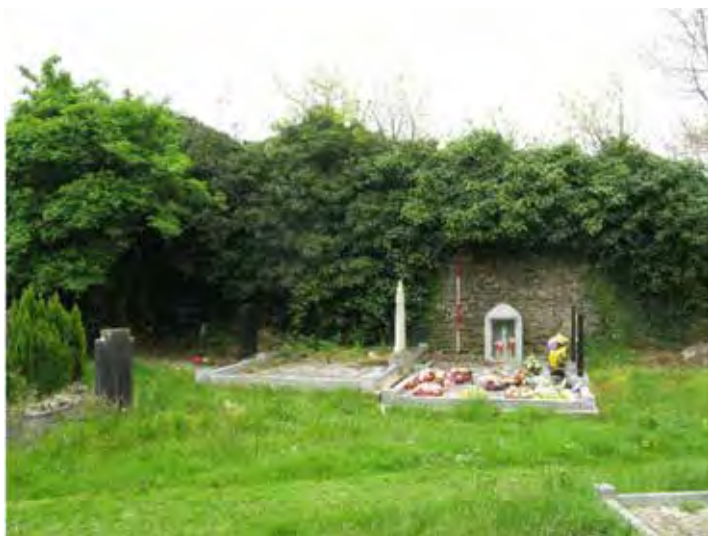
In the central area of the graveyard are the ruins of Kilmurry Church. Only the north, south and east walls survive. These walls are in poor condition and are becoming increasingly unstable (Plates 47, 48 and 49).

Plate 47-View of north elevation of church ruin

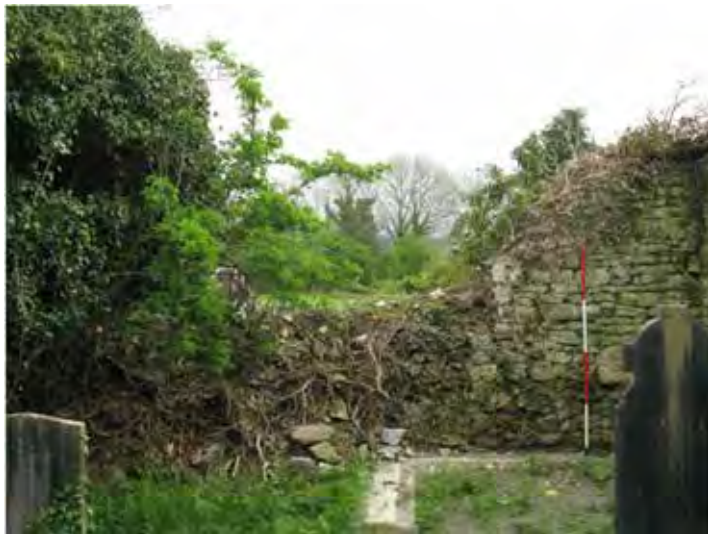
The church ruin is listed in the RMP as KE040-098. The standing walls consist of roughly dressed rubble stone with a lime and gravel mortar. The church is orientated on an east/west axis. Due to excessive amounts of overgrowth, a more detailed description of the church is not possible. In the interior, the area is dense with burials (Plate 50) and is also substantially overgrown (Plates 51 and 52) with the exception of the south-eastern corner which has been recently denuded of vegetation (Plate 53). Spoil from the clearing of vegetation and rubble in the interior of the church has been recently dumped on top of the eastern wall (Plate 51). Included within this spoil are a number of human remains.

Plate 51-Interior view of east elevation of church

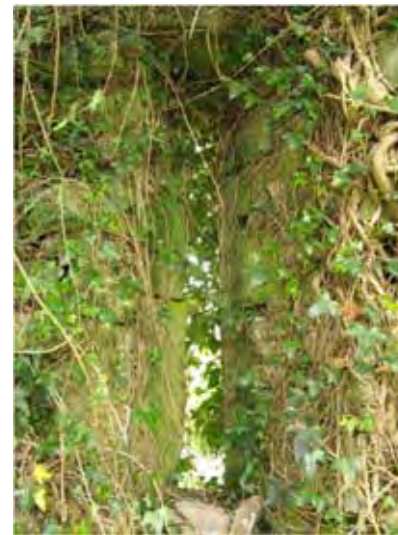
Only two windows survive and are situated in the north and south elevations. The slit aperture in the northern elevation survives in the best condition and consists of tooled stone surrounds, lintel and sill (Plate 54). Some recent rubble has been placed on the sill in the interior. The window in the southern elevation survives in poor condition (Plate 55). Vegetative overgrowth has dislodged much of the stone work including the lintel stones which now are suspended within the ivy. The window has also been partially blocked by loose rubble.

Plate 54-Interior view of window to northern elevation

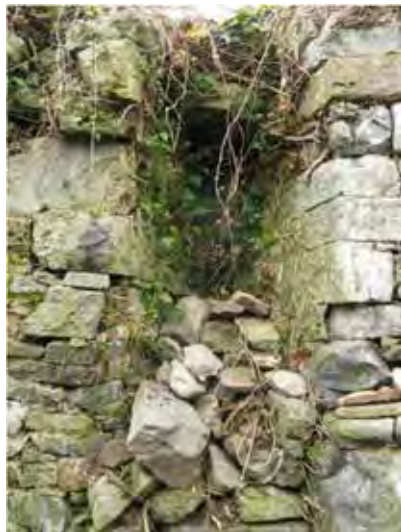
Plate 55-Interior view to window to southern elevation

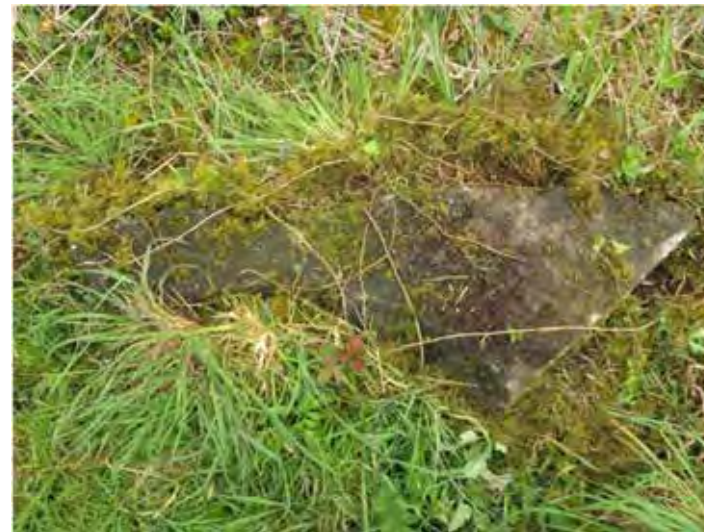
Miscellaneous No. 01: Located in the south side of the southern elevation of the church was a large section of a possible tooled limestone sill or window surround (Plate 56).

Plate 56-View of Miscellaneous No. 01

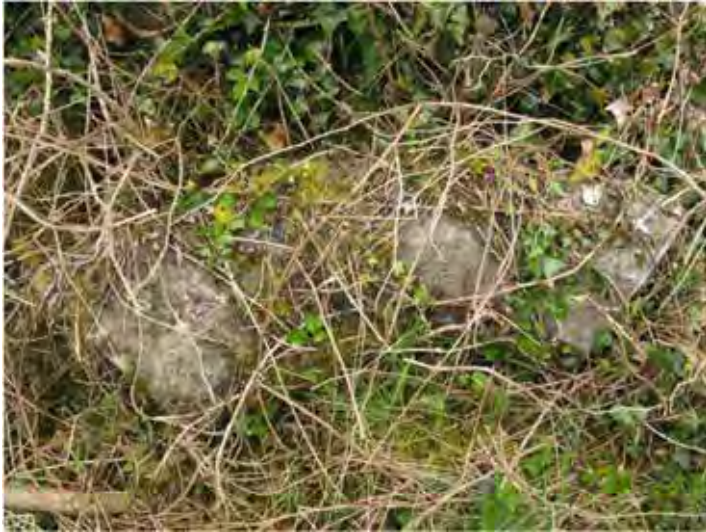
Miscellaneous No. 02: Located in the south side of the southern elevation of the church was a large section of a possible tooled limestone window surround, mullion or lintel, possibly representing evidence of tracery in one of the church windows (Plate 57).

Plate 57-View of Miscellaneous No. 02

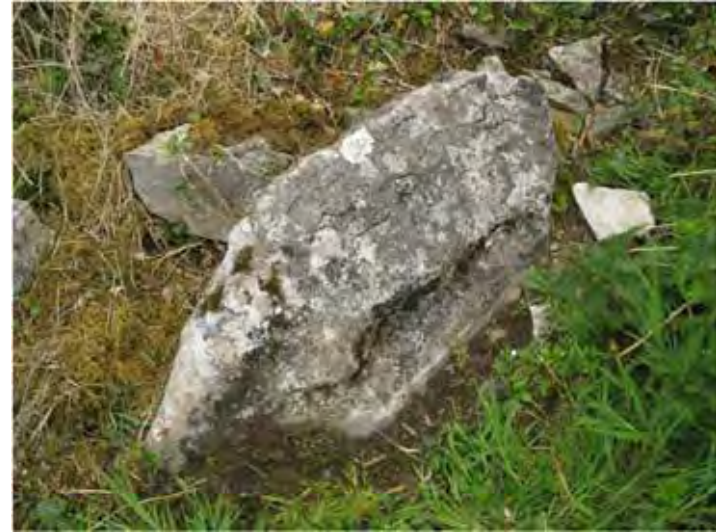
Miscellaneous No. 03: Located to the south side of the southern elevation of the church was a large section of a possible tooled limestone sill or window surround (Plate 58).

Plate 58-View of Miscellaneous No. 03

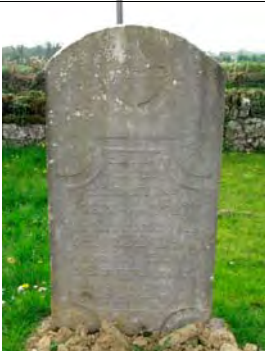
Grave_No	Family Name	Photo_Name
102	Walsh	IMG_0208
Notes		
Headstone 1844

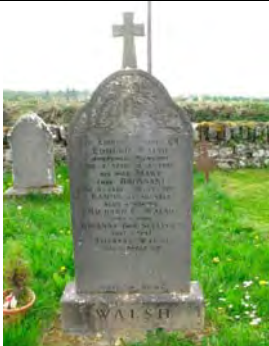
Grave_No	Family Name	Photo_Name
103	Walsh	IMG_0209
Notes		
Headstone

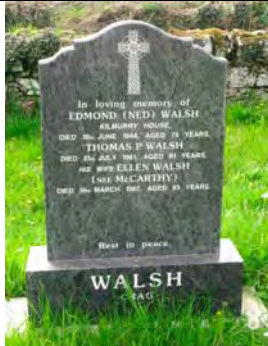
Grave_No	Family Name	Photo_Name
107	Walsh	IMG_0214
Notes		
Headstone

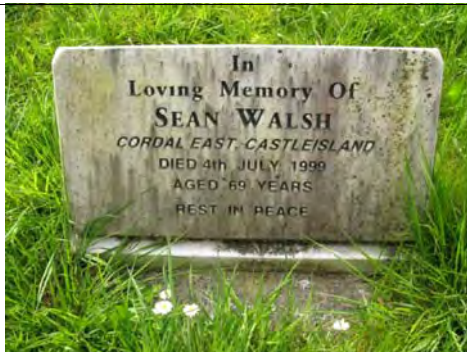
Grave_No	Family Name	Photo_Name
105	Walsh	IMG_0211
Notes		
Headstone

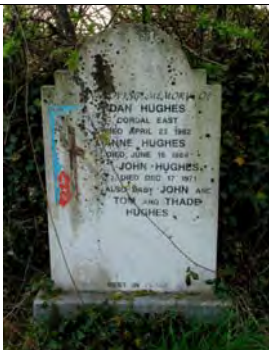
Grave_No	Family Name	Photo_Name
114	Hughes	IMG_0228
Notes		
Headstone

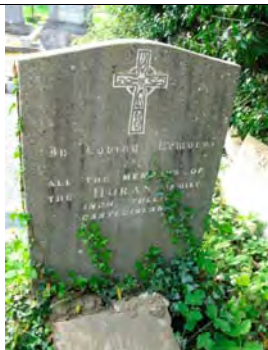
Grave_No	Family Name	Photo_Name
125	Horan	IMG_0250
Notes		
Headstone

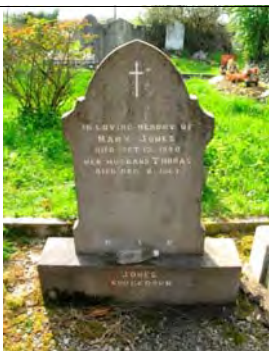
Grave_No	Family Name	Photo_Name
119	Jones	IMG_0239
Notes		
Headstone

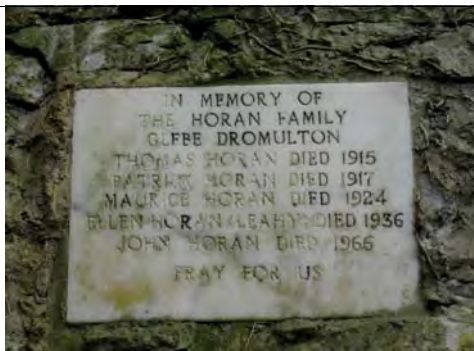
Grave_No	Family Name	Photo_Name
127	Horan	IMG_0254
Notes		
Plaque on church wall

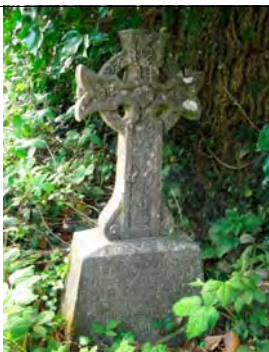
Grave_No	Family Name	Photo_Name
124	Lynch	IMG_0249
Notes		
Single headstone

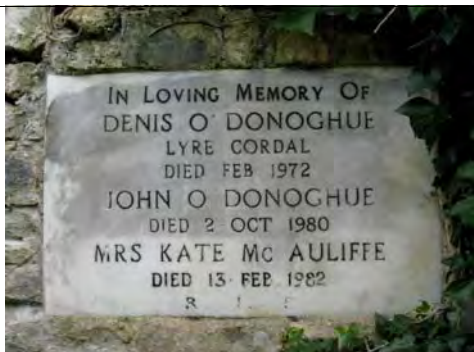
Grave_No	Family Name	Photo_Name
128	O'Donoghue	IMG_0255
Notes		
Plaque on church wall

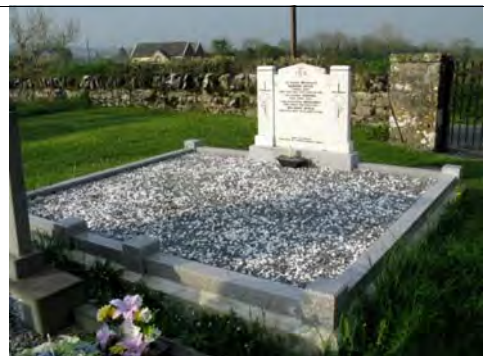
Grave_No	Family Name	Photo_Name
1	Boyle	IMG_0001

Plot in good condition

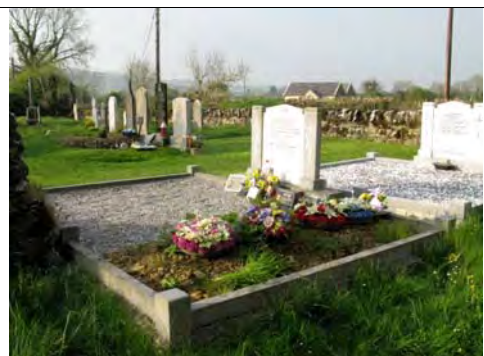
Grave_No	Family Name	Photo_Name
2	O'Meara	IMG_0003

Plot in good condition

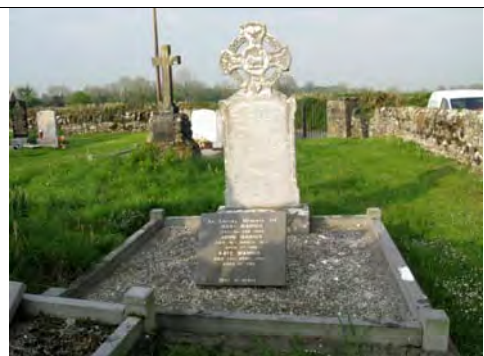
Grave_No	Family Name	Photo_Name
5	Mannix	IMG_0007

Plot in good condition

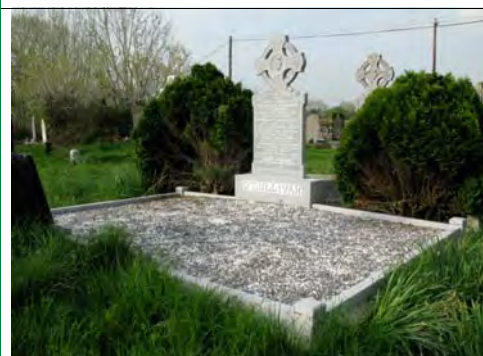
Plot in good condition

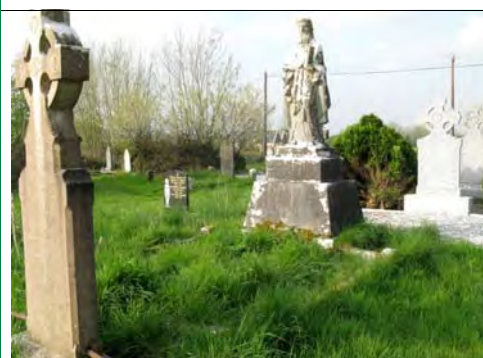
Grave_No	Family Name	Photo_Name
10	Horan	IMG_0018

Overgrown plot in moderate condition, 1880

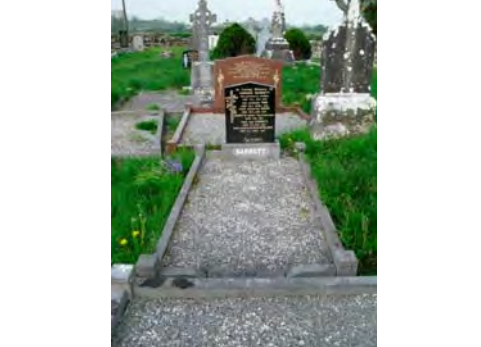
Grave_No	Family Name	Photo_Name
16	Barrett	IMG_0032
Notes		
Plot in good condition

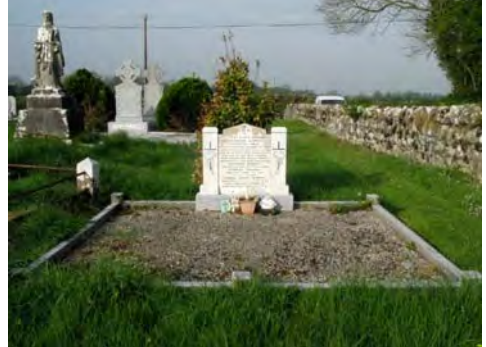
Grave_No	Family Name	Photo_Name
13	Murphy	IMG_0027
Notes		
Plot in good condition

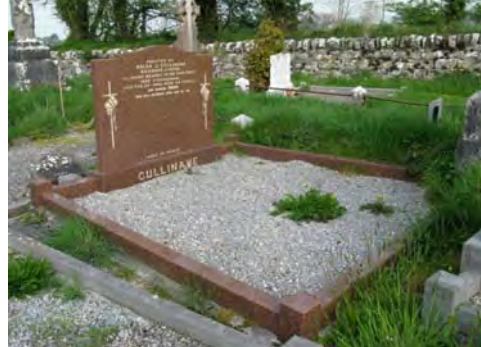
Grave_No	Family Name	Photo_Name
17	Cullinane	IMG_0034
Notes		
Plot in good condition

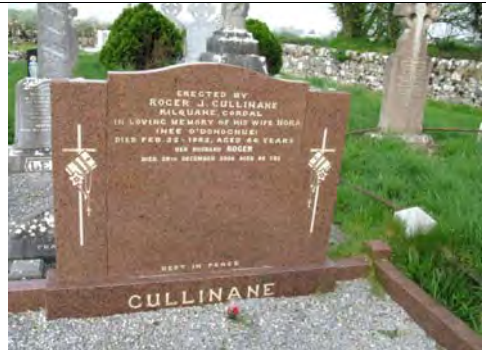
Grave_No	Family Name	Photo_Name
17	Cullinane	IMG_0035
Notes		
Plot in good condition

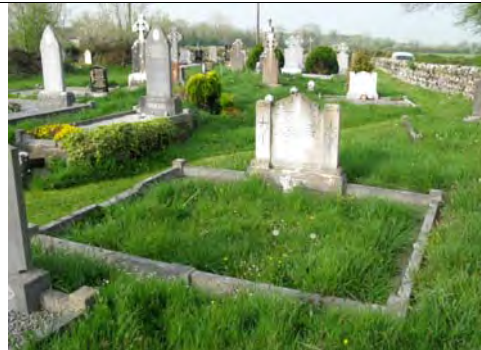
Grave_No	Family Name	Photo_Name
21	Reidy	IMG_0041
Notes		
Overgrown plot in good condition

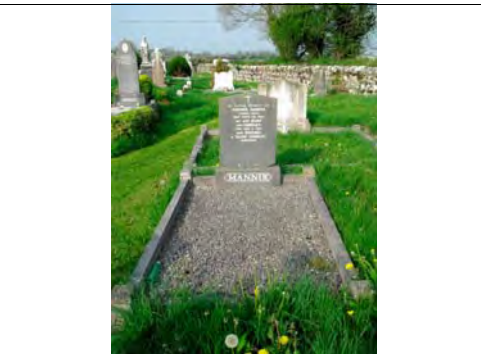
Grave_No	Family Name	Photo_Name
22	Mannix	IMG_0043
Notes		
Plot in good condition

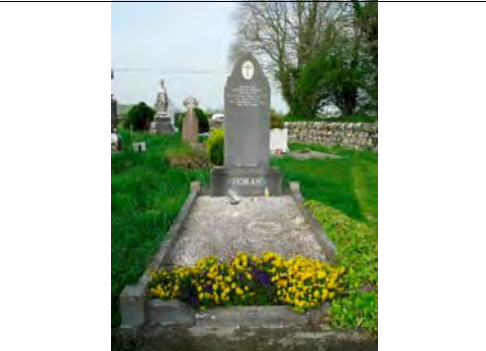
Grave_No	Family Name	Photo_Name
20	Horan	IMG_0039
Notes		
Plot in good condition

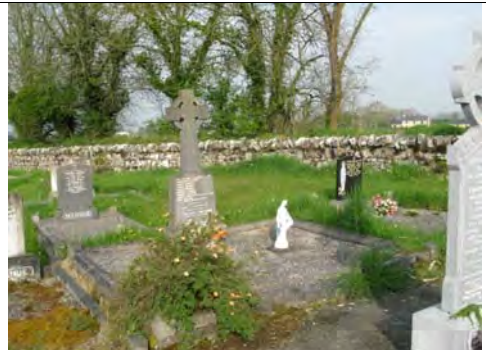
Grave_No	Family Name	Photo_Name
24	Drumm	IMG_0047
Notes		
Plot in moderate condition, som subsiding

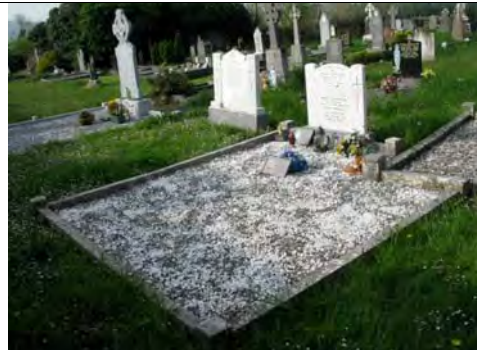
Grave_No	Family Name	Photo_Name
27	Brosnan/Callaghan	IMG_0053
Notes		
Plot in good condition

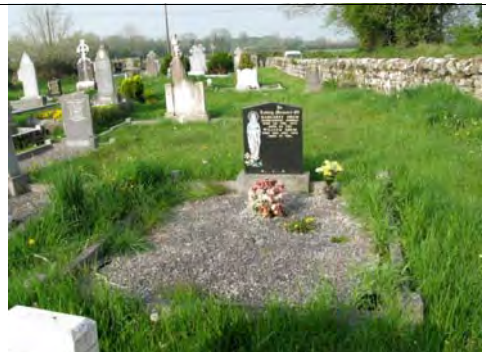
Grave_No	Family Name	Photo_Name
25	Drum	IMG_0049
Notes		
Plot in good condition

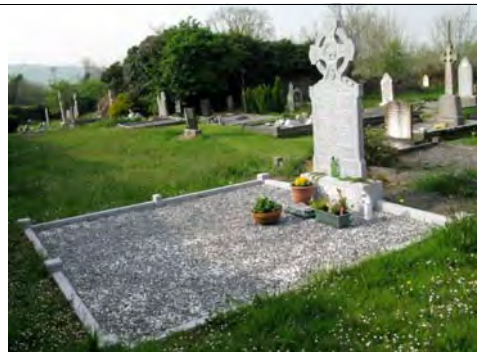
Grave_No	Family Name	Photo_Name
29	Brosnan	IMG_0056
Notes		
Plot in good condition

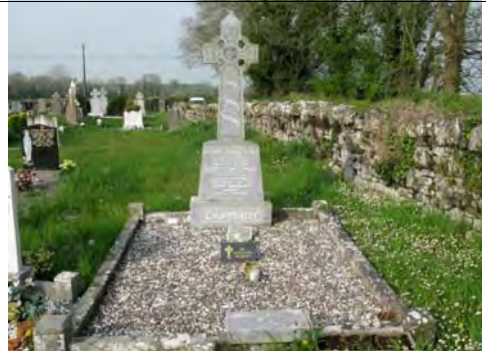
Grave_No	Family Name	Photo_Name
26	Carmody	IMG_0051
Notes		
Plot in good condition

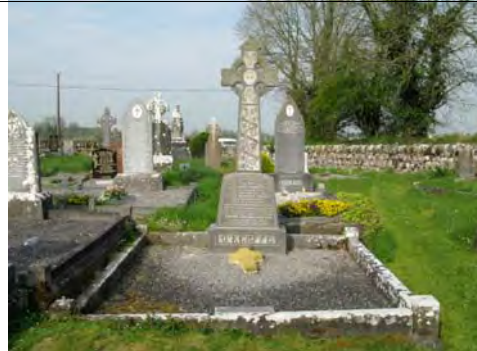
Grave_No	Family Name	Photo_Name
30	O'Keeffe	IMG_0058
Notes		
Plot in moderate condition, slitly subsiding

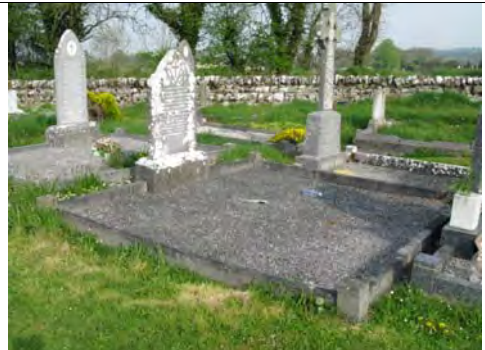
Grave_No	Family Name	Photo_Name
31	Mannix	IMG_0060
Notes		
Plot in moderate condition, subsiding in centre

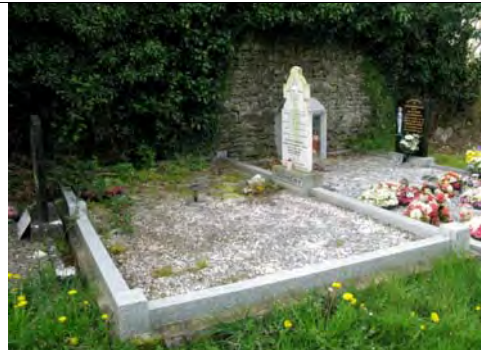
Grave_No	Family Name	Photo_Name
36	Dennehy	IMG_0071
Notes		
Plot in good condition, some weeds

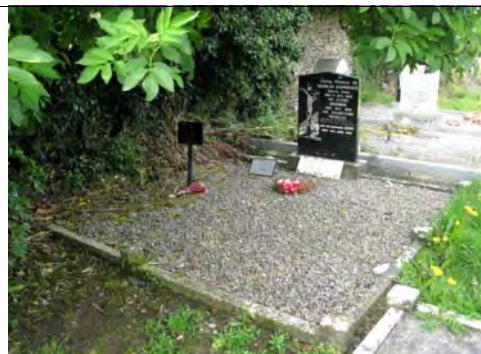
Grave_No	Family Name	Photo_Name
39	O'Donoghue	IMG_0076
Notes		
Plot in good condition

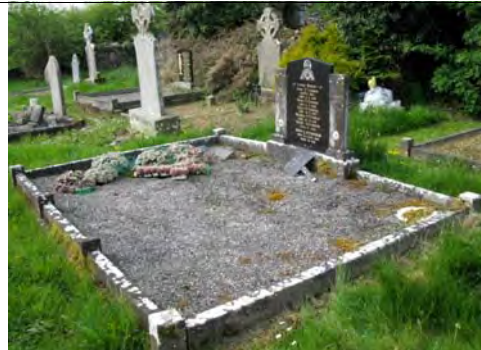
Grave_No	Family Name	Photo_Name
45	O'Connor	IMG_0091
Notes		
Plot in moderate condition, slightly subsiding

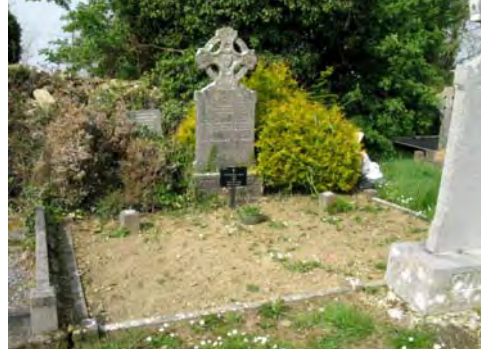
Grave_No	Family Name	Photo_Name
47	Breatnac/Walsh	IMG_0094
Notes		
Plot in good condition

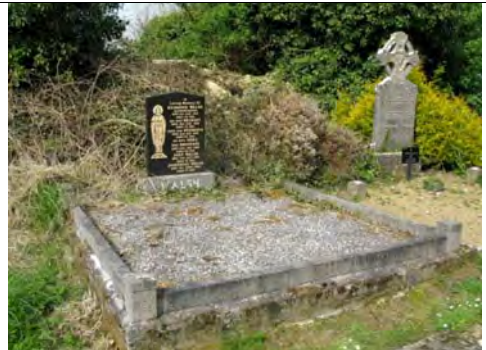
Grave_No	Family Name	Photo_Name
49	Walsh	IMG_0098
Notes		
Plot in good condition

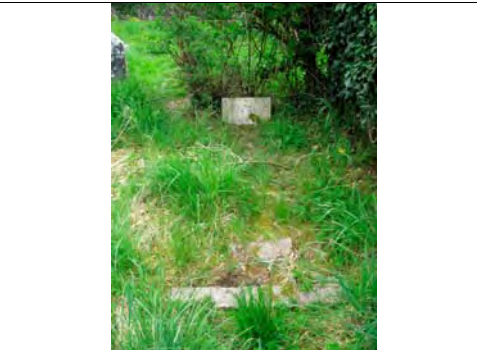
Grave_No	Family Name	Photo_Name
57	Cronin	IMG_0117
Notes		
Overgrown plot in moderate condition

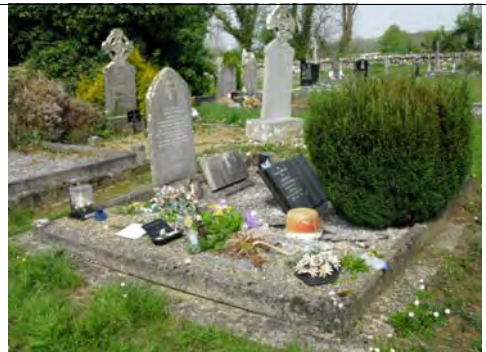
Grave_No	Family Name	Photo_Name
50	O'Connor	IMG_0100
Notes		
Plot in good condition

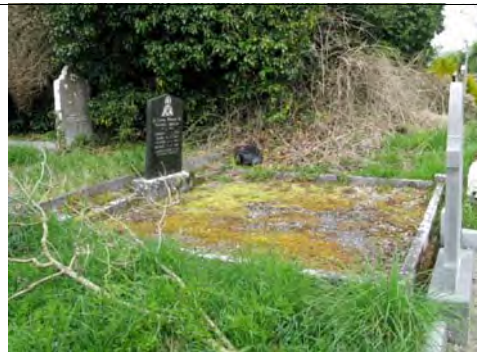
Grave_No	Family Name	Photo_Name
58	Neligan	IMG_0119
Notes		
Plot in moderate condition, some moss

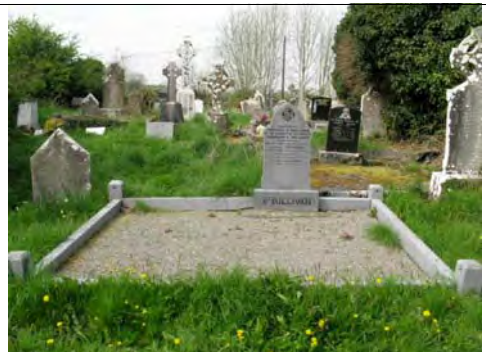
Grave_No	Family Name	Photo_Name
52	O'Sullivan	IMG_0105
Notes		
Plot in good condition

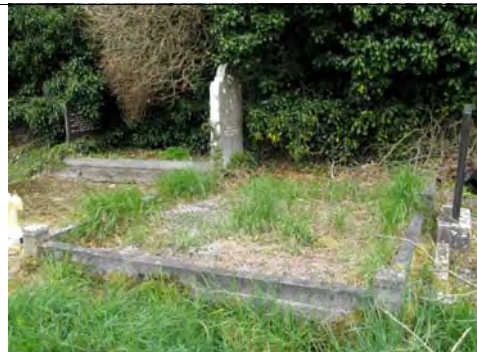
Grave_No	Family Name	Photo_Name
59	Daly	IMG_0121
Notes		
Overgrown plot in good condition

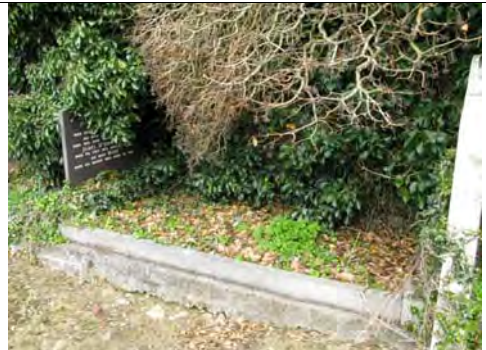
Grave_No	Family Name	Photo_Name
61	O'Donoghue	IMG_0124
Notes		
Plot in good condition, somw overgrowth of ivy

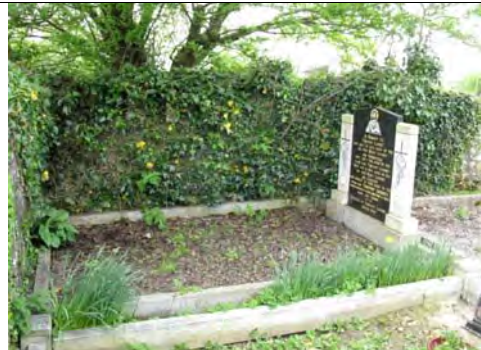
Grave_No	Family Name	Photo_Name
68	Looney	IMG_0136
Notes		
Plot in good condition, some weeds

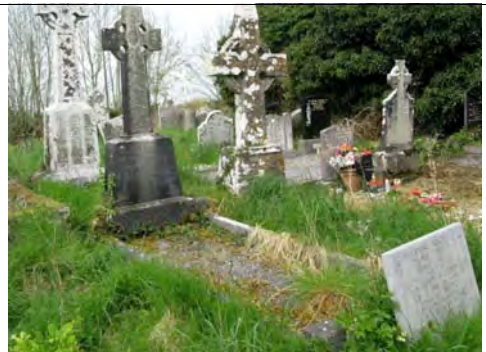
Grave_No	Family Name	Photo_Name
65	O'Donoghue	IMG_0131
Notes		
Plot in good condition, some moss

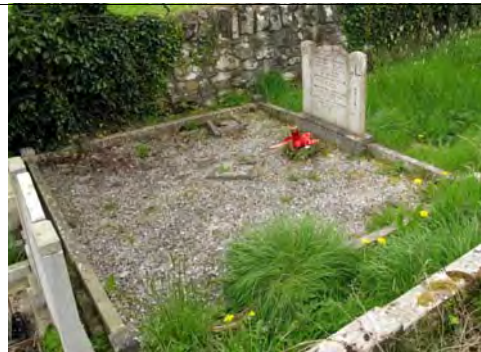
Grave_No	Family Name	Photo_Name
69	Griffin	IMG_0138
Notes		
Plot in moderate condition, subsiding to the south

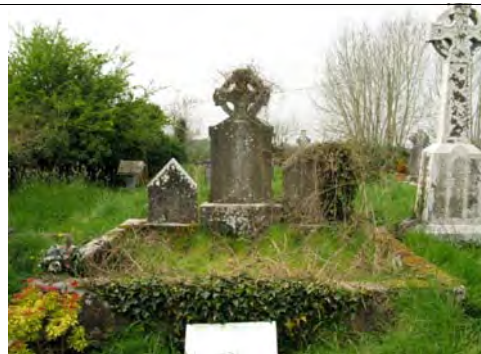
Grave_No	Family Name	Photo_Name
70	O'Connell	IMG_0140
Notes		
Plot in moderate condition, overgrown and headstones are weathered, becoming illegible

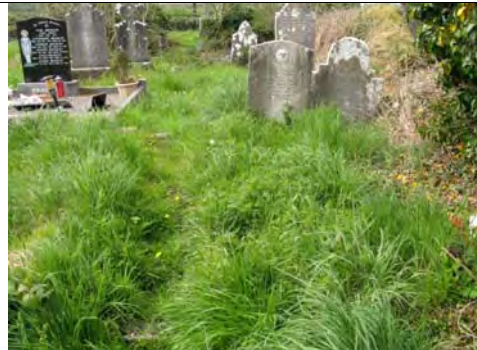
Grave_No	Family Name	Photo_Name
78	Dennehy	IMG_0154
Notes		
Overgrown plot in moderate condition, a desire line is cutting in south

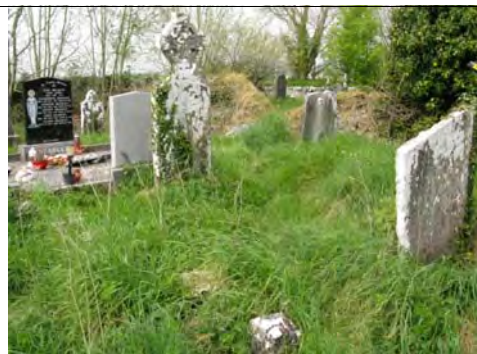
Grave_No	Family Name	Photo_Name
79	Horan	IMG_0156
Notes		
Overgrown plot in poor condition, wrought ironrail is heavily corroded

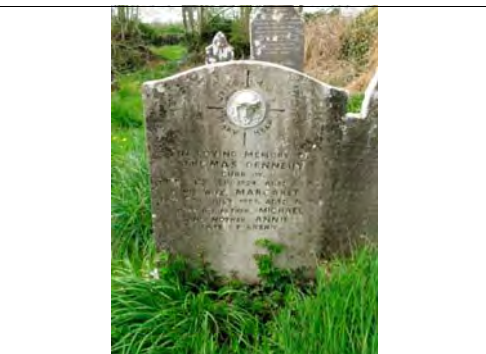
Grave_No	Family Name	Photo_Name
78	Dennehy	IMG_0155
Notes		
Overgrown plot in moderate condition, a desire line is cutting in south

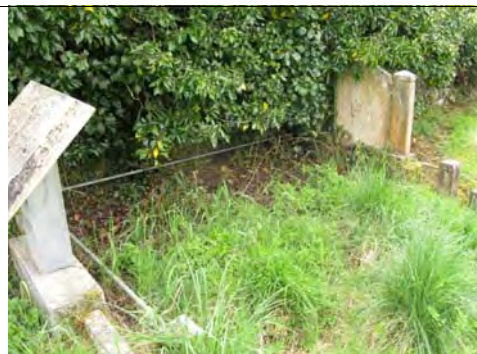
Grave_No	Family Name	Photo_Name
80	Kerins/Lynch/Griffin/	IMG_0158
Notes		
Overgrown plot in poor condition
