Project code: KCCG11
Client: Kerry County Council
Date: July 2011

Archaeological Survey of Kilmurry Burial Ground, Cordal, Co. Kerry.

Surveyors: Ann Frykler & Robert Hanbidge
Report Author: Robert Hanbidge

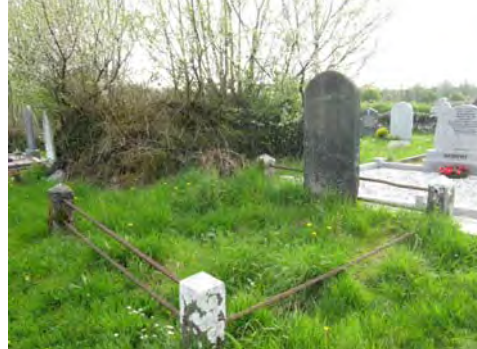
Grave_No	Family Name	Photo_Name
112	White	IMG_0221
Notes		
Overgrown plot in poor condition, wrought iron rail have corroded and partly broken, 1860

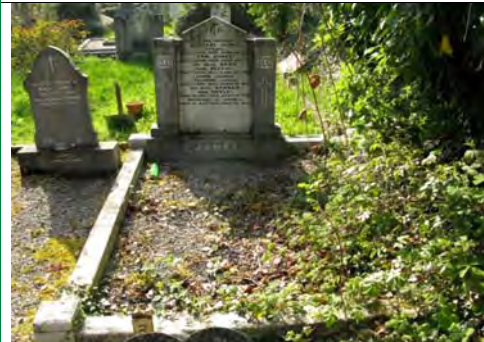
Grave_No	Family Name	Photo_Name
120	Jones	IMG_0240
Notes		
Plot in good condition, some weeds and overgrowth

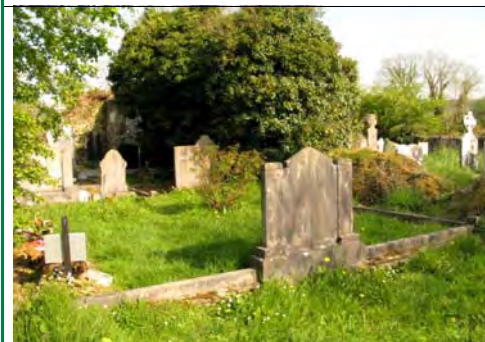
Grave_No	Family Name	Photo_Name
117	Brosnan	IMG_0232
Notes		
Large family plot with desireline cutting accross

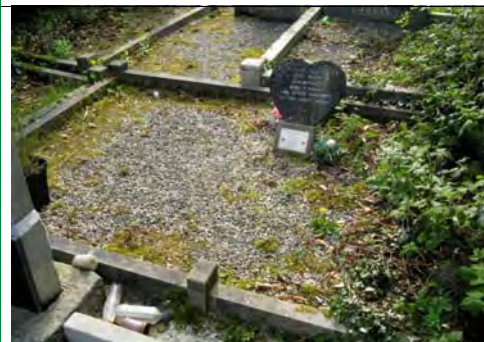
Grave_No	Family Name	Photo_Name
121	Reidy	IMG_0242
Notes		
Plot in good condition, some weeds and overgrowth

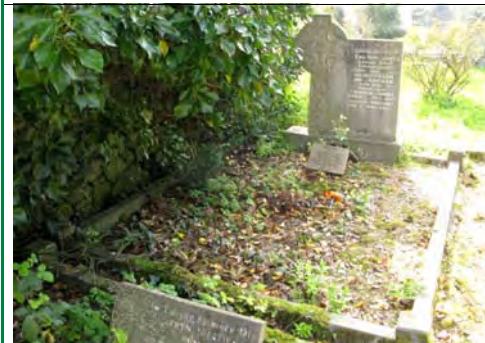
Grave_No	Family Name	Photo_Name
118	Jones	IMG_0236
Notes		
Plot in good condition, some overgrowth

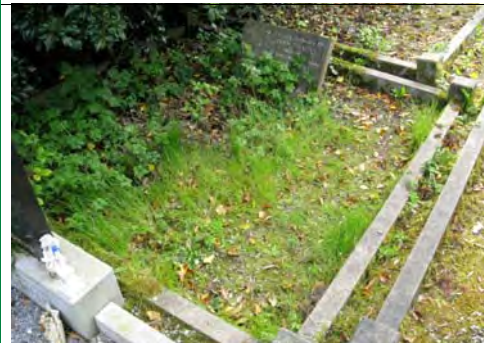
Grave_No	Family Name	Photo_Name
122	Reidy	IMG_0244
Notes		
Plot in good condition, some weeds and overgrowth

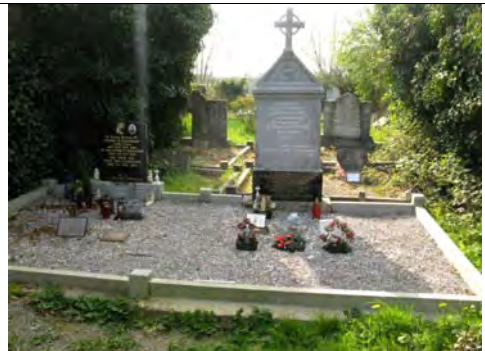
Grave_No	Family Name	Photo_Name
123	O'Donoghue	IMG_0246
Notes		
Plot in good condition

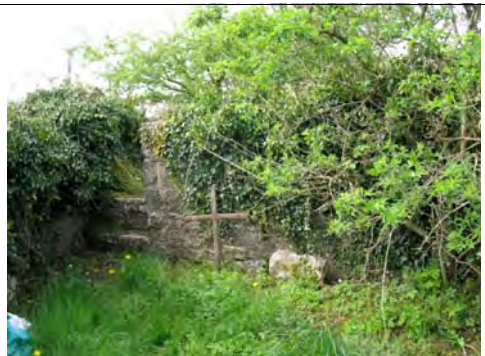
Grave_Type		Tomb
Grave_No	Family Name	Photo_Name
56	Horan/Curtin	IMG_0112
Notes		
Possible mausleum, from1846, recent burial from 2005

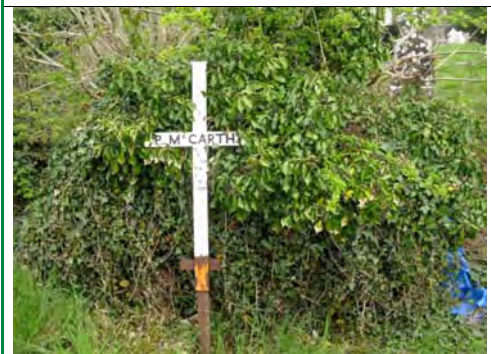
Grave_No	Family Name	Photo_Name
96	McCarthy	IMG_0192

Overgrown tomb

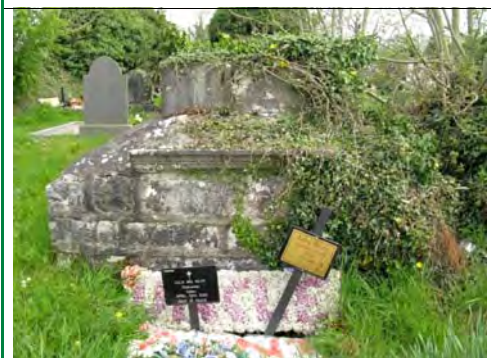
Grave_No	Family Name	Photo_Name
97	Reidy	IMG_0196

Tomb in good condition

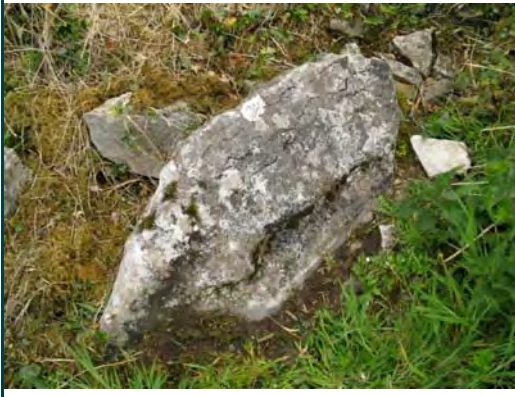
Misc_Item_No	Photo_Name
3	IMG_0292
Notes	
Possible window lintell

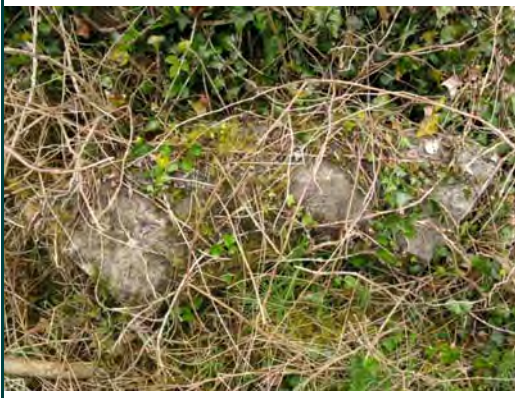
Misc_Item_No	Photo_Name
2	IMG_0291
Notes	
Window lintell
