Project code: KCCG11
Client: Kerry County Council
Date: June 2011

Archaeological Survey of Derryco Burial Ground, Ballyduff, Tralee, Co. Kerry.

Surveyors: Ann Frykler & Robert Hanbidge
Report Author: Robert Hanbidge

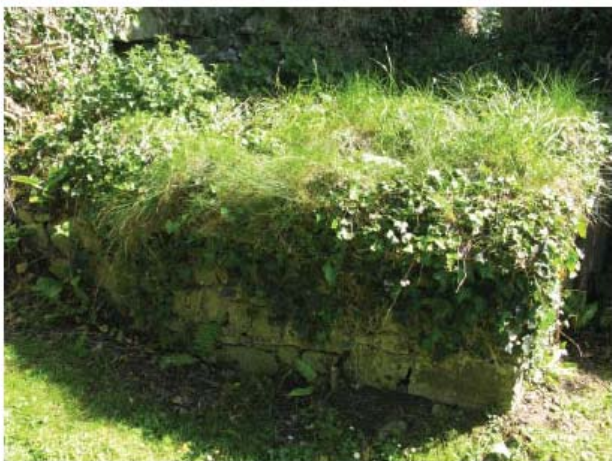
Within the church, there are a number of burials (Plate 30) which have caused the floor surface to rise very slightly in comparison to the exterior. The oldest inscribed burial (Grave No. 50) in the graveyard is located inside the church (Plates 3 & 4). Two square-headed recesses are located flanking the eastern window at sill level to the interior of the east elevation (Plates 31 & 32). A third interior recess (Plate 33) is located in the east corner of the south elevation directly above the top of Grave No. 50. The location of such a recess in the eastern corner of nave is interesting as similar recesses are often associated with the presence of a piscine which is often located below the recess. However the presence of Grave No. 50 in the eastern corner of the church blocks off any access to investigate if a piscina is present or not.

Plate 3 View of the Stack family tomb (Grave No. 50) from north.JPG

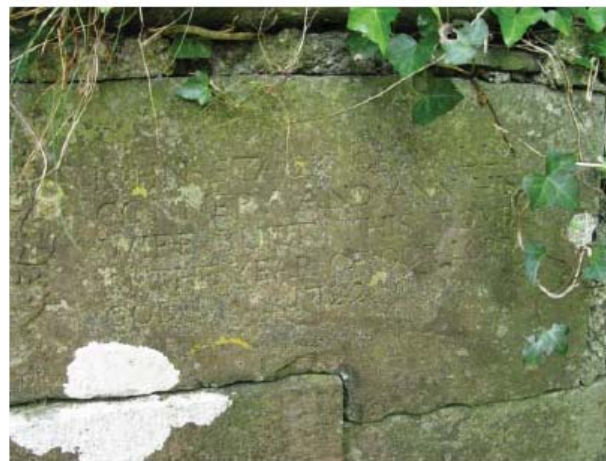
Plate 4 Detail of inscription to the Stack family tomb (Grave No. 50) from west.JPG

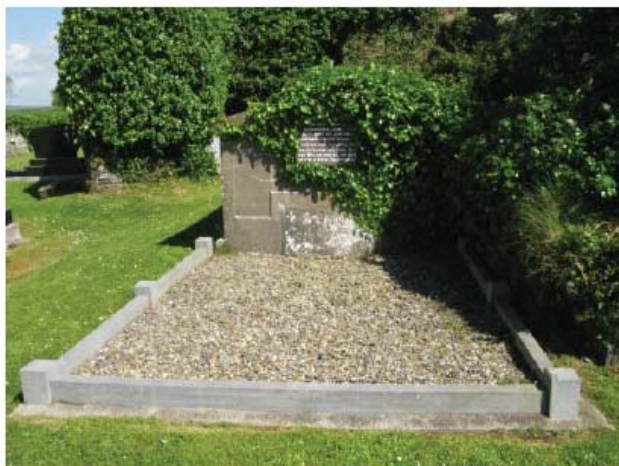
Plate 5 View of the Stack and Walsh family tomb (Grave No. 46) with associated court are, from west.JPG

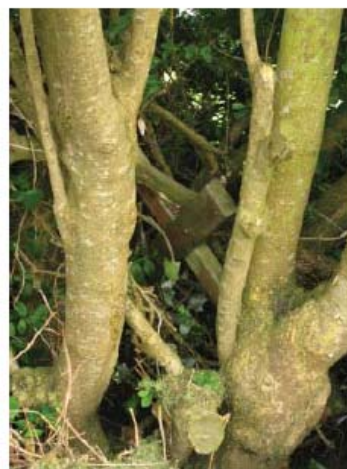
Plate 12 Discarded timber gravemarker to southeast corner of graveyard, from northwest.JPG

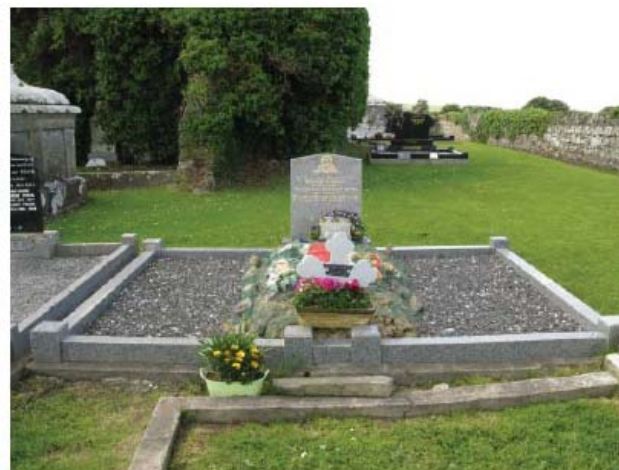
There are 37 inscribed headstones and plots within the graveyard and most of these are in good condition. The majority of the graves date to the 20th century, however there are more recent graves from the 21st century e.g. Grave No. 6 is the latest dating from the 13th of February 2011 and is located in the eastern portion of the graveyard (Plate 16).

Plate 16 View of recent burial to plot (Grave No. 6), from east.JPG

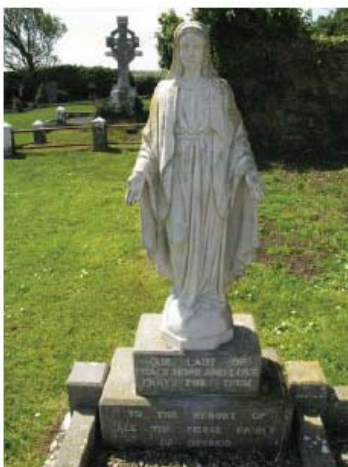
Almost all of the named headstones are associated with plots with the only exceptions including grave Nos. 11, 12, 48 and 53, which are free standing. There is great variation in the types of headstones that are present. Types include Celtic Cross forms, simple inscribed limestone uprights along with modern polished marble and granites headstones of different designs being the most common. Grave No. 18 has one of the more elaborate headstones consisting of a statue of the Blessed Virgin Mary (Plate 17).

Plate 17 Detail of memorial to Pierse Family plot (Grave No. 18), from east.JPG

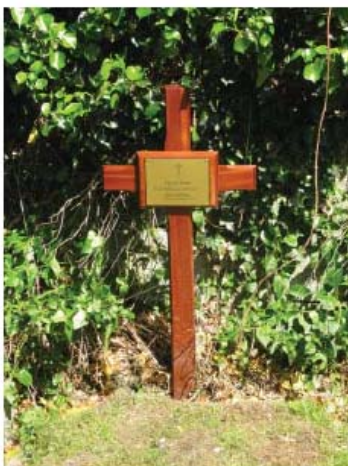
One named gravemarker (Grave No. 51) was recorded within the graveyard. This modest gravemarker was located to the interior of the church ruin adjacent the east elevation and consisted of a wooden cross with a brass mounted plaque (Plate 19). No other singular named gravemarkers were present during this survey. Although a discarded wooden cross gravemarker, observed within the tree (Plate 12) surrounded by the mound of grass clippings to the southeast corner, may have originated from an unknown grave within the graveyard or is a discarded gravemaker that was replaced by a headstone.

Plate 19 View of named gravemarker (Grave No. 51) to interior of church, from west.JPG

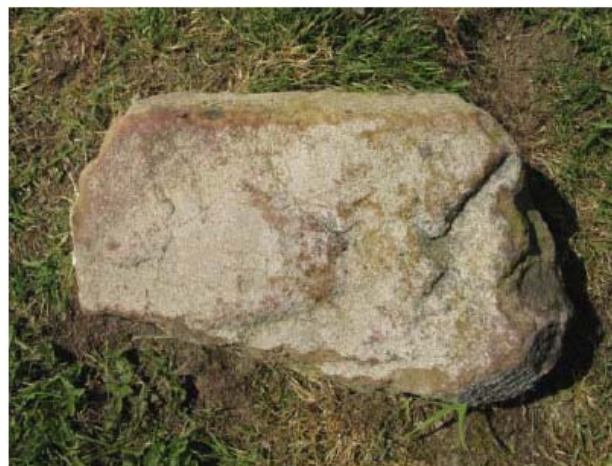
The gravemarkers consisted of a simple natural local stone being placed in the ground e.g. grave no. 4 (Plate 20). There are possibly many unmarked graves within the burial ground which is supported by the exposing of human bones to the sprayed areas parallel to the northern boundary wall. It must be noted that Grave No. 8 was loose and appears to have been removed from its original socket and replaced. A large mound of rubble including some curious examples of stone, to the exterior of the graveyard adjacent the entrance raises questions. Some are clearly from areas of collapse associated with the boundary walls and/or the church ruin. However the possibility of some of these stones being shallow-set gravemarkers which were removed from the graveyard due to collapse or otherwise must not be overlooked.

Plate 20 View of unnamed gravemarker (Grave No. 4), from east.JPG

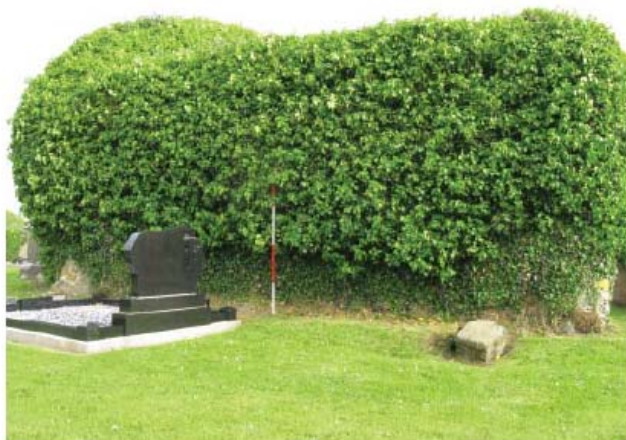
The church ruin is listed in the RMP as KE009-022 and is in reasonable condition with only the north, south and east walls remaining (Plates 21, 22 & 23). The west wall has completely disappeared, so the full dimensions of the church could not be recorded. The church is orientated on an east/west axis. From what remains, the church had a minimum length of 9.6 m and measured 6.6 m wide (internally). The walls measured c. 1.15 m wide and consist of roughly dressed rubblestone with a lime and gravel mortar.

Plate 21 Side (north) elevation of church ruin.JPG

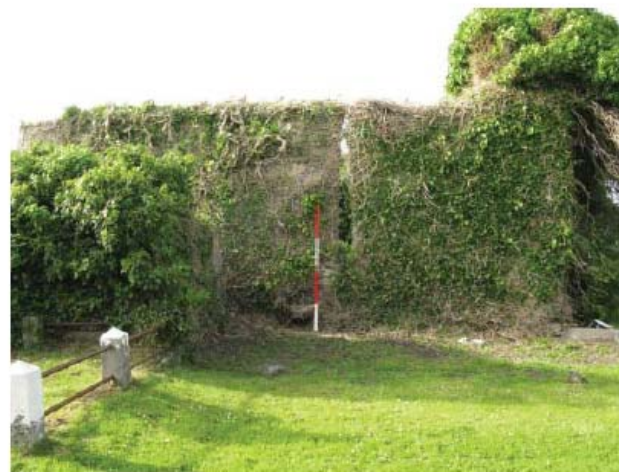
Plate 22 Side (south) elevation of church ruin.JPG

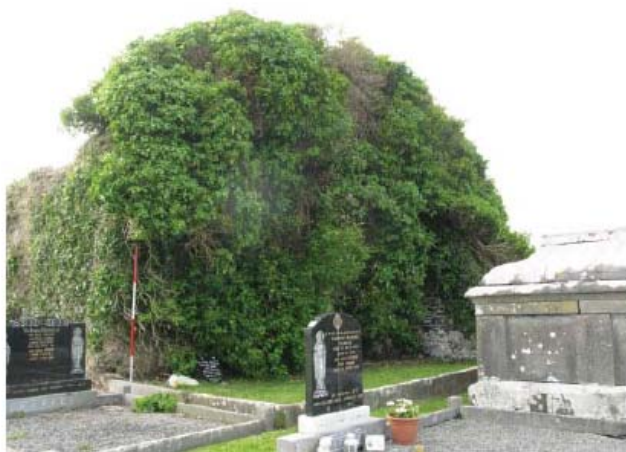
Plate 23 Side (east) elevation of church ruin.JPG

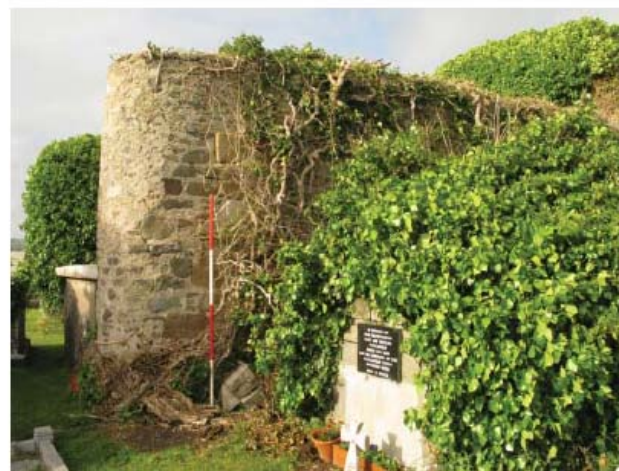
Maintenance work to the western termini of the north and south walls has resulted in unusual bowed terminals (Plate 24). However this is probably a response to the prevailing westerly wind and thus the rounded surfaces not only reduce the impact of the weather on the wall structure but also stabilise the masonry. A later addition of a rubblestone buttress to the east adds support to the east elevation of the church (Plates 23 & 25). The partially ruinous steep pitched wall that forms the east elevation indicates that the church once had a pitched roof.

Plate 24 Detail to bowed corner of church ruin.JPG

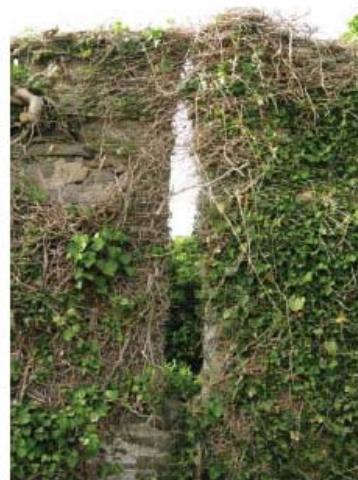
Within the walls, two narrow windows survive, one to the east end of the south elevation (Plates 26 & 27) and the second centrally located within the east elevation (Plates 28 & 29). Both windows are splayed to the internal elevations with roughly dressed rubblestone forming the internal reveals and sills. The top of the southern window has been destroyed as the southern wall only exists to the impost level of this window. The eastern window survives in greater condition featuring dressed rubblestone surrounds and displays a more modest round-headed arch at the top (partially hidden by ivy).

Plate 26 Exterior view of window to side (south) elevation.JPG

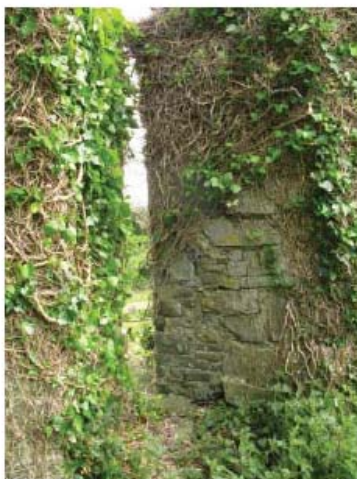
Plate 27 Interior view of window to side (south) elevation.JPG

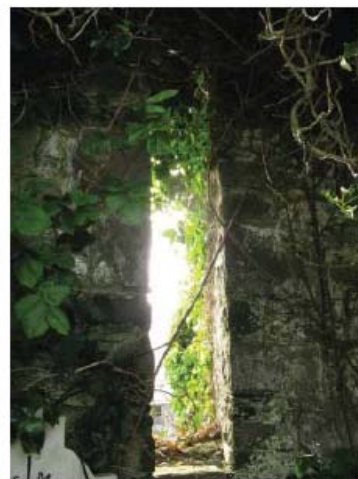
Plate 28 Exterior view of window to side (east) elevation.JPG

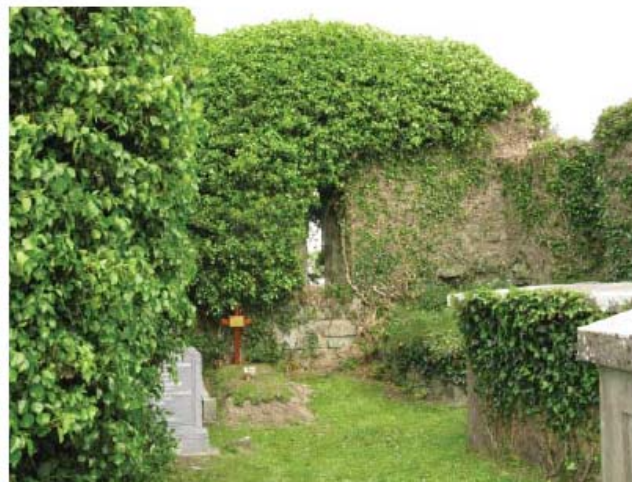
Plate 30 View of burials to interior of church ruin from west.JPG

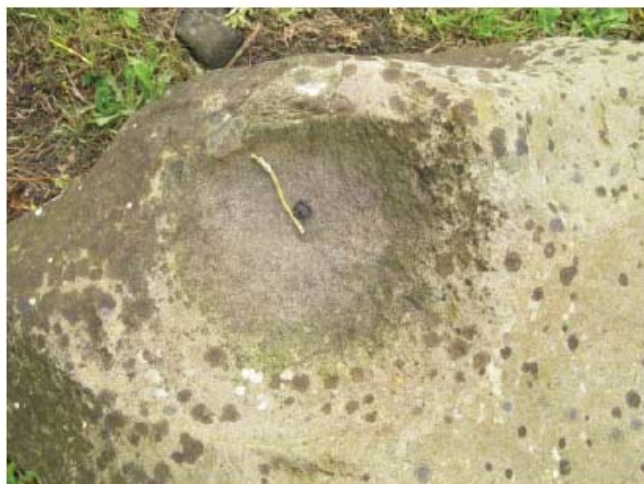
An unrecorded font/bullaun stone was found immediately to the north of the north elevation of the church ruins beside Grave No. 55 (Plates 34 & 35). The font/bullaun is located close to the western edge of a large irregular-shaped boulder and has a diameter of approximately 25 cm and a depth of c. 8 cm. The boulder appears to have been moved to its current location so the original provenience is unknown this position.

Plate 35 Detail to fontbullaun from east.JPG

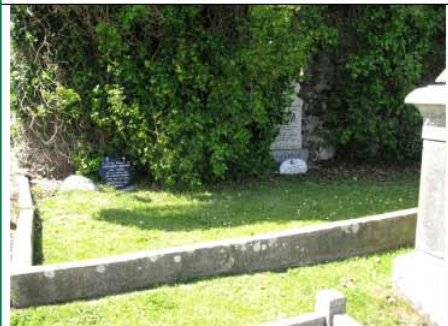
Grave_No	Family Name	Photo_Name
16	Farrell/Gibbons	IMG_0032
Notes		
Grass covered plot in good condition

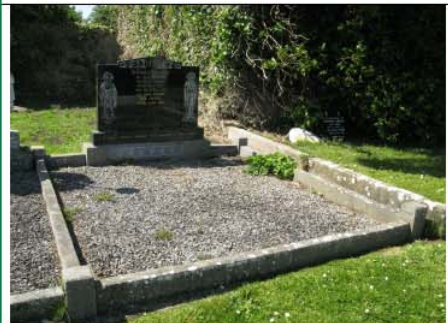
Grave_No	Family Name	Photo_Name
17	Dunne	IMG_0035
Notes		
Plot in good condition

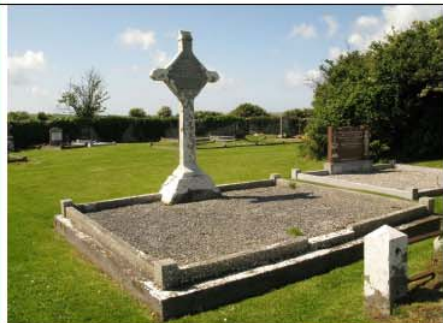
Grave_No	Family Name	Photo_Name
26	McCarthy	IMG_0050
Notes		
Plot in good condition

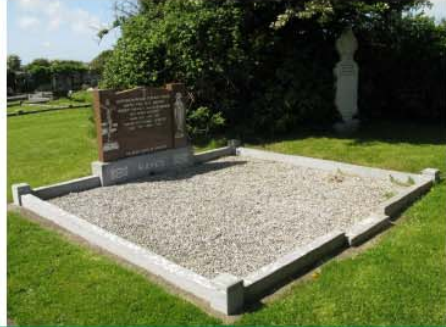
Grave_No	Family Name	Photo_Name
27	Hayes	IMG_0052
Notes		
Plot in good condition

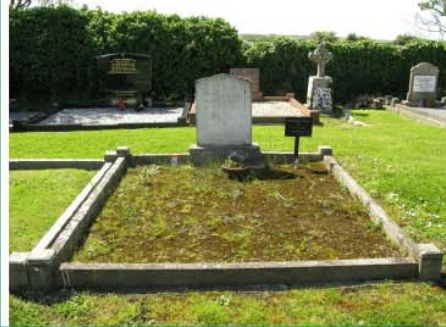
Grave_No	Family Name	Photo_Name
30	O'Connor	IMG_0058
Notes		
Plot in good condition, moss

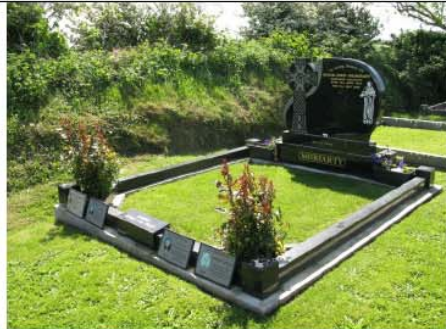
Grave_No	Family Name	Photo_Name
28	Moriarty	IMG_0054
Notes		
Grass covered plot in good condition

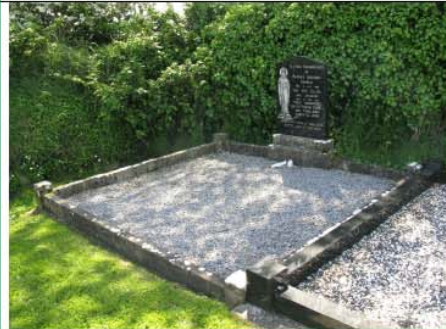
Grave_No	Family Name	Photo_Name
31	Moloney	IMG_0061
Notes		
Plot in good condition

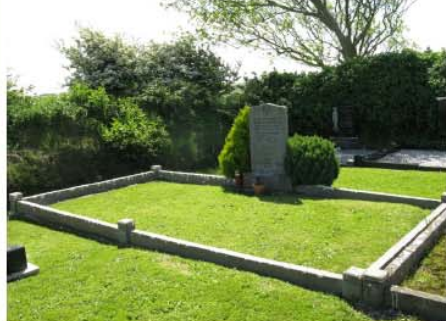
Grave_No	Family Name	Photo_Name
29	Moriarty	IMG_0056
Notes		
Plot in good condition

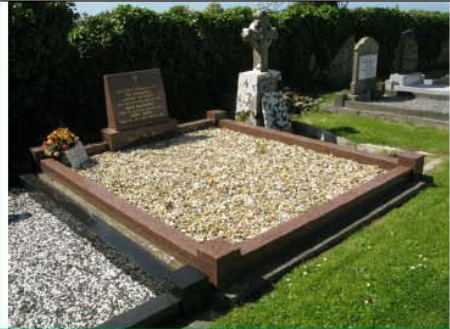
Grave_No	Family Name	Photo_Name
33	McCarthy	IMG_0065
Notes		
Plot in good condition, flint based gravel

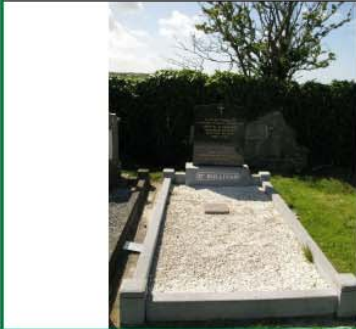
Grave_No	Family Name	Photo_Name
36	O'Sullivan	IMG_0071
Notes		
Plot in good condition

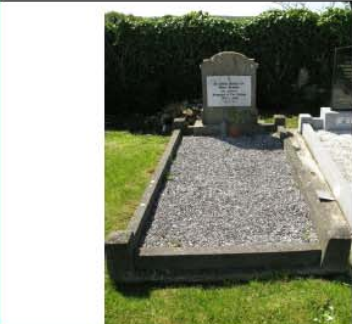
Grave_No	Family Name	Photo_Name
35	Gregan	IMG_0069
Notes		
Plot in good condition

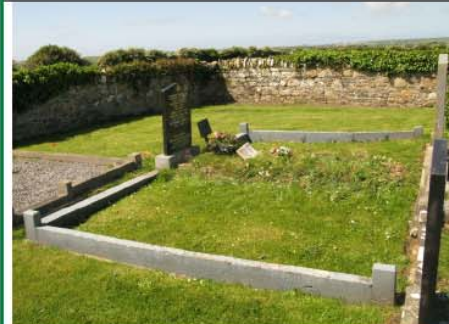
Grave_No	Family Name	Photo_Name
39	Scanlan/Guiney/Lawl	IMG_0076
Notes		
Plot in good condition

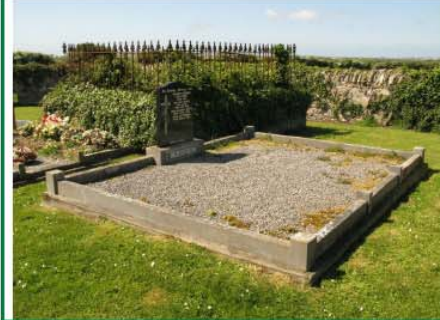
Grave_No	Family Name	Photo_Name
44	Keown	IMG_0087
Notes		
Plot in good condition, moss

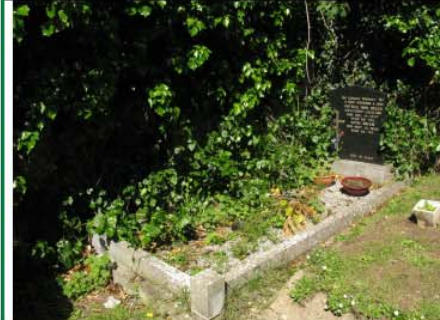
Grave_No	Family Name	Photo_Name
52	Breen	IMG_0115
Notes		
Plot in good condition

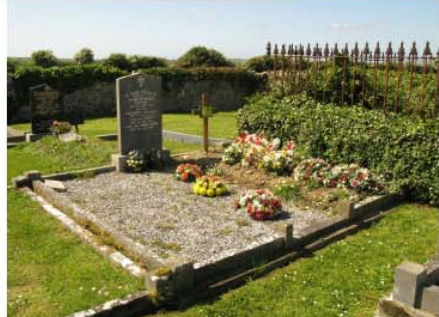
Grave_No	Family Name	Photo_Name
42	O'Connor	IMG_0083
Notes		
Plot in good condition

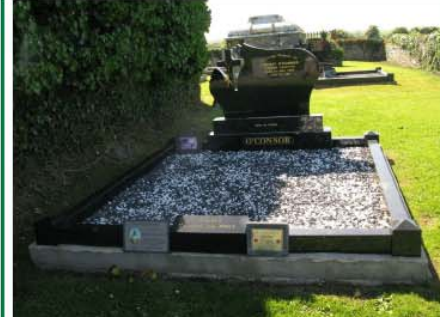
Grave_No	Family Name	Photo_Name
56	O'Connor	IMG_0120
Notes		
Plot in good condition

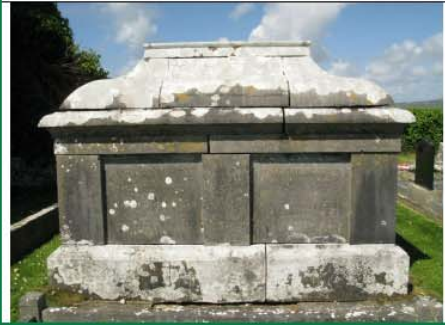
Grave_No	Family Name	Photo_Name
15	Stack	IMG_0026
Notes		
Tomb in good condition

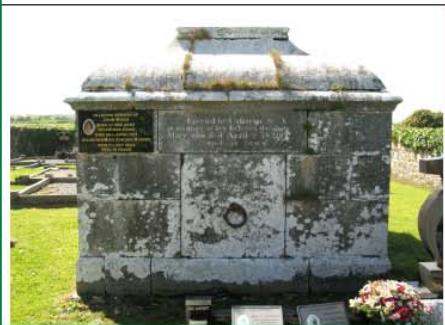
Grave_No	Family Name	Photo_Name
45	Stack	IMG_0089
Notes		
Tomb in good condition, 1870

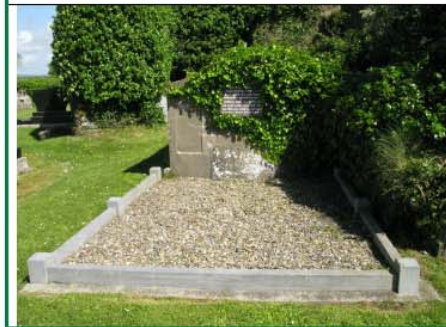
Grave_No	Family Name	Photo_Name
46	Stack/Walsh	IMG_0095
Notes		
Tomb in good condition, with court, old headstone 1799

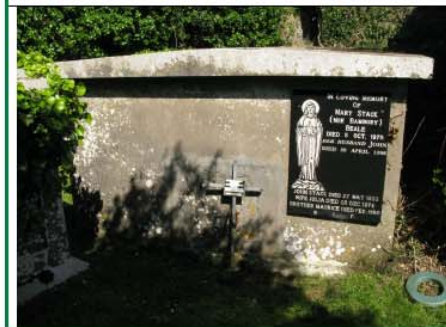
Grave_No	Family Name	Photo_Name
49	Stack	IMG_0103
Notes		
Tomb in good condition

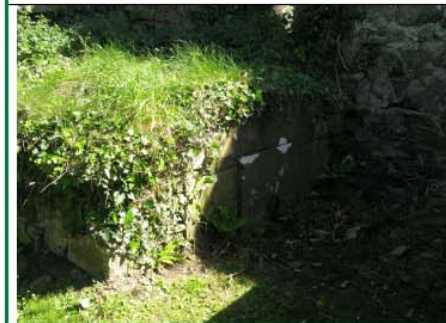
Grave_No	Family Name	Photo_Name
50	Stack	IMG_0108
Notes		
Tomb is in good condition, 1722, erected by John Stack of Kerry Arms

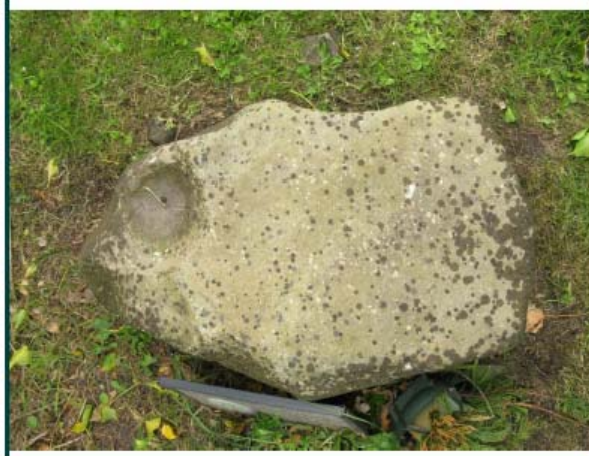
Misc Item No	Photo Name
1	IMG_0164

Notes Possible bullaun stone or shallow font, possibly used as gravemarker
--

- The Record of Monuments and Places (RMP) should be updated with the recently found font/bullaun stone.
- The publications: *Guidance for the Care, Conservation & Recording of Historic Graveyards* by the Heritage Council (October 2010). And *The Care and Conservation of Graveyards* by the Office of Public Works should be consulted prior to the carrying out of any maintenance work on the burial grounds or church.
