Project code: KCCG11
Client: Kerry County Council
Date: July 2011

Archaeological Survey of Murher, Moyvane, County Kerry

Surveyors: Ann Frykler & Robert Hanbidge
Report Author: Robert Hanbidge

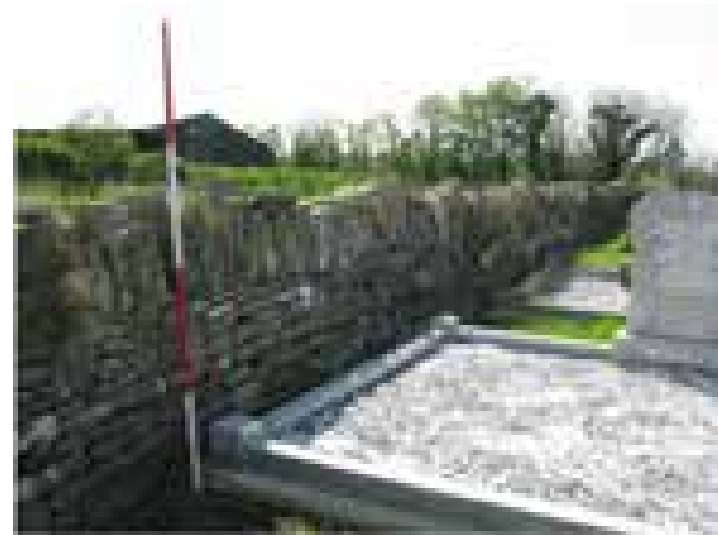
Plate 6-Showing collapse on southern boundary wall

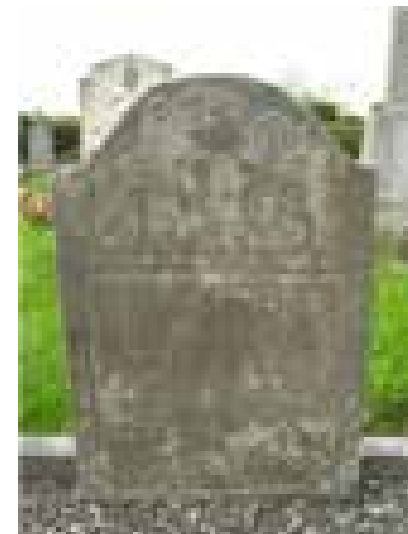
The oldest inscribed headstone with a date of 1793 belongs to Grave No. 71 (Plate 12) and commemorates Mick Hanrahan. This headstone also features some modest ornamentation which enhances its artistic value. There are a number of other graves which are from the early nineteenth century e.g. Grave Nos. 56, 67, 72, 120 ad 127.

Plate 12-View of headstone
(Grave No. 71) from east

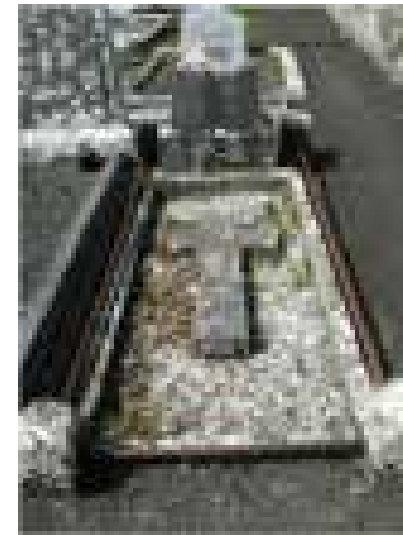
Generally most of the named headstone and plots are in good condition, however there are occasional damaged, partially illegible or broken examples scattered through the graveyard, e.g. Grave No. 172 which consists of a plot where the headstone is broken and the broken cross finial is placed on top of the plot (Plate 14).

Plate 14-View of Grave No. 172, from east

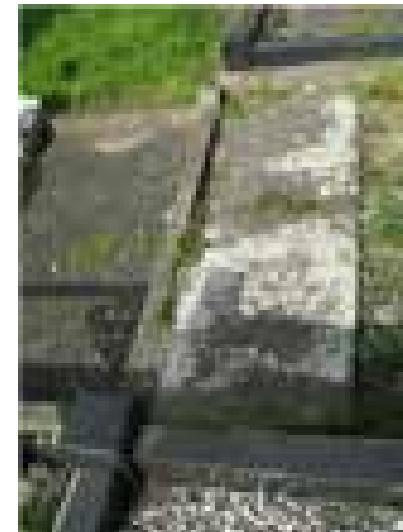
There are 11 unnamed or illegible headstones and plots at Murher Burial Ground. These take a number of different forms which include; partially overgrown plots, an un-inscribed small concrete slab indicating a burial beneath e.g. Grave No. 111 (Plate 16) and partially inscribed headstones,

Plate 16-View of Grave No. 111 from east

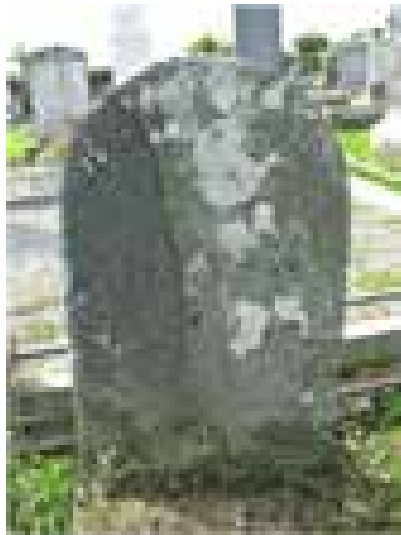
where only a small amount of lettering is visible e.g. Grave No. 94 where only a date is visible (Plate 17). Within the internal area of the church two large stone slabs placed beside each other may also present a burial (Grave No. 203).

Plate 17-View of Grave No.
94 from east

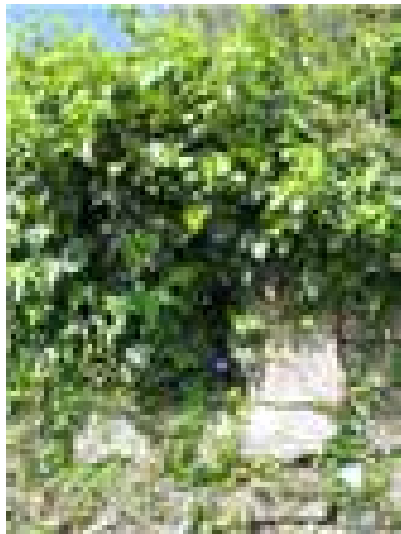
The window forms are narrow and consist of weather tooled limestone sills and surrounds (Plate 27). No voussoirs to the window.

Plate 27-View of to south elevation of church

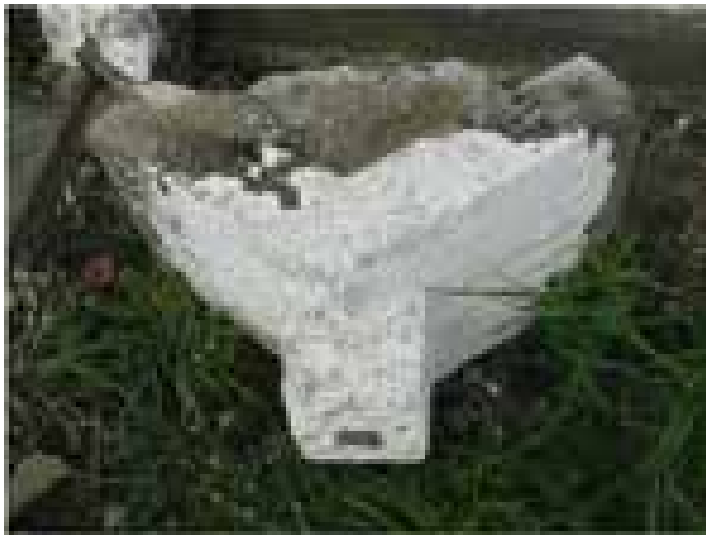
Miscellaneous No. 02: Consists of an apex stone block with a plinth (also known as an acroterion) (Plate 29) which was located at the gable end at the apex level of a pitched roof. The hole in the centre of the plinth would have originally accommodated a stone/iron finial, possibly a cross. This piece may be associated with the roof of the church and indicates that the gable ends most likely had tooled limestone coping. The location of this item to the east of the church supports this idea.

Plate 29-View of Apex of coping with acroterion
(Miscellaneous Items No. 2) from above

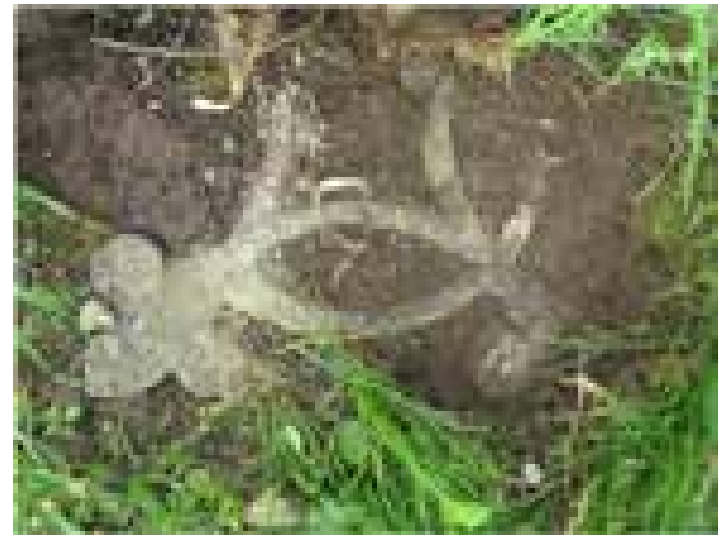
Miscellaneous No. 03: Located close to the Miscellaneous No. 02 is a broken piece of a finely tooled stone finial (Plate 30). This finial may have formed the finial of the church roof.

Plate 30-View of Finial (Miscellaneous Items No. 3) from
above

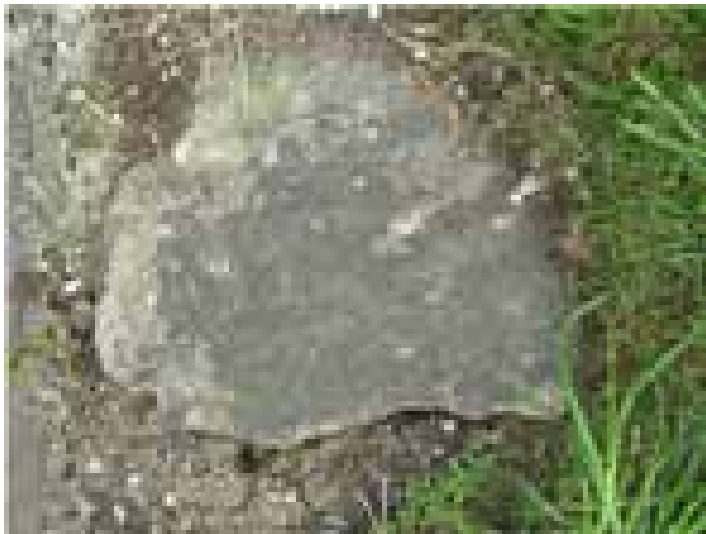
Miscellaneous No. 04: Located close to Miscellaneous Nos. 02 and 03 is an unusual carved stone slab (Plate 31). This broken stone has a drilled hole at one end. The exact function of this stone is unknown, it may possibly represent a wall mounted plaque or a more elaborate headstone.

Plate 31-View of Roof tile (Miscellaneous Items No. 4)
from above

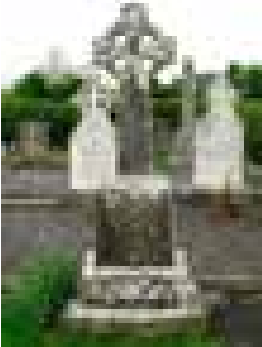
Grave_No	Family Name	Photo_Name
81	Guiney	IMG_0157
Notes		
Headstone in moderate condition, plaque has fallen off

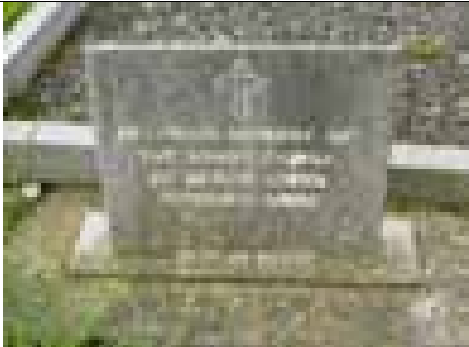
Grave_No	Family Name	Photo_Name
74	Grady	IMG_0144
Notes		
Single headstone

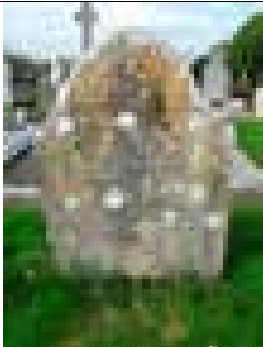
Grave_No	Family Name	Photo_Name
149	Hayes	IMG_0305
Notes		
Headstone from 1842

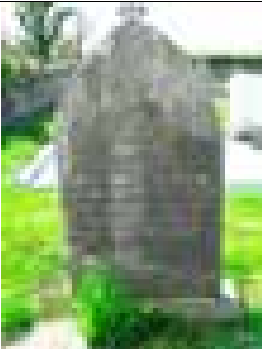
Grave_No	Family Name	Photo_Name
78	Hudson	IMG_0152
Notes		
Single headstone

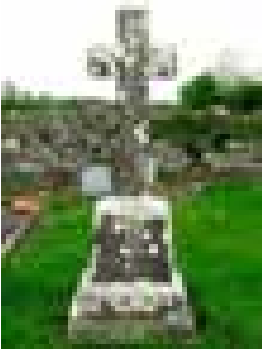
Grave_No	Family Name	Photo_Name
28	Keane	IMG_0052
Notes		
Single headstone

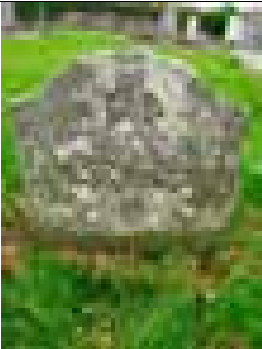
Grave_No	Family Name	Photo_Name
56	Kennelly	IMG_0113
Notes		
Headstone from 1802 in moderate condition upper parts are weathered

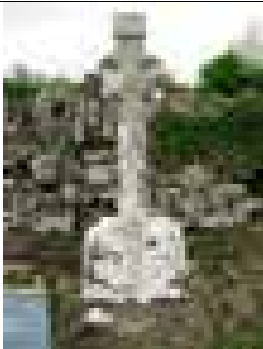
Grave_No	Family Name	Photo_Name
6	Maher	IMG_0011
Notes		
Single headstone

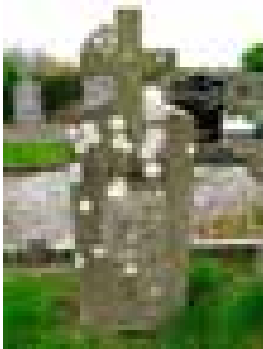
Grave_No	Family Name	Photo_Name
41	McCulhane	IMG_0081
Notes		
Single headstone

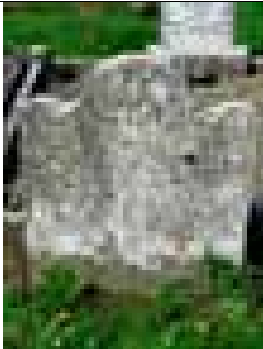
Grave_No	Family Name	Photo_Name
156	Moore	IMG_0321
Notes		
Headstone from 1832 partly illegible

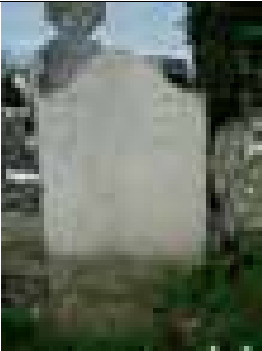
Grave_No	Family Name	Photo_Name
127	Mulvehill	IMG_0252
Notes		
Headstone from 1811 partly illegible

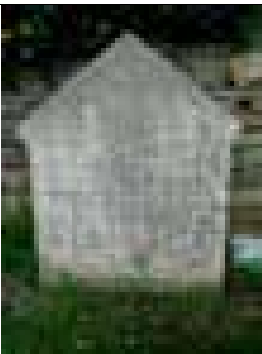
Grave_No	Family Name	Photo_Name
128	Mulvihill	IMG_0253
Notes		
Single headstone

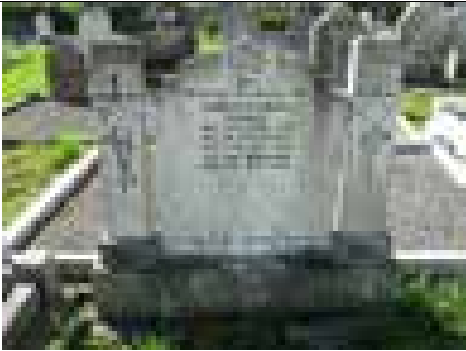
Grave_No	Family Name	Photo_Name
86	O'Connell	IMG_0167
Notes		
Single headstone

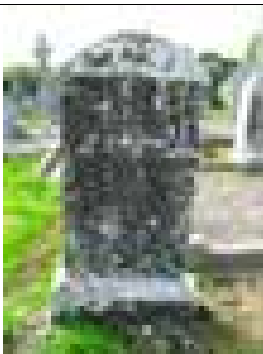
Grave_No	Family Name	Photo_Name
90	O'Connor	IMG_0176
Notes		
Single headstone

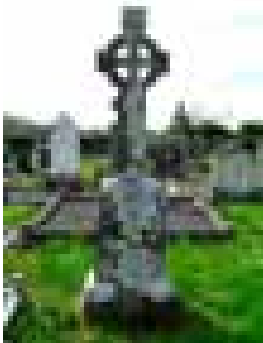
Grave_No	Family Name	Photo_Name
92	O'Connor	IMG_0178
Notes		
Single headstone

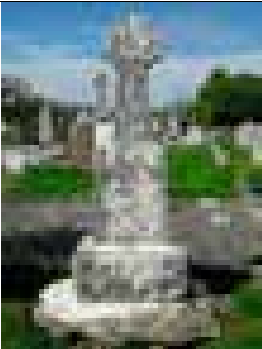
Grave_No	Family Name	Photo_Name
159	O'Connor	IMG_0325
Notes		
Single headstone

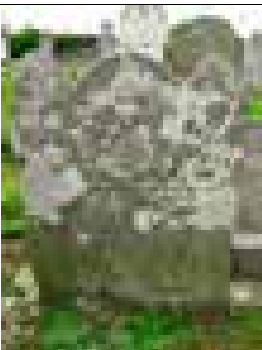
Grave_No	Family Name	Photo_Name
72	Rioidan	IMG_0141
Notes		
Headstone from 1800 weathered and becoming illegible

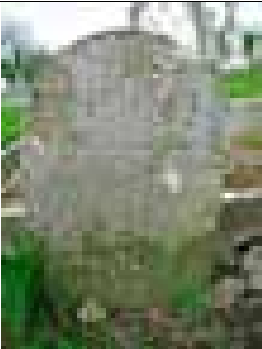
Grave_No	Family Name	Photo_Name
120	Shanahan	IMG_0237
Notes		
Headstone from 1812, partly illegible

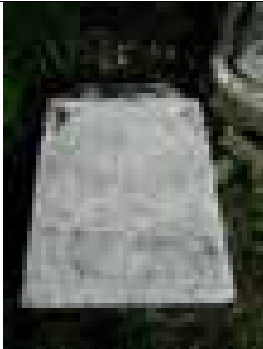
Grave_No	Family Name	Photo_Name
115	Shine	IMG_0227
Notes		
Broken headstone, cross and plinth in one pile, named part of headstone to the south of grave 116

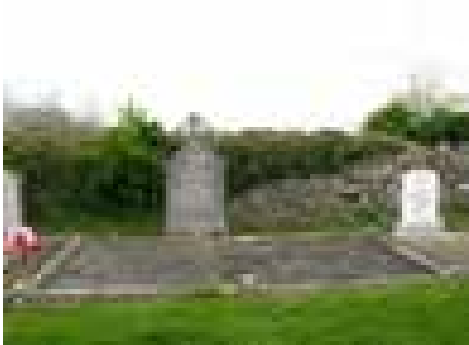
Grave_No	Family Name	Photo_Name
11	Ahern	IMG_0020
Notes		
Plot in good condition

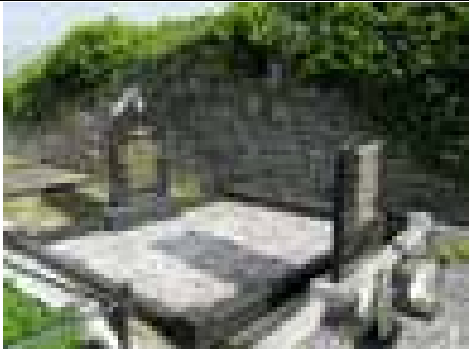
Grave_No	Family Name	Photo_Name
112	Ahern	IMG_0220
Notes		
Plot in good condition

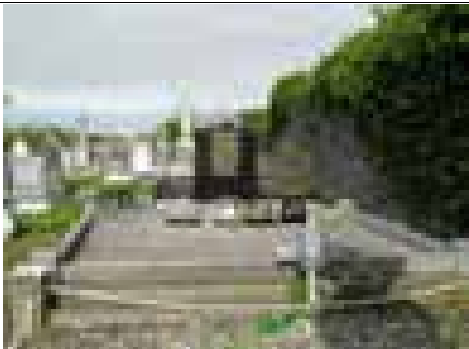
Grave_No	Family Name	Photo_Name
114	Ahern	IMG_0224
Notes		
Plot in good condition

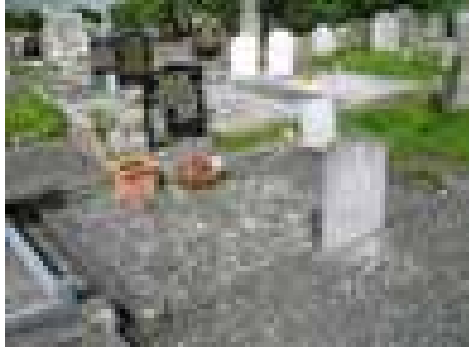
Grave_No	Family Name	Photo_Name
146	Ahern	IMG_0299
Notes		
Plot in good condition

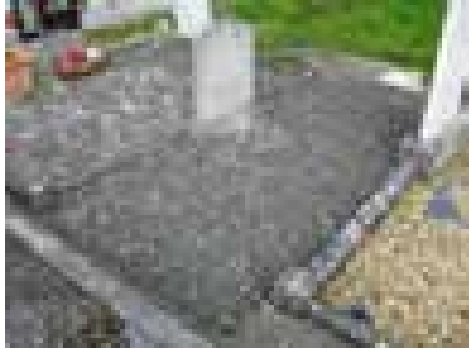
Grave_No	Family Name	Photo_Name
147	Ahern	IMG_0301
Notes		
Plot in good condition

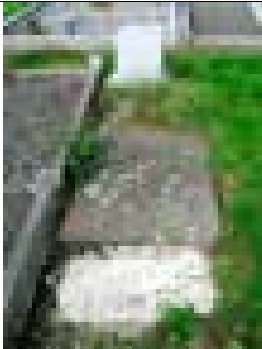
Grave_No	Family Name	Photo_Name
148	Ahern	IMG_0303
Notes		
Plot in moderate condition

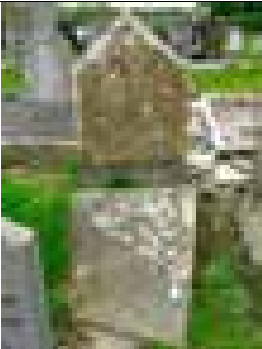
Grave_No	Family Name	Photo_Name
62	Barrett	IMG_0122
Notes		
Headstone from 1869

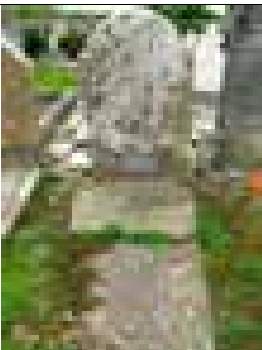
Grave_No	Family Name	Photo_Name
63	Barrett	IMG_0125
Notes		
Plot covered by large stone slab with modern plaque attached to old headstone.

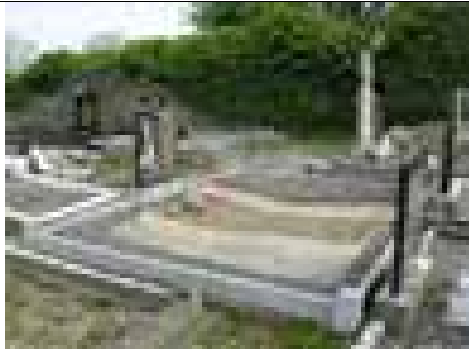
Grave_No	Family Name	Photo_Name
118	Barry/Dowling	IMG_0233
Notes		
Moderate condition, concrete basin subsiding

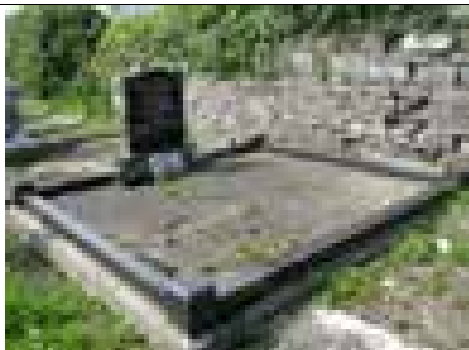
Grave_No	Family Name	Photo_Name
89	Brandon	IMG_0174
Notes		
Plot in good condition

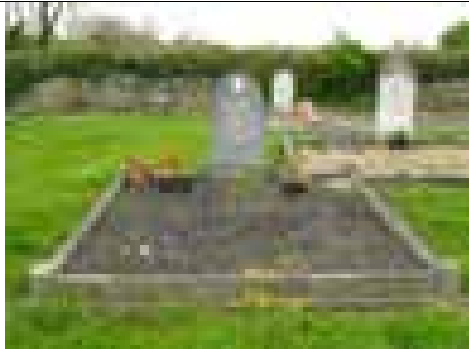
Grave_No	Family Name	Photo_Name
23	Buckley	IMG_0039
Notes		
Plot in good condition

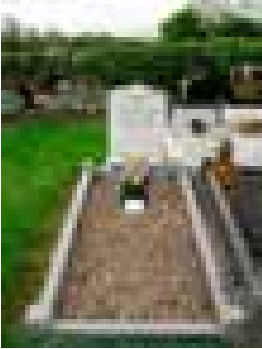
Grave_No	Family Name	Photo_Name
31	Buckley	IMG_0057
Notes		
Plot in good condition

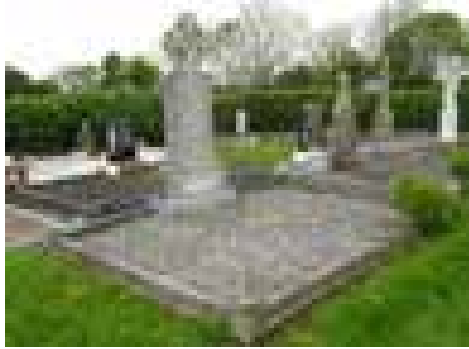
Grave_No	Family Name	Photo_Name
30	Buckley/O'Connell	IMG_0055
Notes		
Plot in good condition

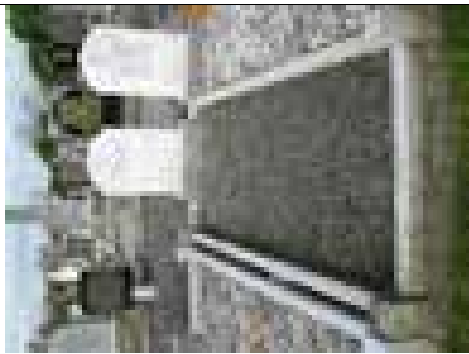
Grave_No	Family Name	Photo_Name
133	Bunce	IMG_0269
Notes		
Plot in good condition

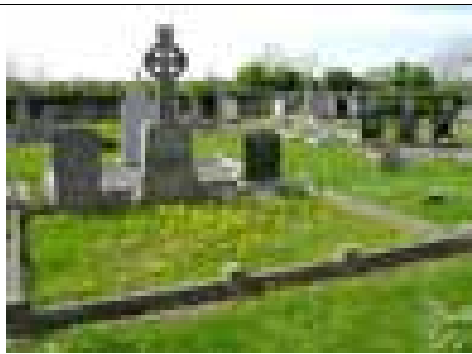
Grave_No	Family Name	Photo_Name
76	Carmody	IMG_0146
Notes		
Southern headstone mentions IRA, plot in moderate condition, grass growth

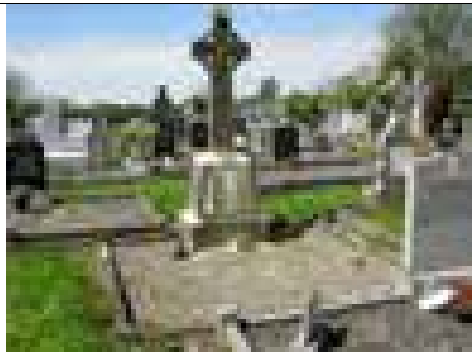
Grave_No	Family Name	Photo_Name
179	Carr	IMG_0387
Notes		
Plot in good condition

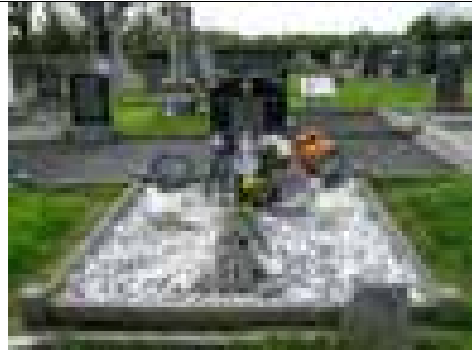
Grave_No	Family Name	Photo_Name
96	Collins	IMG_0183
Notes		
Plot in good condition

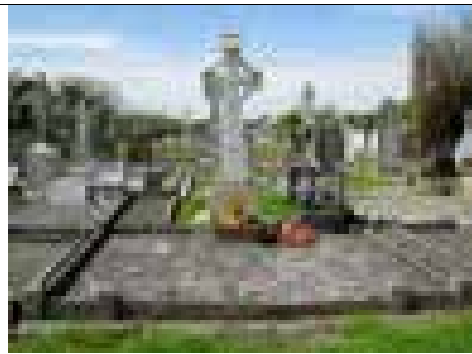
Grave_No	Family Name	Photo_Name
176	Collins	IMG_0380
Notes		
Plot in good condition

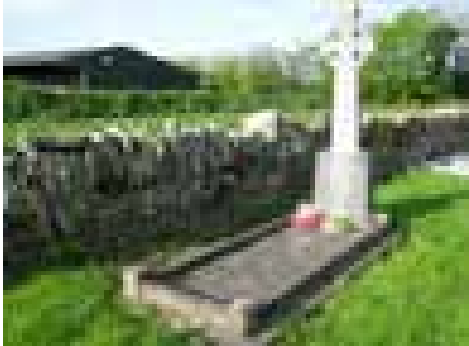
Grave_No	Family Name	Photo_Name
102	Culhane	IMG_0196
Notes		
Plot in good condition

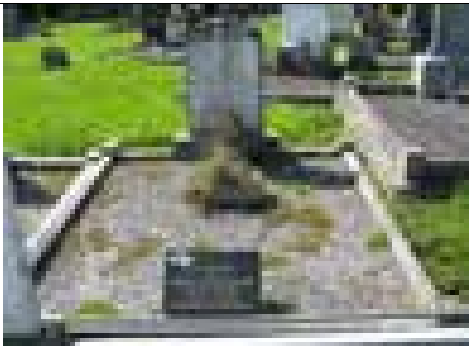
Grave_No	Family Name	Photo_Name
84	Culhane/Connor	IMG_0162
Notes		
Plot in good condition, some weeds

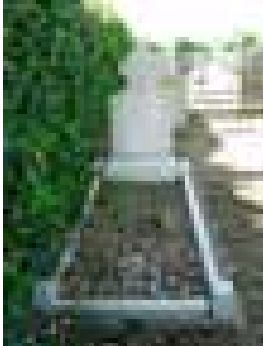
Grave_No	Family Name	Photo_Name
211	Cunningham	IMG_0472
Notes		
Plot in good condition, some weeds

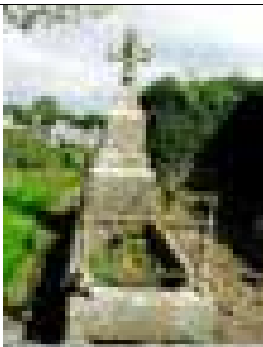
Grave_No	Family Name	Photo_Name
212	Cunningham	IMG_0474
Notes		
Moderate condition, plinths are disturbed and parts of the cast / wrought iron fence are broken

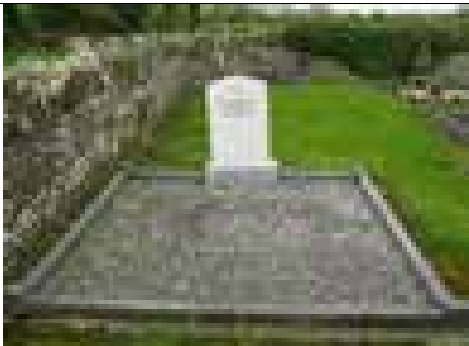
Grave_No	Family Name	Photo_Name
131	Dore/O'Connor	IMG_0262
Notes		
Overgrown plot in moderate condition

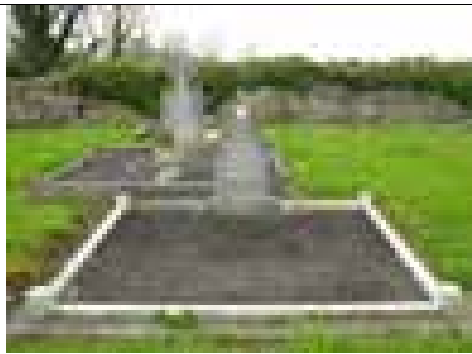
Grave_No	Family Name	Photo_Name
1	Dunne	IMG_0001
Notes		
Plot in good condition

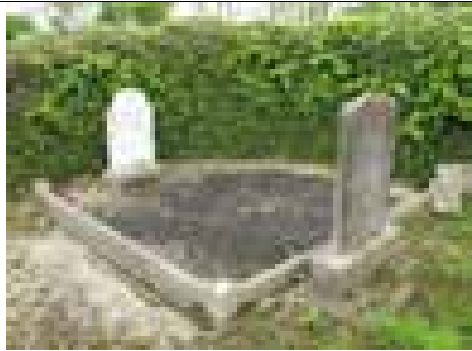
Grave_No	Family Name	Photo_Name
34	Enright	IMG_0064
Notes		
Plot in good condition

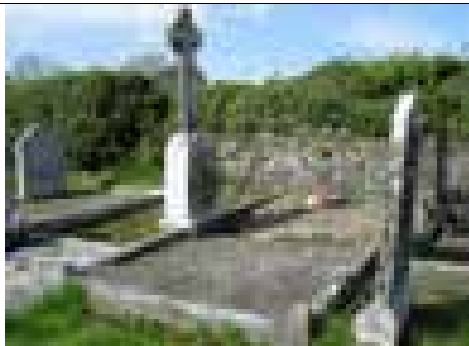
Grave_No	Family Name	Photo_Name
88	Guiney	IMG_0171
Notes		
Plot in moderate condition

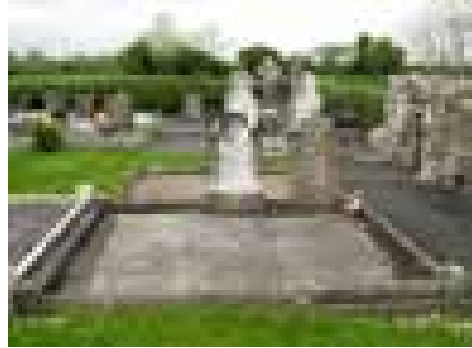
Grave_No	Family Name	Photo_Name
70	Hanrahan	IMG_0136
Notes		
Plot in good condition

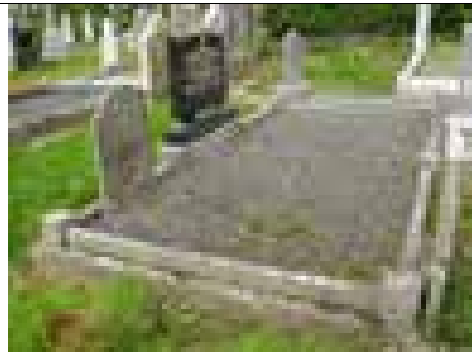
Grave_No	Family Name	Photo_Name
71	Hanrahan	IMG_0138
Notes		
Old headstone date 1793

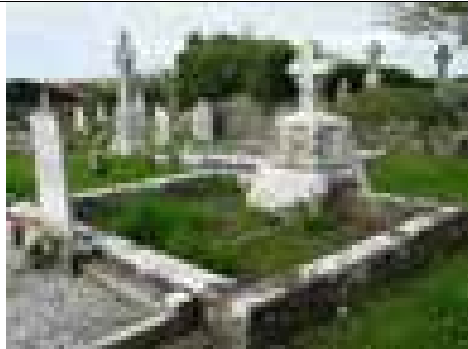
Grave_No	Family Name	Photo_Name
130	Hayes	IMG_0256
Notes		
Plot in moderate condition, appears to have been sprayed, soil is subsiding from the plot plinths

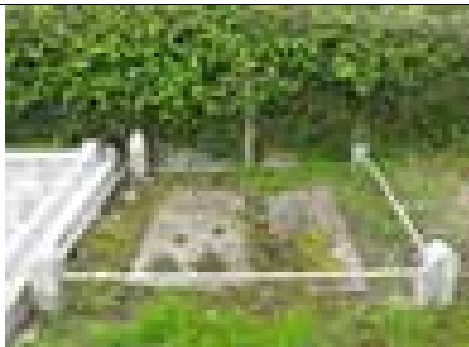
Grave_No	Family Name	Photo_Name
3	Long	IMG_0004
Notes		
Plot in moderate condition

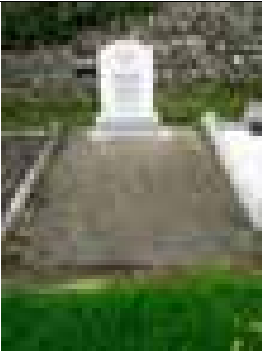
Grave_No	Family Name	Photo_Name
10	Mulvihill	IMG_0018
Notes		
Plot in moderate condition, concrete cracked and subsiding

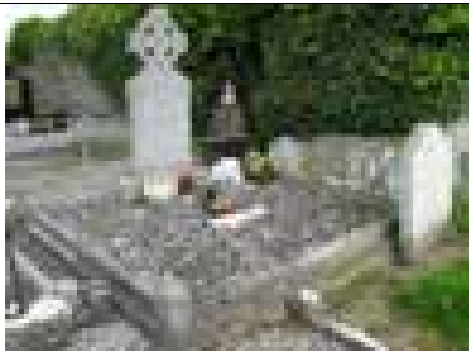
Grave_No	Family Name	Photo_Name
126	Mulvihill	IMG_0249
Notes		
Plot in good condition

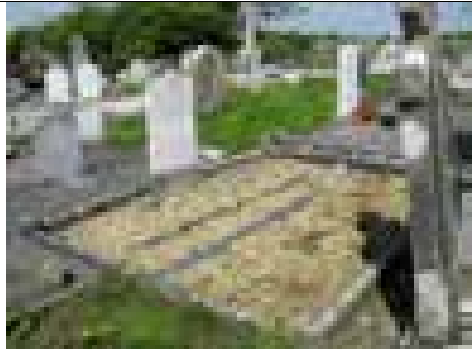
Grave_No	Family Name	Photo_Name
161	Mulvihill	IMG_0328
Notes		
Good condition, plastic membrane is visible through gravel, hollow flint scraper was found in gravel

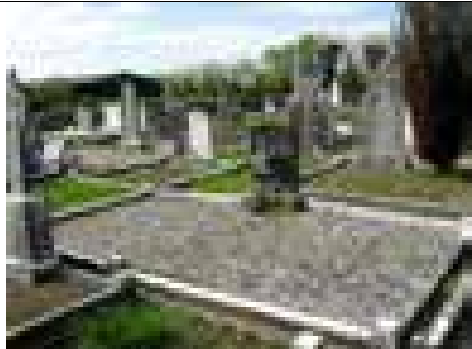
Grave_No	Family Name	Photo_Name
168	Mulvihill	IMG_0353
Notes		
Plot in good condition some weeds

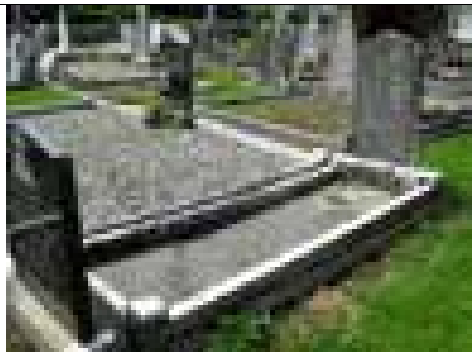
Grave_No	Family Name	Photo_Name
169	Mulvihill	IMG_0355
Notes		
Plot in good condition

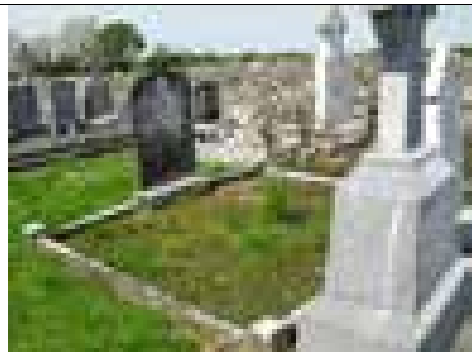
Grave_No	Family Name	Photo_Name
188	Mulvihill	IMG_0415
Notes		
Plot in moderate condition

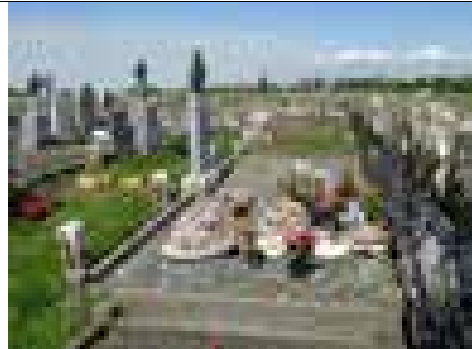
Grave_No	Family Name	Photo_Name
192	Mulvihill	IMG_0424
Notes		
Large plot in good condition

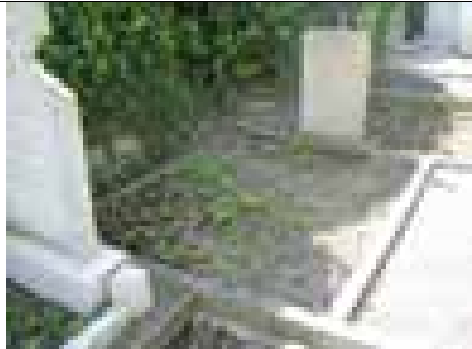
Grave_No	Family Name	Photo_Name
209	Mulvihill	IMG_0467
Notes		
Plot in good condition, some overgrowth

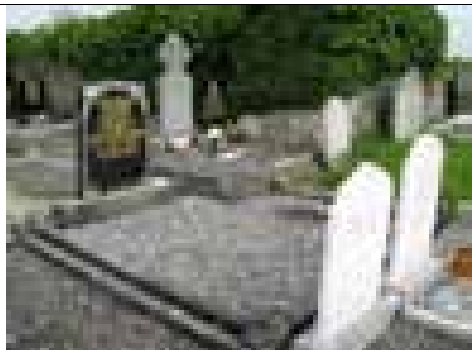
Grave_No	Family Name	Photo_Name
125	Mulvihill/O'Connor	IMG_0246
Notes		
Plot in good condition

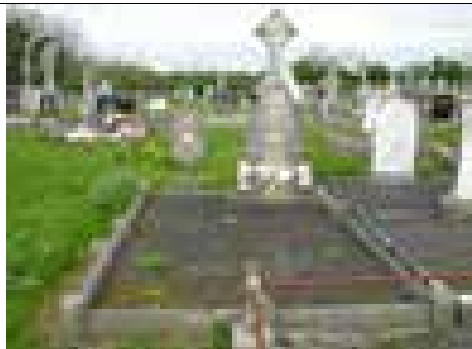
Grave_No	Family Name	Photo_Name
122	Nolan	IMG_0240
Notes		
Plot in good condition

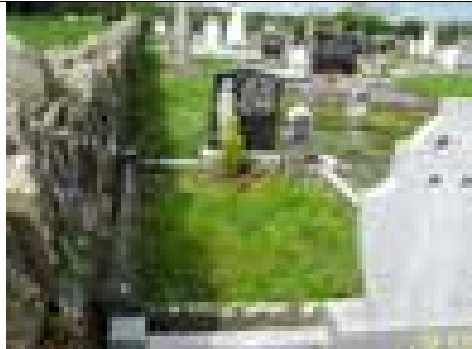
Grave_No	Family Name	Photo_Name
139	Nolan	IMG_0280
Notes		
Plot in good condition

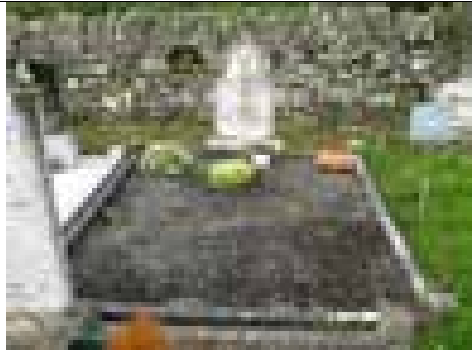
Grave_No	Family Name	Photo_Name
8	O'Connell	IMG_0014
Notes		
Plot in good condition

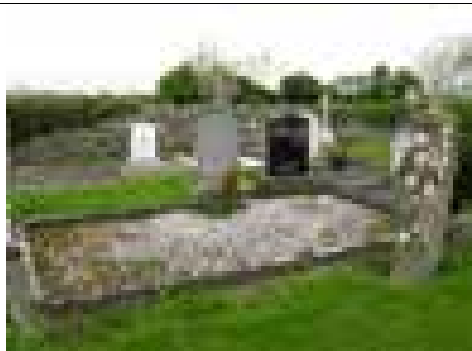
Grave_No	Family Name	Photo_Name
25	O'Connor	IMG_0044
Notes		
Plot in good condition, some weeds

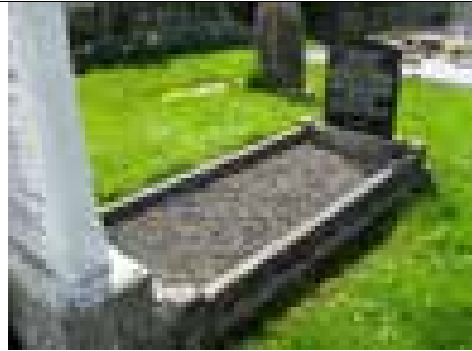
Grave_No	Family Name	Photo_Name
77	O'Connor	IMG_0150
Notes		
Plot in good condition

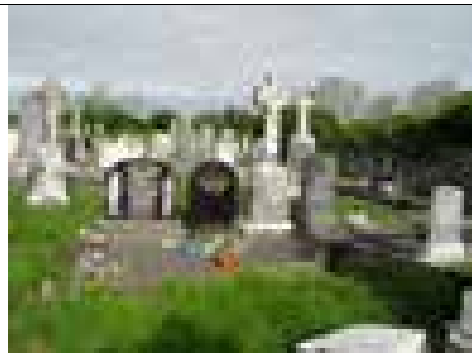
Grave_No	Family Name	Photo_Name
110	O'Connor	IMG_0214
Notes		
Plot in good condition

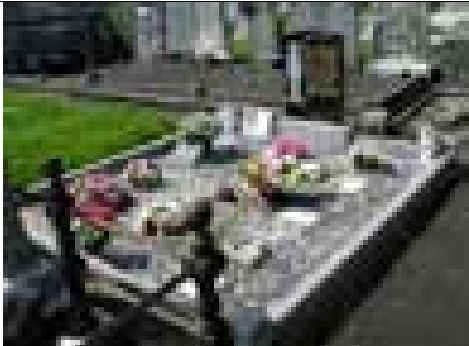
Grave_No	Family Name	Photo_Name
173	O'Connor	IMG_0374
Notes		
Plot in good condition

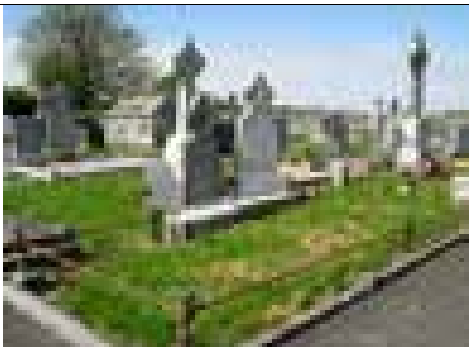
Grave_No	Family Name	Photo_Name
194	O'Connor	IMG_0428
Notes		
Plot in moderate condition

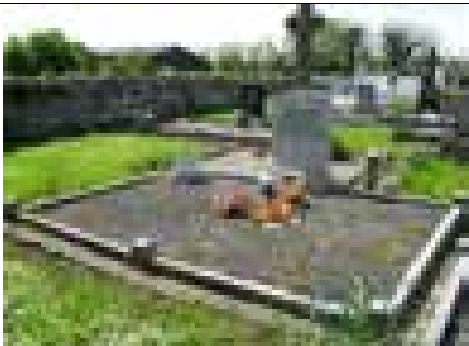
Grave_No	Family Name	Photo_Name
198	O'Connor	IMG_0439
Notes		
Plot in good condition some weeds

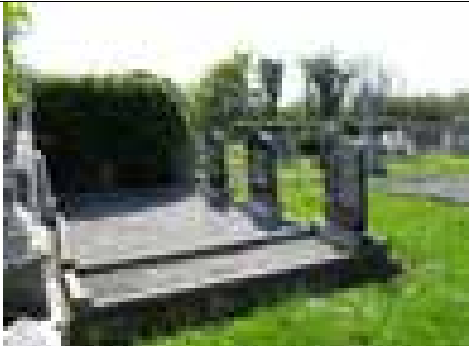
Grave_No	Family Name	Photo_Name
200	O'Connor	IMG_0442
Notes		
Plot in good condition

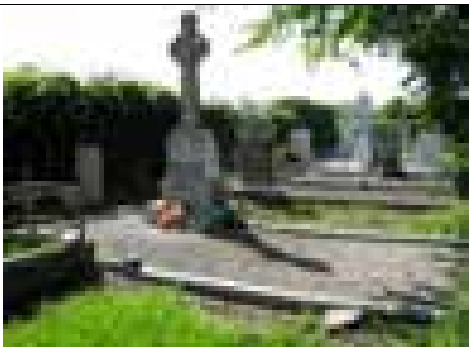
Grave_No	Family Name	Photo_Name
210	O'Connor	IMG_0469
Notes		
Plot in good condition

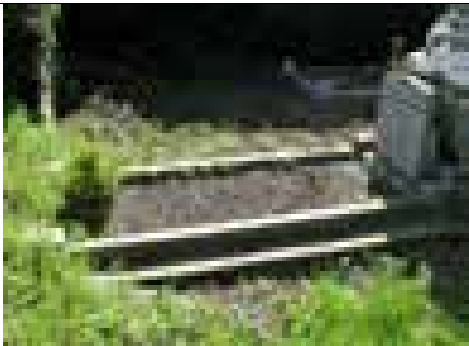
Grave_No	Family Name	Photo_Name
213	O'Gorman	IMG_0476
Notes		
Plot in good condition

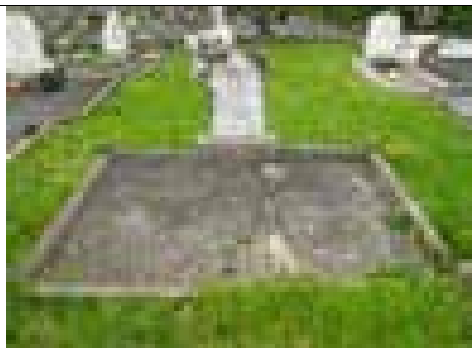
Grave_No	Family Name	Photo_Name
29	O'Grady	IMG_0053
Notes		
Plot in moderate condition, concrete subsiding

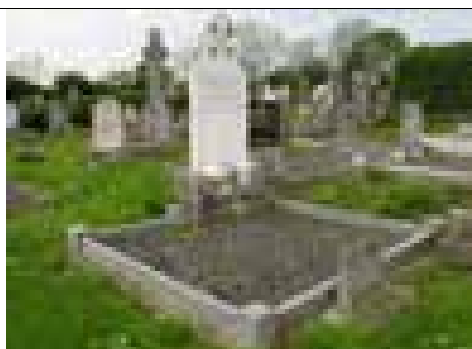
Grave_No	Family Name	Photo_Name
73	O'Sullivan	IMG_0142
Notes		
Plot in good condition

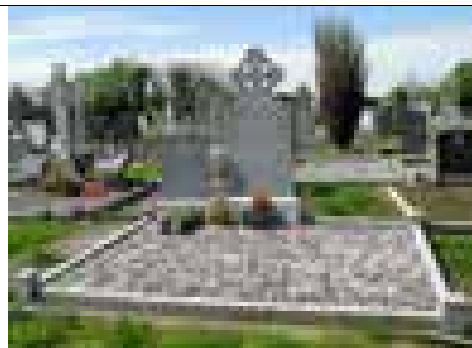
Grave_No	Family Name	Photo_Name
183	O'Sullivan	IMG_0397
Notes		
Plot in good condition

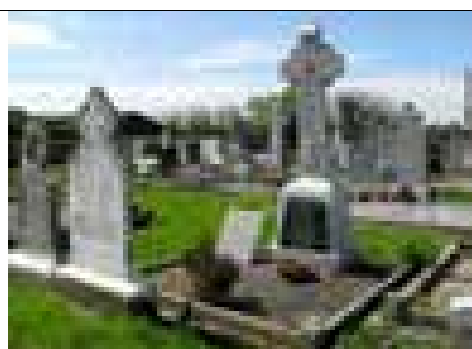
Grave_No	Family Name	Photo_Name
182	O'SullivanWhite	IMG_0394
Notes		
Plot in good condition

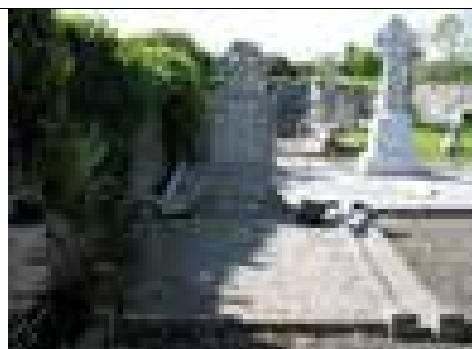
Grave_No	Family Name	Photo_Name
205	Quinn	IMG_0460
Notes		
Plot in good condition

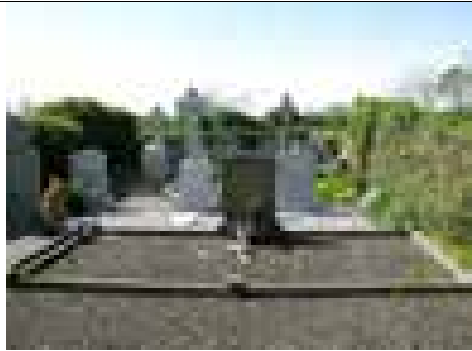
Grave_No	Family Name	Photo_Name
206	Quinn	IMG_0462
Notes		
Plot in good condition

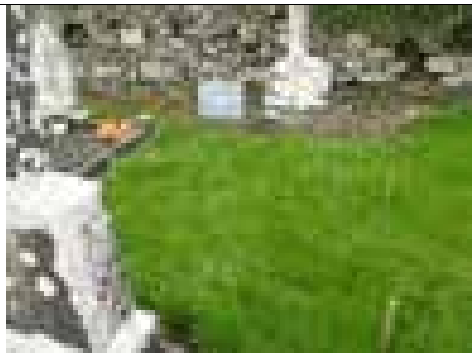
Grave_No	Family Name	Photo_Name
7	Roche	IMG_0012
Notes		
Temporarily marked out plot. Notice present stating that a plot and headstone will be erected here

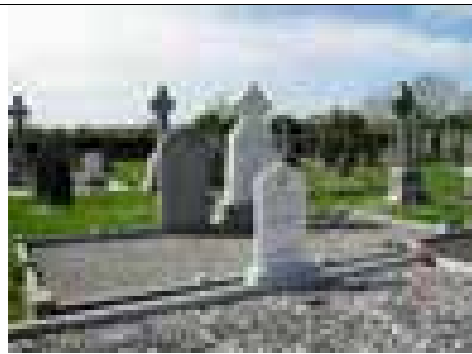
Grave_No	Family Name	Photo_Name
80	Scanlan	IMG_0154
Notes		
Plot in good condition

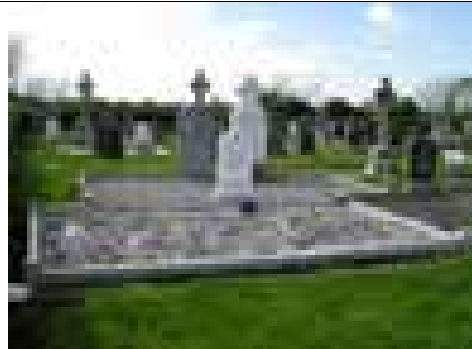
Grave_No	Family Name	Photo_Name
100	Scanlan	IMG_0192
Notes		
Plot in good condition

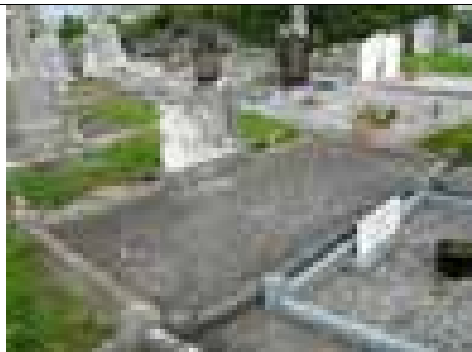
Grave_No	Family Name	Photo_Name
136	Scanlan	IMG_0276
Notes		
Plot in good condition

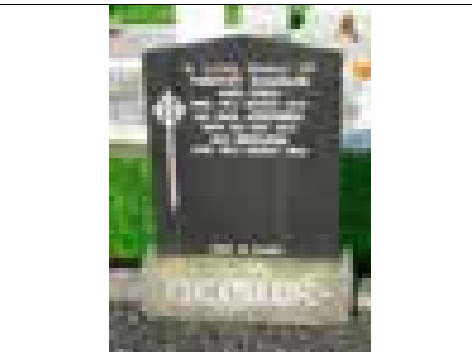
Grave_No	Family Name	Photo_Name
101	Scanlon	IMG_0195
Notes		
Plot in good condition

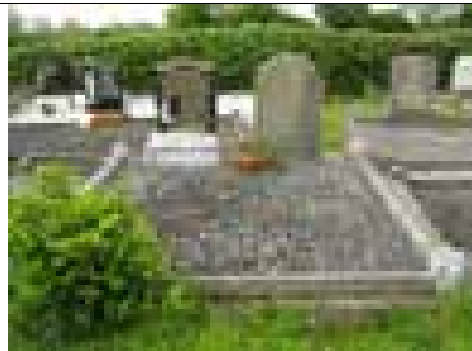
Grave_No	Family Name	Photo_Name
33	Shanahan	IMG_0061
Notes		
Plot in good condition, old headstone 1882/1881 the n in one of the names is written backwards

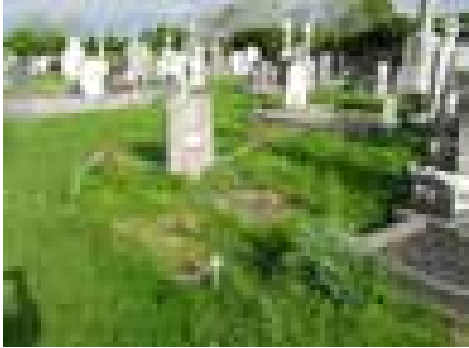
Grave_No	Family Name	Photo_Name
107	Shanahan	IMG_0206
Notes		
Overgrown plot in moderate condition, stone slabs are subsiding

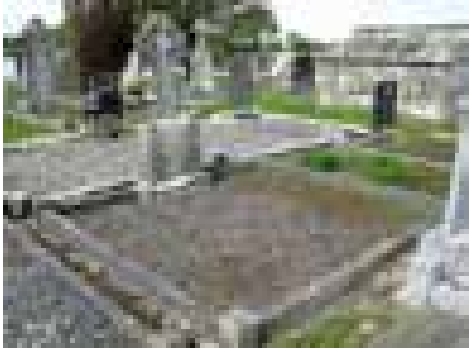
Grave_No	Family Name	Photo_Name
175	Shanahan	IMG_0378
Notes		
Plot in good condition some weeds

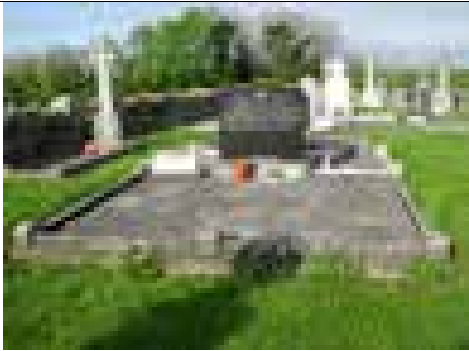
Grave_No	Family Name	Photo_Name
105	Sheahan	IMG_0202
Notes		
Southern headstone for Patrick Sheahan, New York CPL 7 INF 3 INF DIV Korea PH

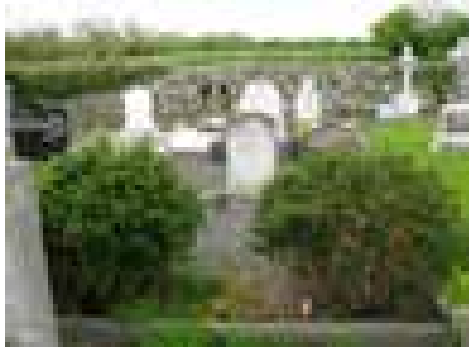
Grave_No	Family Name	Photo_Name
26	Sheehan	IMG_0047
Notes		
Plot in good condition, some weeds/moss

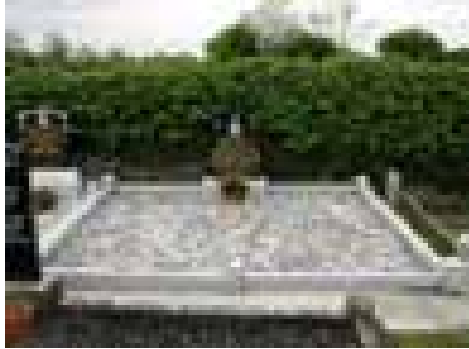
Grave_No	Family Name	Photo_Name
4	Shine	IMG_0006
Notes		
Plot in good condition

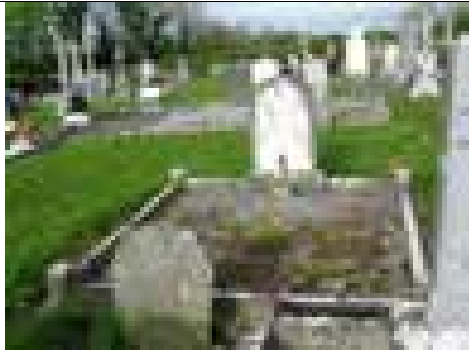
Grave_No	Family Name	Photo_Name
108	Shine	IMG_0210
Notes		
Plot in good condition, some moss and weeds

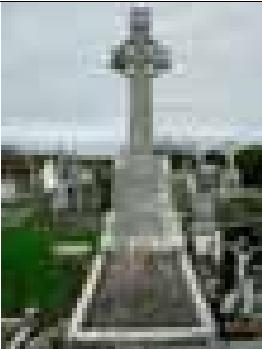
Grave_No	Family Name	Photo_Name
116	Shine	IMG_0228
Notes		
Plot in good condition

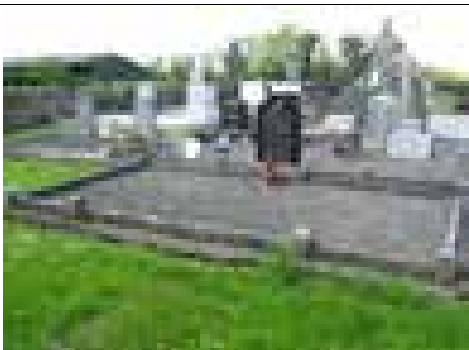
Grave_No	Family Name	Photo_Name
177	Shine	IMG_0383
Notes		
Plot in good condition some weeds

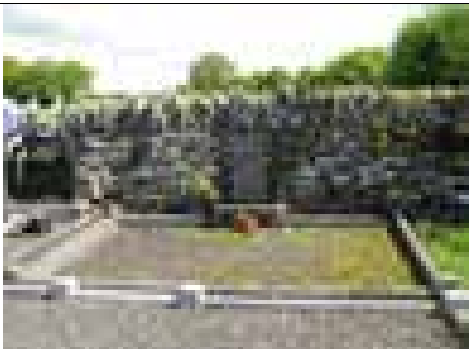
Grave_No	Family Name	Photo_Name
196	Shine	IMG_0435
Notes		
Plot in good condition some weeds and moss

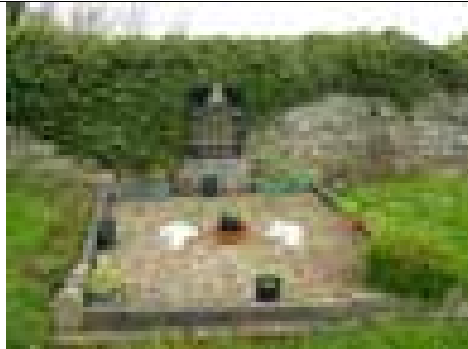
Grave_No	Family Name	Photo_Name
15	Stack	IMG_0026
Notes		
Plot in good condition, flint based plot gravel

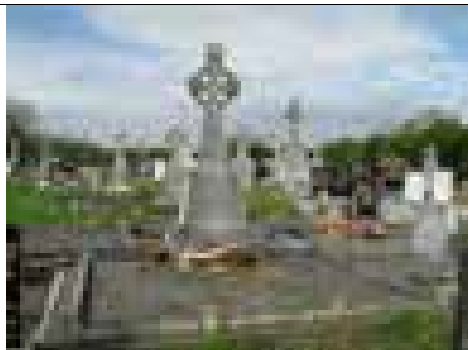
Grave_No	Family Name	Photo_Name
144	Stack	IMG_0293
Notes		
Plot in good condition some weeds

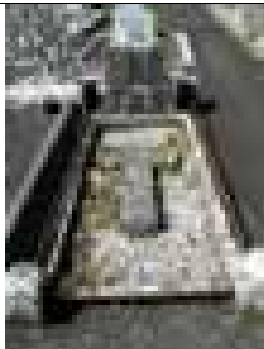
Grave_No	Family Name	Photo_Name
172	Stack	IMG_0372
Notes		
Plot in good condition, headstone broken and cross placed on top of plot

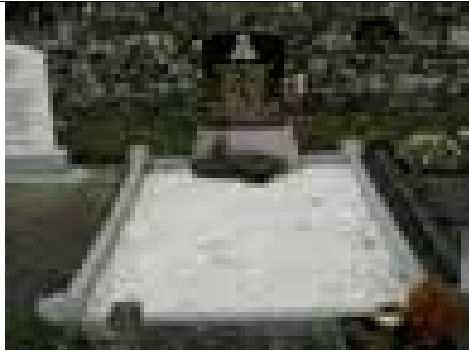
Grave_No	Family Name	Photo_Name
9	Sweeney	IMG_0016
Notes		
Plot in good condition

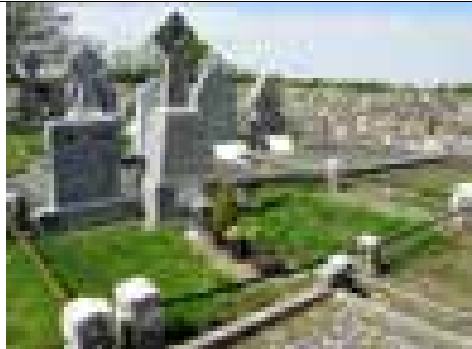
Grave_No	Family Name	Photo_Name
191	Walsh	IMG_0420
Notes		
Plot in good condition

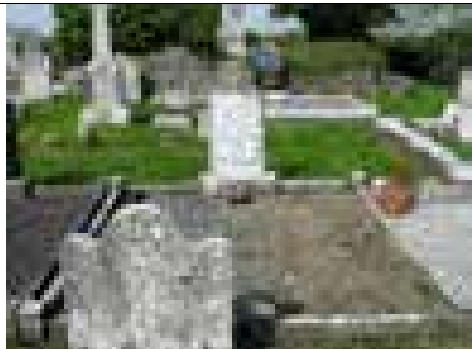
Grave_No	Family Name	Photo_Name
151	Windle	IMG_0309
Notes		
Plot in good condition

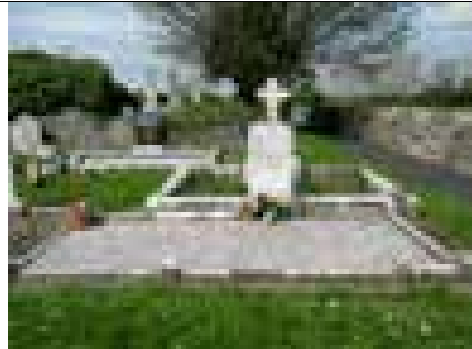
Grave_No	Family Name	Photo_Name
152	Windle	IMG_0311
Notes		
Plot in good condition

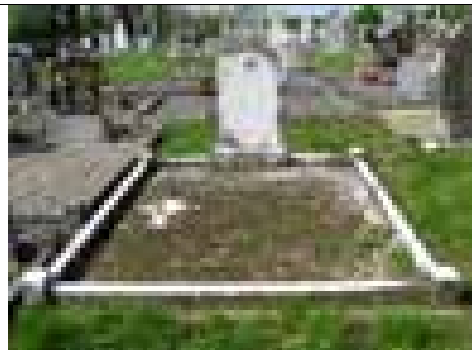
Grave_No	Family Name	Photo_Name
163	Windle	IMG_0332
Notes		
Plot in good condition, some weeds and moss

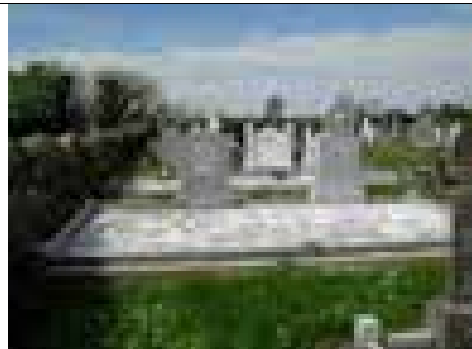
Grave_No	Family Name	Photo_Name
165	Windle	IMG_0338
Notes		
Plot in good condition

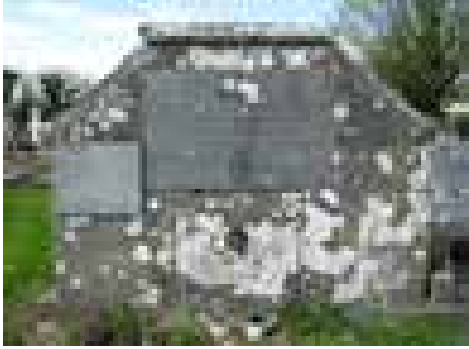
Grave_No	Family Name	Photo_Name
170	O'Connell	IMG_0357
Notes		
Tomb in good condition, 1822

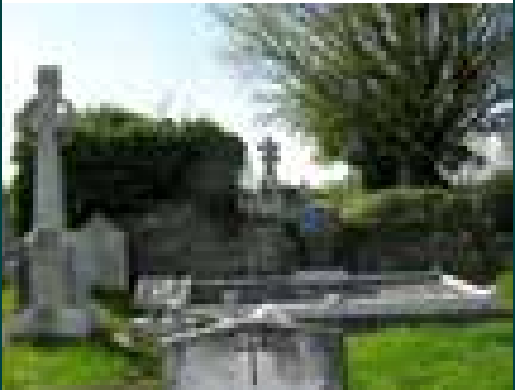
Type	Building
Misc Item No	Photo Name
5	IMG_0498
Notes	
Remains of Church ruin
